## Carburetor Icing Probability Graph – CEN24LA052

Airplane: Cessna 182C

Accident Date: 11/30/23

Accident Location: Manitowoc, WI

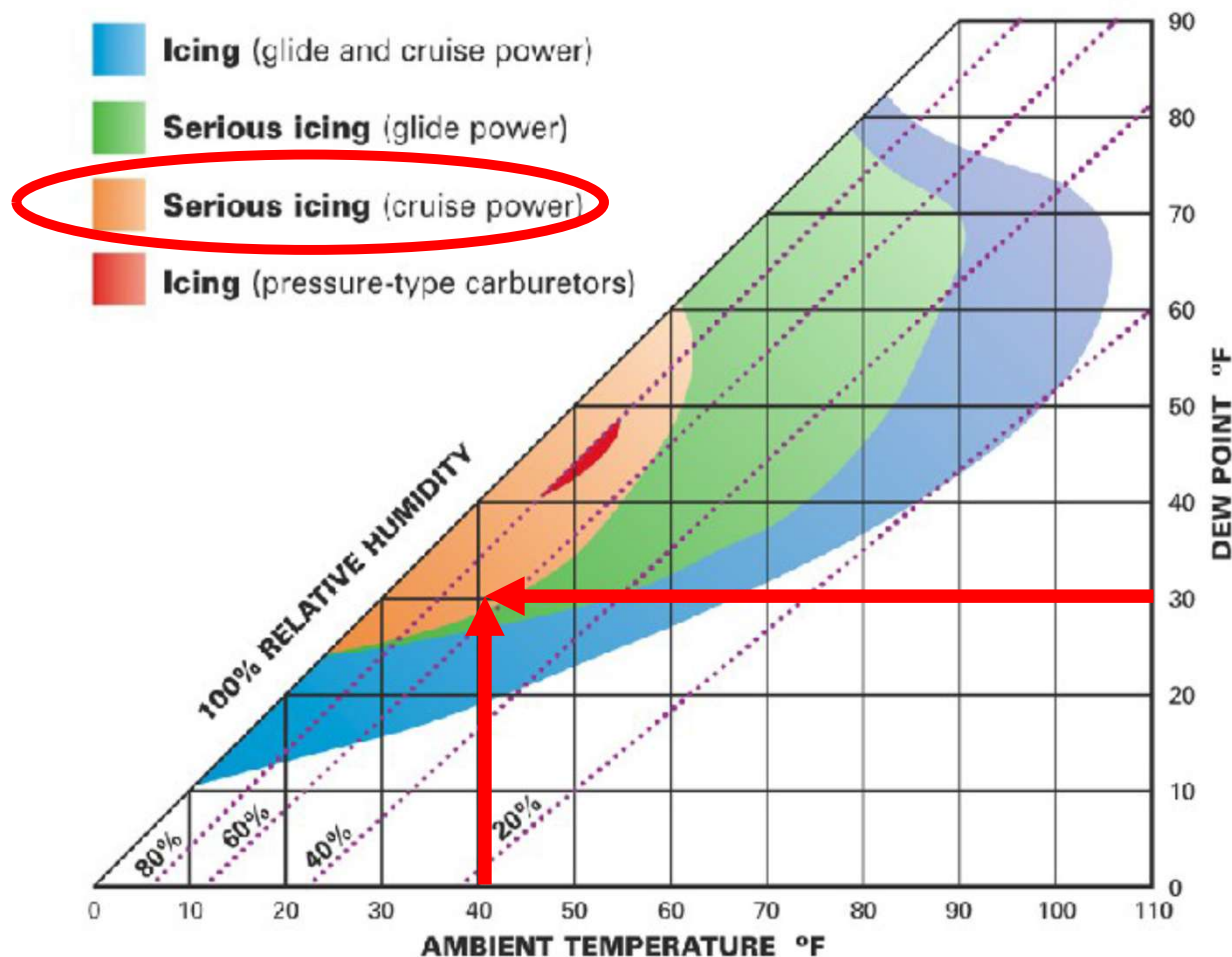
Weather: KMTW 302156Z AUTO 28005KT 10SM CLR  
05/M01 A2977 RMK AO2 SLP087 T00501011

Temperature, 5° C = 41° F

Dew Point, 1° C = 30.2° F

Special Airworthiness Information Bulletin CE-09-35

Carburetor Icing Prevention
