**From:** Olivia Fowler  
**Sent:** Friday, March 27, 2026 10:55 AM  
**To:** Daniel Bower  
**Cc:** Christopher Babcock; Deven Chen; Sean Payne; Errol R. Jordheim  
**Subject:** DCA26FA019 Email Report  
**Attachments:** Figure 2.jpg; Figure 1.jpg

**Case:** DCA26FA019

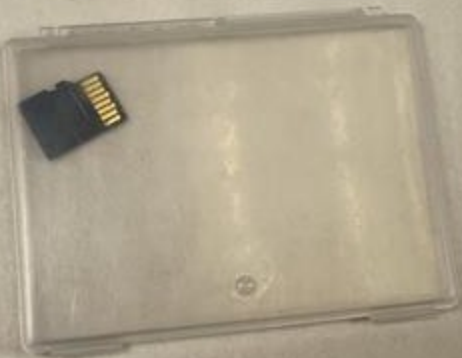
**Email Report:** The Vehicle Recorder Lab received a microSD card which had been installed in a Broadcasting Outer Module (BOM) device mounted on the accident aircraft. The microSD card appeared in good condition (figure 1) however, the microSD card was not readable using card readers. The manufacturer of the BOM device informed NTSB recorder specialists that they sourced the microSD card from a foreign online marketplace, and that there was no specific brand or manufacturer associated with it, thus there was no supporting documentation available. NTSB recorder specialists were able to read out the raw image of the microSD card by bypassing its controller and interfacing directly with its technological pad (figure 2). NTSB recorder specialists engaged a third party to attempt to reconstruct the raw image into the original CSV (comma separated value) data format. Many CSV files dated in 2024 were recovered; however, the recent data, including data from the accident flight was unable to be recovered.

According to the manufacturer, data were stored directly on the microSD card and was not stored anywhere else within the device.
