**NATIONAL TRANSPORTATION SAFETY BOARD**

**ERA14FA077**

**Figure 1 - N8372Y Flight Track Overview**

**Figure 2 - N8372Y Flight Track Final Portion**

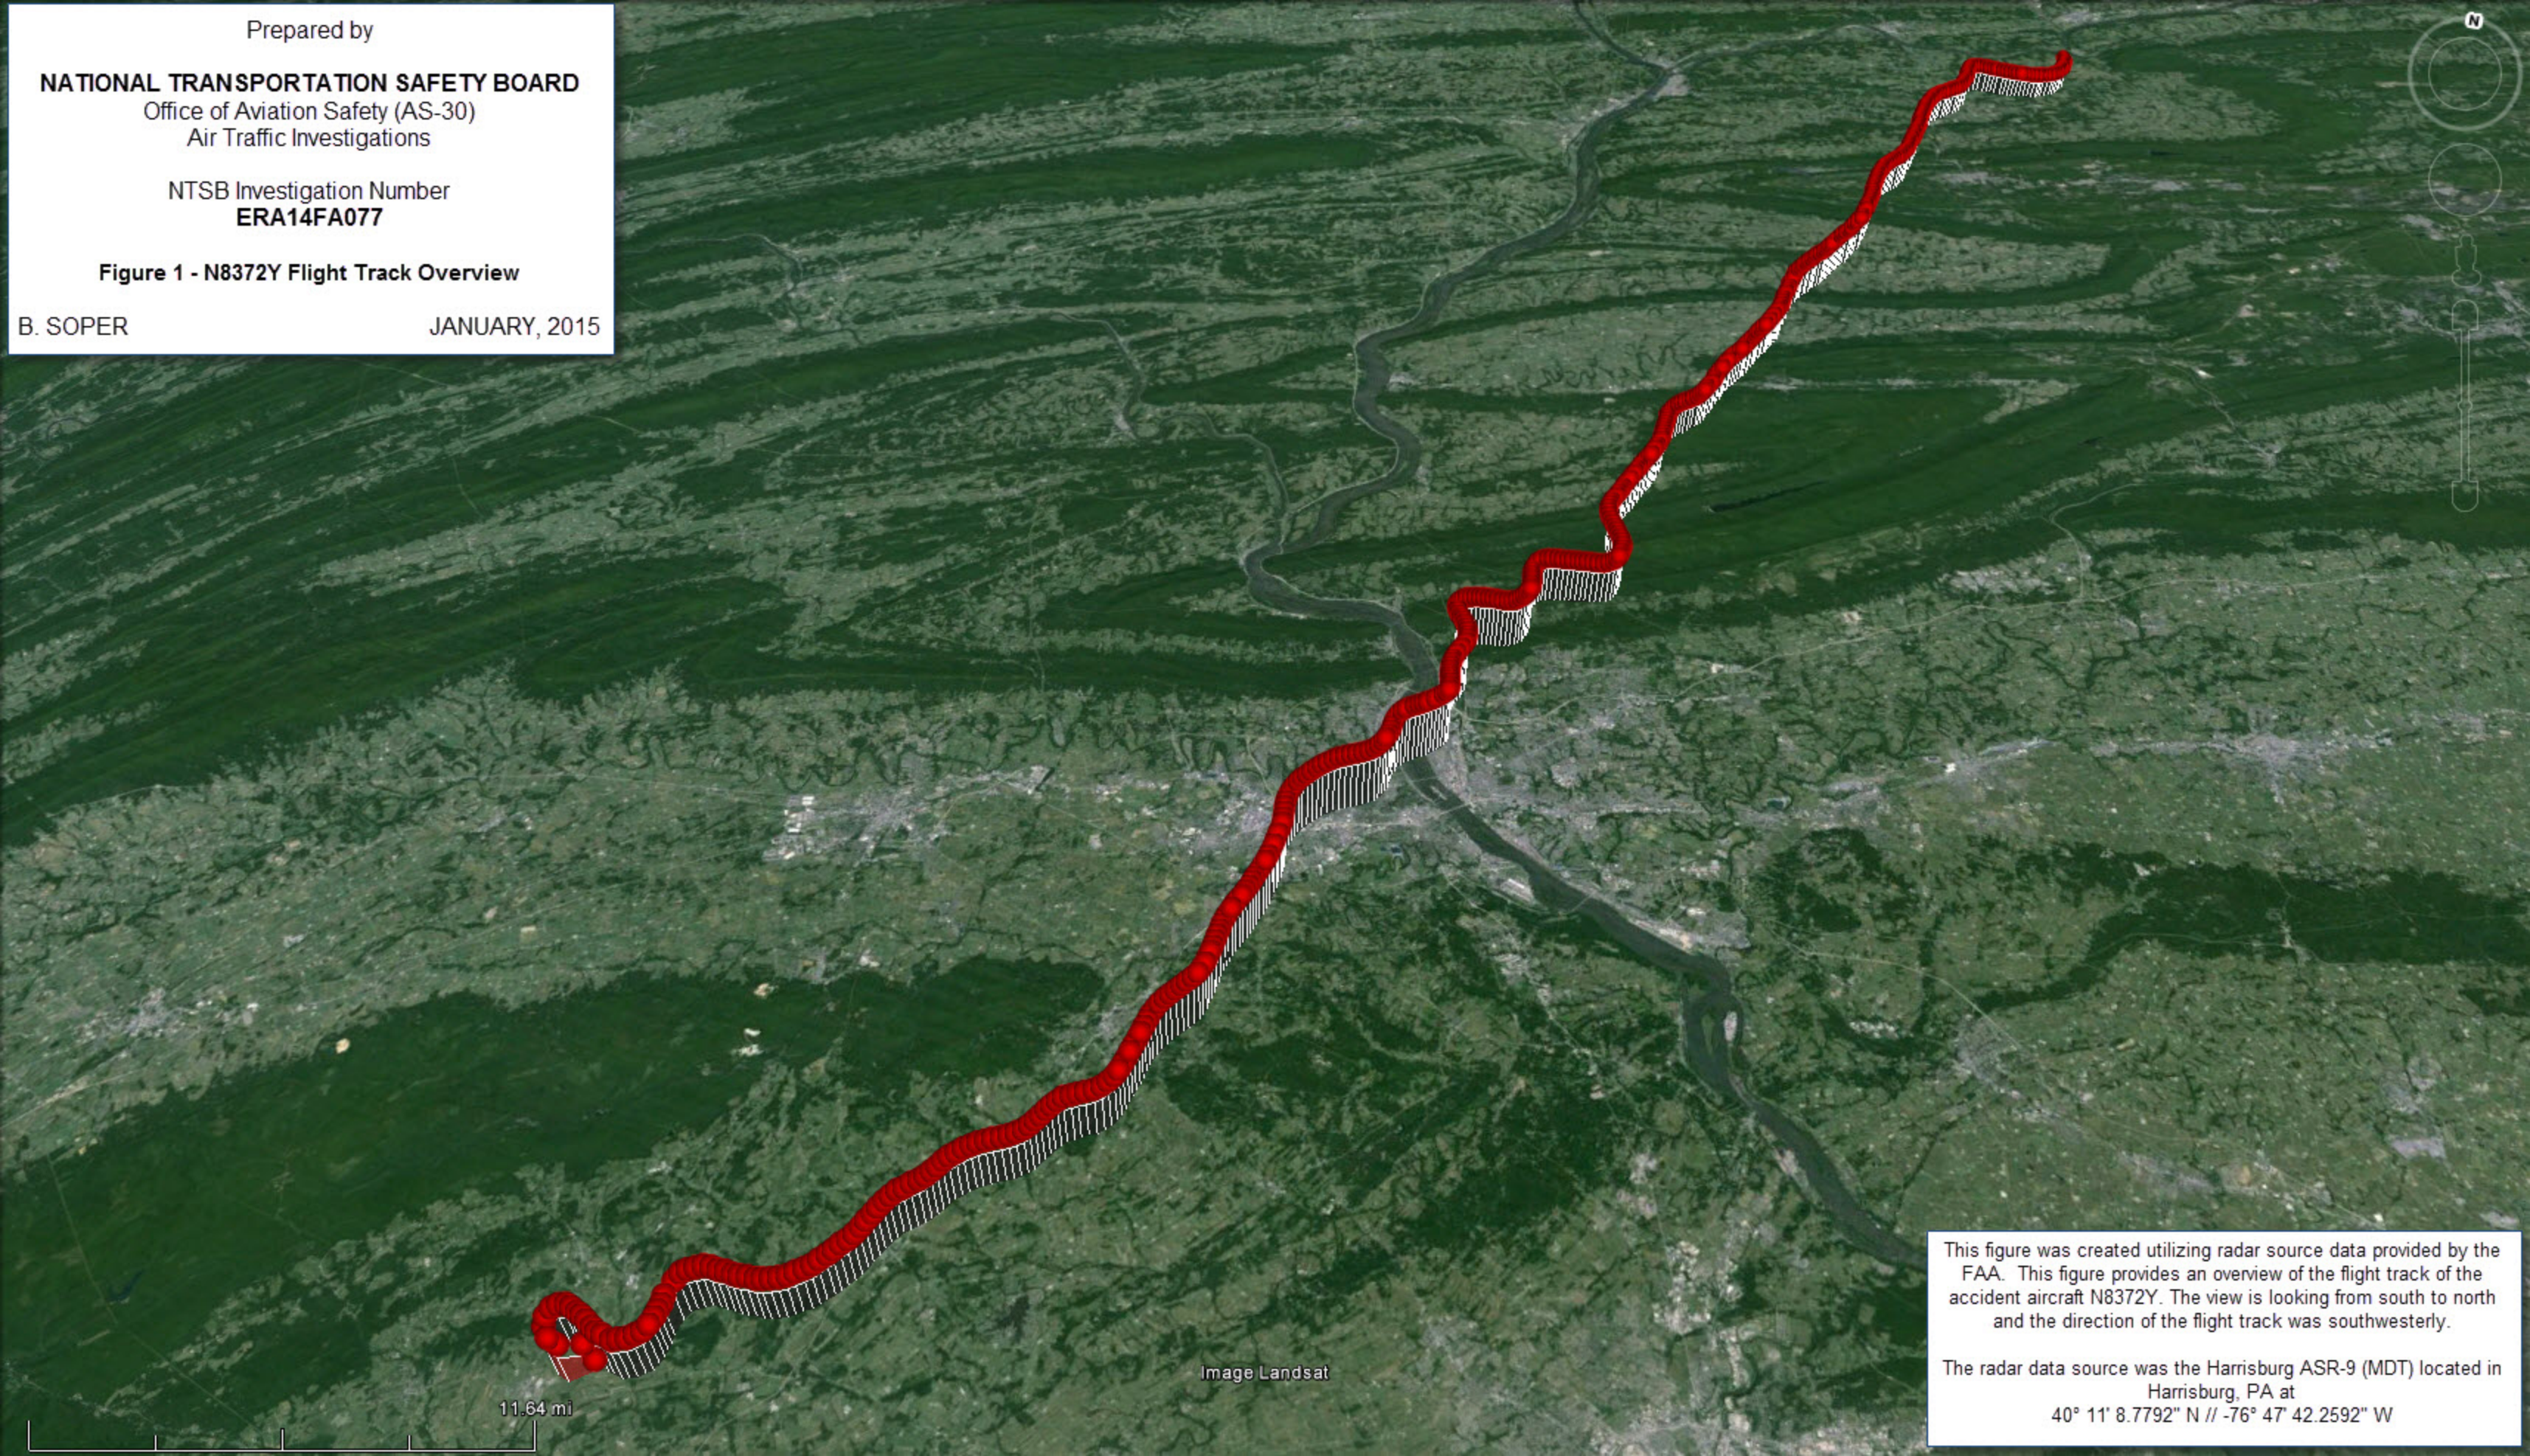
This figure was created utilizing radar source data provided by the FAA. This figure provides an overview of the flight track of the accident aircraft N8372Y. The view is looking from south to north and the direction of the flight track was southwesterly.

The radar data source was the Harrisburg ASR-9 (MDT) located in Harrisburg, PA at

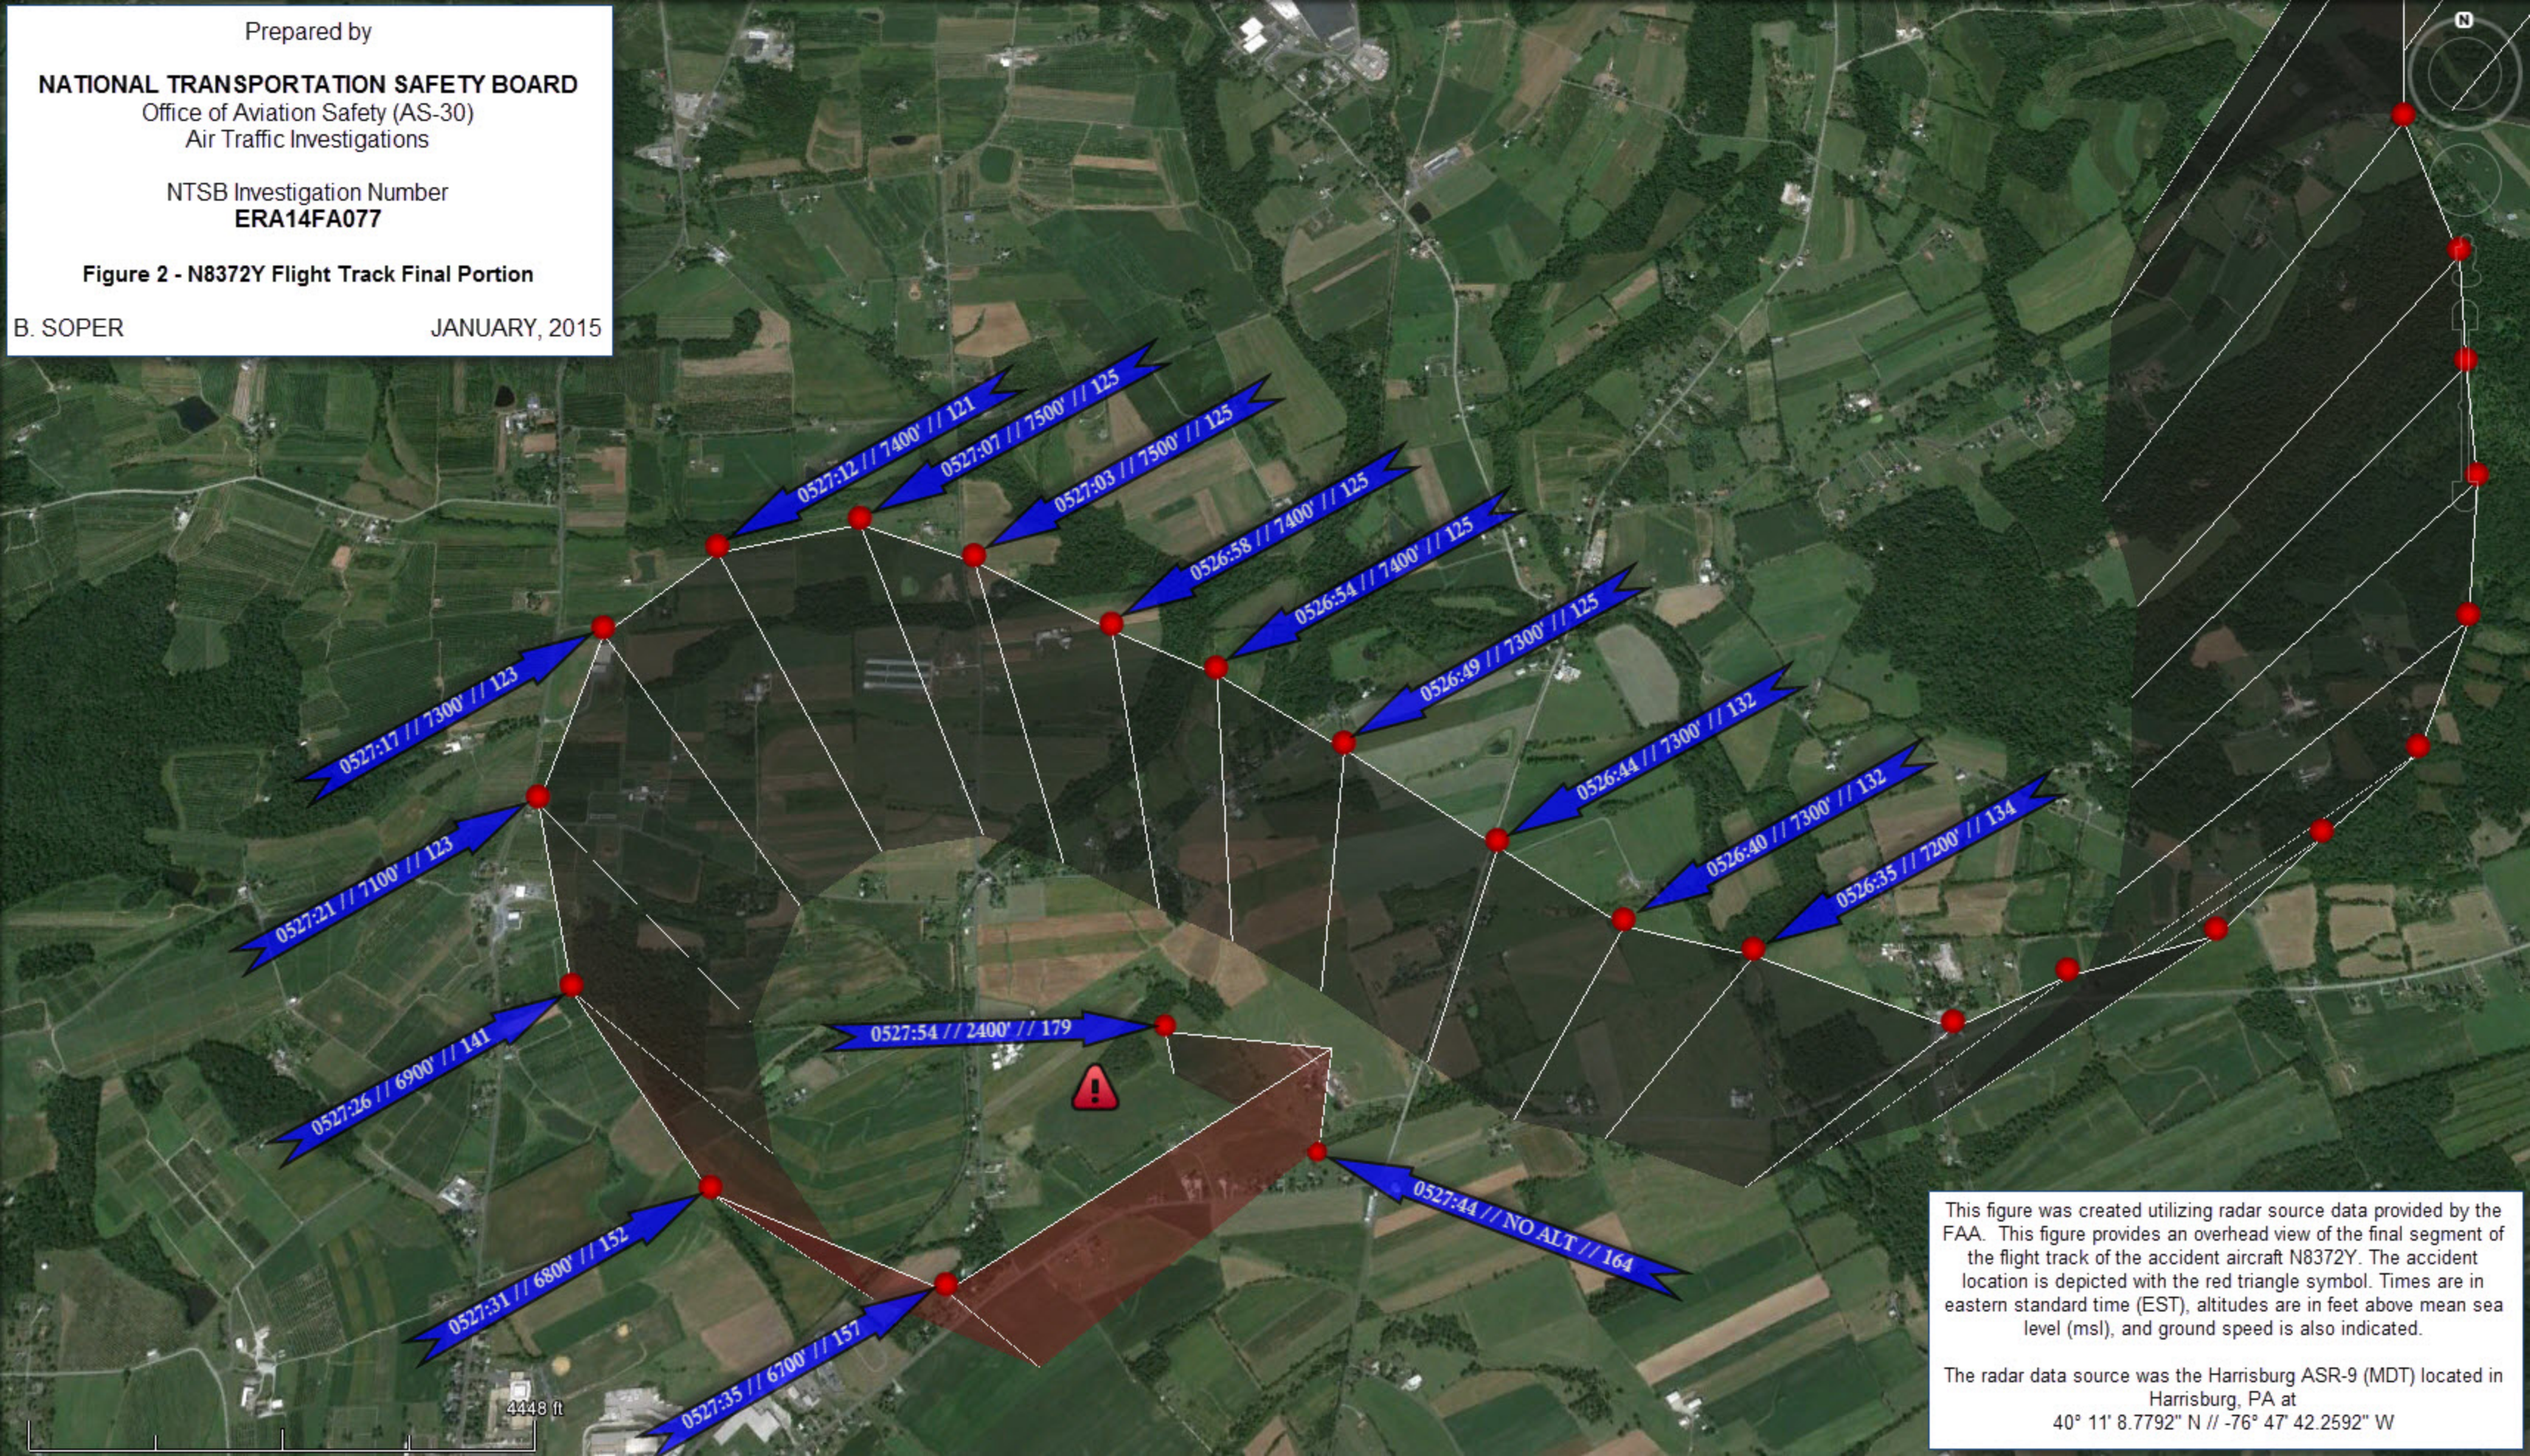
This figure was created utilizing radar source data provided by the FAA. This figure provides an overhead view of the final segment of the flight track of the accident aircraft N8372Y. The accident location is depicted with the red triangle symbol. Times are in eastern standard time (EST), altitudes are in feet above mean sea level (msl), and ground speed is also indicated.

The radar data source was the Harrisburg ASR-9 (MDT) located in Harrisburg, PA at  
40° 11' 8.7792" N // -76° 47' 42.2592" W
