**From:** Epperson Joe  
**Sent:** Tuesday, June 03, 2014 6:19 PM  
**To:** Hicks Ralph  
**Cc:** Budinski Michael  
**Subject:** ERA14LA178 Fuel Tubes  
**Attachments:** IMG\_3063.JPG

Place : Bay St Louis, Mississippi  
Date : March 3, 2014  
Vehicle : Bellanca 8KCAB, N11FS  
NTSB No. : ERA14LA178  
Investigator : Ralph Hicks, ASI-ERA

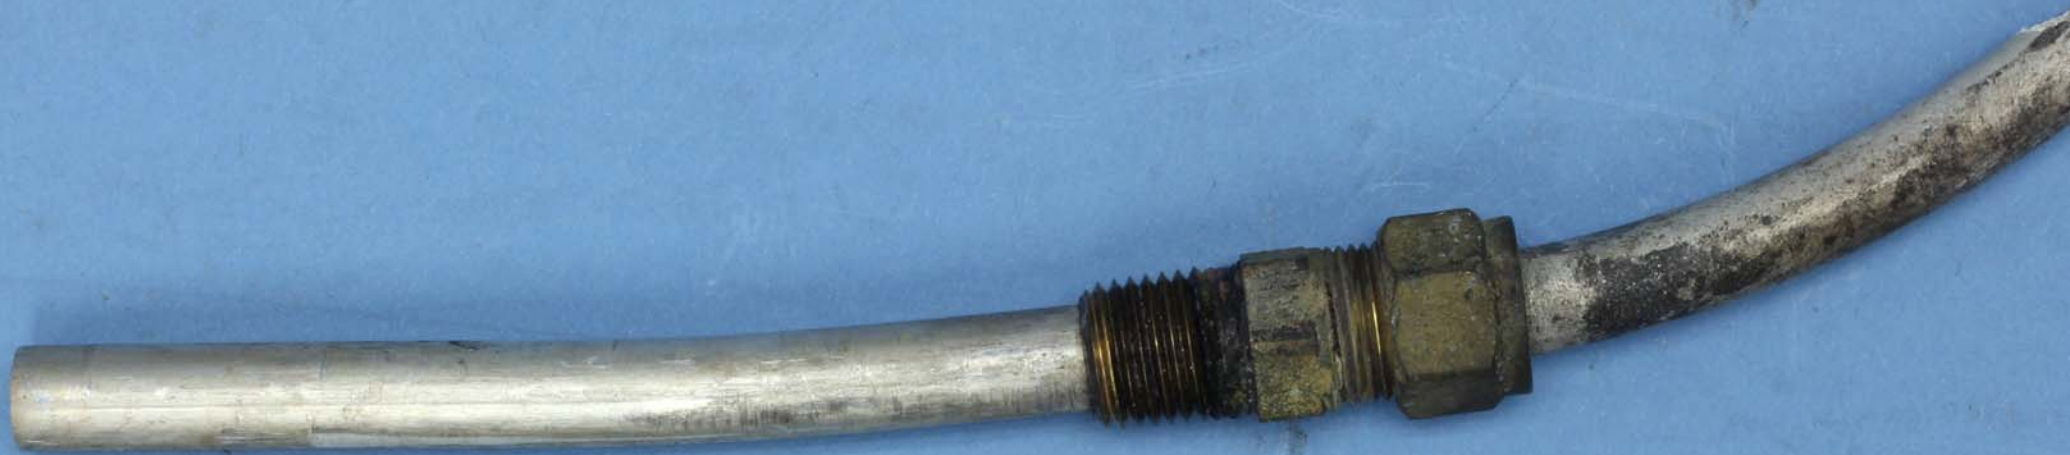
Optical examinations of the two fuel tube fractures (tubes shown in the attached image) revealed features consistent with overstress separations while the tubes were at elevated temperatures. No indications of fatigue or other preexisting cracking was uncovered.

As received, the nut on the fitting of the larger tube was finger tight and could be easily unthreaded. With the nut fully loosened the fractured tube would not move in the fitting under hand pressure.
