**GROUP CHAIRMAN'S FACTUAL REPORT OF INVESTIGATION**

**ERA15FA129**

## **Cockpit Voice Recorder**

Location: Miami, Florida  
Date: February 11, 2015  
Aircraft: Beechcraft 1900C, Registration YV1674  
Operator: Aeropanamericano CA  
NTSB Number: ERA15FA129

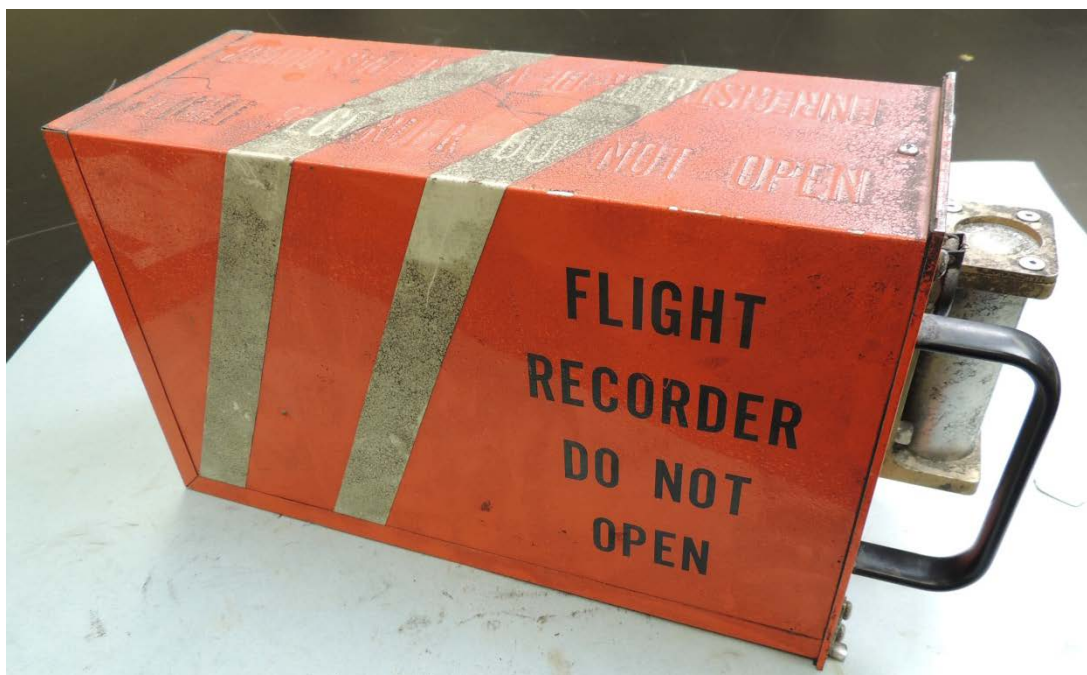
This model CVR, the Fairchild A-100S, records a minimum of 30 minutes of digital audio stored on solid state memory modules. Four channels are recorded: one channel for each flight crew, one channel for a cockpit observer, and one channel for the cockpit area microphone (CAM).

**Figure 1. Fairchild A-100S CVR recovered from the Beech 1900C, YV1674.**
