# Stabilized Approaches Lead to Safe Landings

## The problem

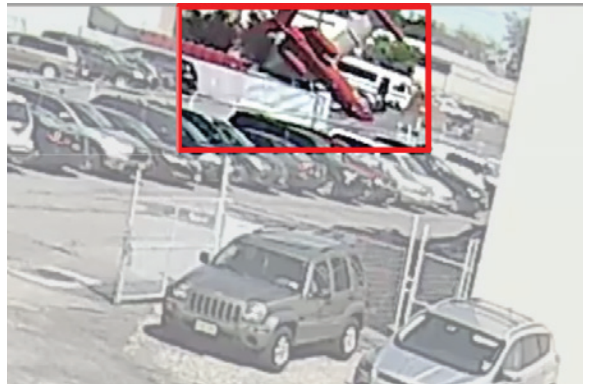
- A Learjet 35A airplane departed controlled flight while on a circling approach and impacted a commercial building and parking lot. The two pilots died. Because neither pilot realized that the airplane's navigation equipment had not been properly set for the instrument approach clearance they received, the flight crew improperly executed the vertical profile of the approach. When the crew initiated the circle-to-land maneuver, the airplane was so close to the airport that it could not be maneuvered to line up with the landing runway under the company's stabilized approach criteria. Neither pilot called for a go-around, and the pilot-in-command continued the approach by initiating a steep turn to align with the landing runway. Radar data indicated that the airplane's airspeed was below the approach speed dictated by company standard operating procedures (SOPs). During the turn, the

airplane stalled and crashed about 1/2 nautical mile south of the landing runway threshold. ([CEN17MA183](#))

Security video image of the accident airplane at ground impact ([CEN17MA183](#)).

- Follow SOPs and industry best practices for stabilized approach criteria, including a normal glidepath, specified airspeed and descent rate, landing configuration (flaps, gear, etc.), appropriate power setting, landing checklists, and a heading that ensures only small changes are necessary to maintain runway alignment. Guidance and tips (see the “Interested in more information?” section) indicate that, in most cases, the approach should be stabilized by 1,000 ft in instrument conditions or 500 ft in visual conditions. If the approach becomes unstabilized at any time after that, go around.

- Never attempt to “save” an unstabilized approach. If the approach becomes unstabilized, conduct an immediate go-around. Remember, when two pilots are on duty, either crewmember may call for a go-around at any time.

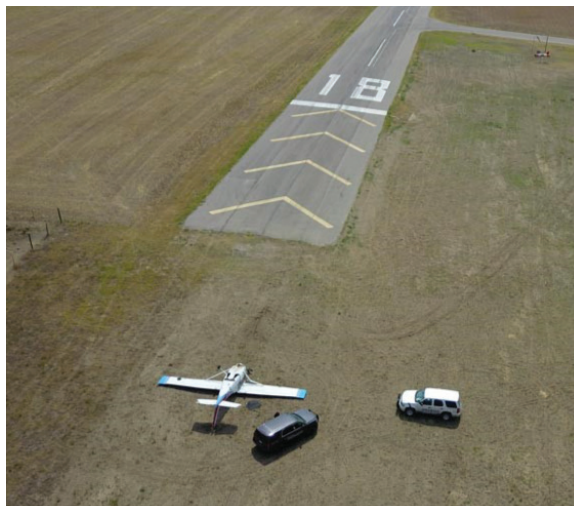
- A Cessna 210 airplane sustained substantial damage during a runway excursion. The pilot reported that he "didn't get the flaps down" before landing. He further reported that the airplane "didn't want to stop" and it then "ran off the runway." During the runway excursion, the nosewheel collapsed, and the airplane nosed over. A witness reported that the airplane was "high, fast, and downwind." (GAA17CA531)

Overhead view of Cessna 210 and runway (GAA17CA531).  
Source: Edwards County Sherriff's Department
