# NATIONAL TRANSPORTATION SAFETY BOARD

## Fuel Totalizer

**Specialist's Factual Report**  
**by Joe Gregor**

Location: Danville, Virginia  
Date: March 27, 2016  
Aircraft: Piper PA-23-250  
Registration: N22AM  
Operator: Private  
NTSB Number: ERA16LA142

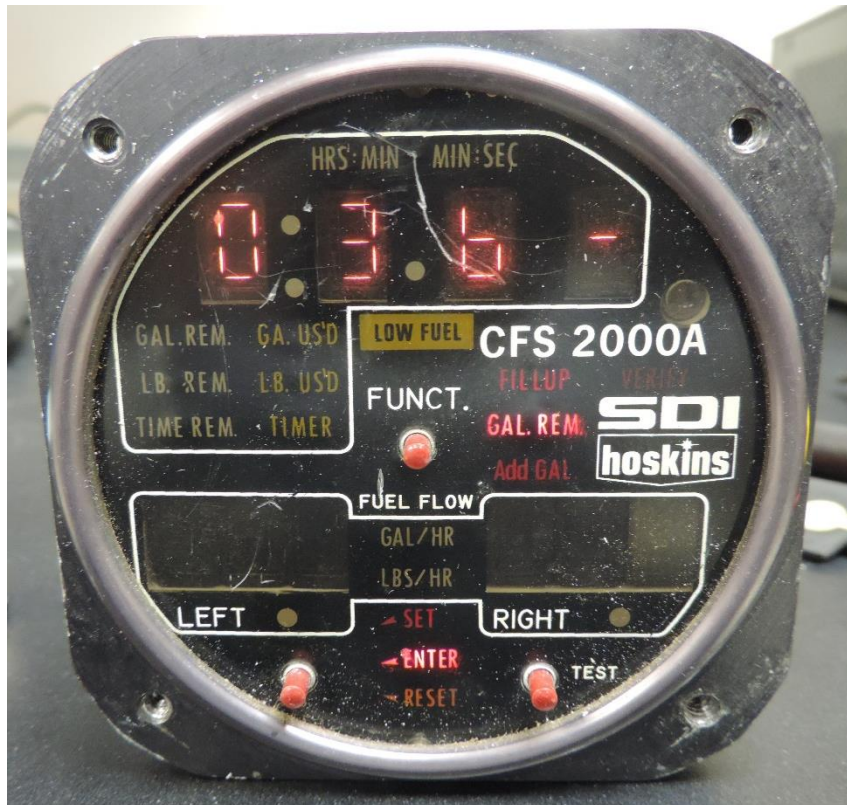
**Figure 1.** Photo of startup screen #1.

Upon arrival at the Vehicle Recorder Laboratory, an examination revealed the unit had not sustained damage disabling device startup. The CFS 2000a is not designed to export data electronically. Information was extracted photographically by taking pictures of the front panel display as it cycled through the normal startup sequence.

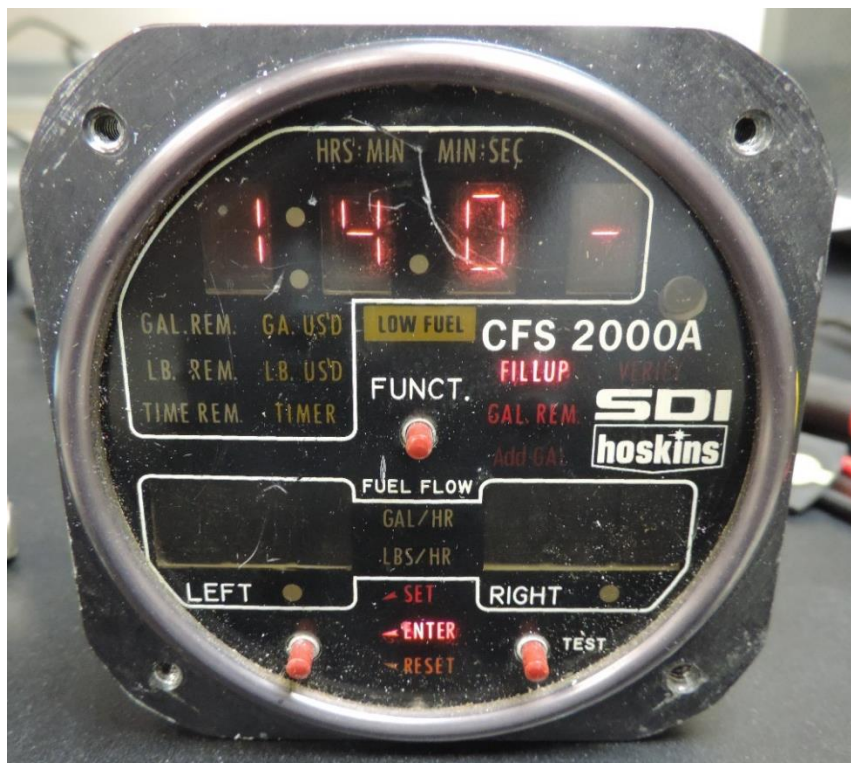
Figure 2. Photo of startup screen #2.

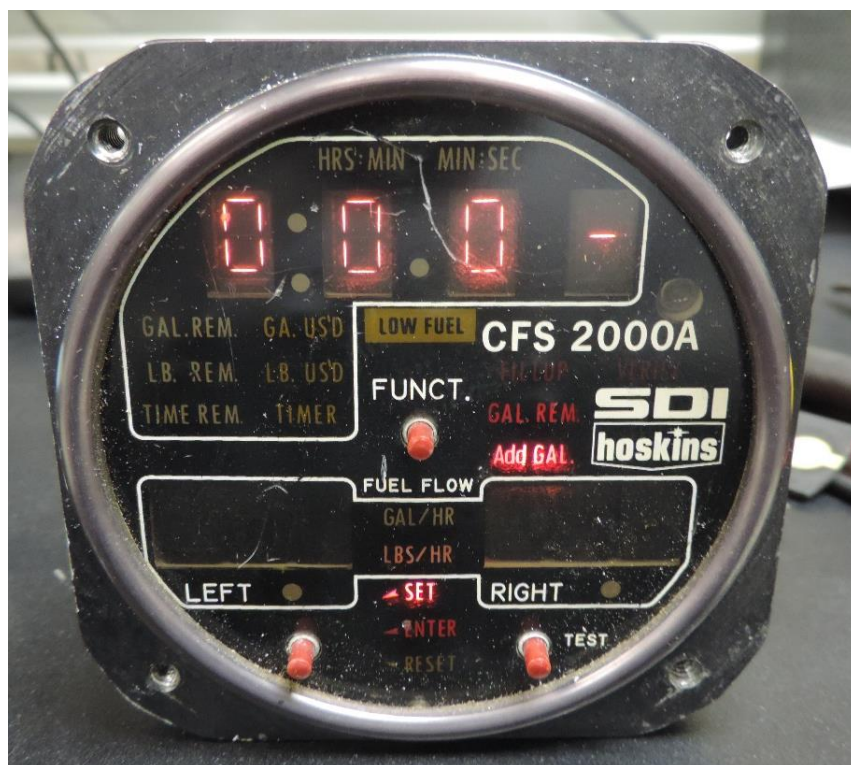
Figure 3. Photo of startup screen #3.

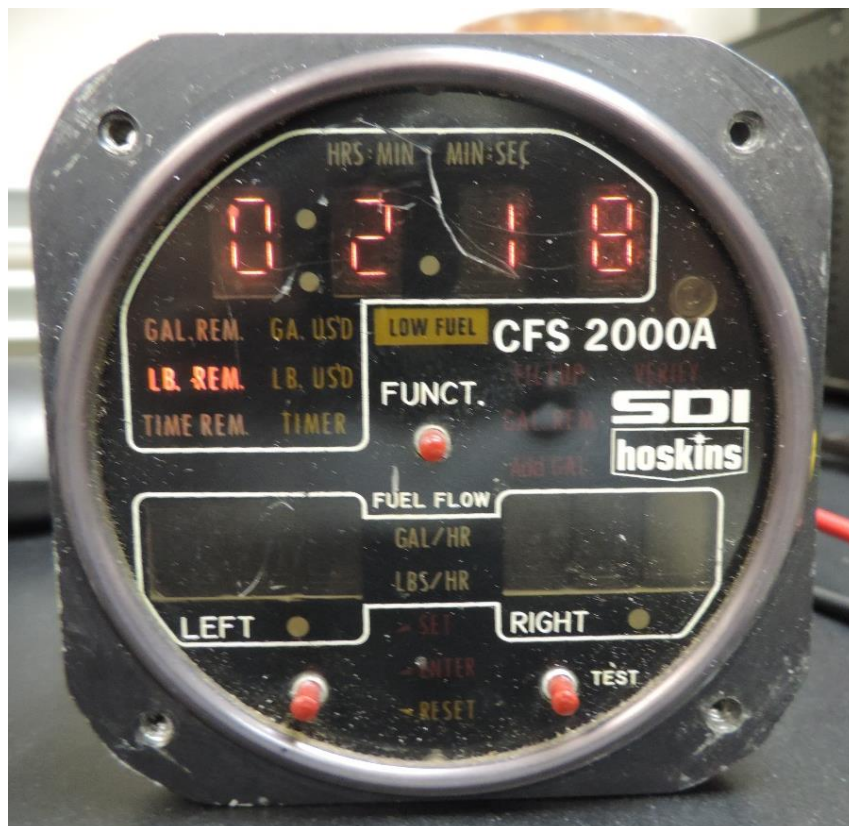
Figure 4. Photo of startup screen #4.

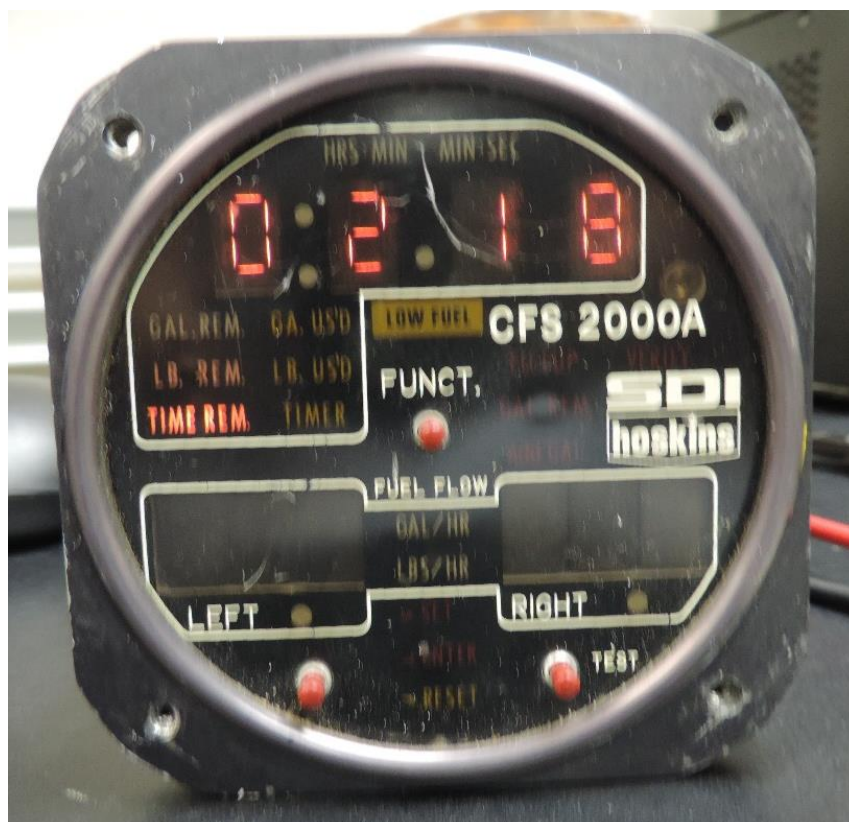
Figure 5. Photo of startup screen #5.

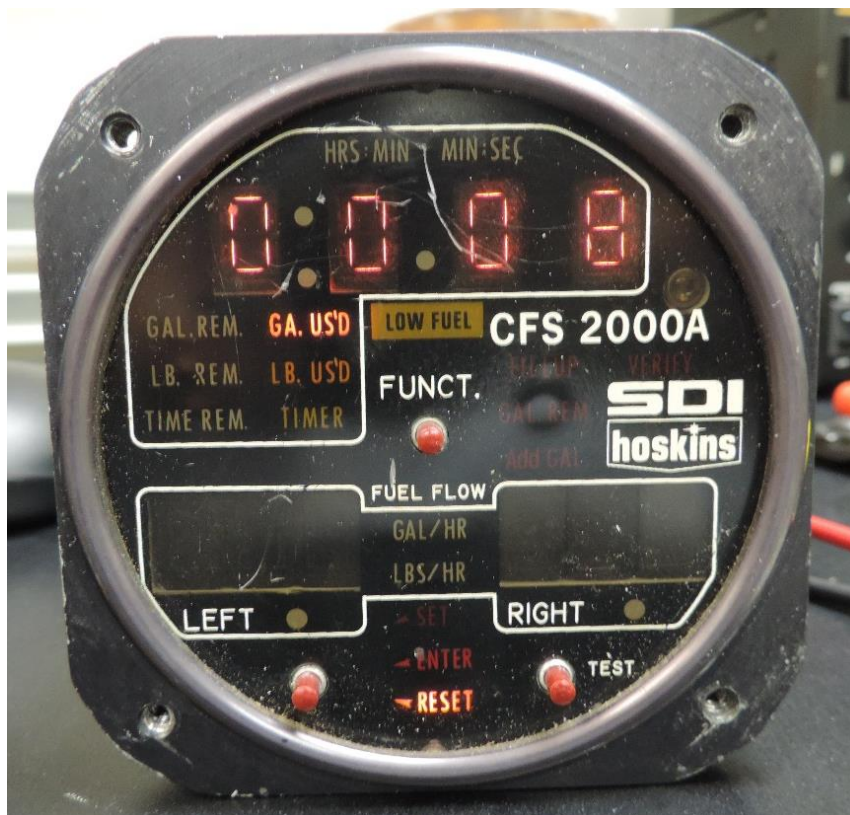
Figure 6. Photo of startup screen #6.

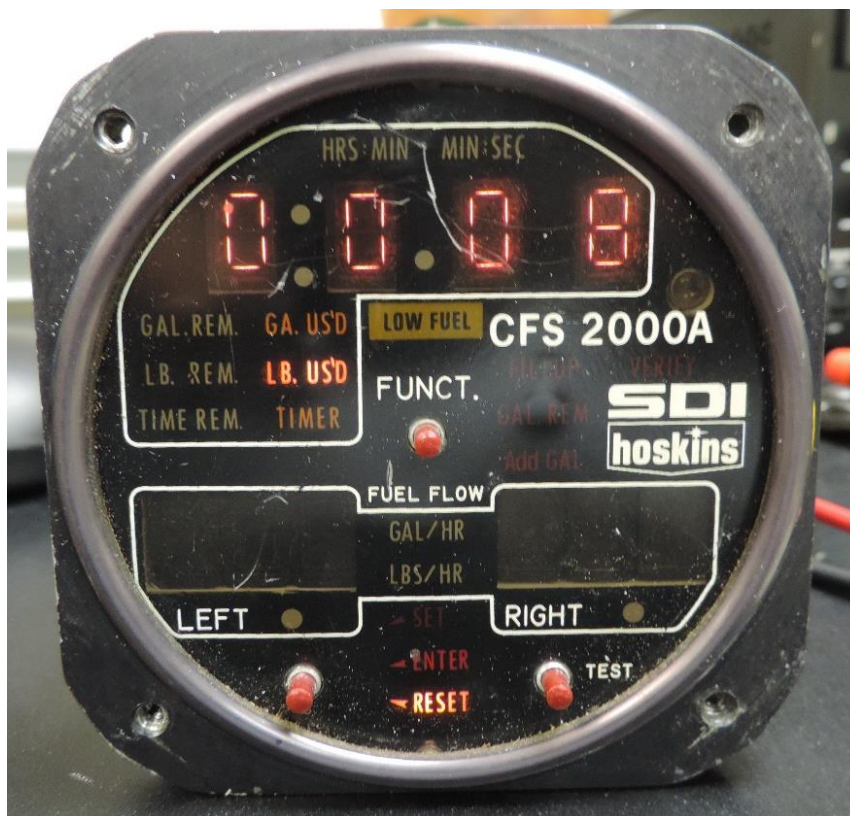
Figure 7. Photo of startup screen #7.

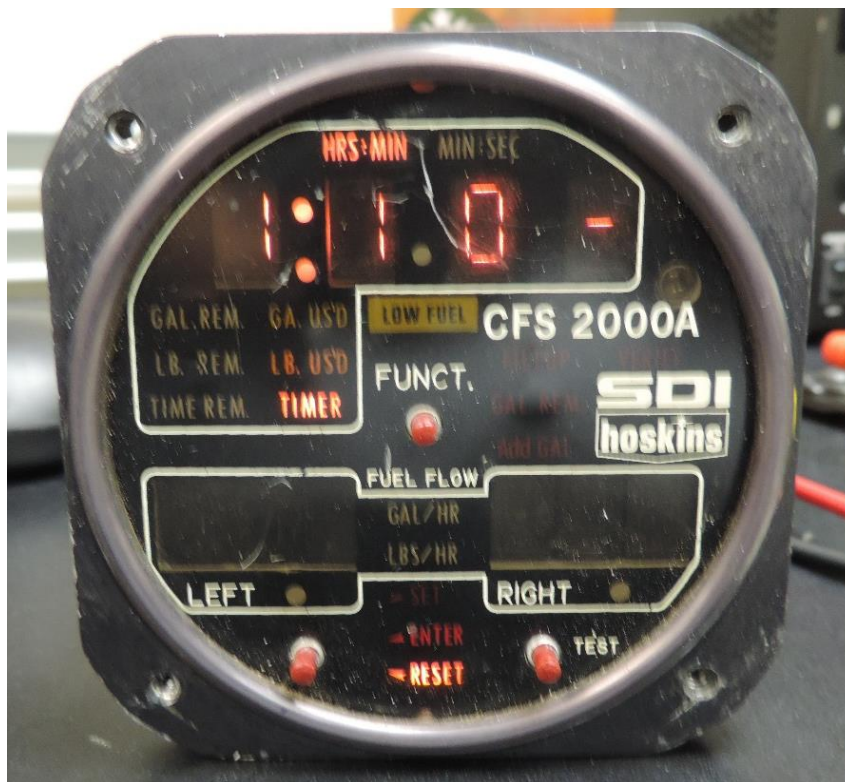
Figure 8. Photo of startup screen #8.

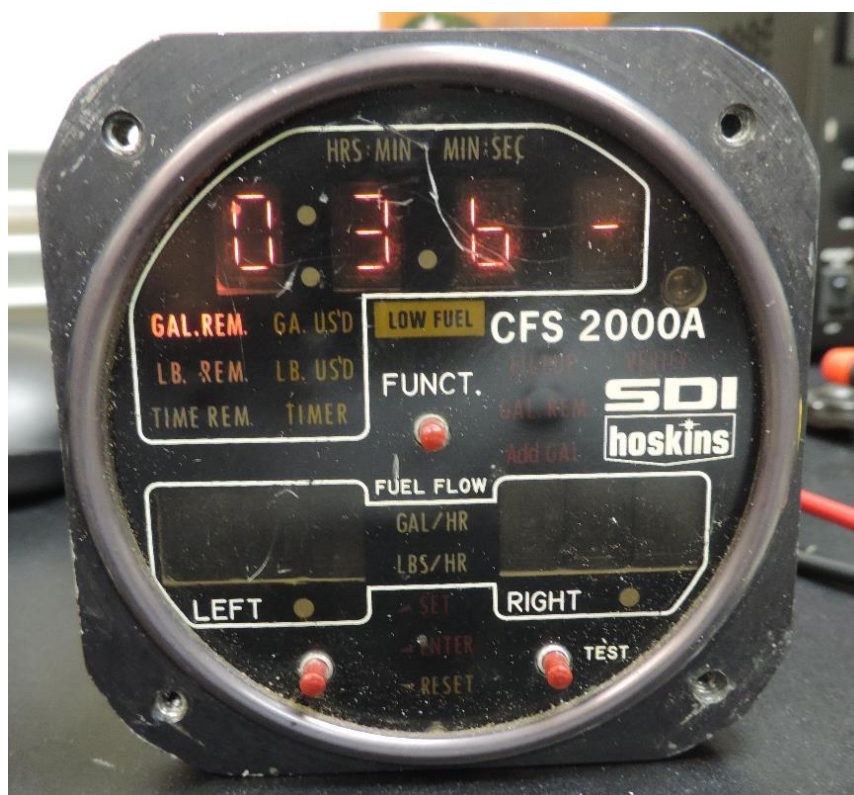
Figure 9. Photo of startup screen #9.
