**Photo 1 – NTSB Digital Photograph. View Looking to the West, taken East of the Eastern Most Airplane Debris**

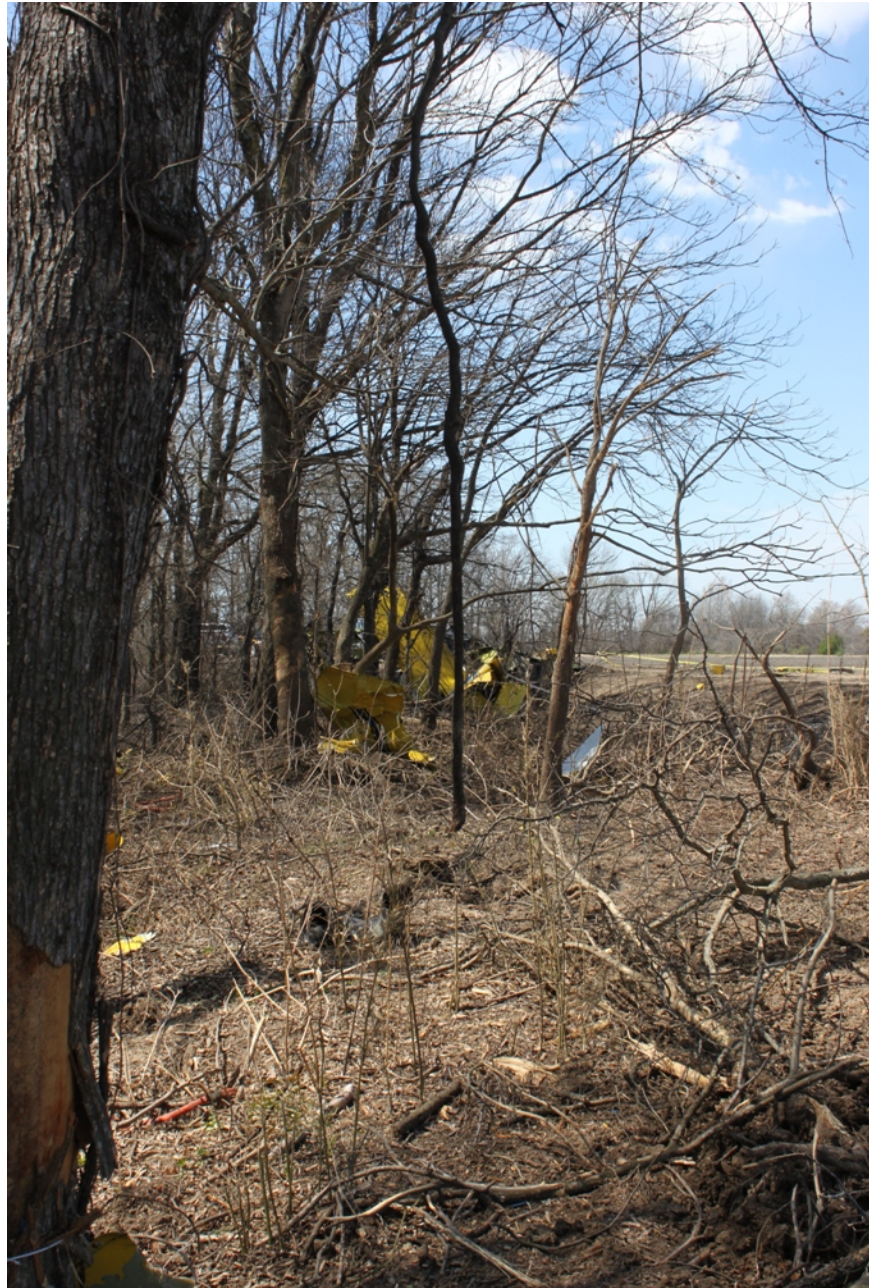
**Photo 2 – NTSB Digital Photograph. View Looking to the West Showing Airplane Wreckage Among Treeline**

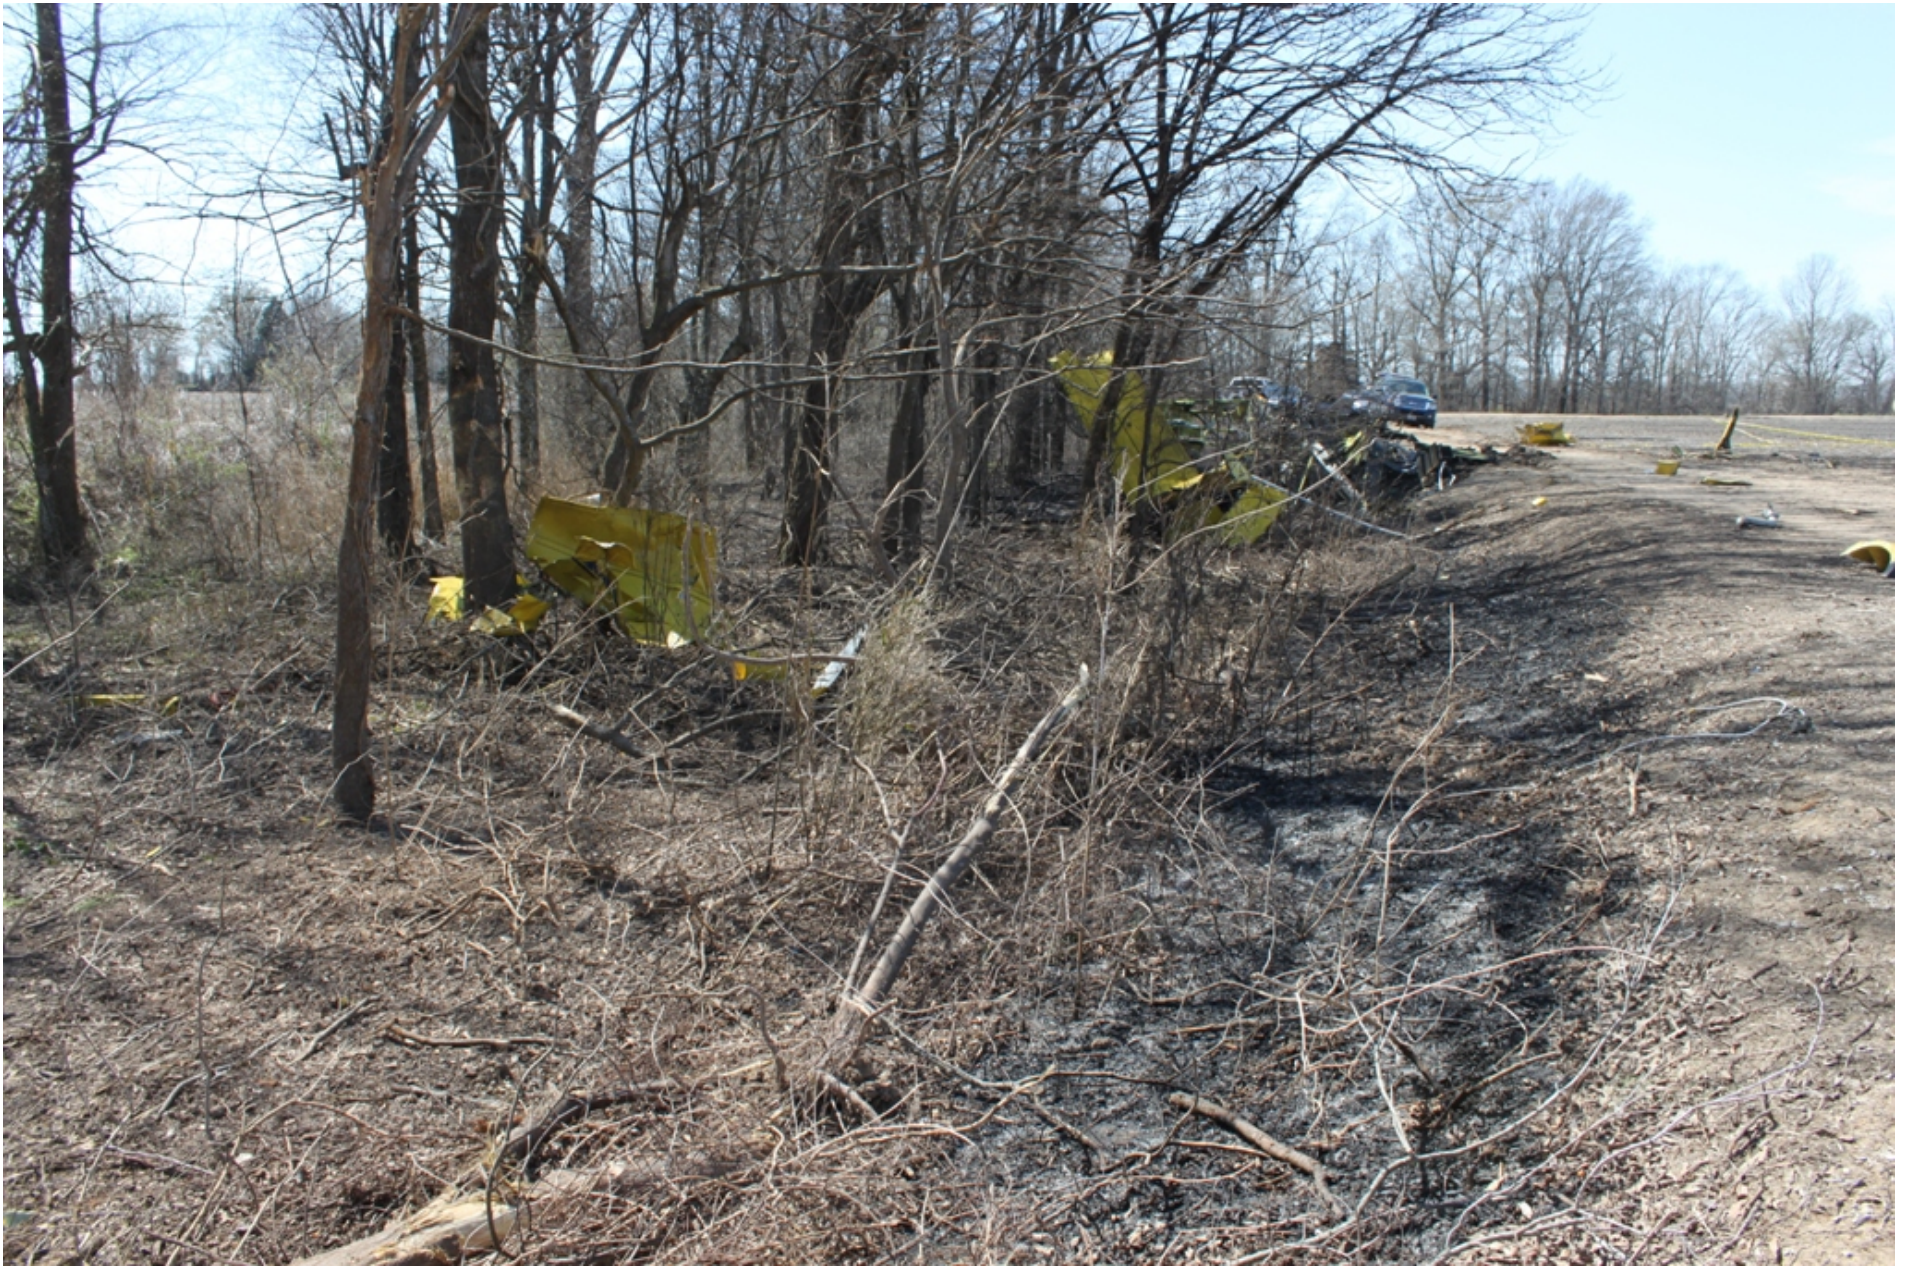
**Photo 3 - NTSB Digital Photograph. View Looking West Showing Wreckage Among the Trees**

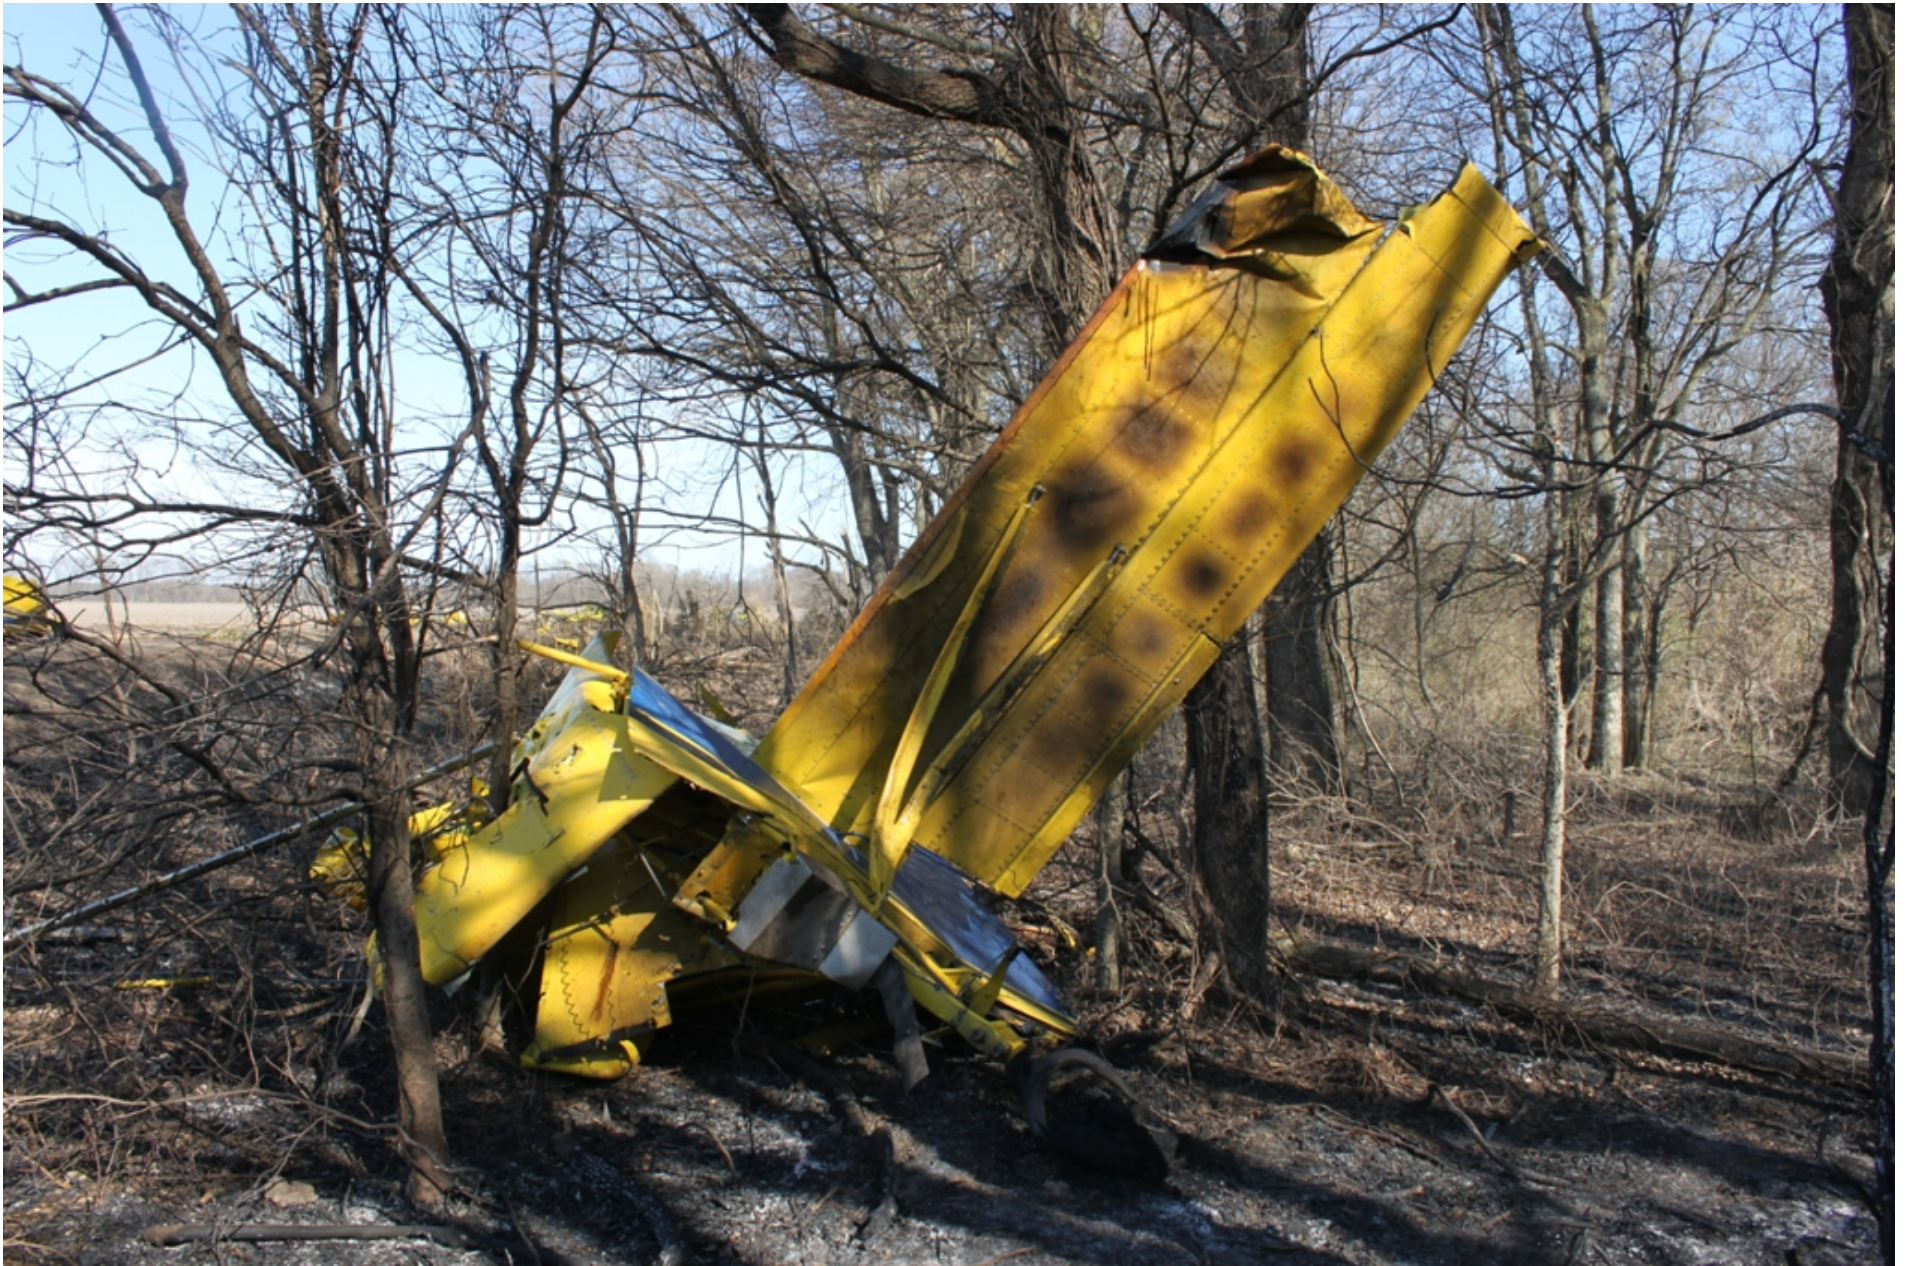
**Photo 4 - NTSB Digital Photograph. View of the Empennage. Note the Heat Damage to the Ground Area Adjacent to the Empennage**

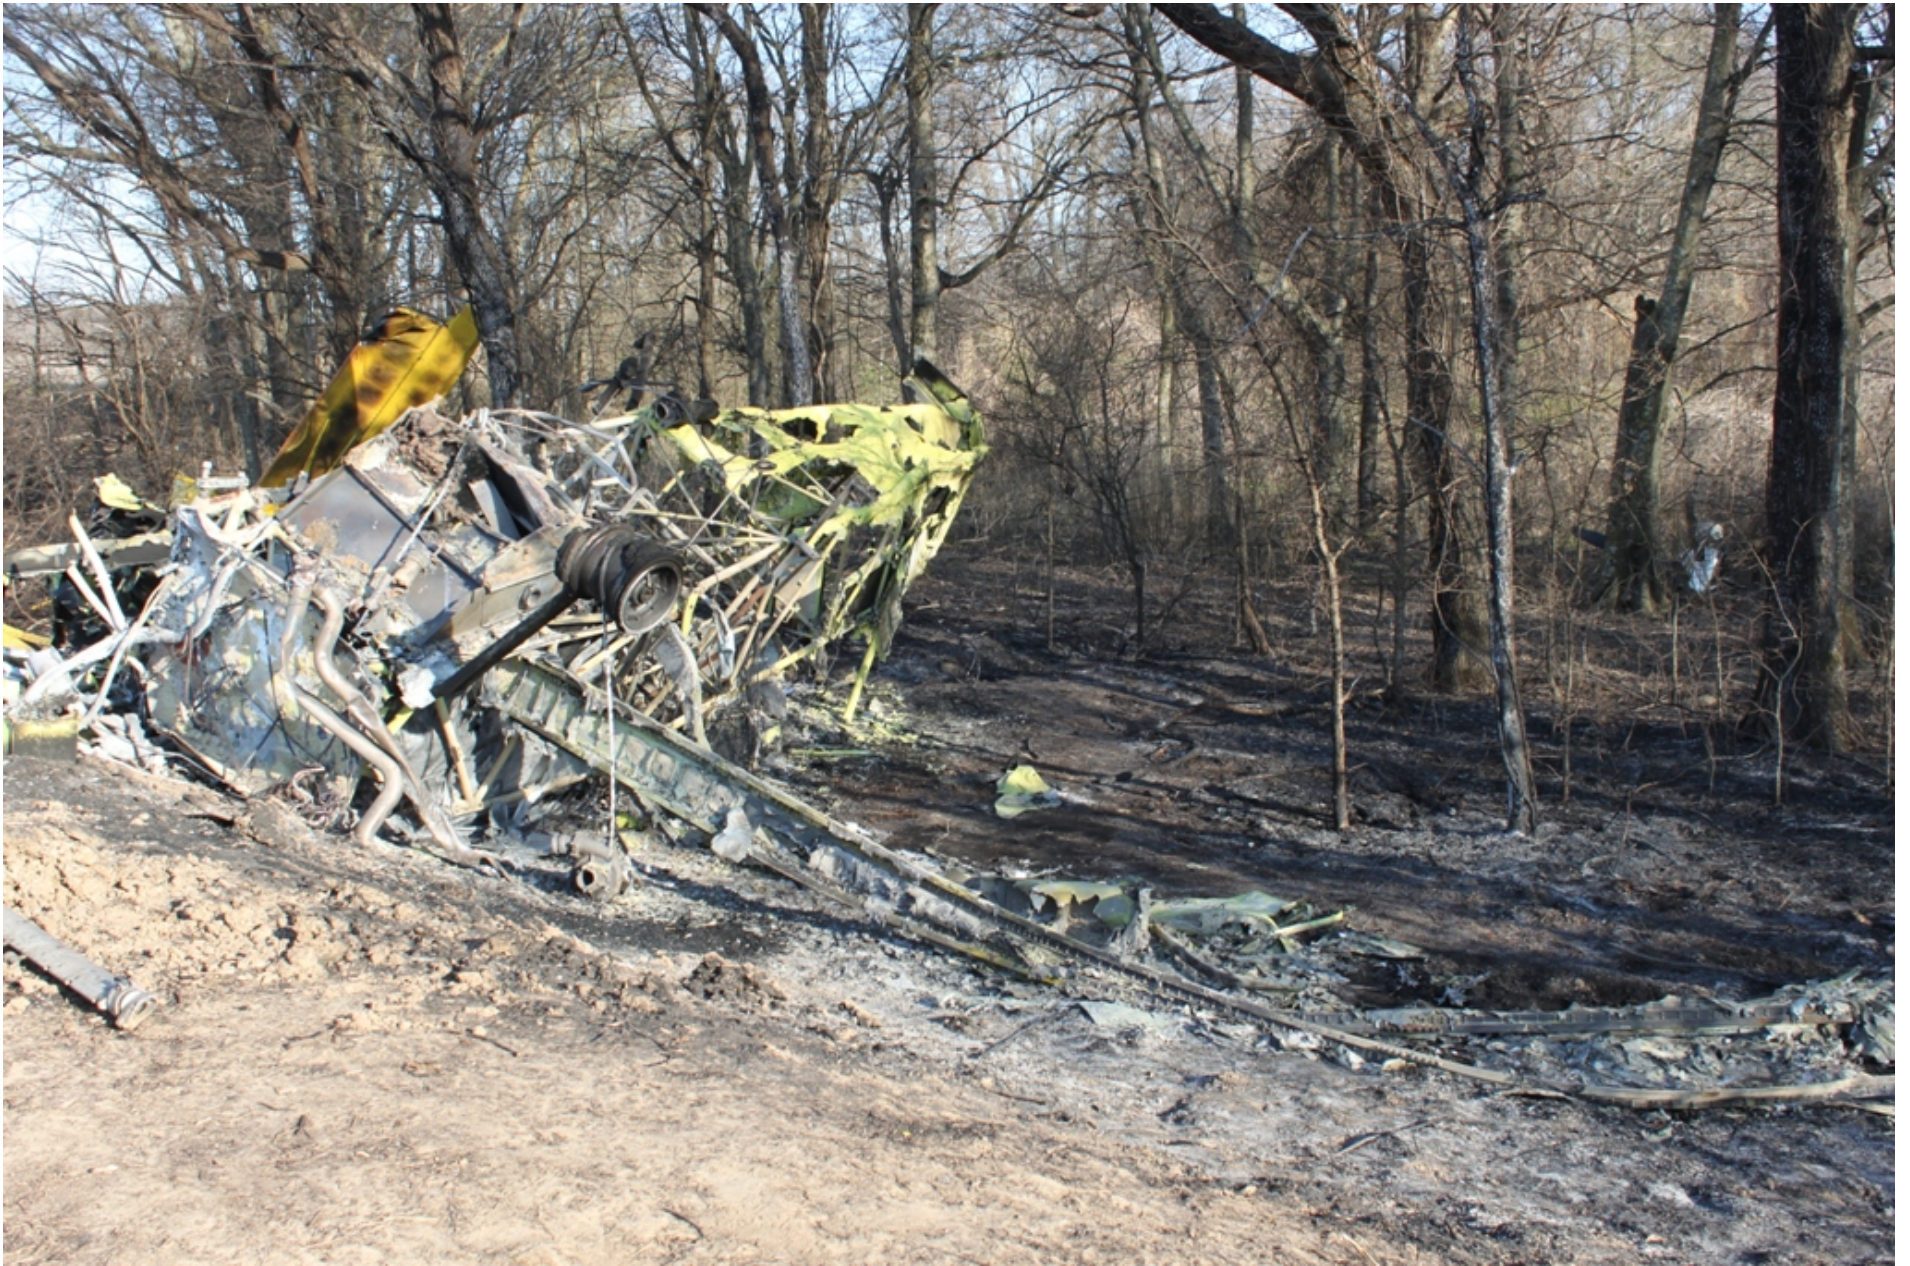
**Photo 5 - NTSB Digital Photograph. View of the Heat Damaged Fuselage and Partial View of the Right Wing Spar**

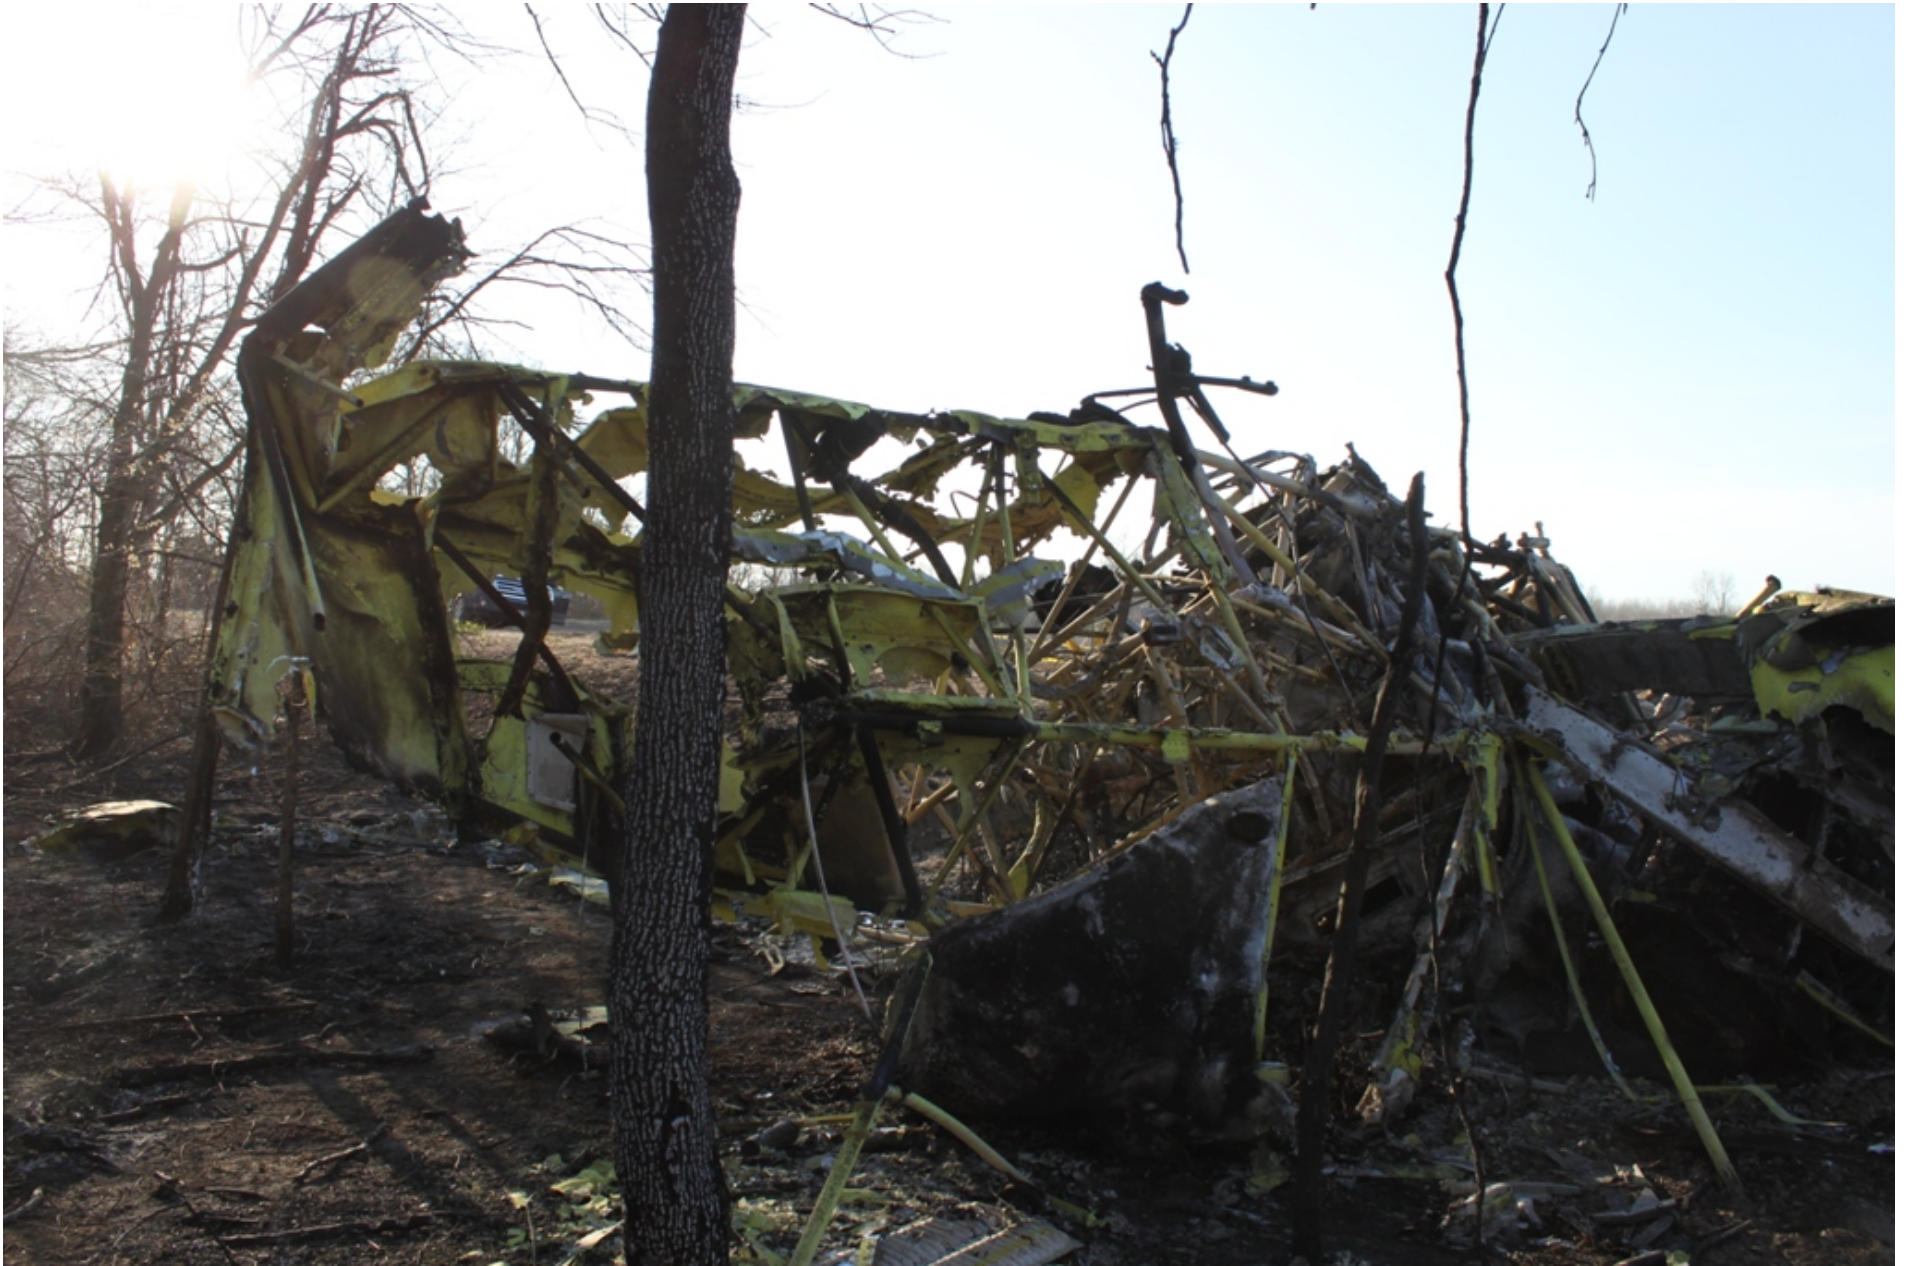
**Photo 6 - NTSB Digital Photograph. Another View of the Heat Damaged Fuselage**

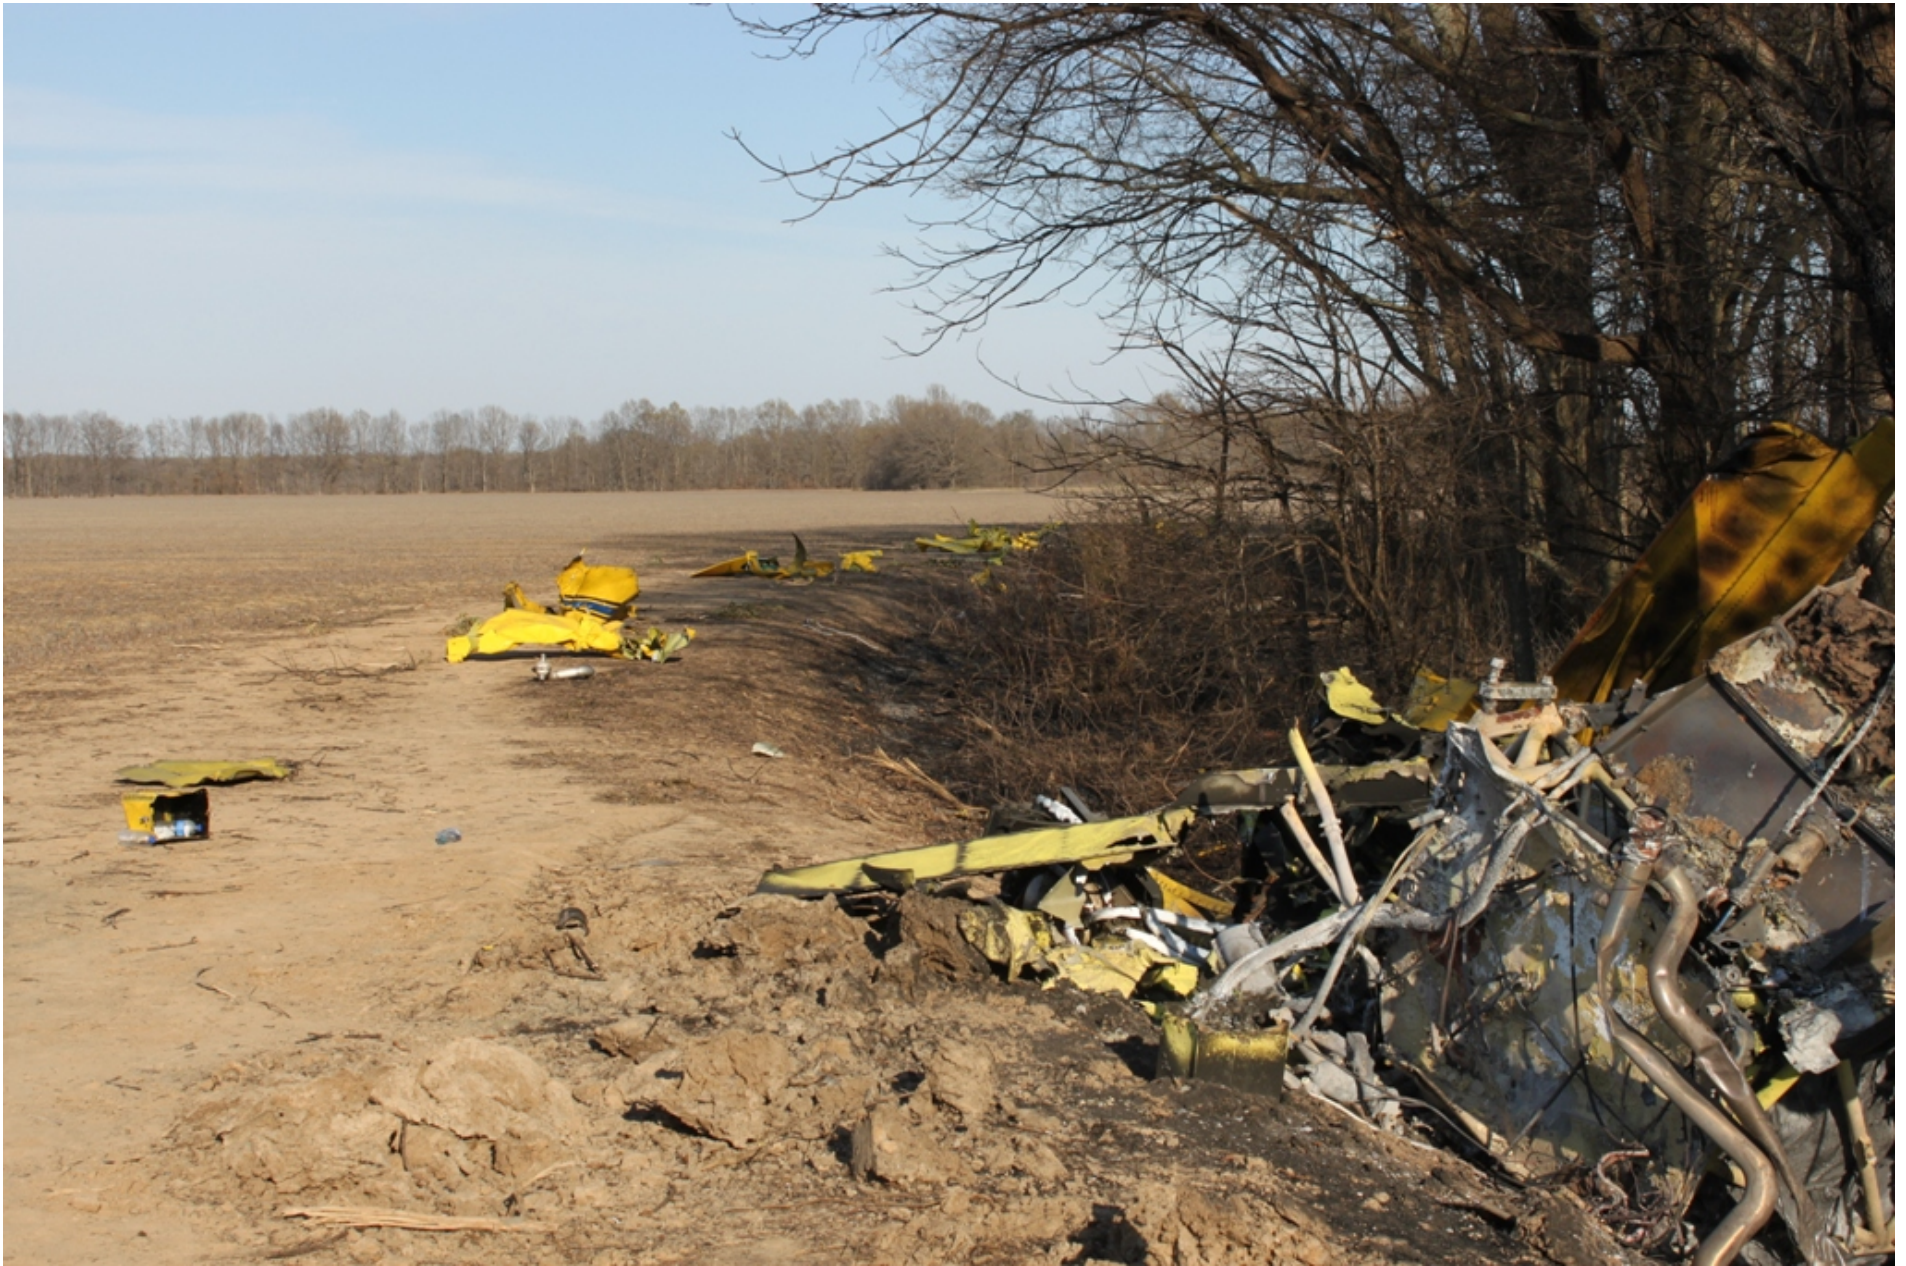
**Photo 7 - NTSB Digital Photograph. View Looking Towards the East and a Portion of the Fuselage to the Right and Wreckage in the Background.**

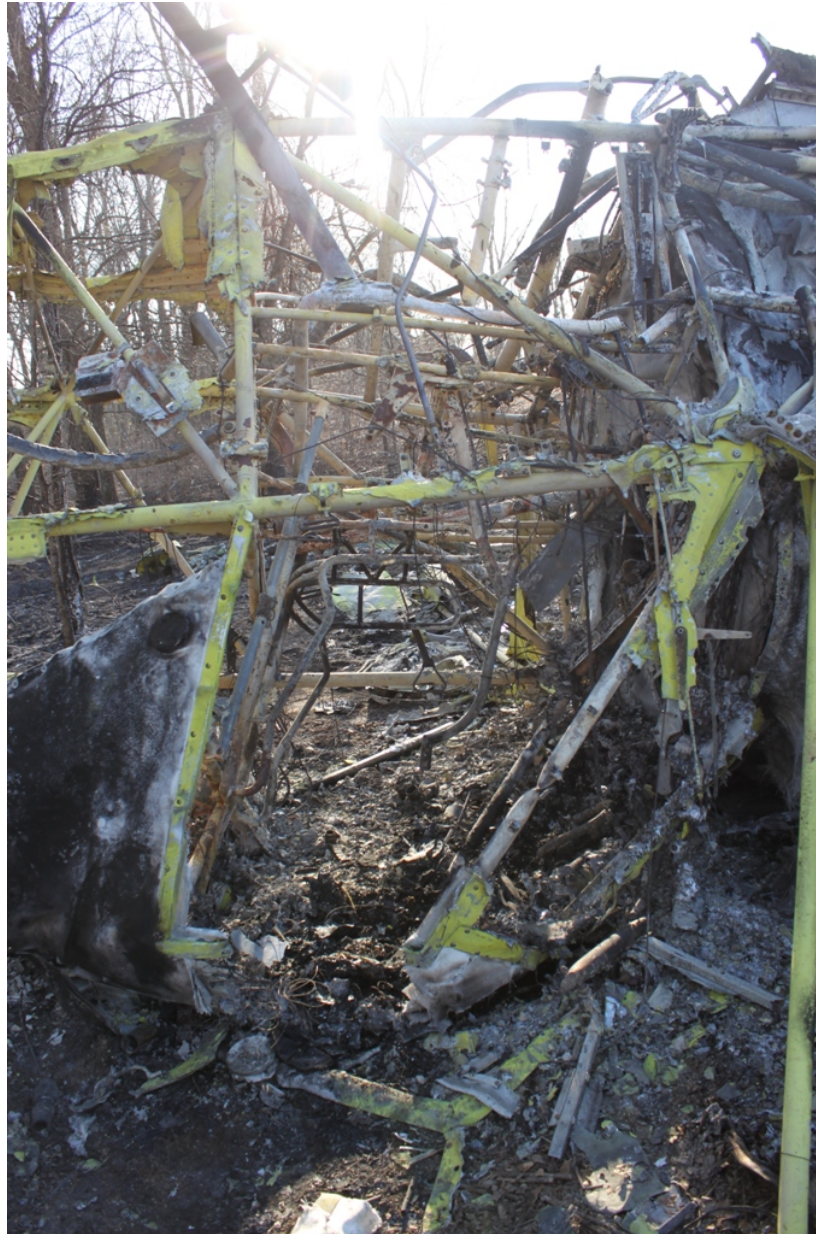
**Photo 8 - NTSB Digital Photograph. View of the Cockpit Area of the Fuselage. Note the Minimal Distortion of the Occupiable Space**

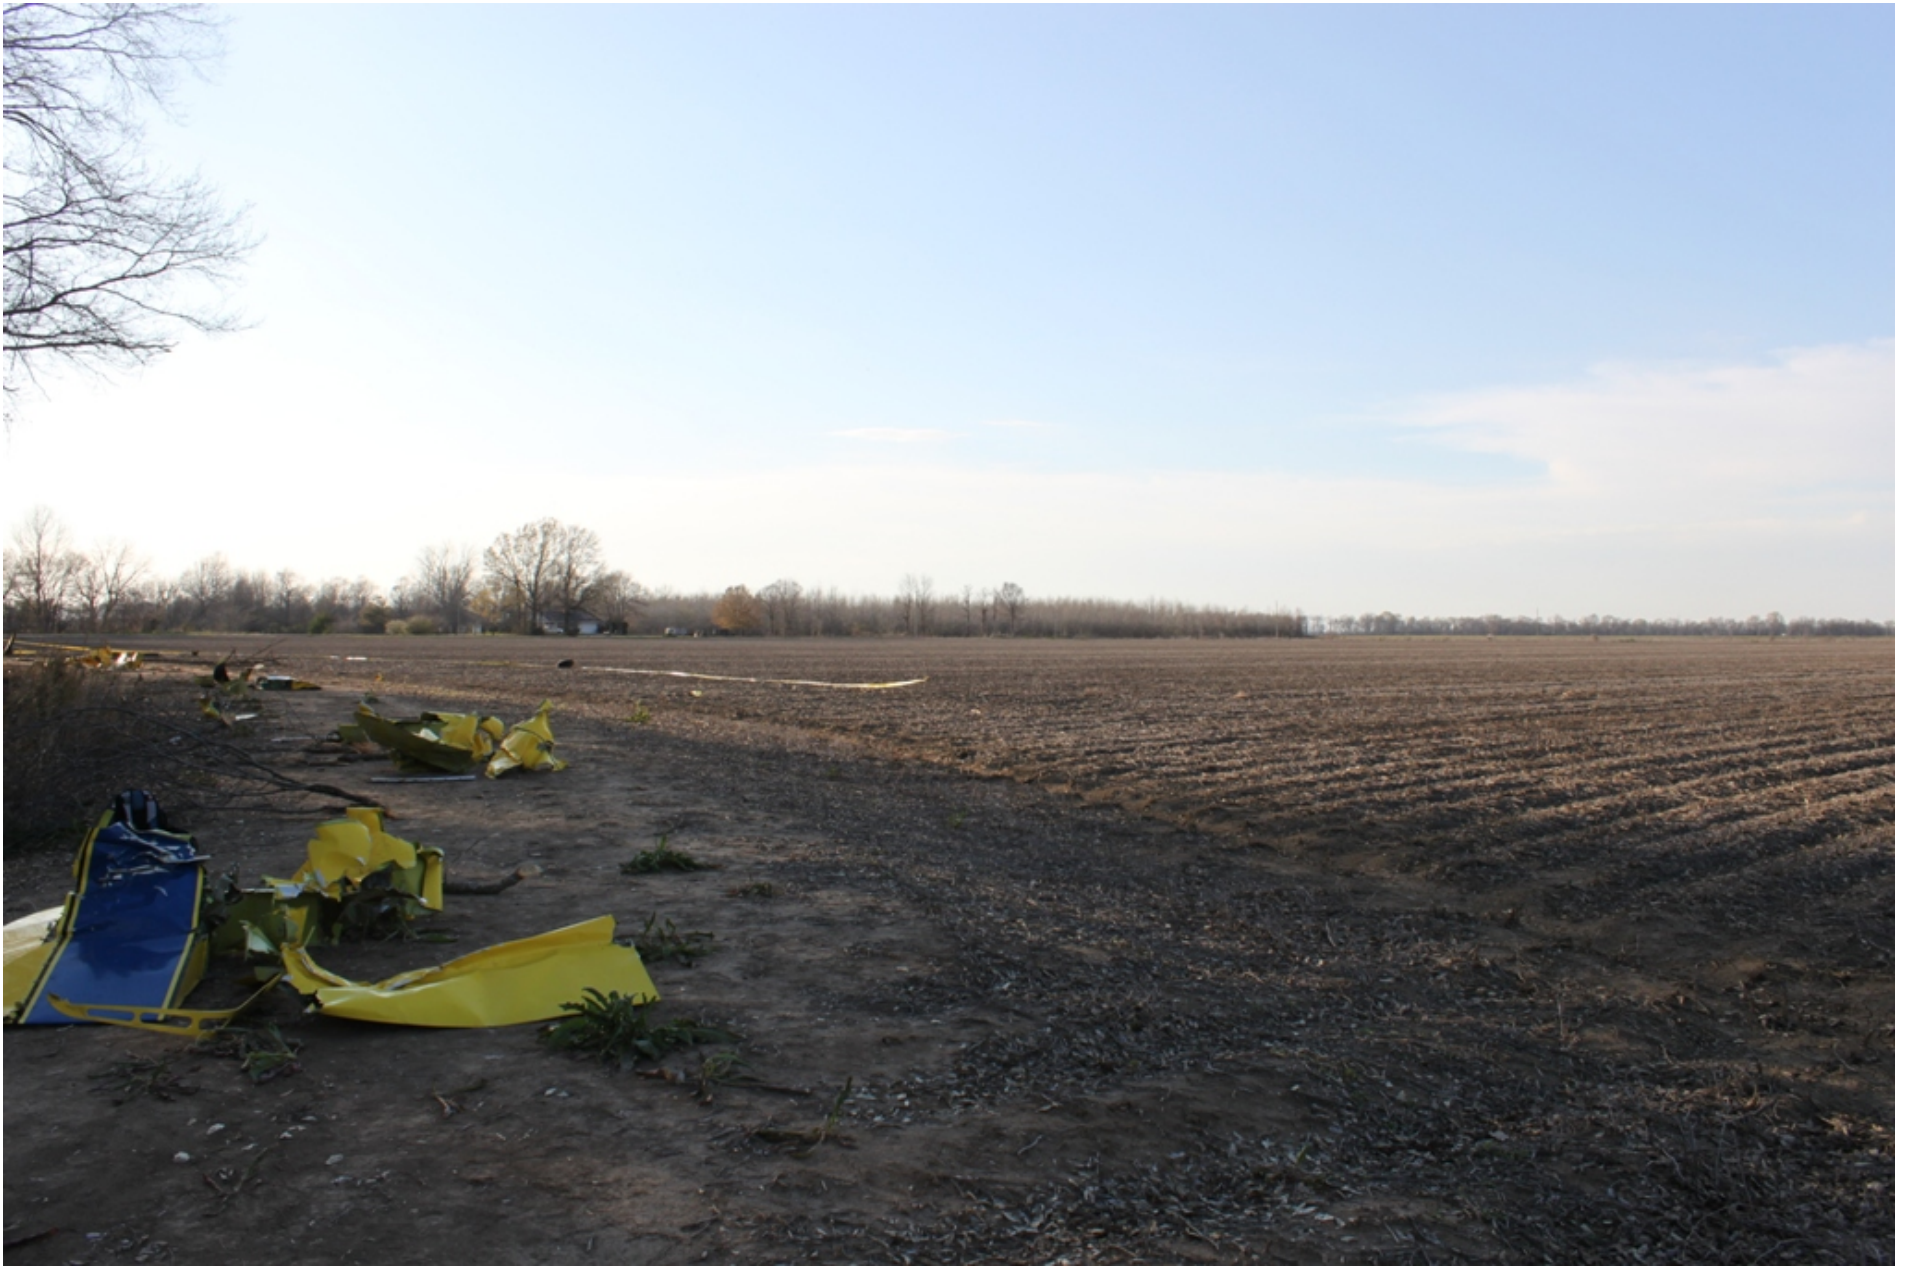
**Photo 9 - NTSB Digital Photograph. View Looking towards the Northwest Showing the Large Open Field Adjacent to the Accident Site Area.**

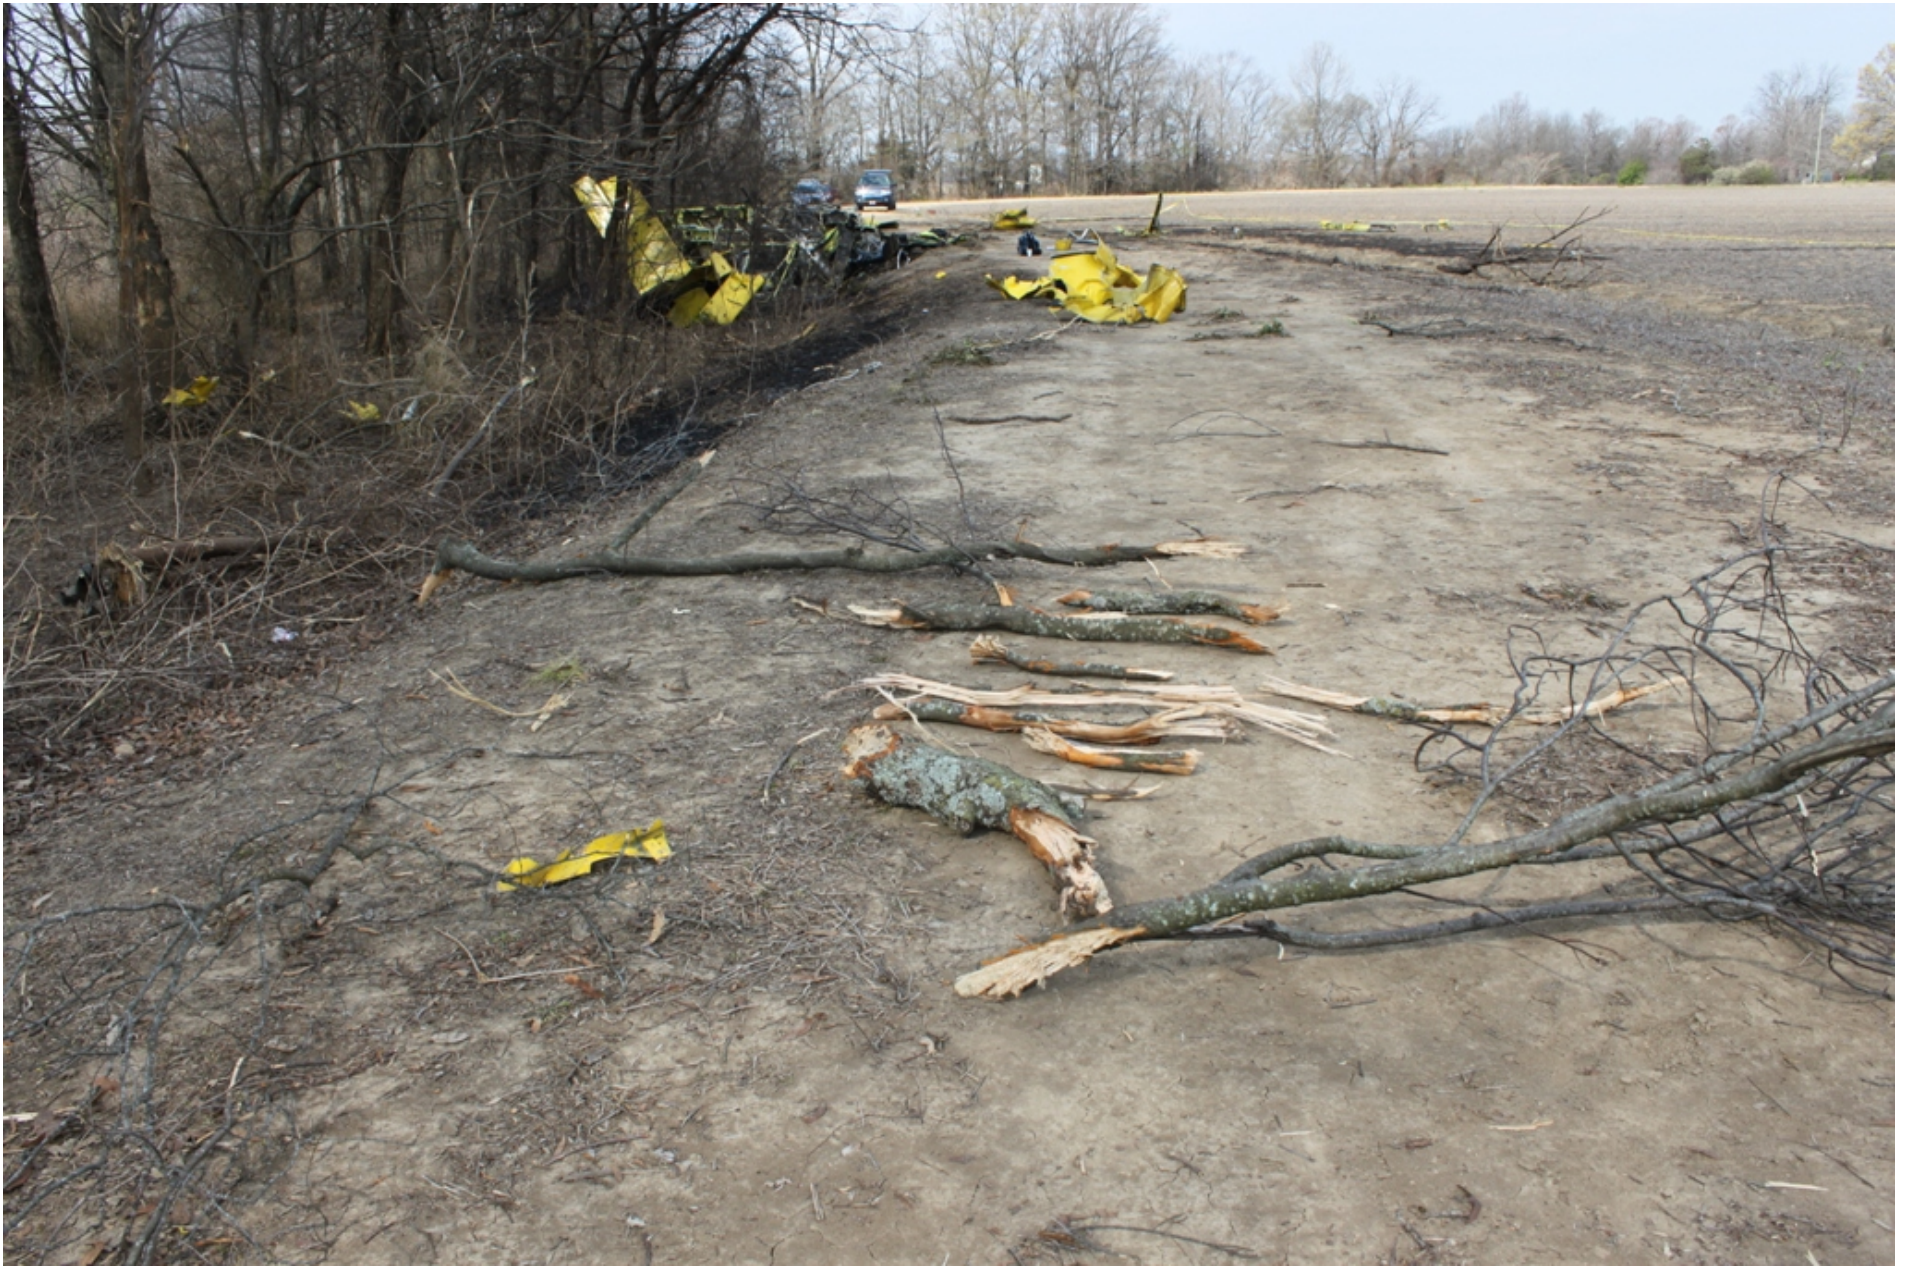
**Photo 10 - NTSB Digital Photograph. View Depicting the Recovered Tree Limbs of Various Diameters and Trunk That Exhibited Cut Surfaces Consistent with Propeller Blade Contact**

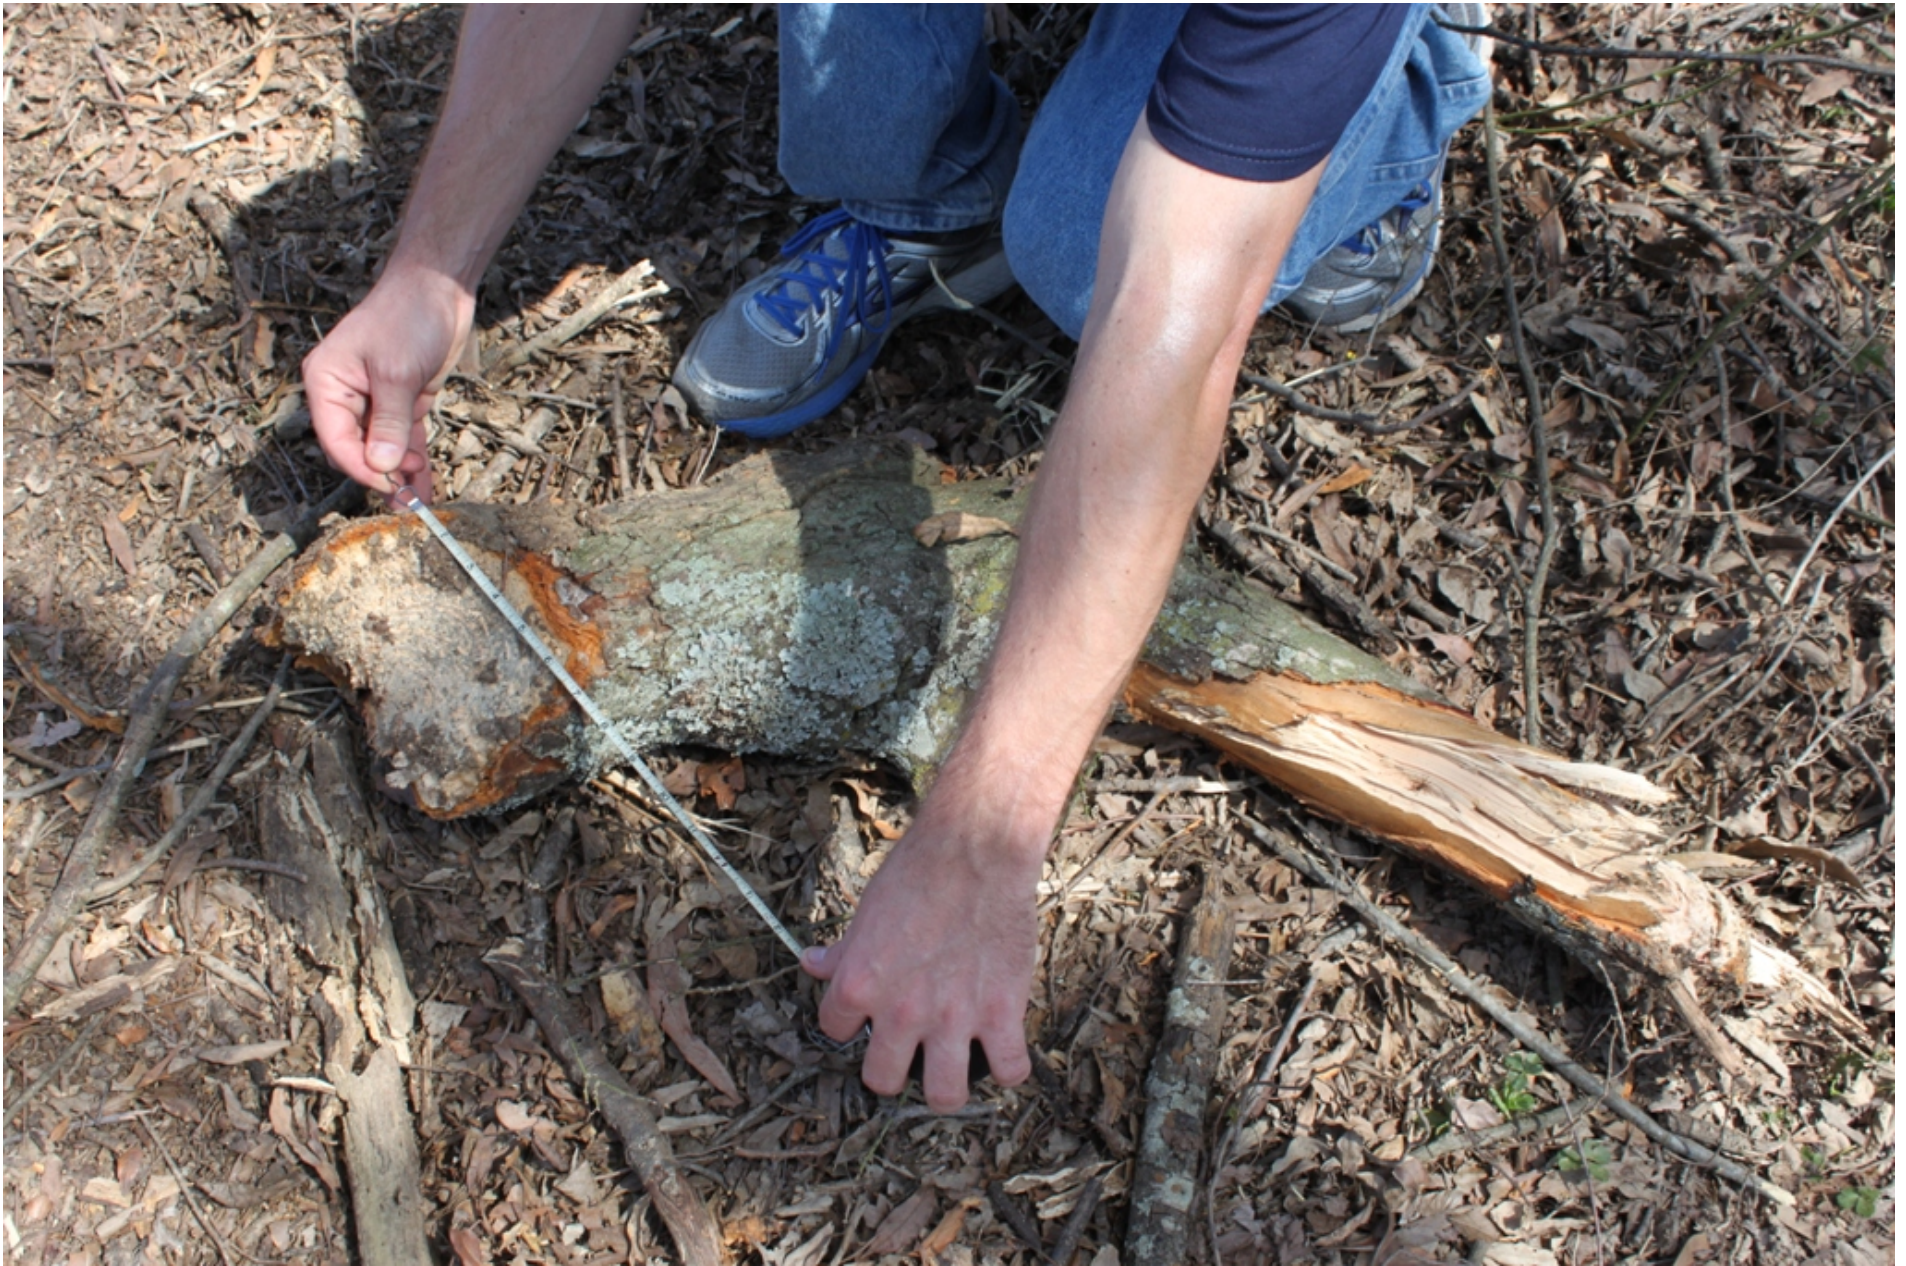
**Photo 11 - NTSB Digital Photograph. View Depicting the Cut Surface With Gray Transfer of 7 Inch Diameter Tree Trunk**
