**Photo 1 – NTSB Digital Photograph. View Looking to the West, taken East of the Eastern Most Airplane Debris**

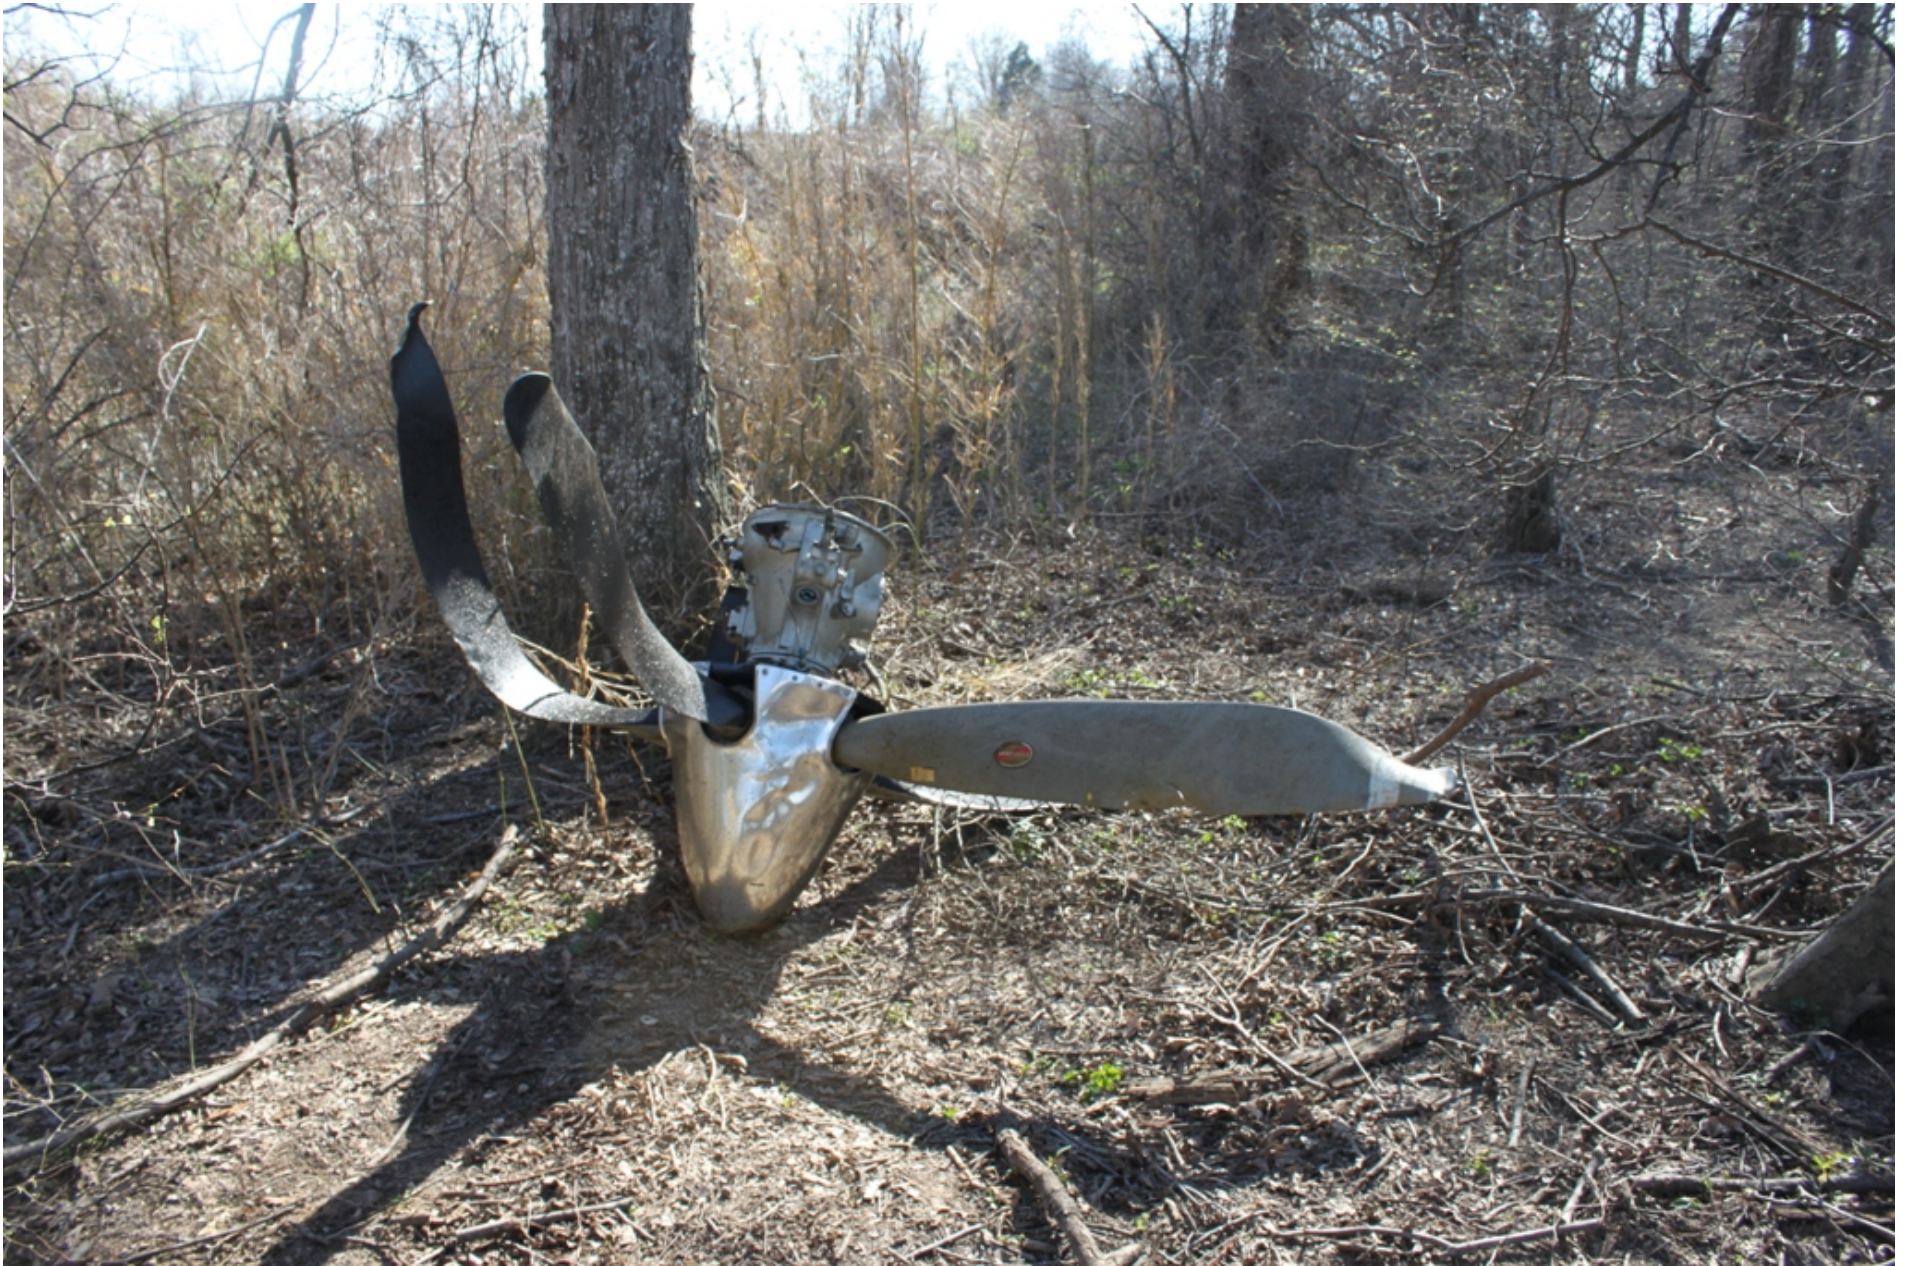
**Photo 12 - NTSB Digital Photograph. View Depicting the Propeller and Reduction Gearbox**

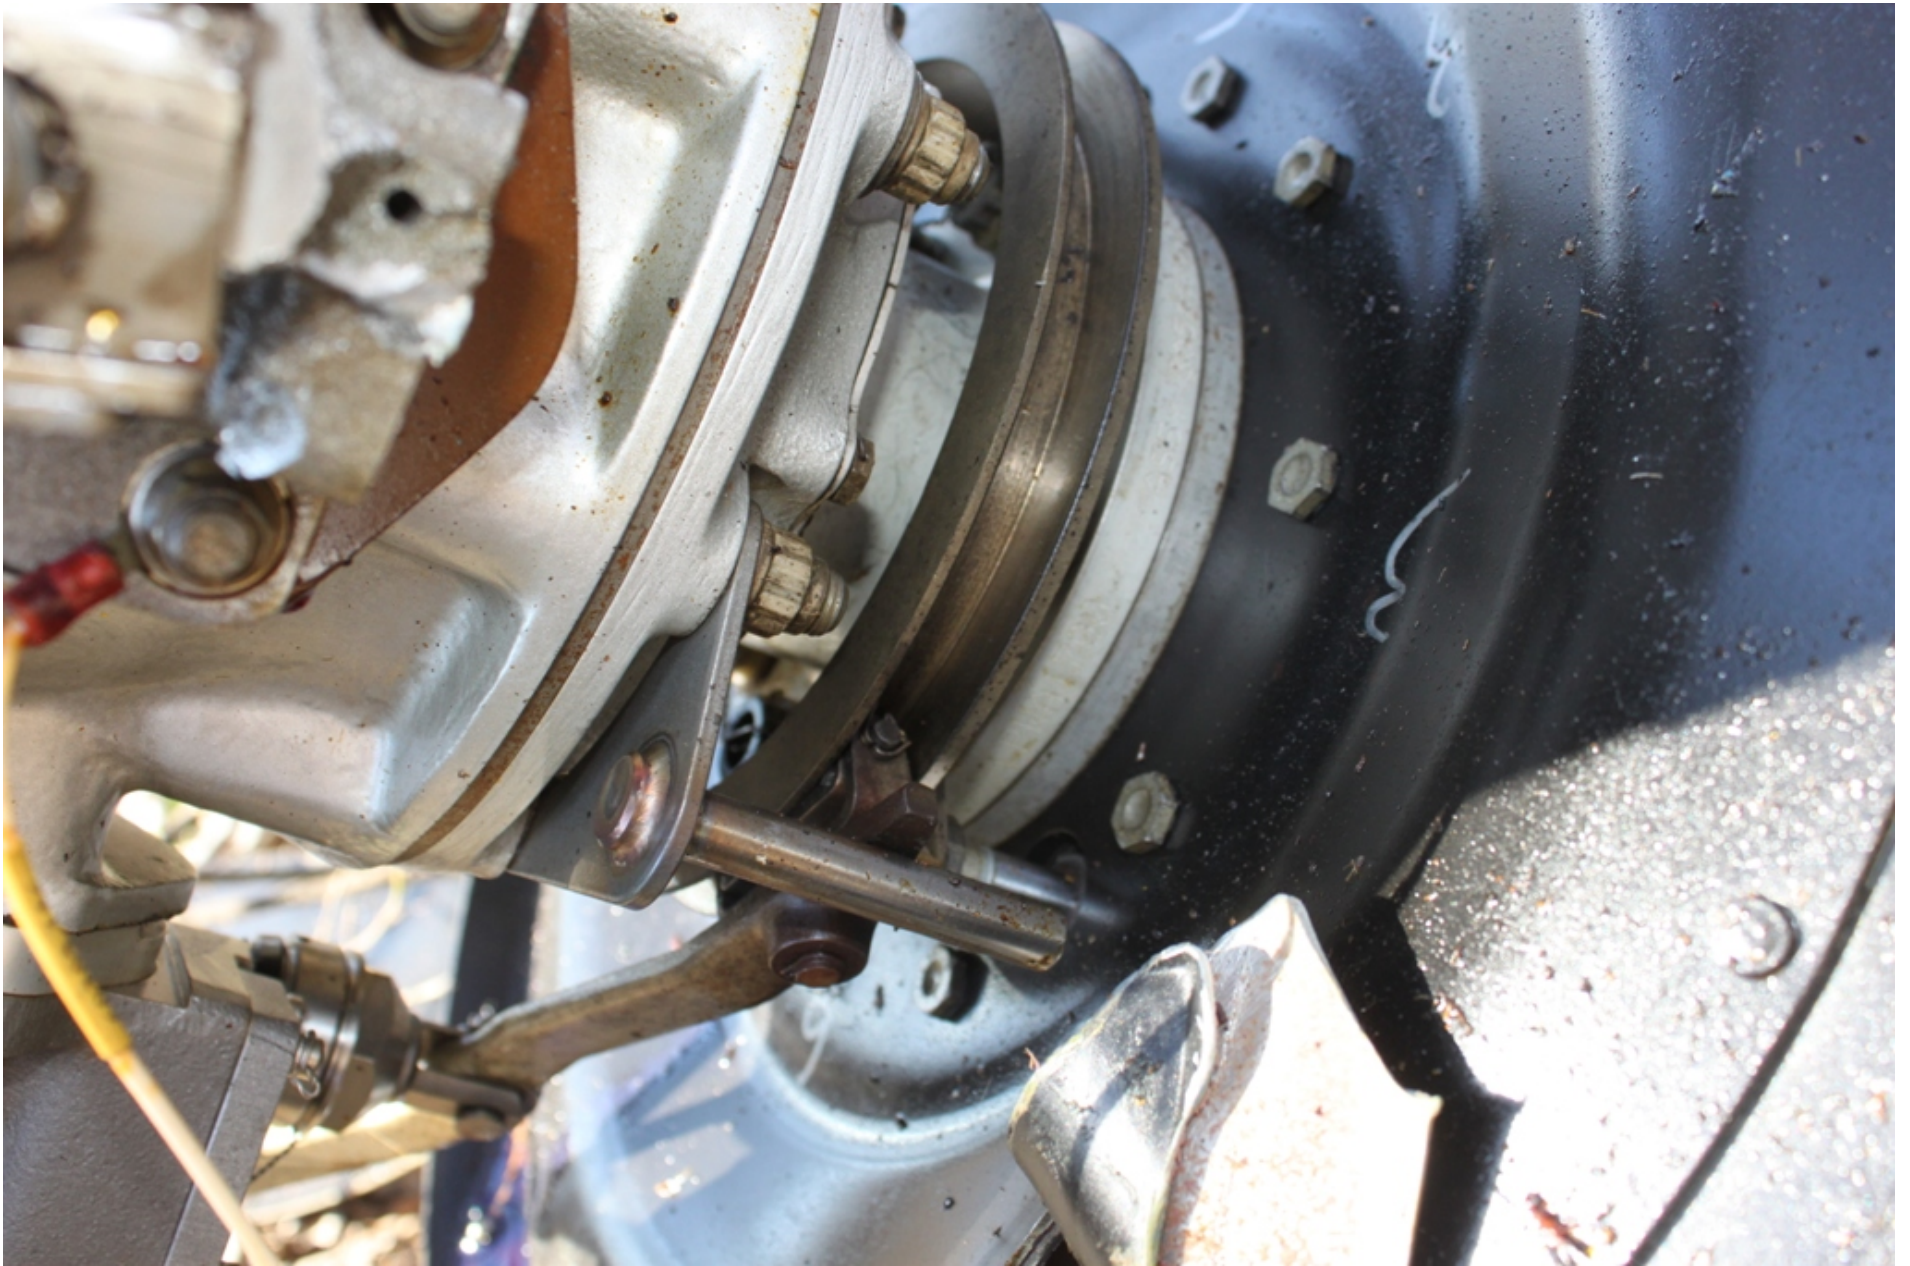
**Photo 13 - NTSB Digital Photograph. View Depicting the Beta Block In Proper Relation to the Guide Pin**

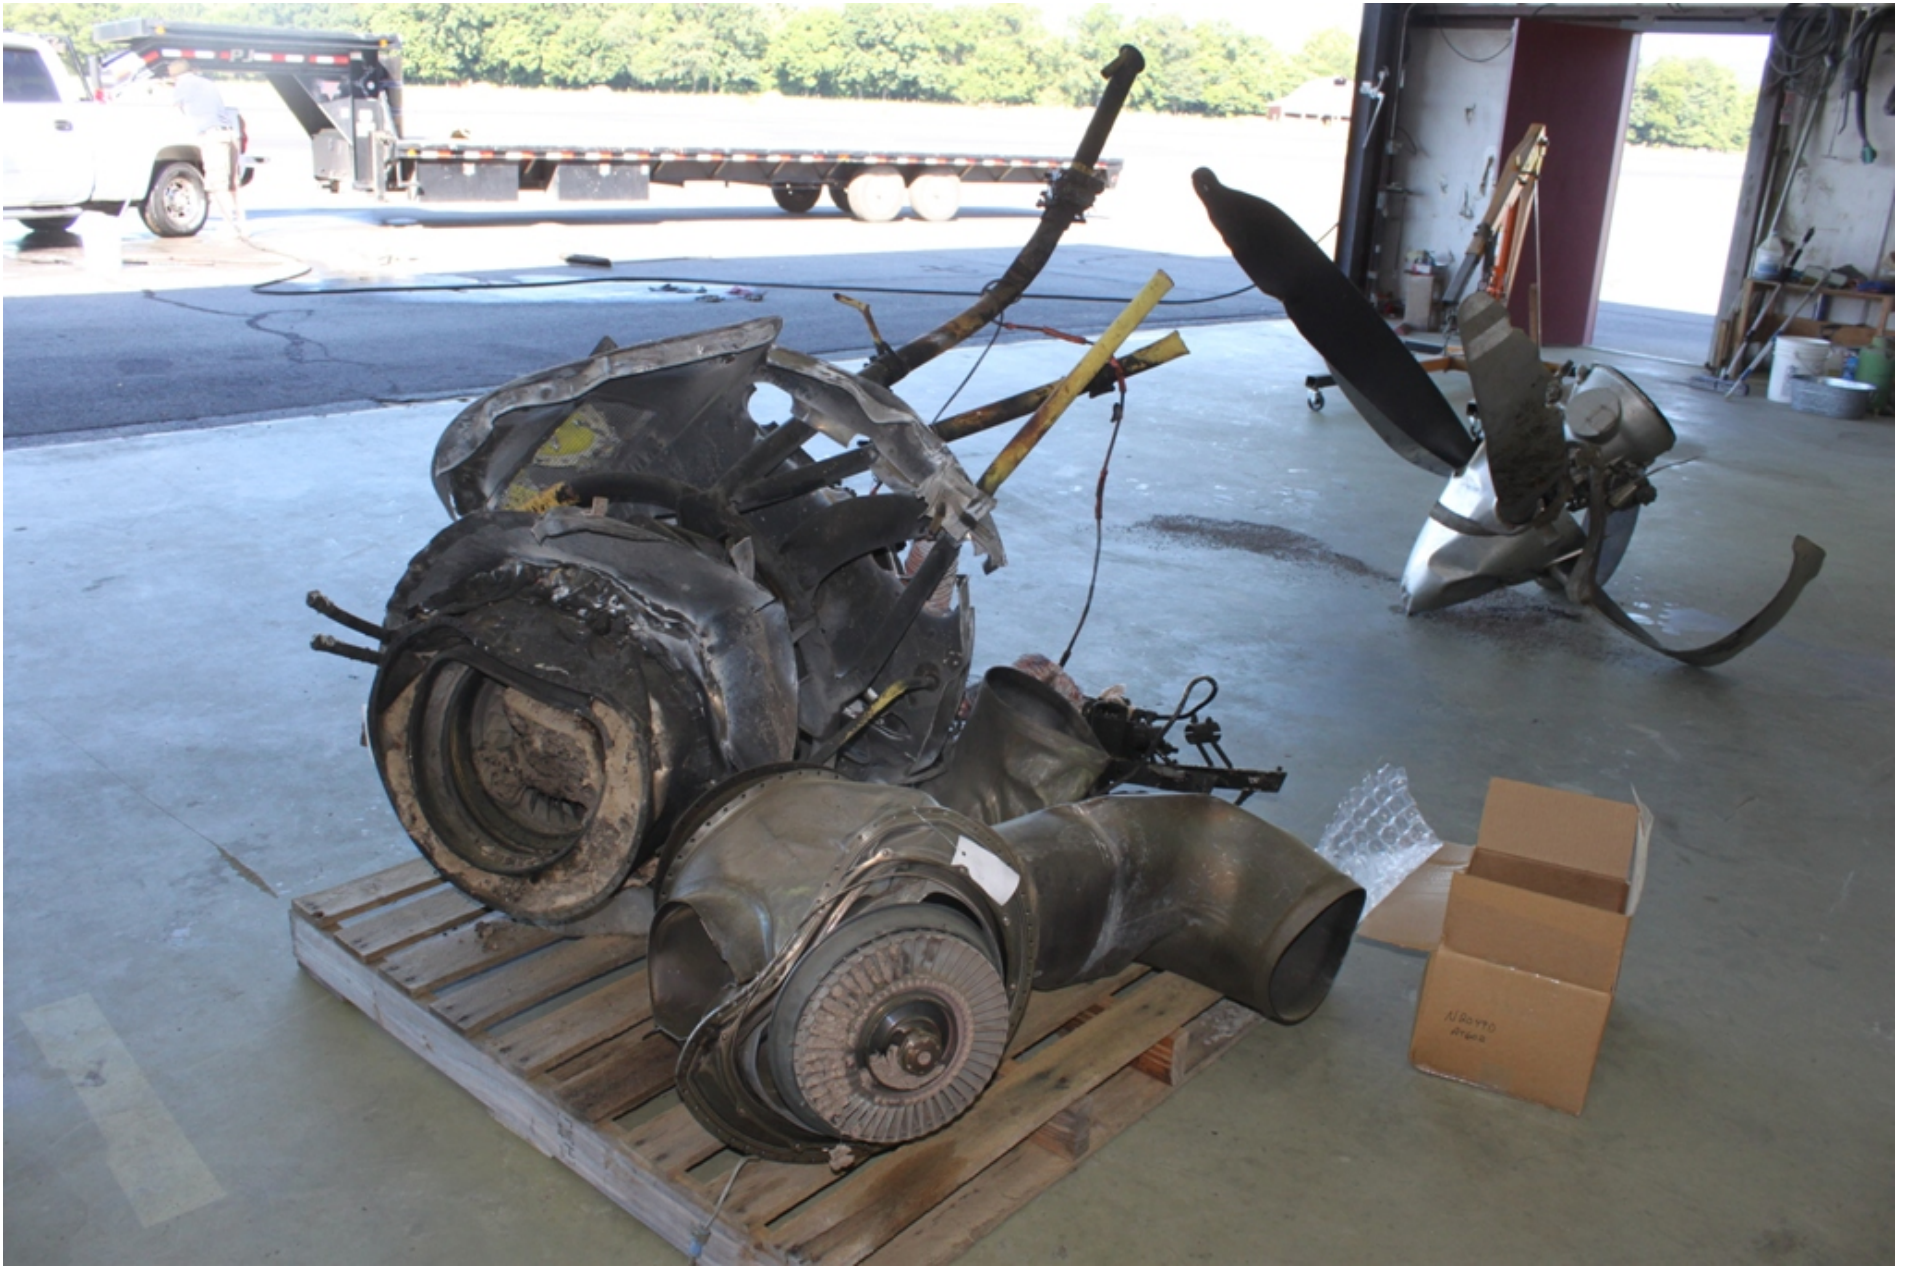
**Photo 14 - NTSB Digital Photograph. View Depicting the Engine Assembly**

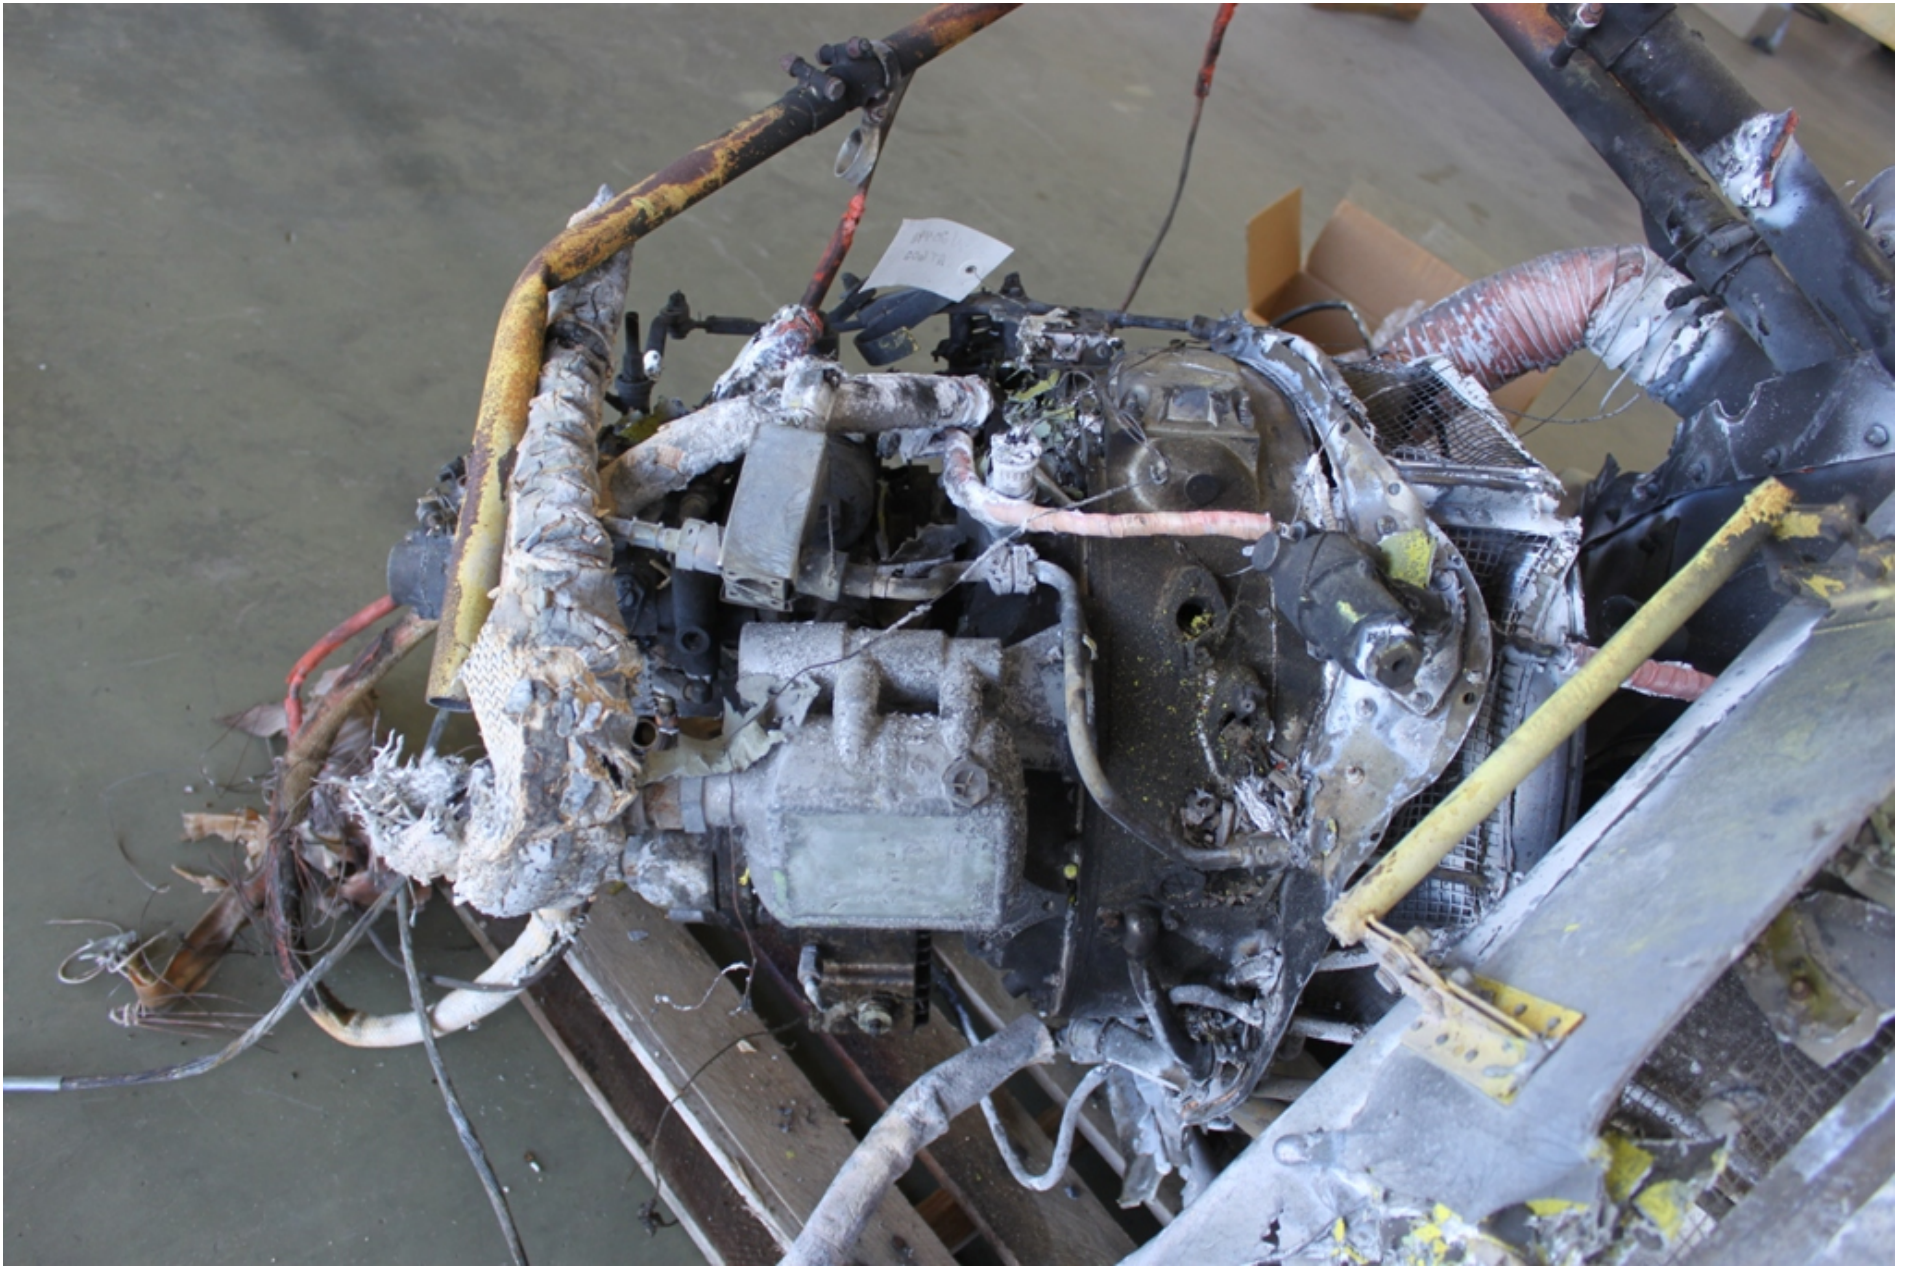
**Photo 15 - NTSB Digital Photograph. Another View Depicting the Engine Assembly. Note the Heat Damage to the Hoses and Accessories**

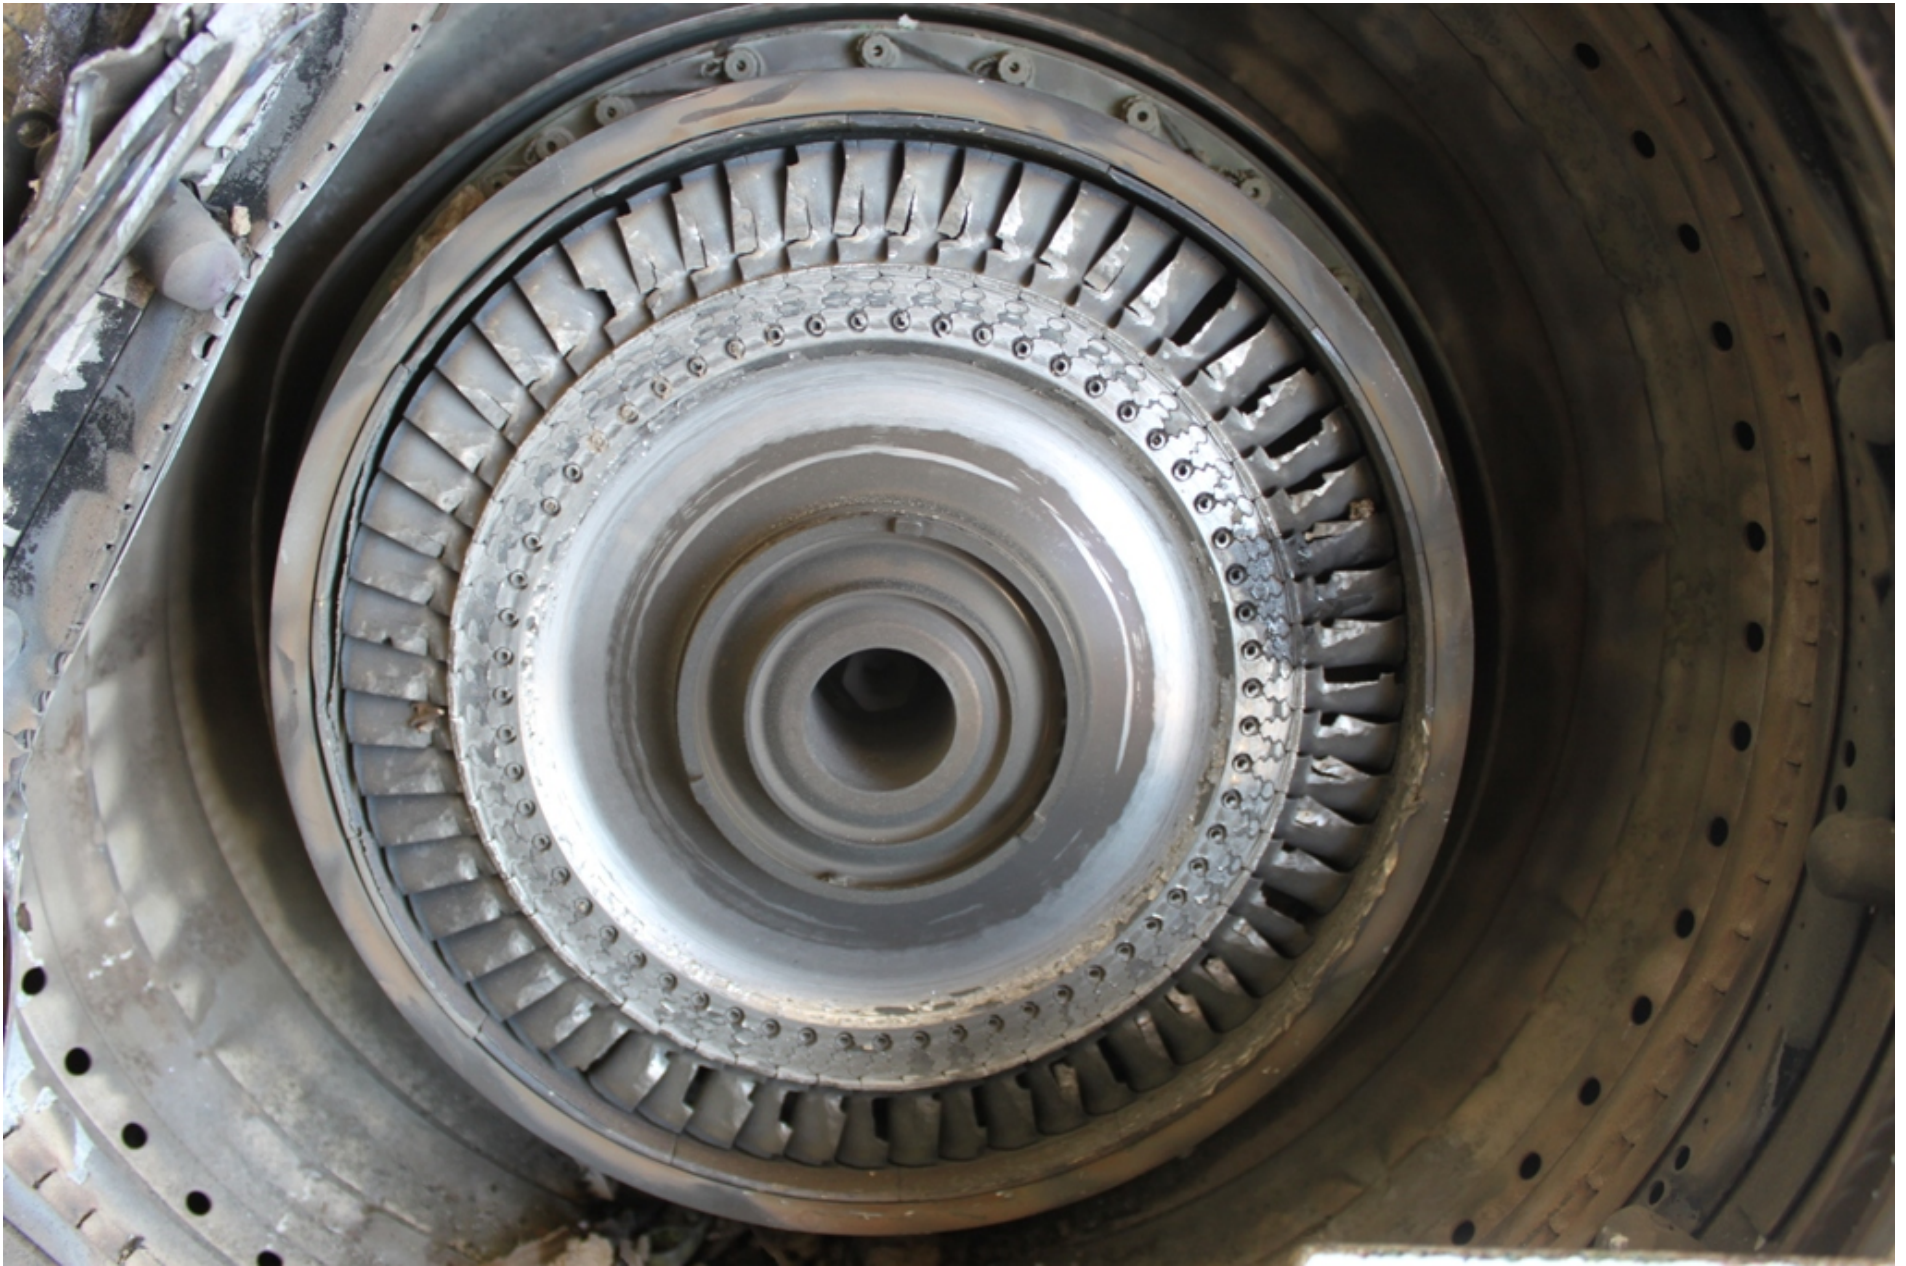
**Photo 16 - NTSB Digital Photograph. Close-Up View of the Downstream Side of the Compressor Turbine. Note the Circumferential Damage to the Disk and Blades**

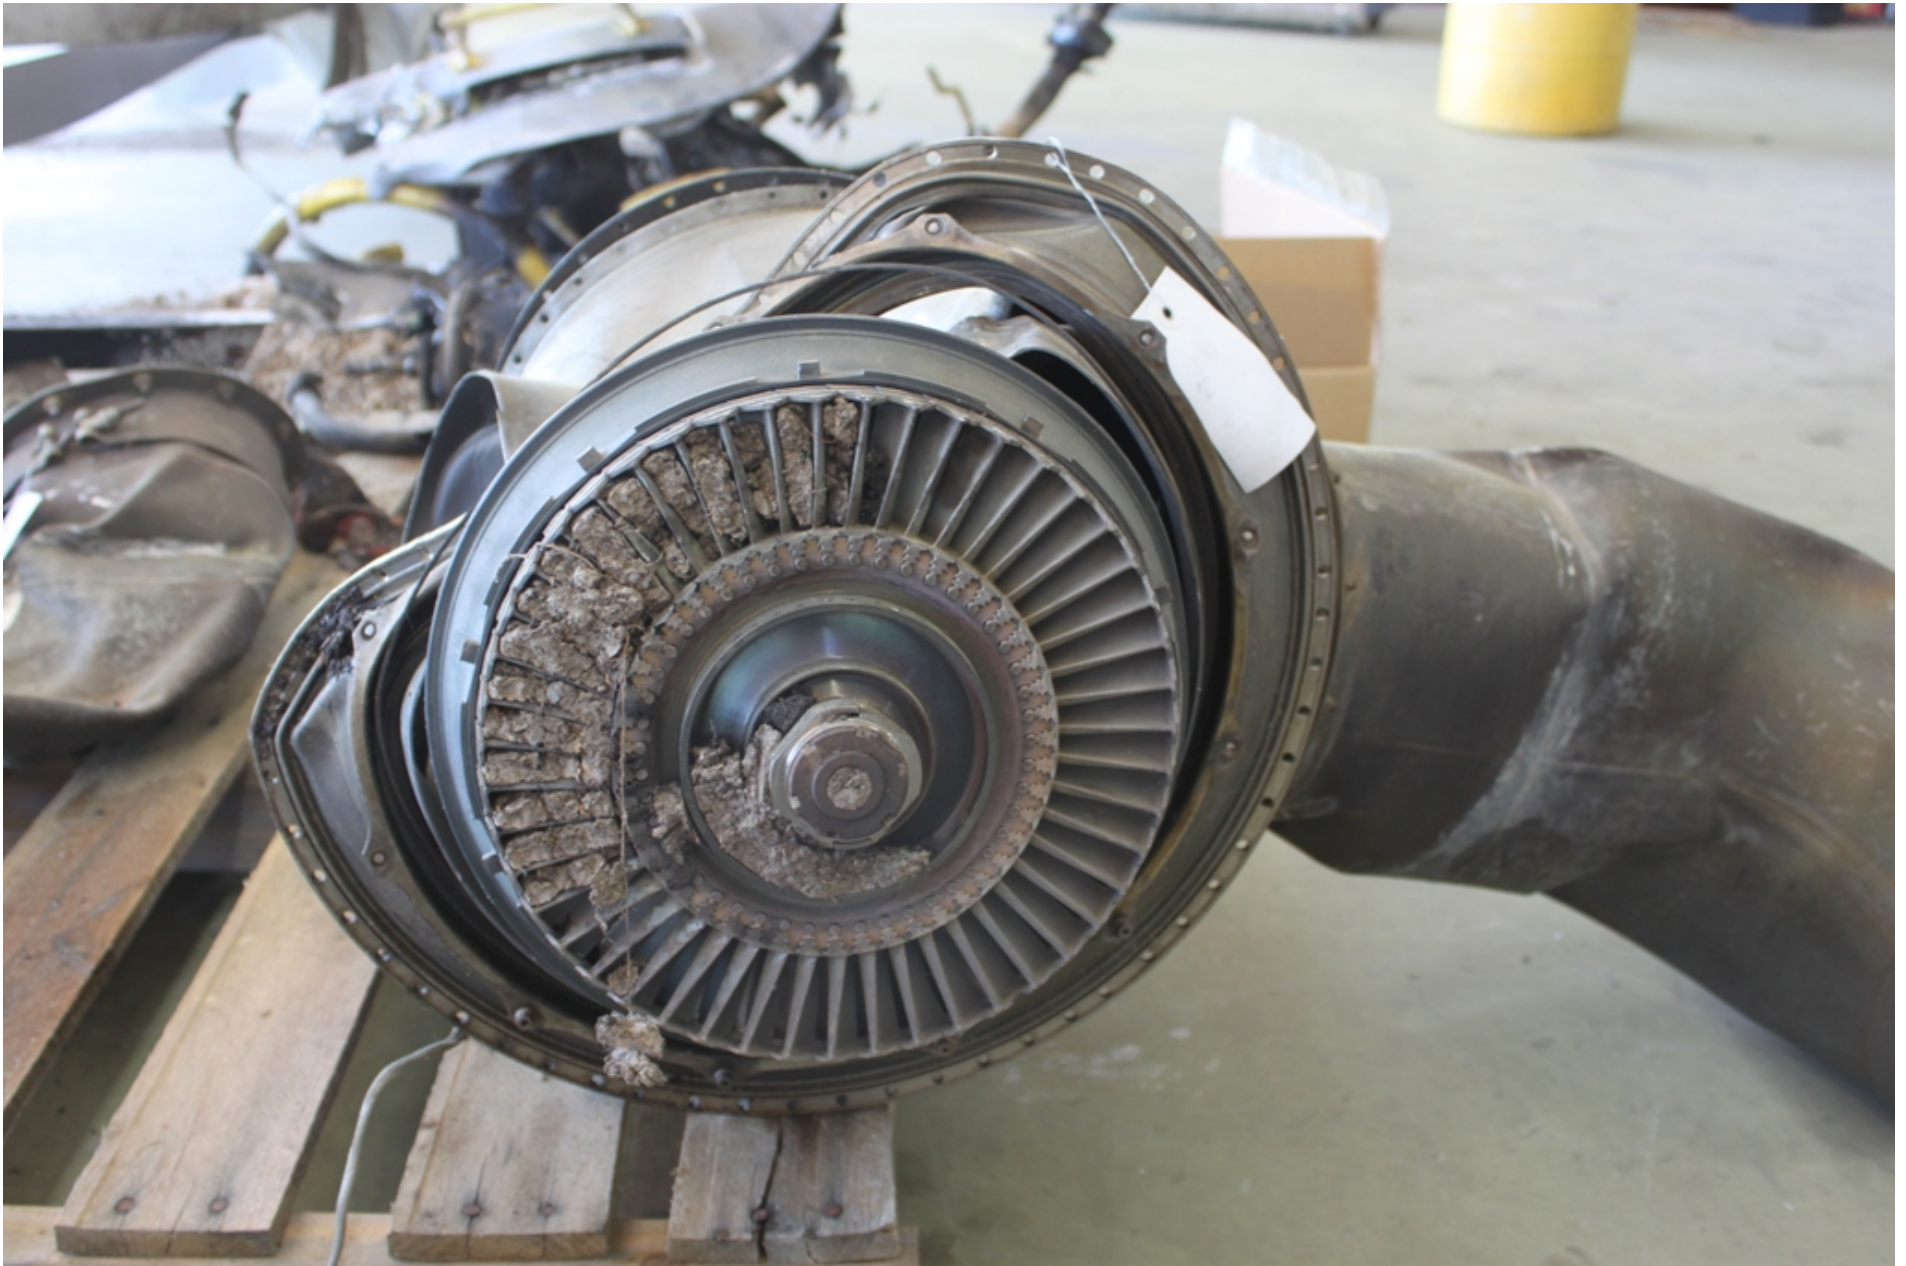
**Photo 17 - NTSB Digital Photograph. Close-Up View of the 1st Stage Power Turbine. Note the Impacted Earth.**

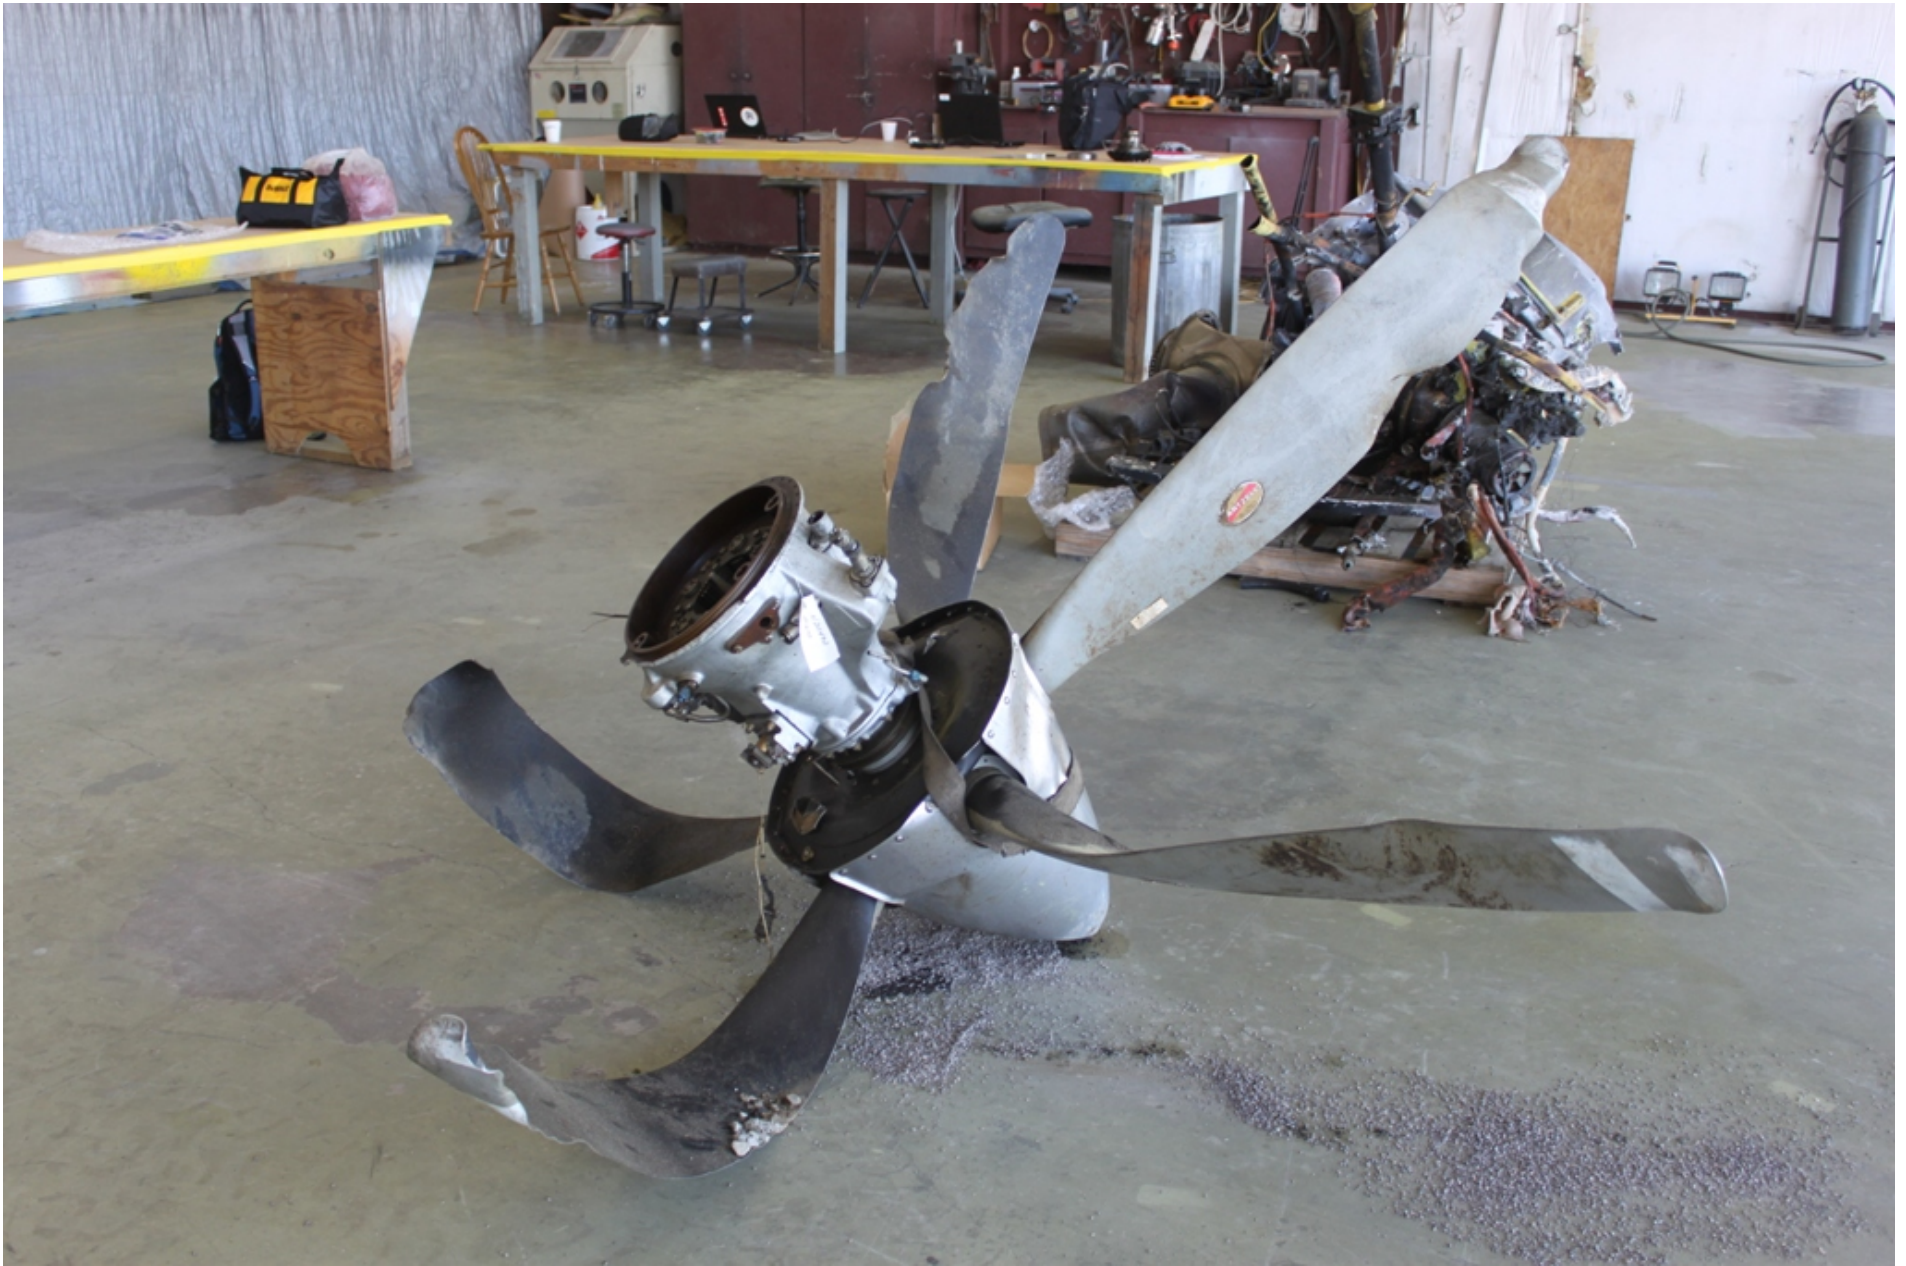
**Photo 18 - NTSB Digital Photograph. View of the Propeller. Note the Blade Bending**
