# NATIONAL TRANSPORTATION SAFETY BOARD

MATERIALS LABORATORY FACTUAL REPORT

Report No. 19-015

Place : Thomaston, GA  
Date : 7/4/2018  
Vehicle : N8314W  
NTSB No. : ERA18LA226  
Investigator : Heidi Kemner

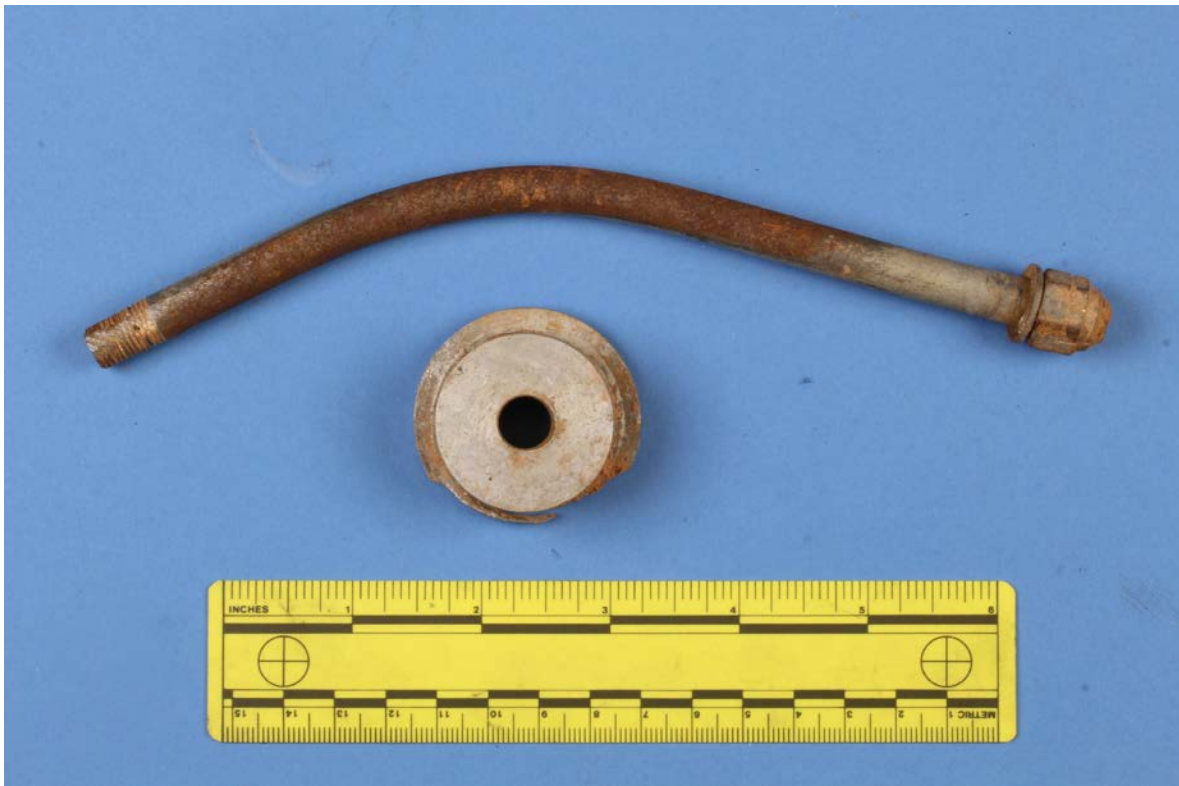
The nose landing gear wheel attach bolt exhibited a bend at approximately the midpoint of its length. The attach bolt consisted of a 3/8-inch rod threaded on both ends. One end had a nut attached and the other end exhibited bare threads. Examination of the threads (figures 2, 3) revealed that they had been deformed in a manner consistent with the nut having been pulled off the threads.

Figure 1: Nose landing gear wheel attach bolt as received.

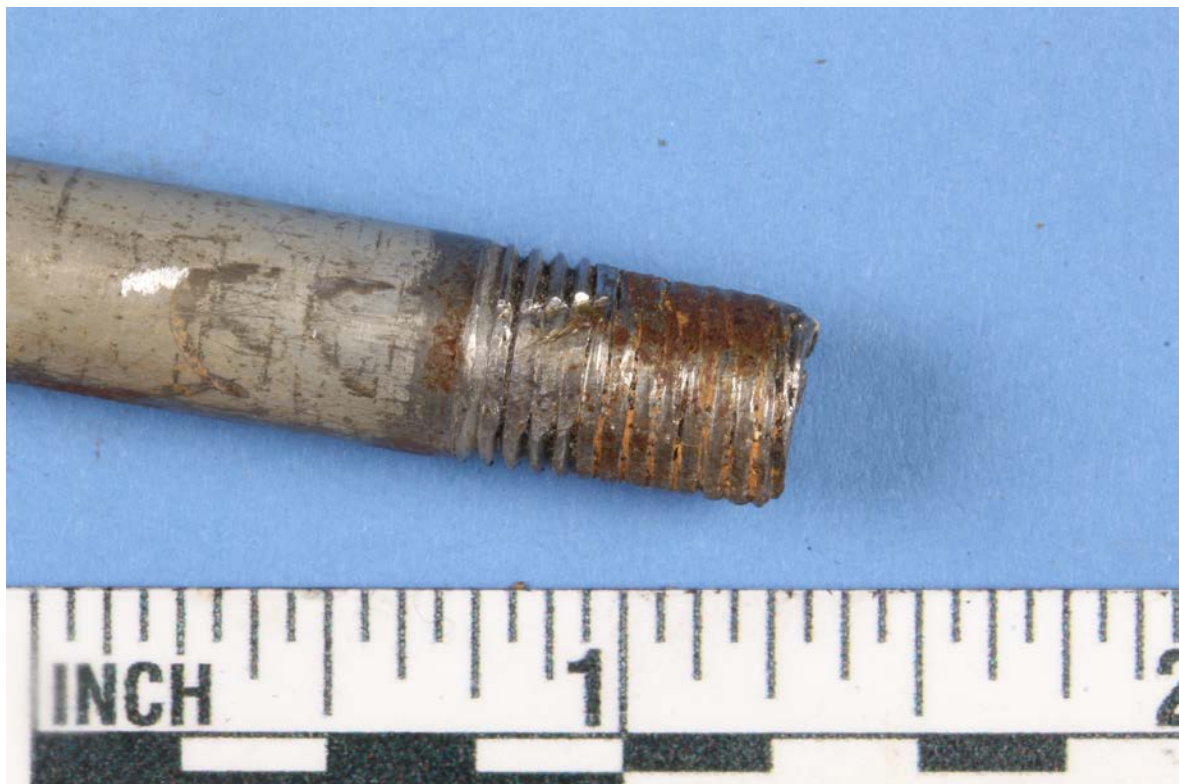
Figure 2: Damaged threads at end of wheel attach bolt.

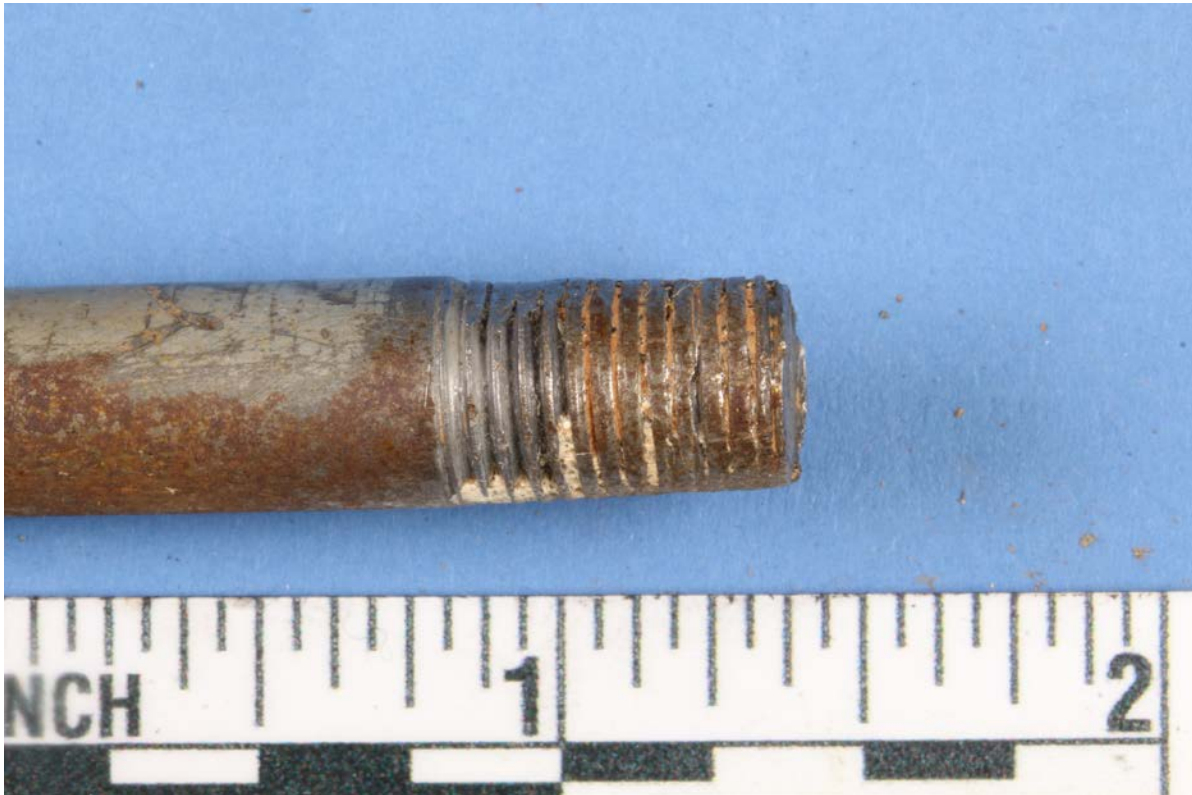
Figure 3: Damaged threads at end of wheel attach bolt (alternate view).
