**NATIONAL TRANSPORTATION SAFETY BOARD**  
Vehicle Recorder Division  
Washington, D.C. 20594

### **Specialist's Factual Report by Gerald Kawamoto**

Location: Marion, South Carolina  
Date: September 12, 2018  
Aircraft: Sonex  
Registration: N75SX  
Operator: Private  
NTSB Number: ERA18LA249

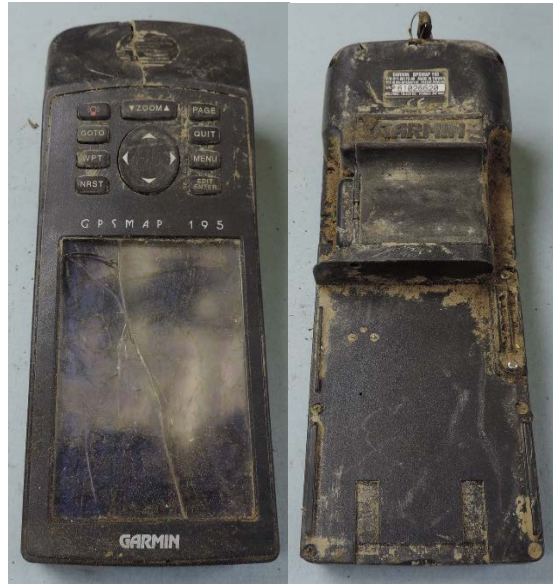
Upon arrival at the Vehicle Recorder Division, an exterior examination revealed impact damage, as shown in Figure 1. The internal components were found damaged preventing the device from powering on normally. The extent of the damage precluded normal recovery procedures and additional attempts were unsuccessful in yielding usable data.

**Figure 1. Front and back of the Garmin GPSMAP 195 as received.**

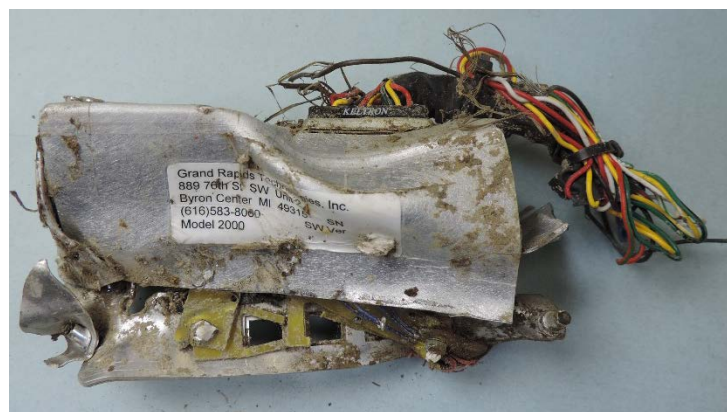
Upon arrival at the Vehicle Recorder Laboratory, an exterior examination revealed the unit had sustained severe impact damage. The device's memory chip was cracked and no data were recovered.

**Figure 2. Grand Rapids Technology EIS 2000 as received.**
