**From:** Chen Deven  
**Sent:** Monday, November 2, 2020 9:38 AM  
**To:** Gretz Robert  
**Cc:** Smith Greg  
**Subject:** ERA20FA086 (Senoia, GA) iPhone 8 Email Report  
**Attachments:** iPhone 8 front.jpg; iPhone 8 back.jpg

### Email Report

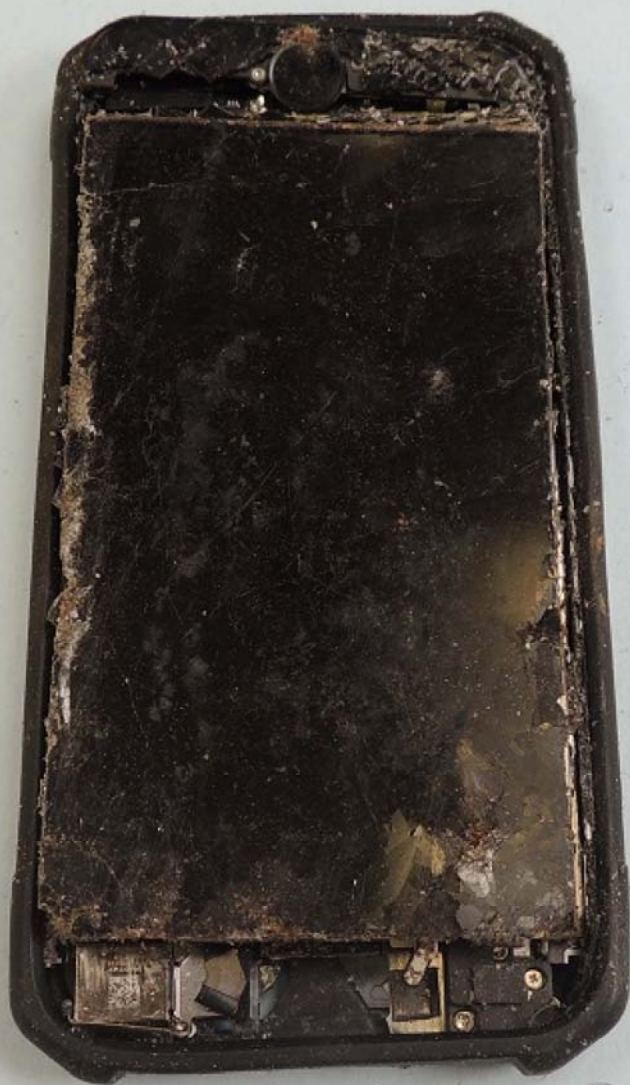
The Vehicle Recorder Division received an iPhone 8 (IMEI 353002090459560). The device arrived exhibiting signs of impact damage (iPhone 8 front.JPG and iPhone 8 back.JPG). The motherboard was removed and did not power up on a surrogate device. In a discussion with the IIC, the device was sent to a commercial data recovery facility. With passcode provided by the family member of the owner, the data recovery facility fully extracted data from the device. The recovered data contained some pictures of the pilot on a flight prior to the accident flight, but did not contain any photos or video recordings from the accident flight.
