# NTSB Review of Illustrated Parts Catalog and Photographs

ERA20LA008

N86MN

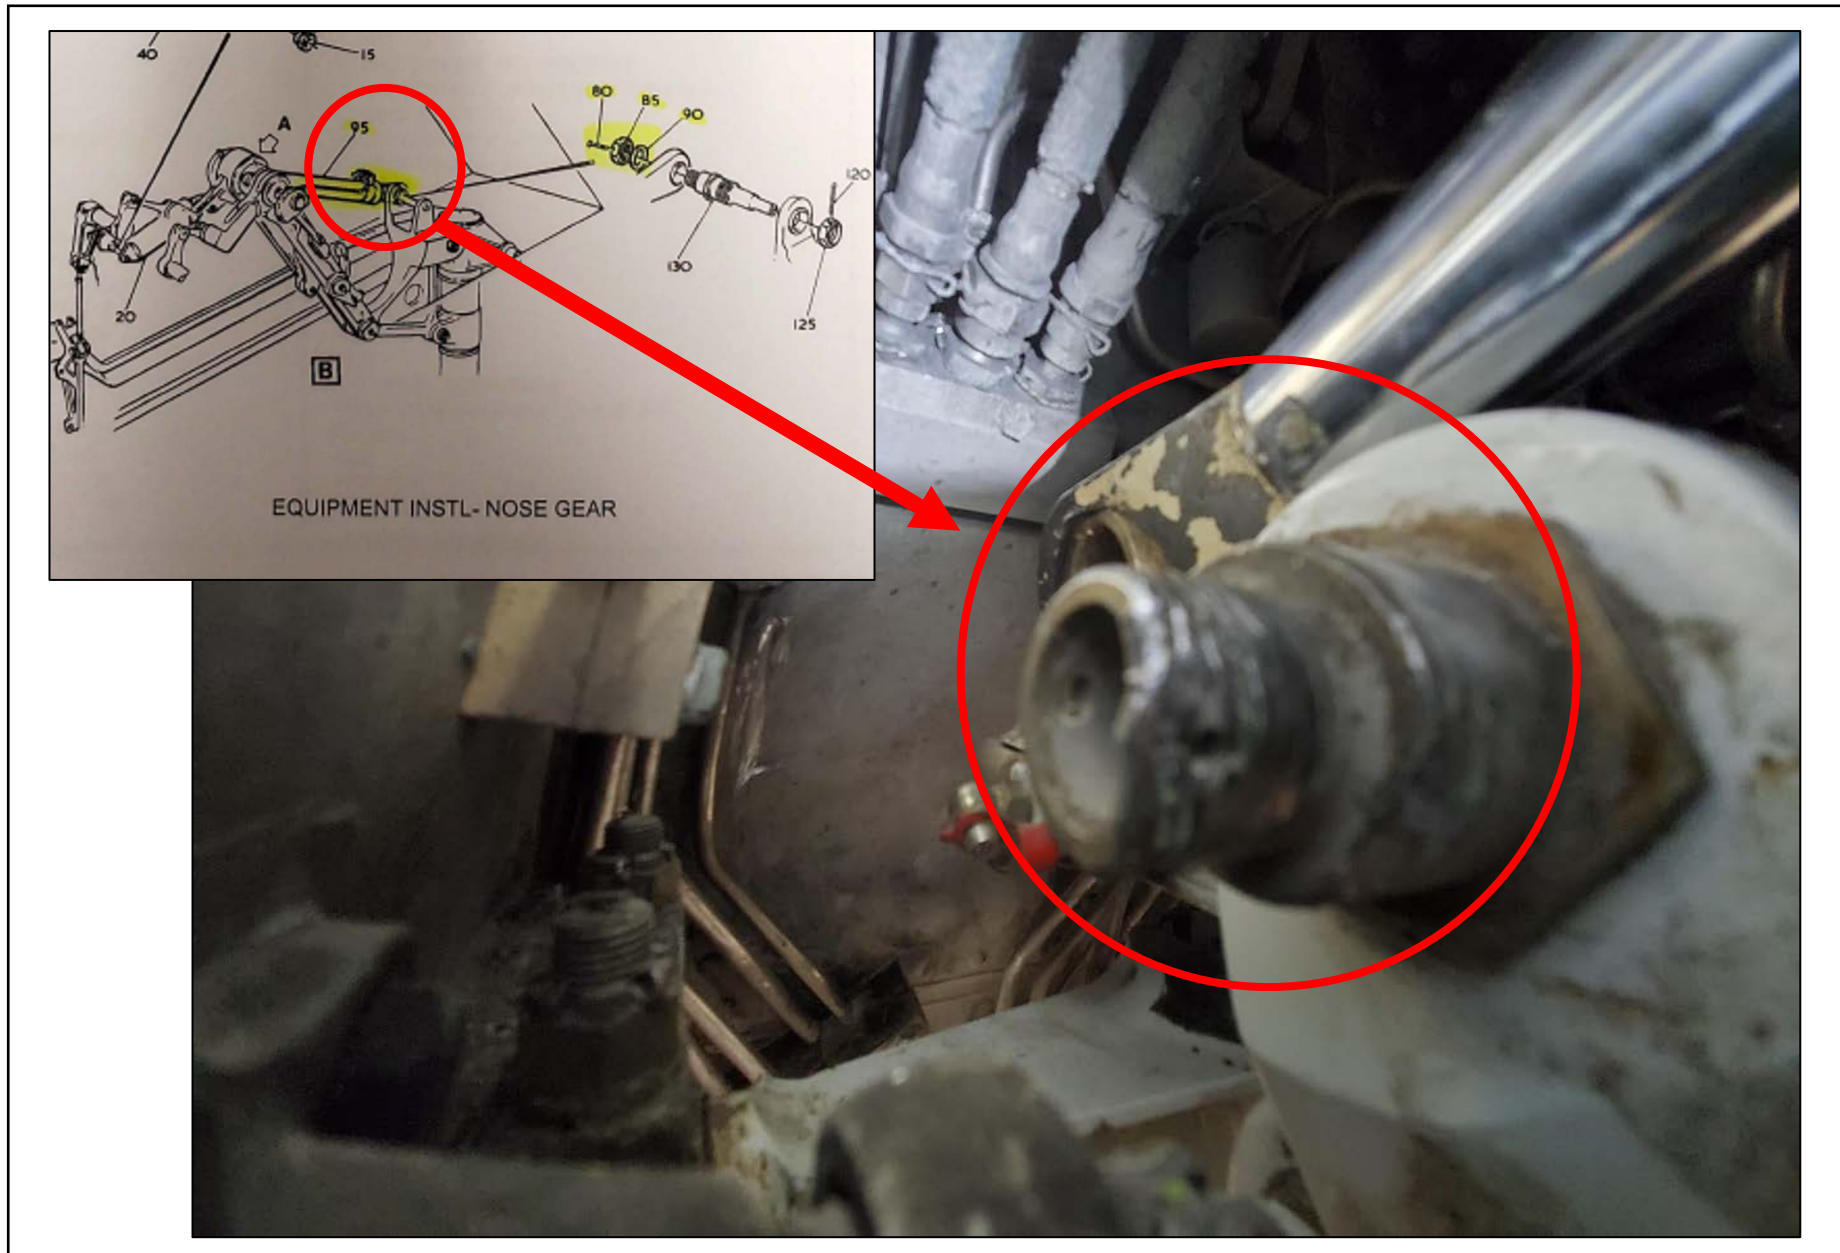
Photo 1 – View of the nose landing gear actuator (Photograph Courtesy of FAA)

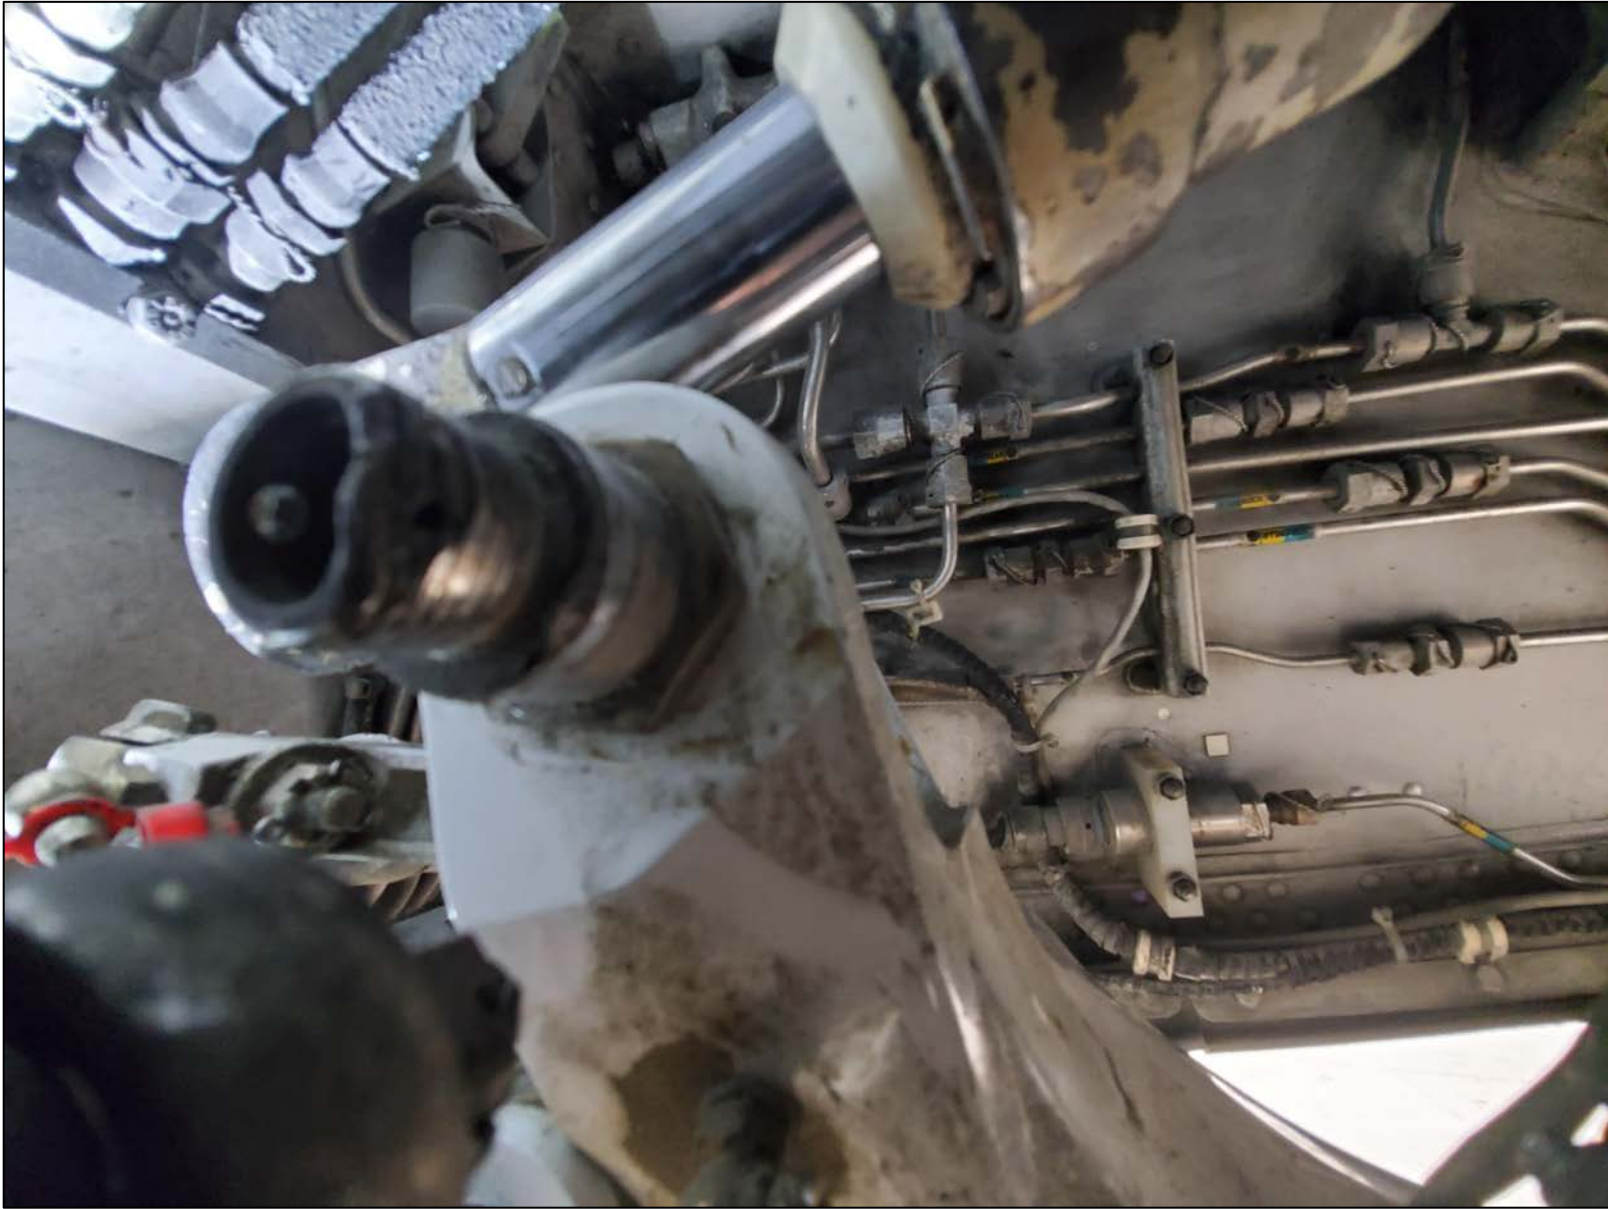
Photo 2 – View of the nose landing gear actuator attachment area (Photograph Courtesy of FAA)

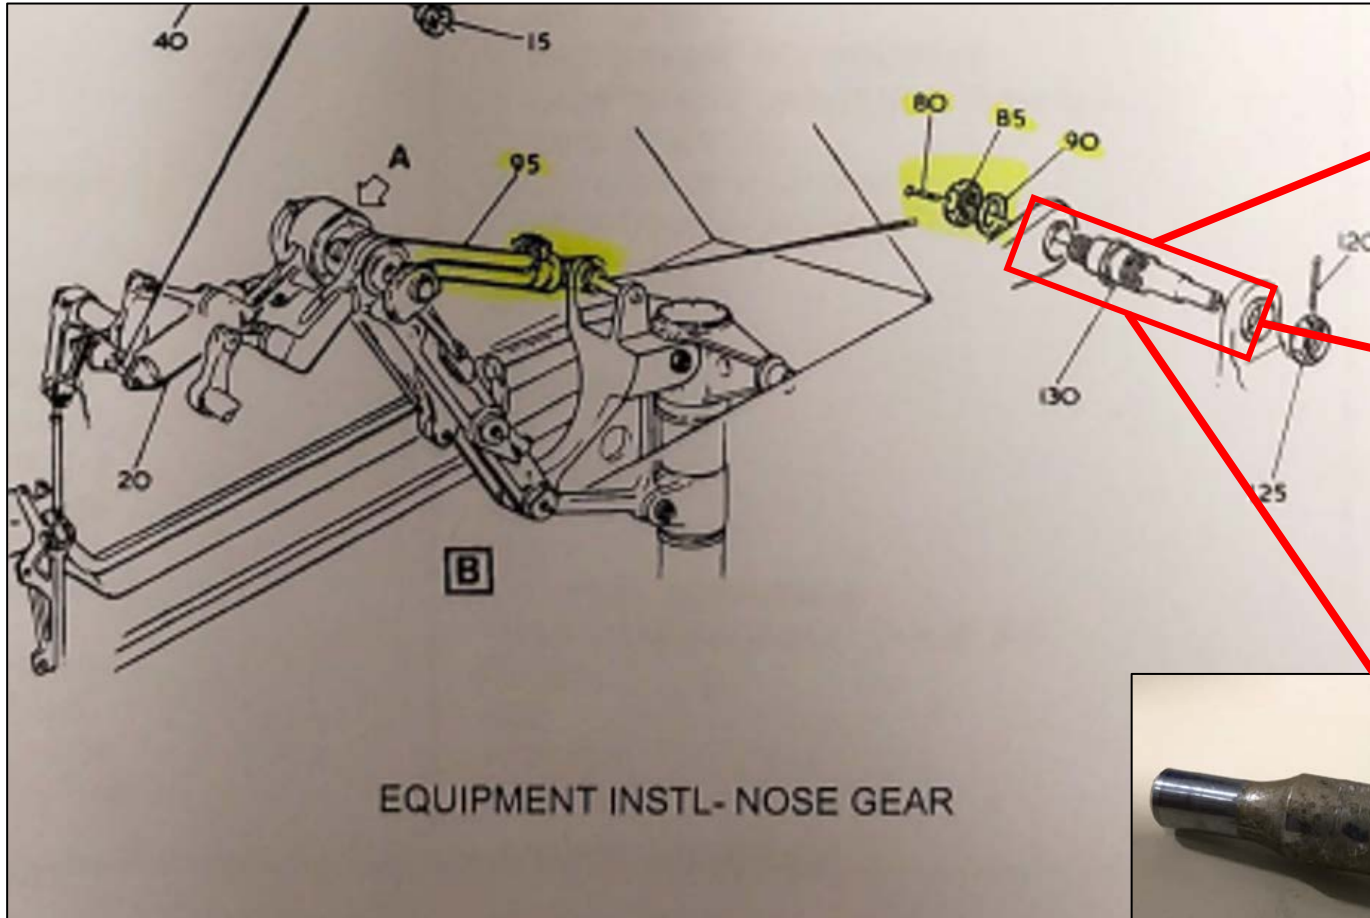
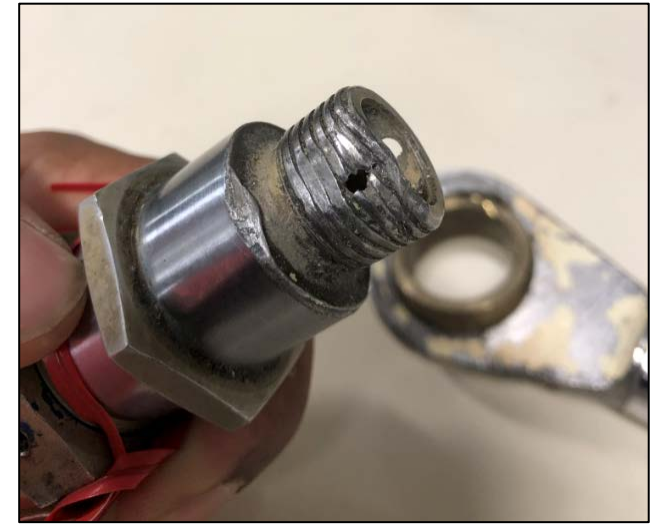
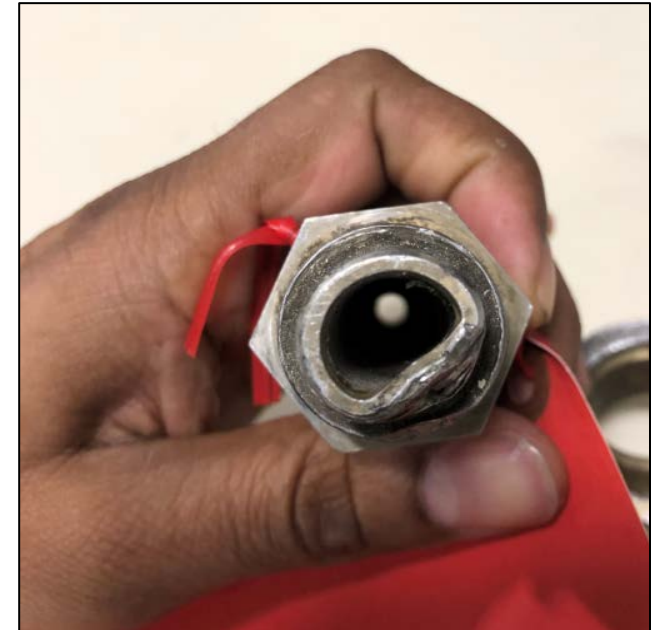
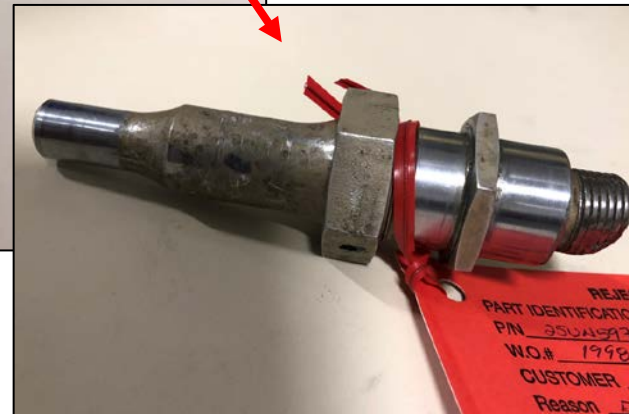
Raytheon Hawker 800/ 850XP illustrated parts catalog, Item 130,  
Part Number 25UN597. Photographs courtesy of Delta Private Jets.

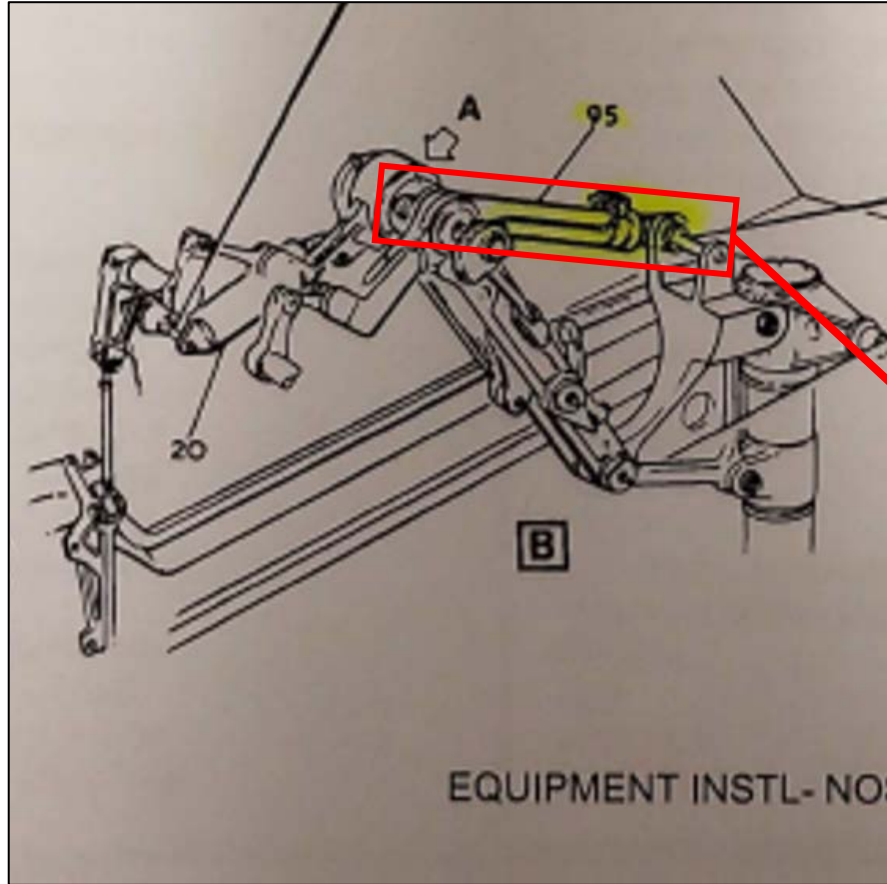
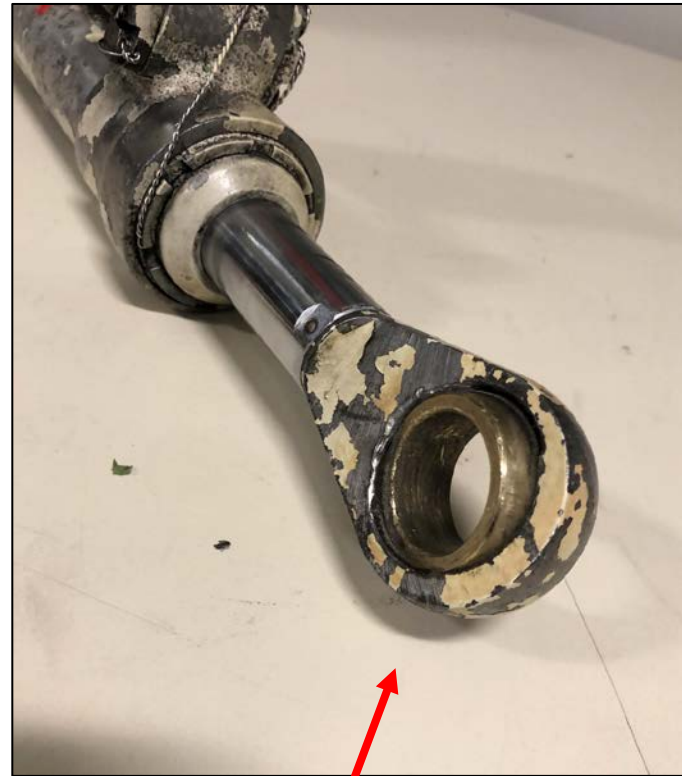
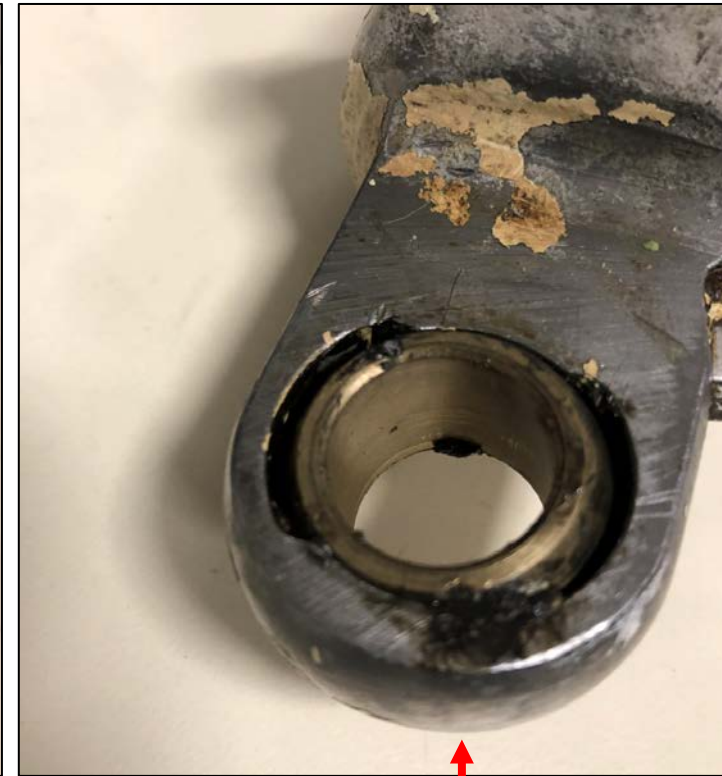
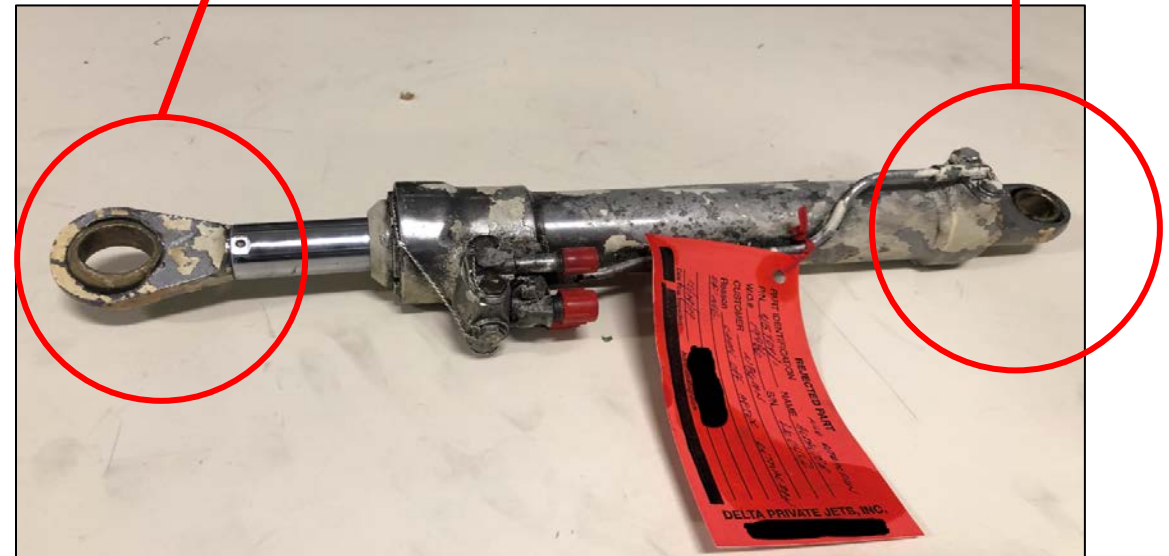
Raytheon Hawker 800/ 850XP illustrated parts catalog, Item 95, Part Number AIR45404.  
Photographs courtesy of Delta Private Jets.

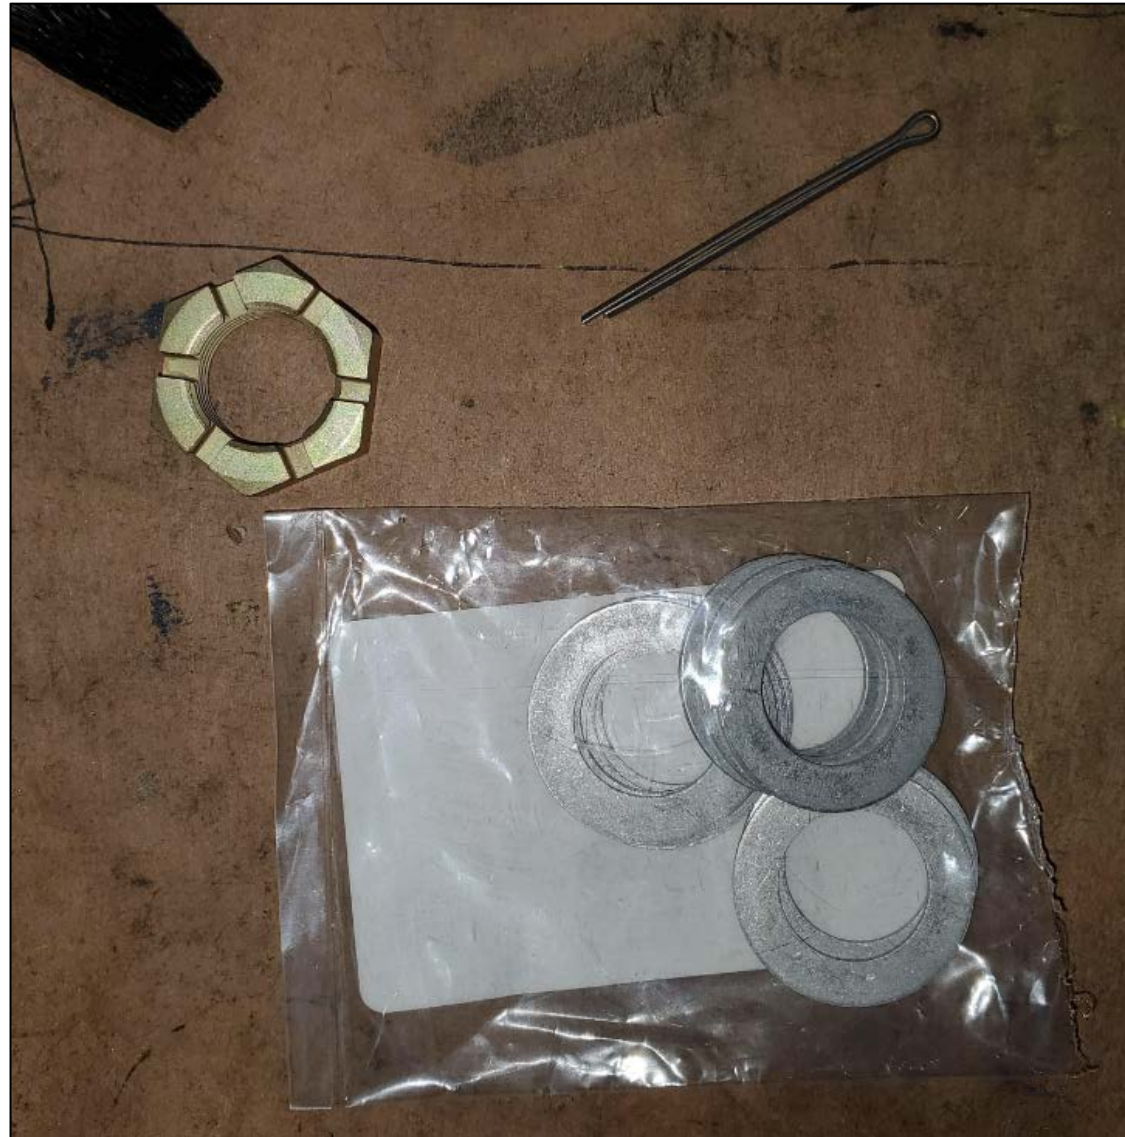
Raytheon Hawker 800/ 850XP illustrated parts catalog, Items 80 (pin-split), 85 (nut), 90 (washer). Photo of *exemplar* missing parts. Photographs courtesy of Delta Private Jets.

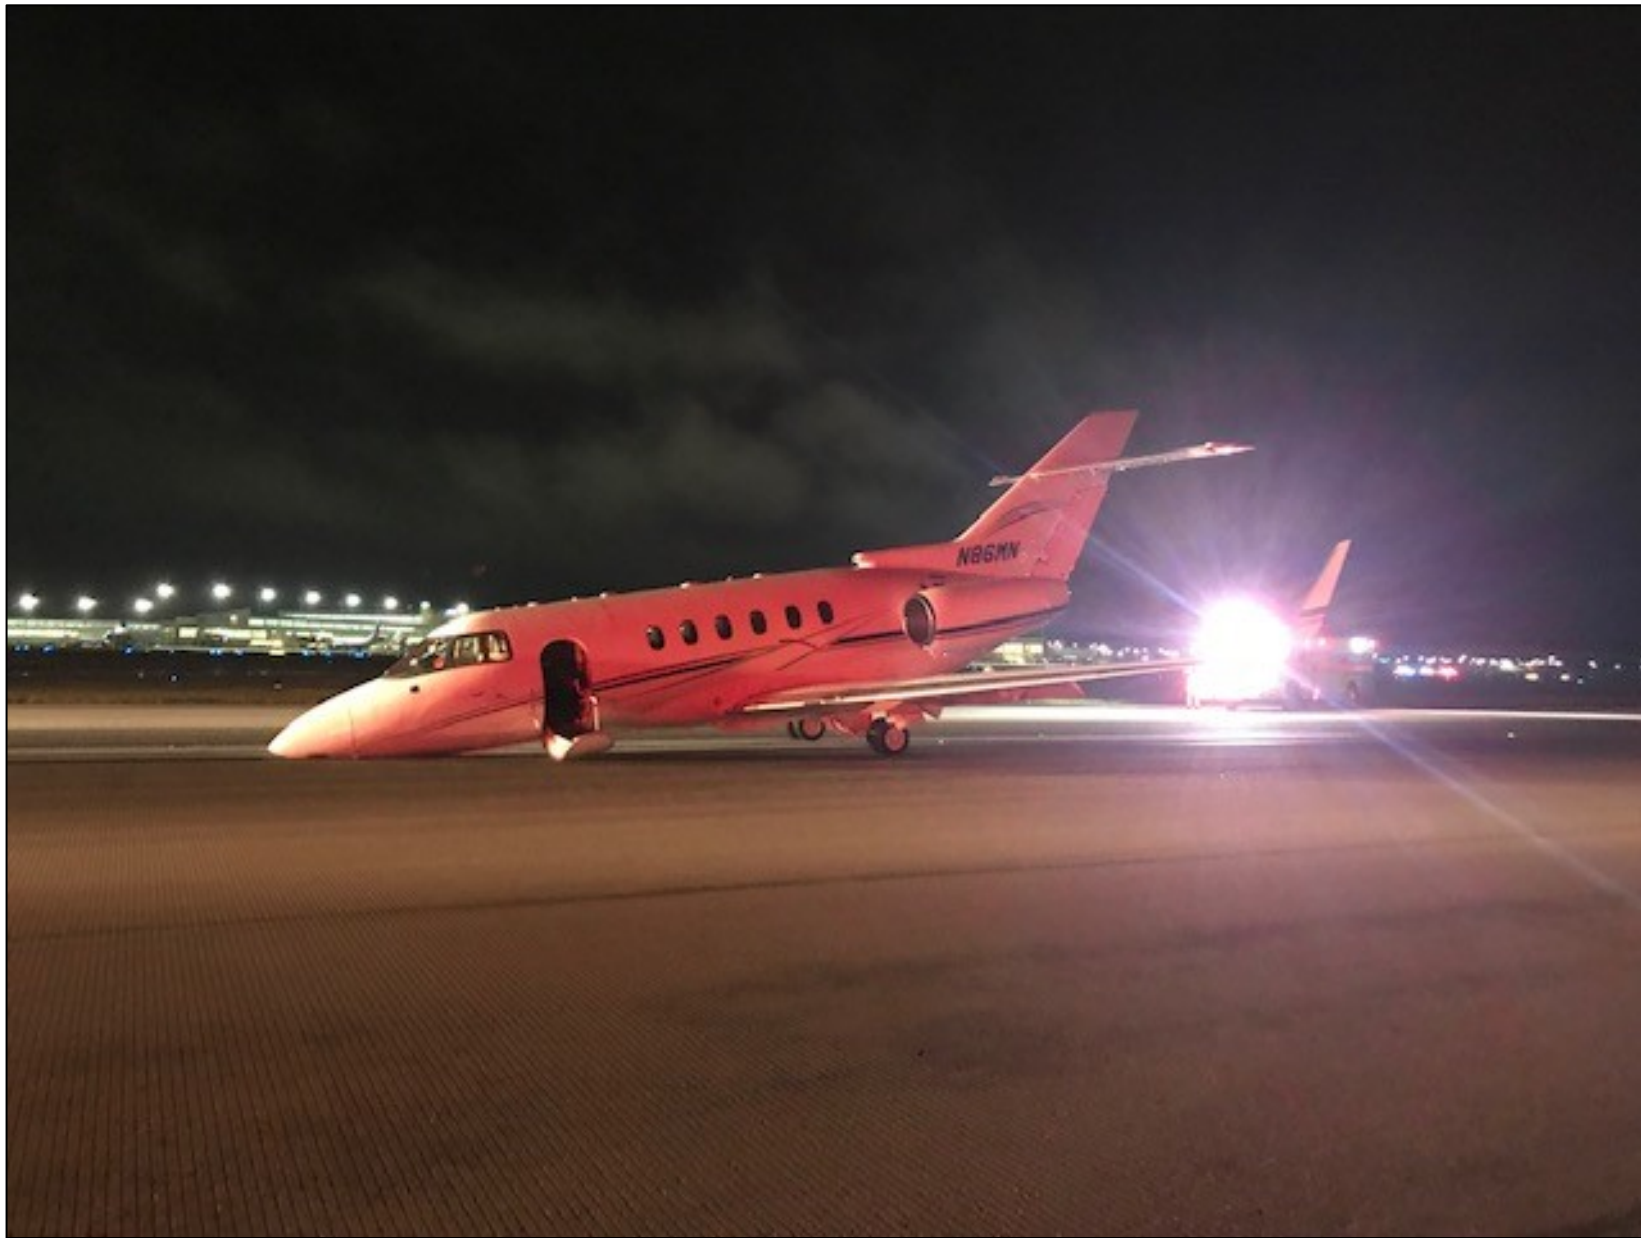
Photo 3 – View of the accident airplane on the runway (Photograph Courtesy of FAA)

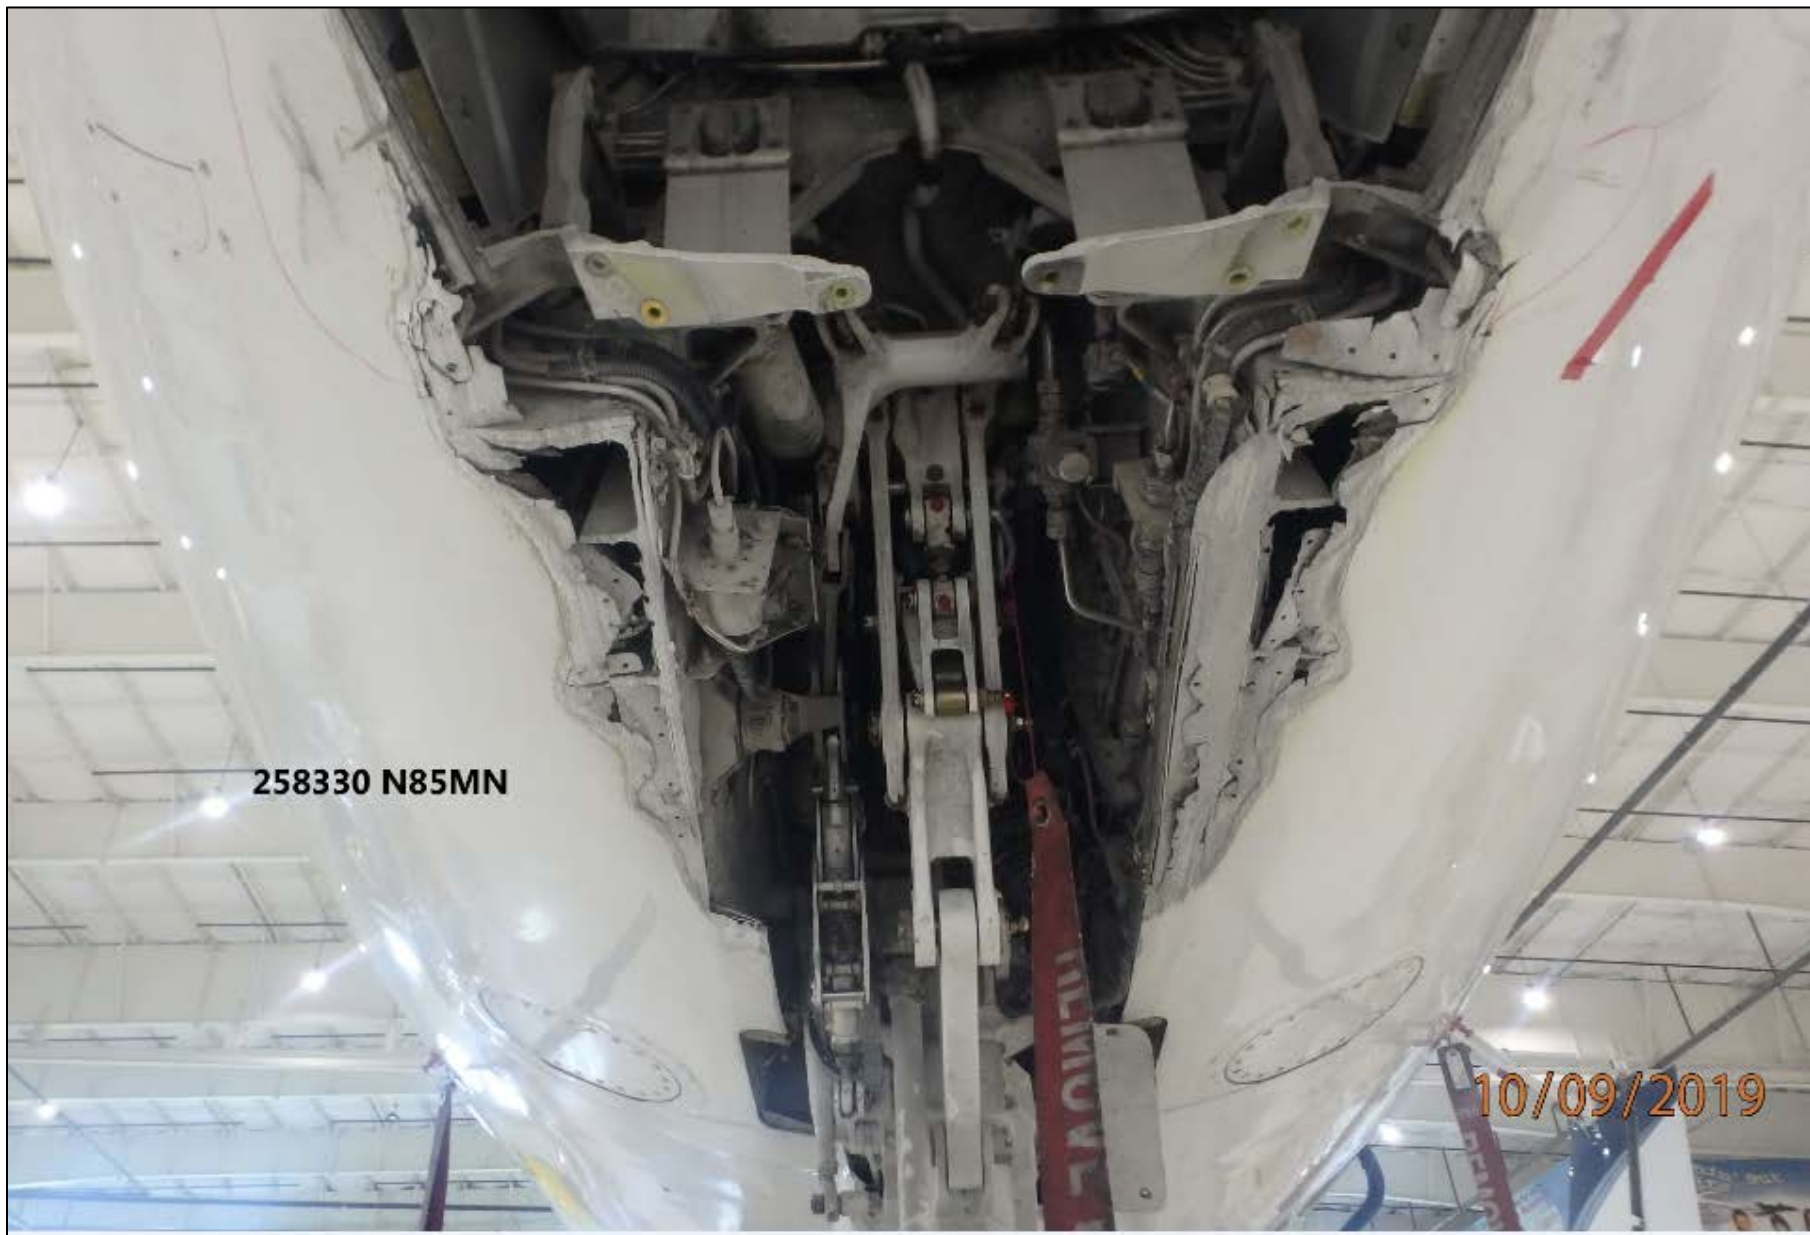
Photo 3 – View of the substantially damaged fuselage (Photograph Courtesy of Delta Private Jets)
