**ACCIDENT SITE**

**N135VE Position @ 1515 EDT**

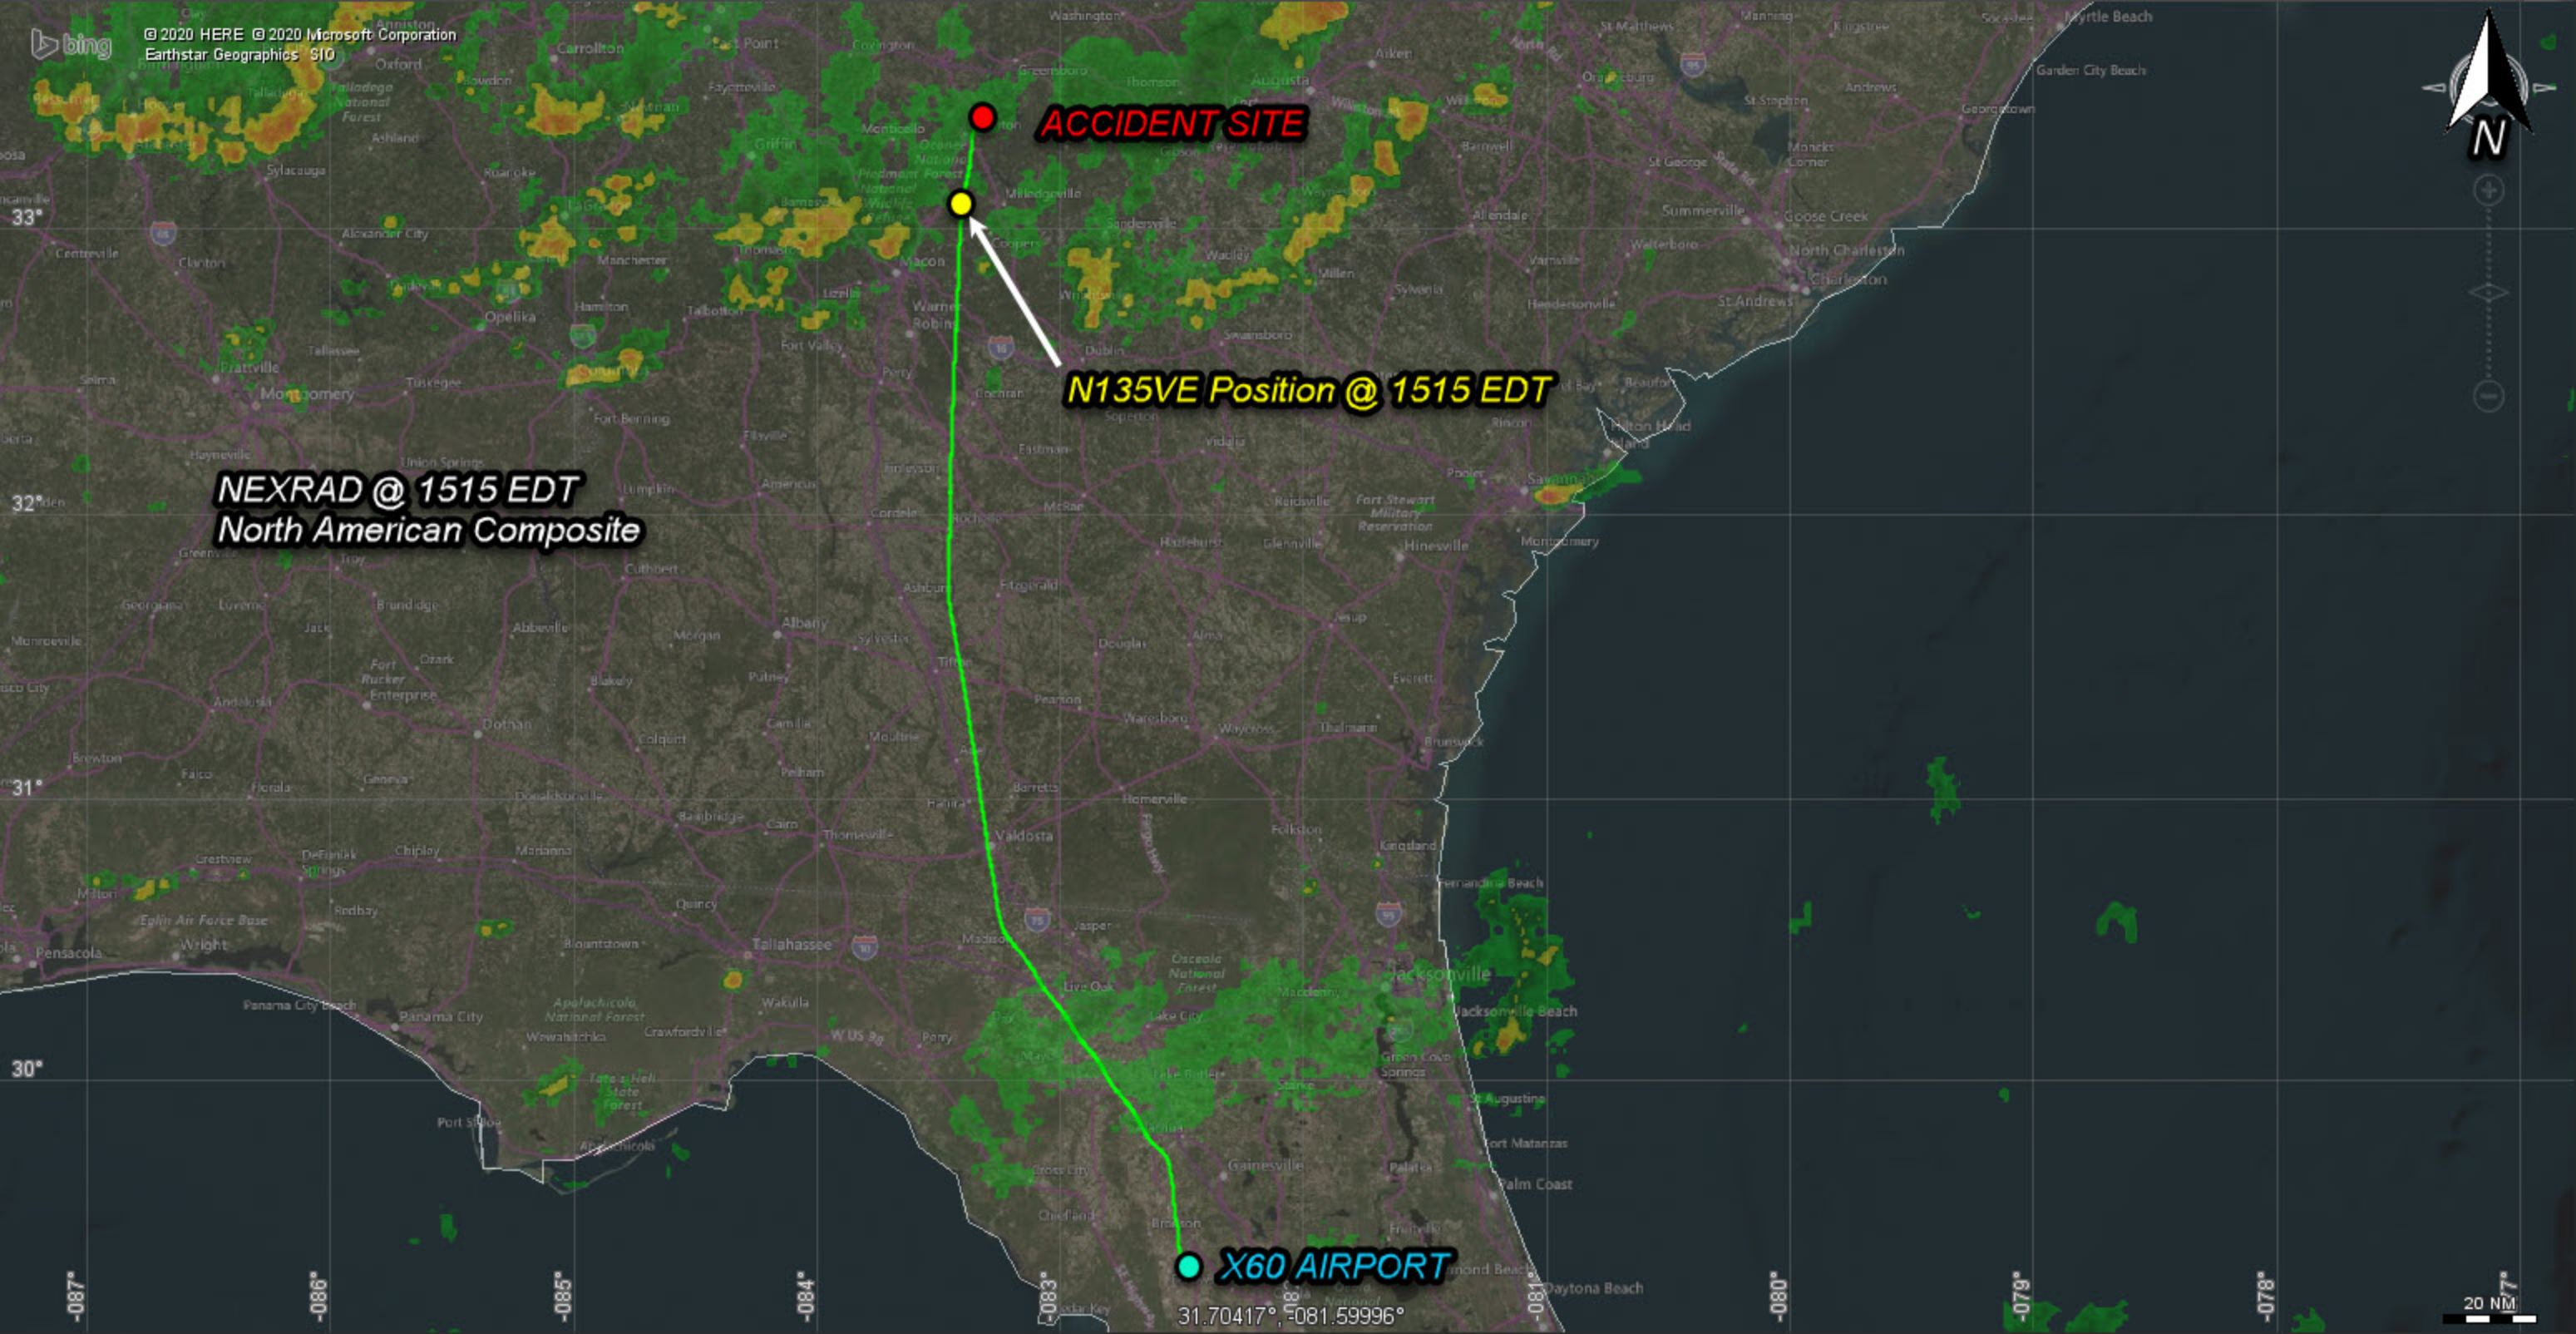
**NEXRAD @ 1515 EDT**  
**North American Composite**

**X60 AIRPORT**

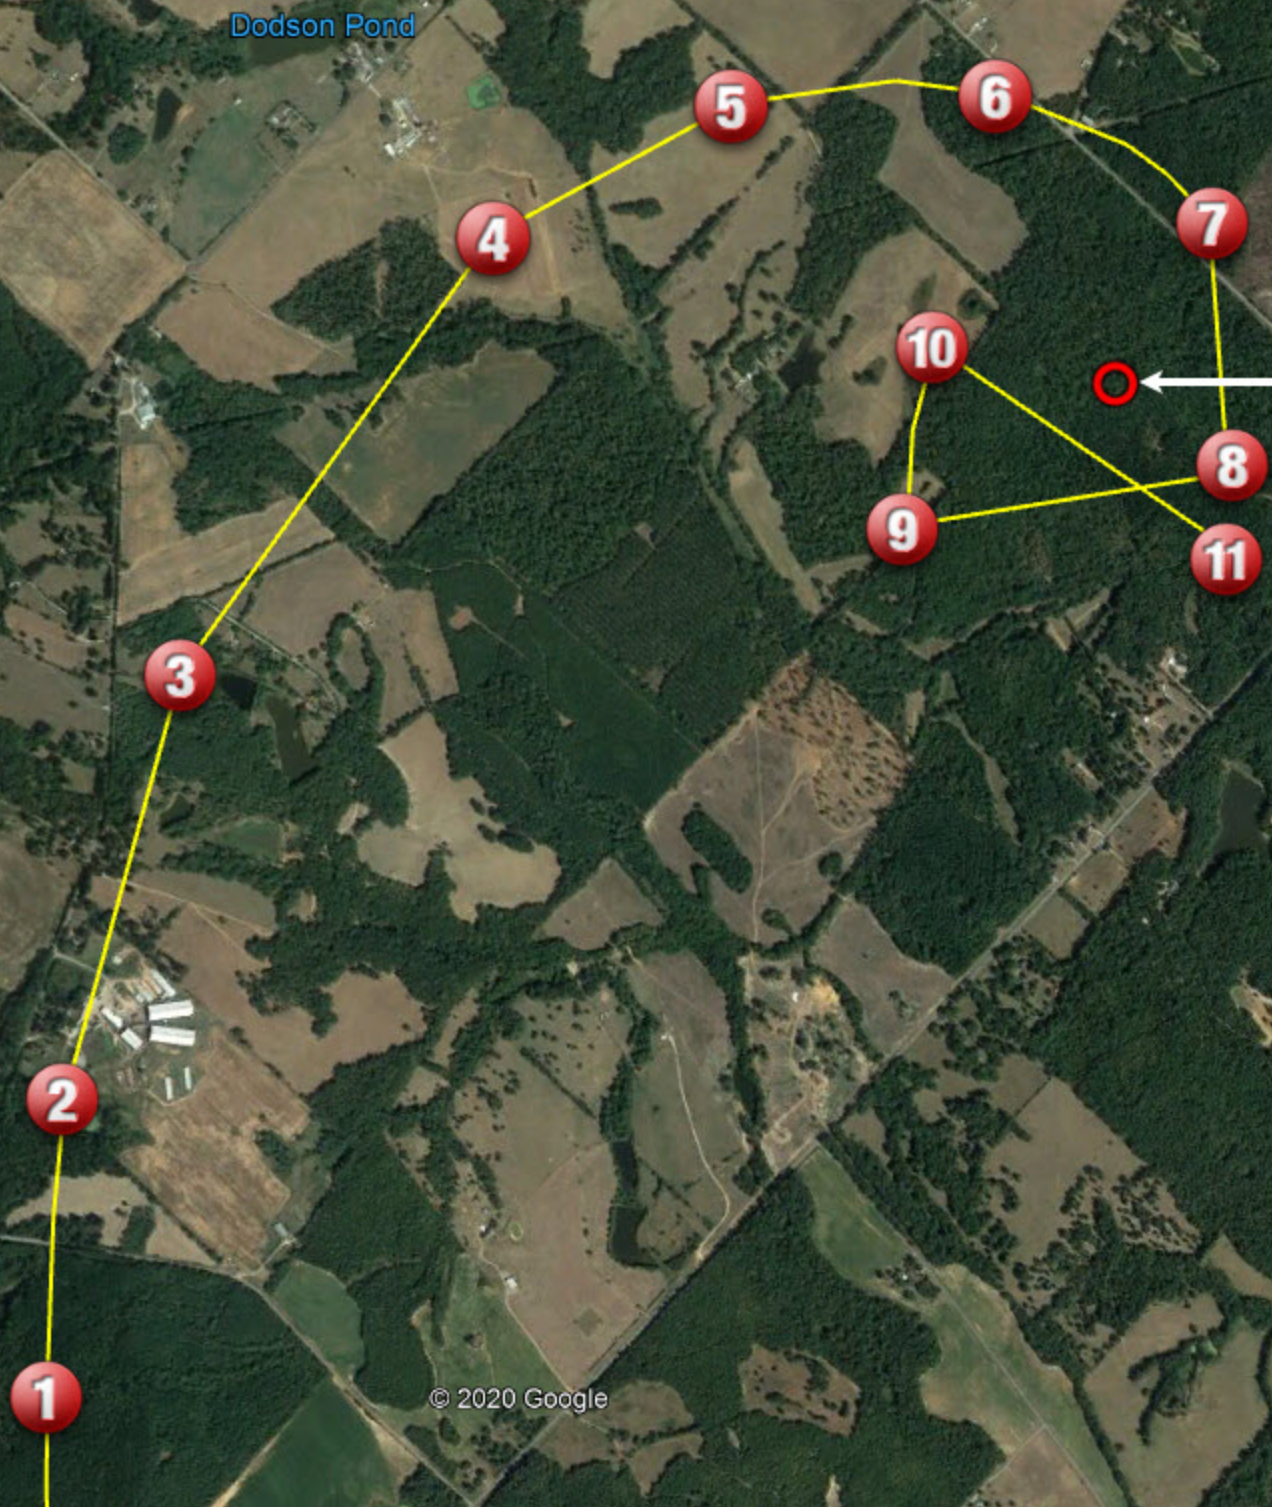
- 1** 1518:25 EDT // 24,900 ft msl // 272 kts // H001
- 2** 1518:30 EDT // 24,800 ft msl // 276 kts // H008
- 3** 1518:39 EDT // 24,800 ft msl // 275 kts // H023
- 4** 1518:48 EDT // 24,500 ft msl // 287 kts // H050
- 5** 1518:53 EDT // 23,700 ft msl // 292 kts // H072
- 6** 1518:58 EDT // 22,500 ft msl // 281 kts // H097
- 7** 1519:03 EDT // 20,400 ft msl // 221 kts // H138
- 8** 1519:11 EDT // 22,794 ft msl // 167 kts // H183
- 9** 1519:18 EDT // 22,013 ft msl // 178 kts // H292
- 10** 1519:53 EDT // 0 ft msl // 96 kts // H097
- 11** 1520:06 EDT // 0 ft msl // 97 kts // H188

**ACCIDENT SITE**
