## Memorandum For Record

**Date: 7/29/2023**  
**NTSB Accident Number: ERA21FA346**

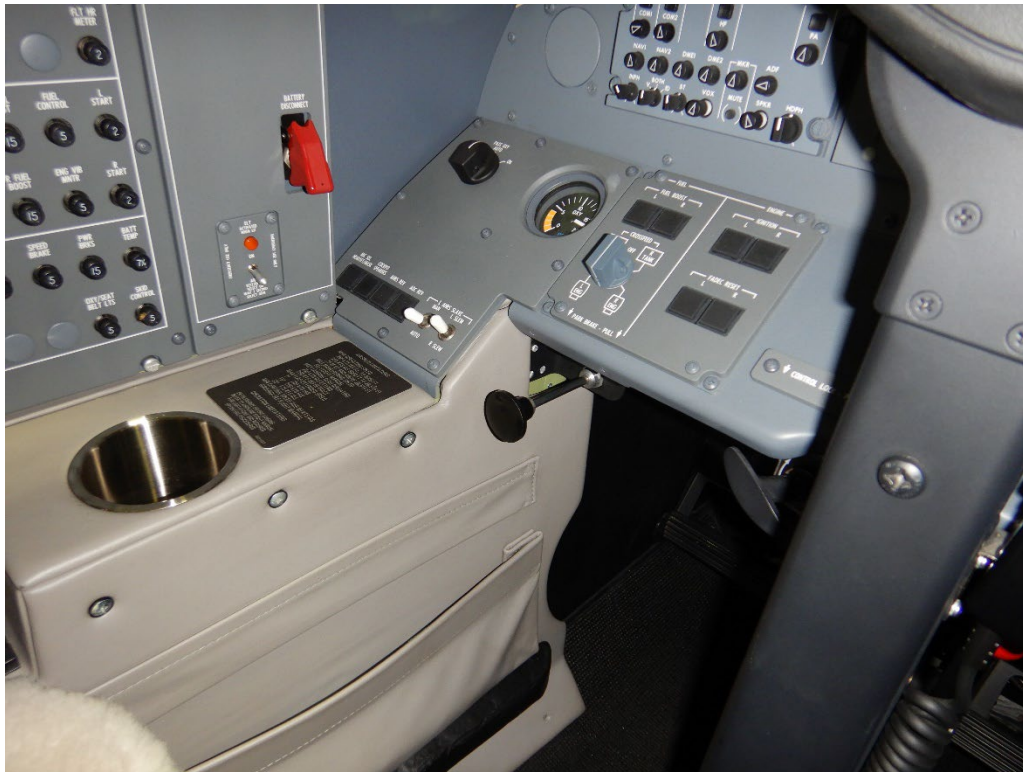
Figure 1: Digital Photograph From Textron Aviation. View of the Park Brake Handle in Pulled Position of an Exemplar Airplane.

The park brake knob was located on the tilt panel forward of the pilot's seat adjacent to the knee of the person sitting in the seat and was not visible to the right seat occupant. Per the airplane Operating Manual, the brakes are set by applying the brakes in the normal manner, then pulling out the PARK BRAKE handle on the left lower side of the tilt panel (Figure 1). That action mechanically actuates the parking brake valve, trapping fluid in the brakes. The parking brake is released by pushing in the PARK BRAKE handle (Figure 2).
