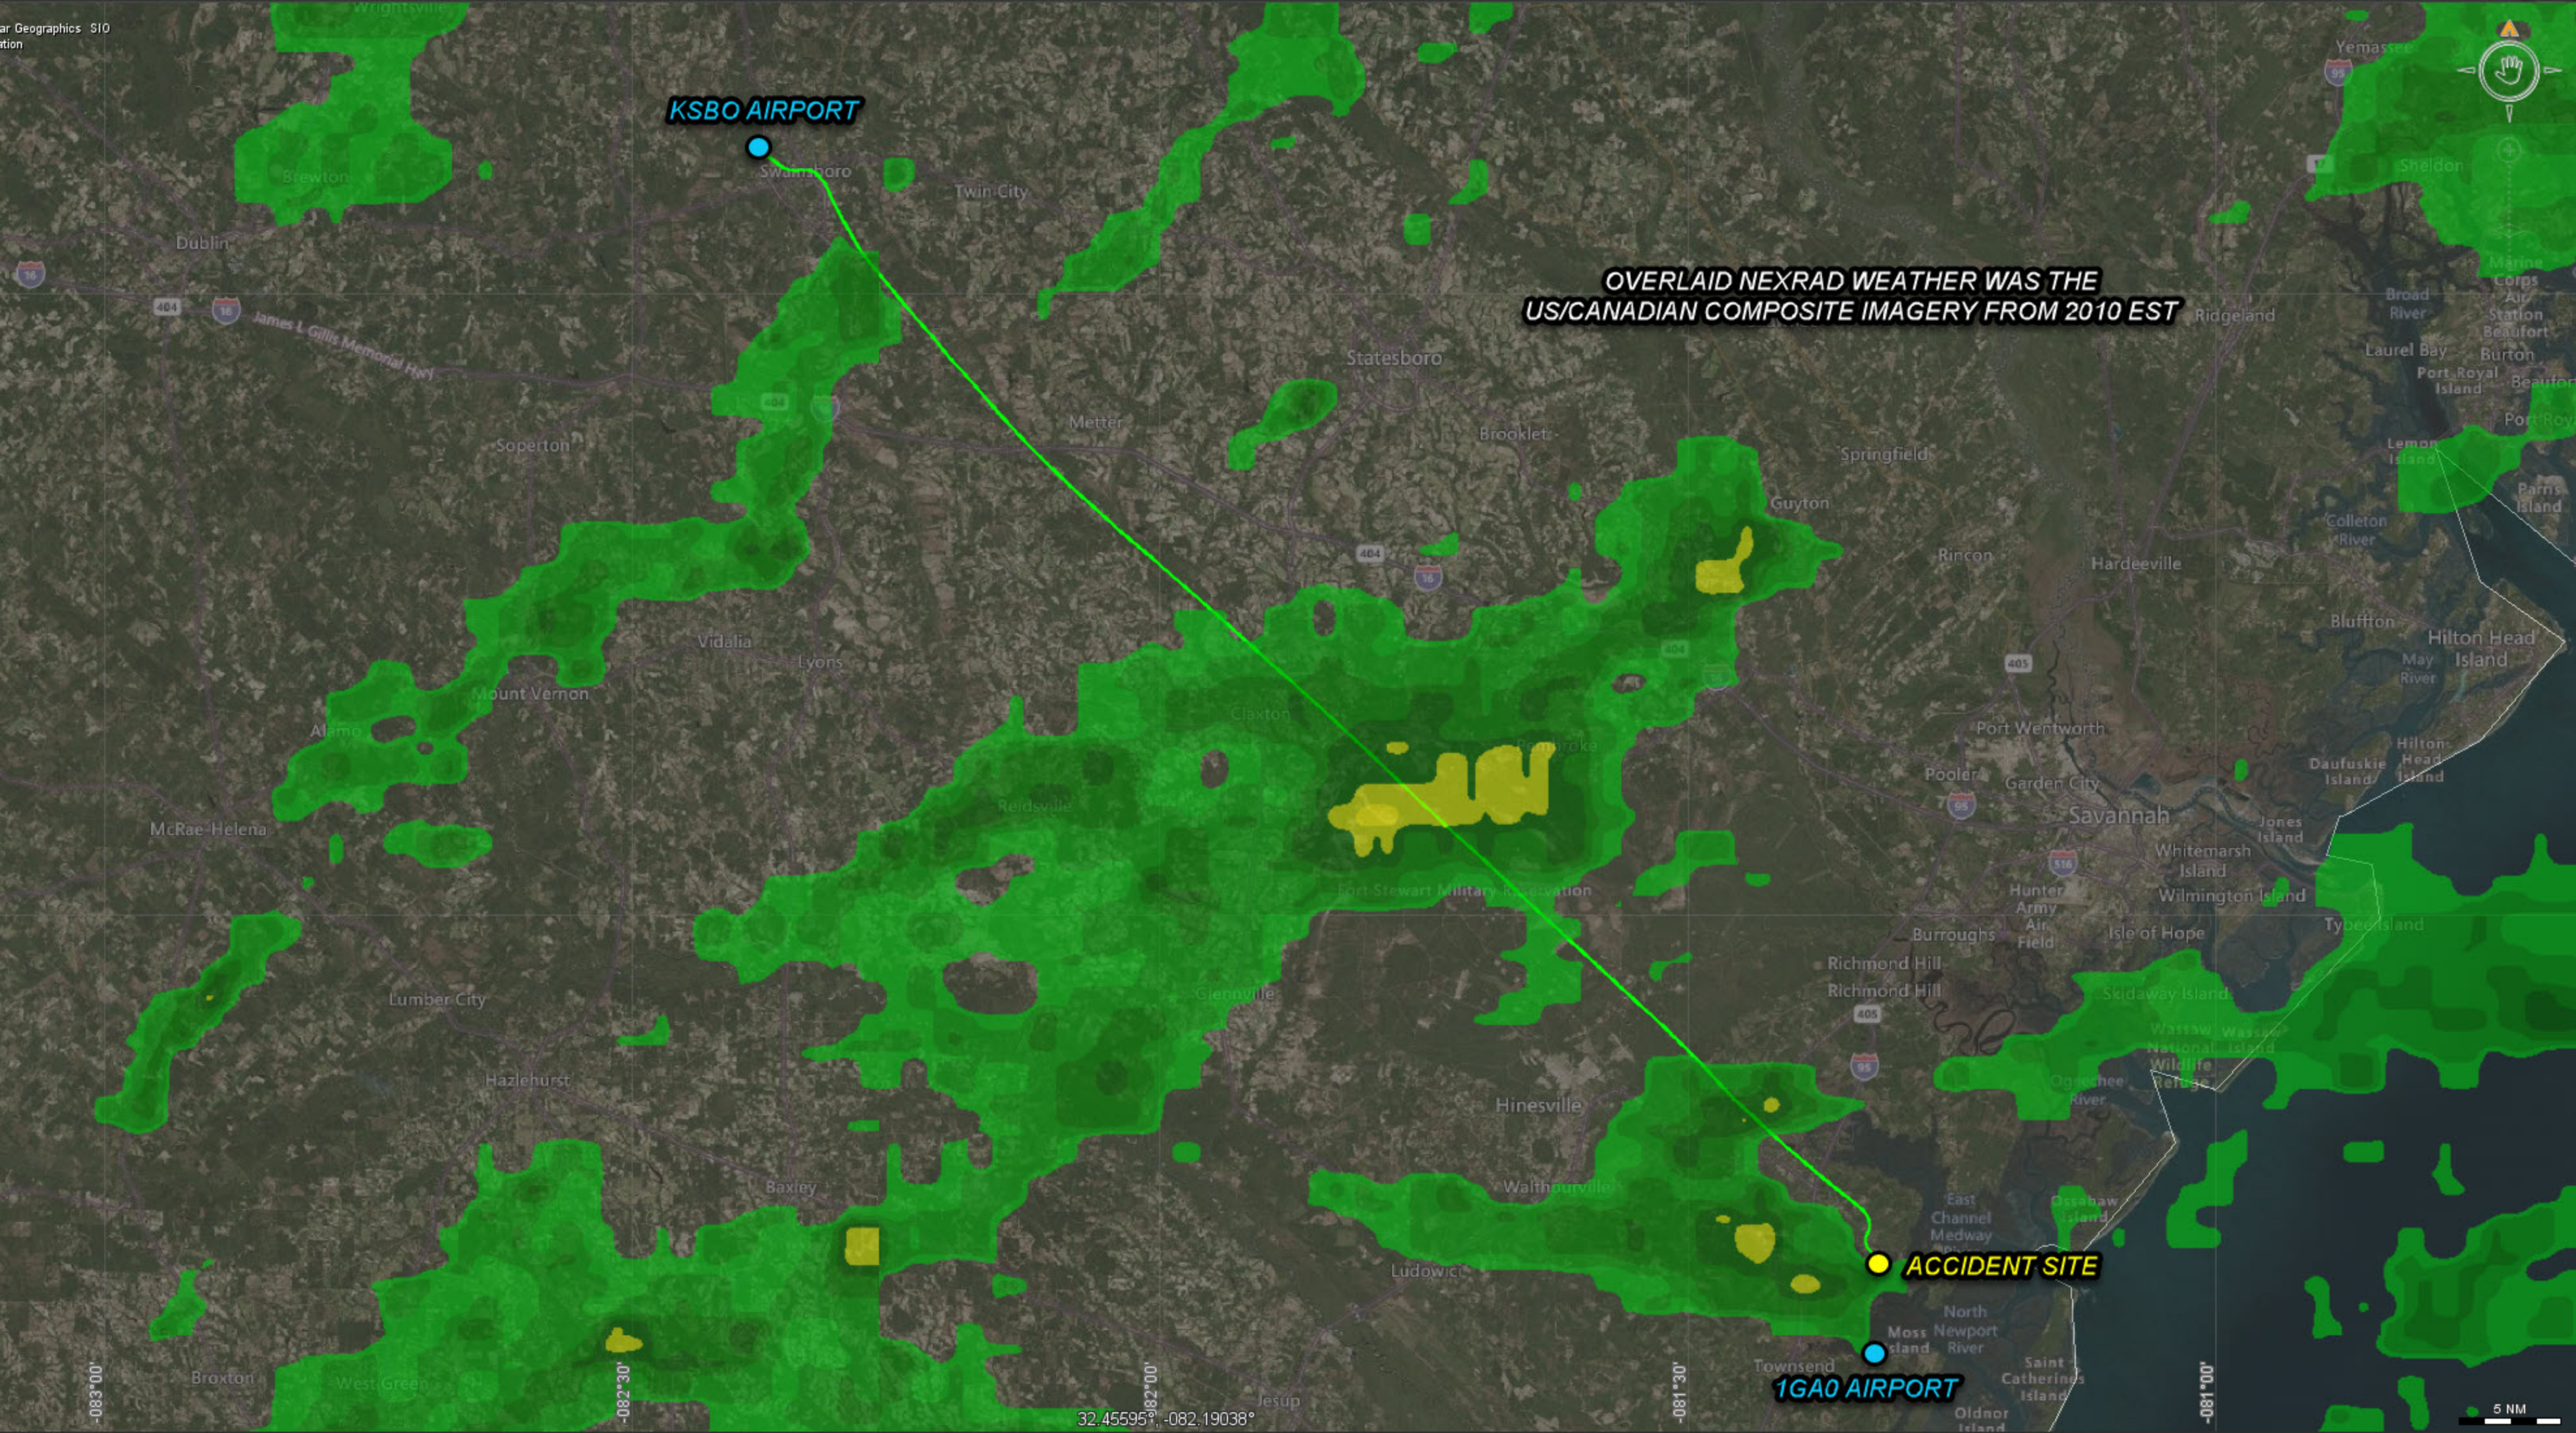
**KSBO AIRPORT**

**OVERLAID NEXRAD WEATHER WAS THE  
US/CANADIAN COMPOSITE IMAGERY FROM 2010 EST**

**ACCIDENT SITE**

**1GA0 AIRPORT**

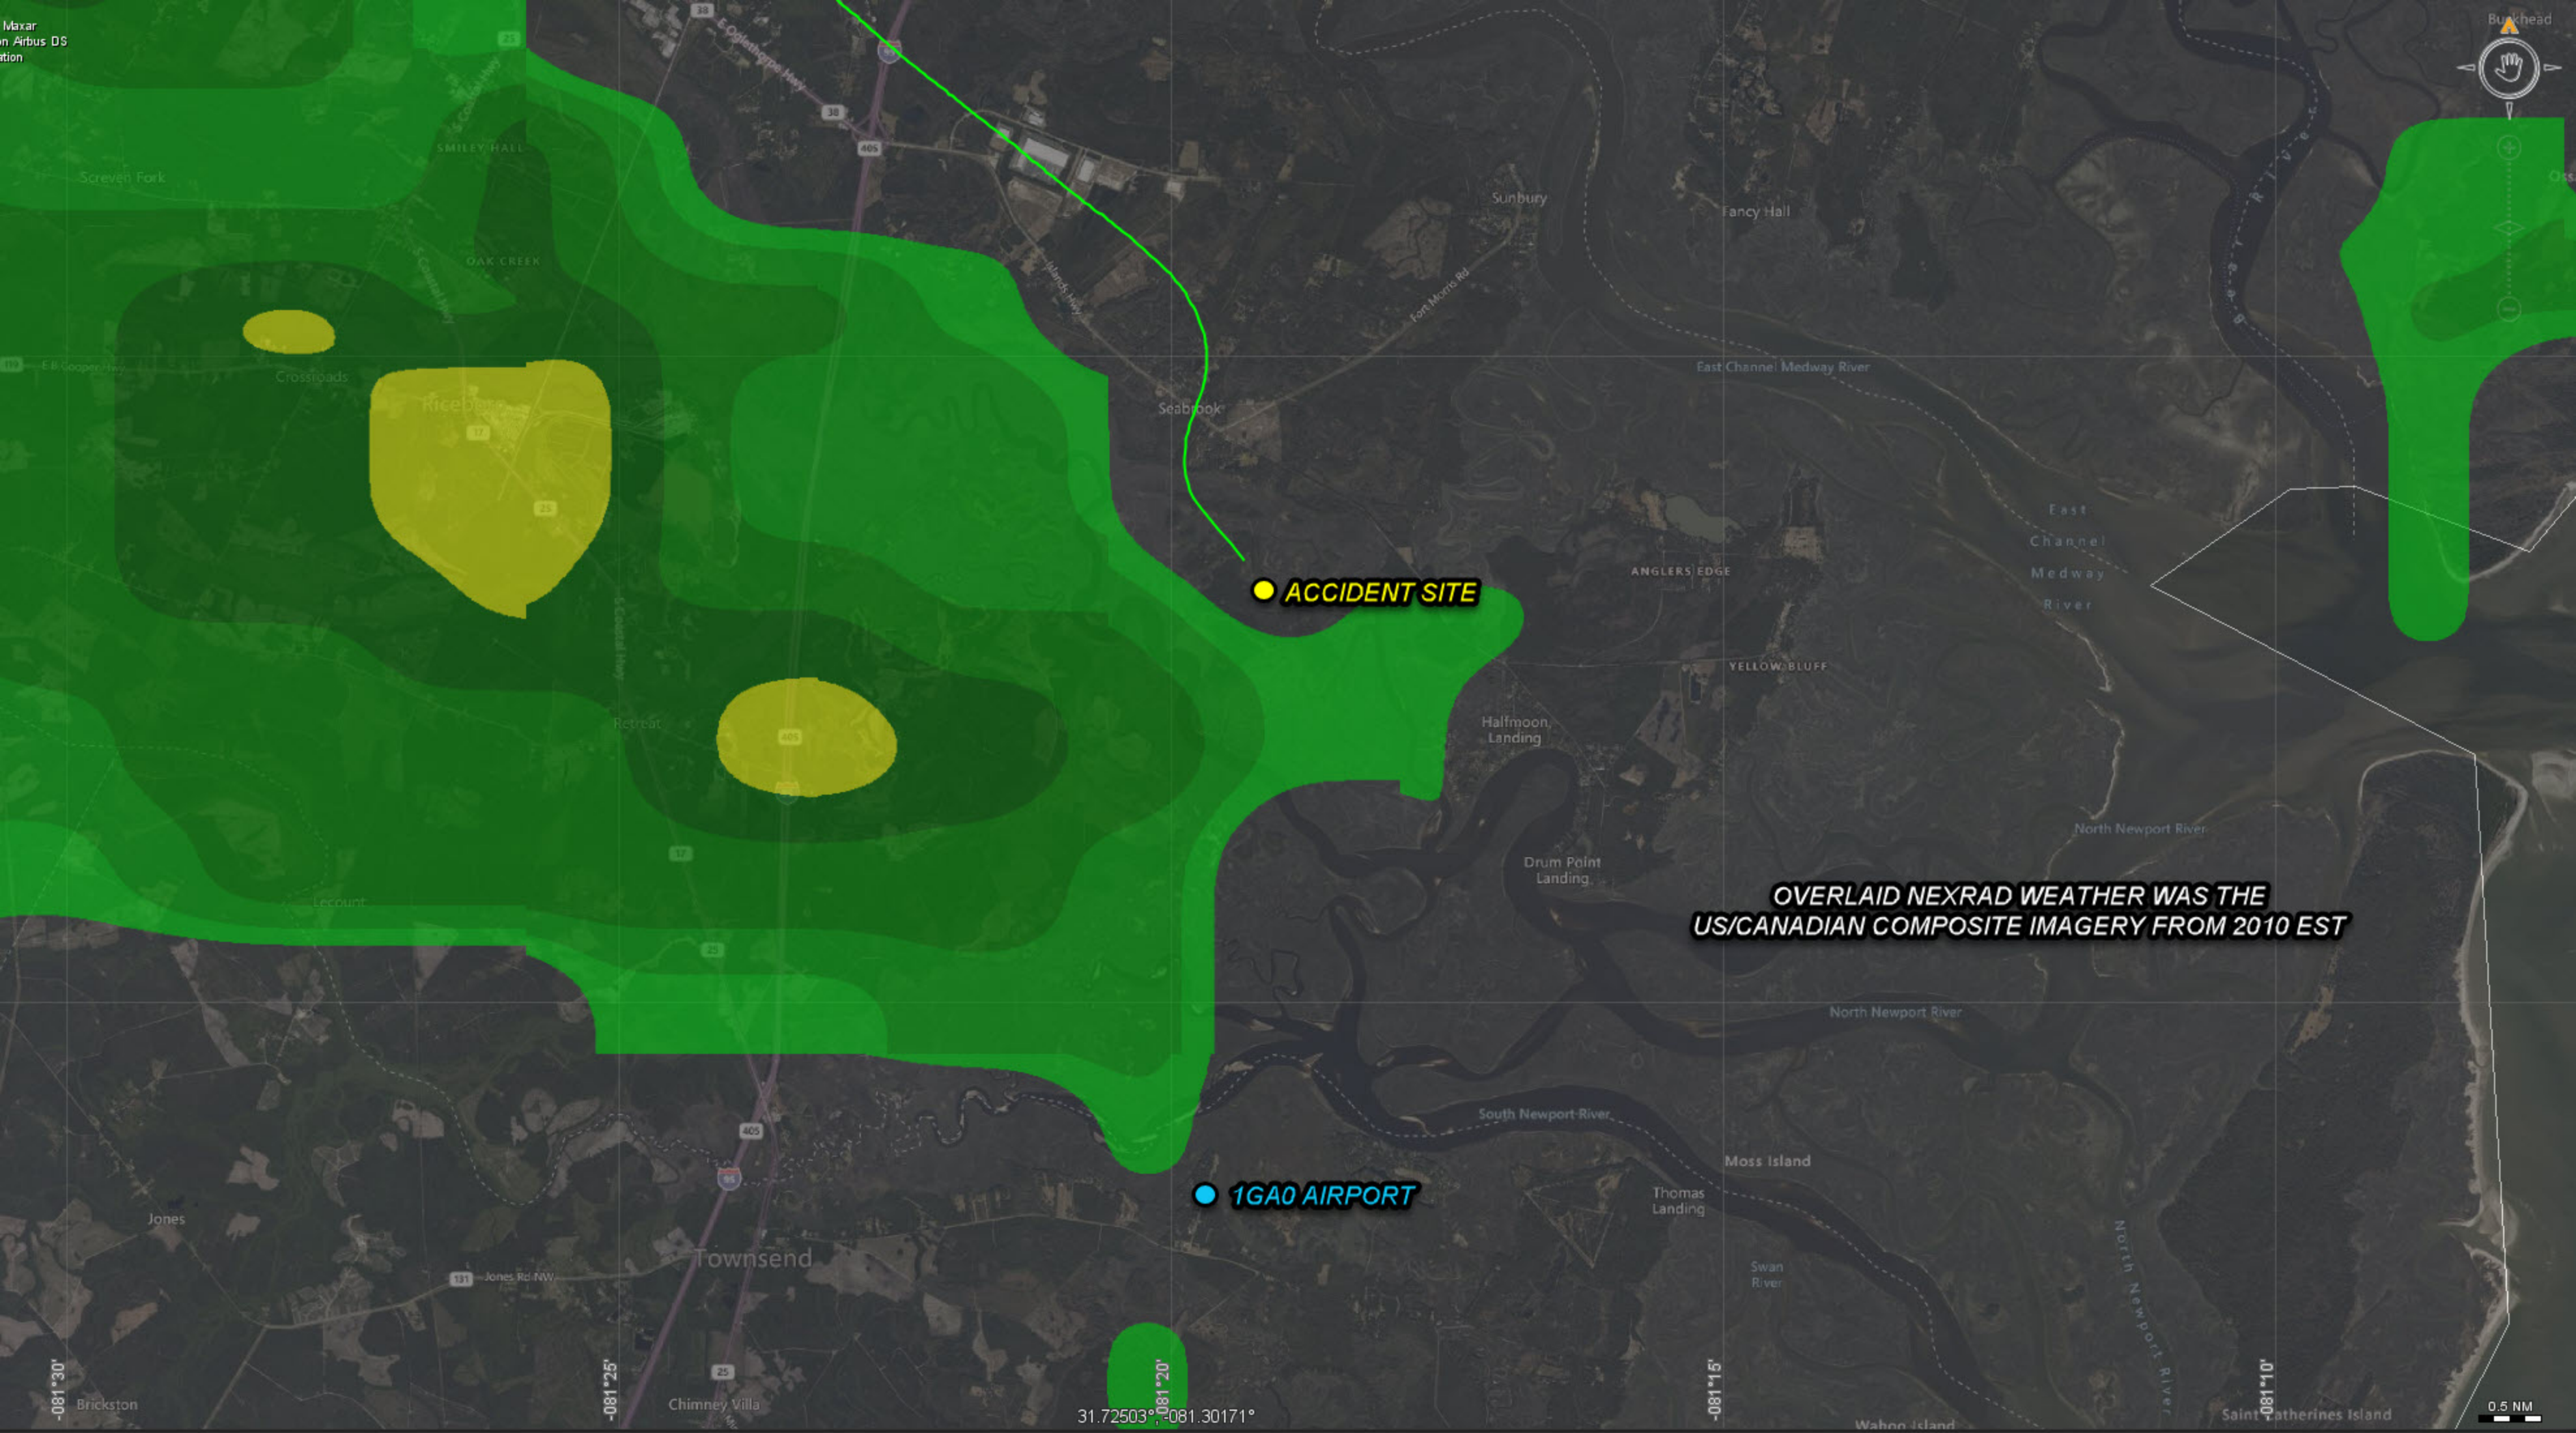
● **ACCIDENT SITE**

● **1GA0 AIRPORT**

**OVERLAID NEXRAD WEATHER WAS THE  
US/CANADIAN COMPOSITE IMAGERY FROM 2010 EST**

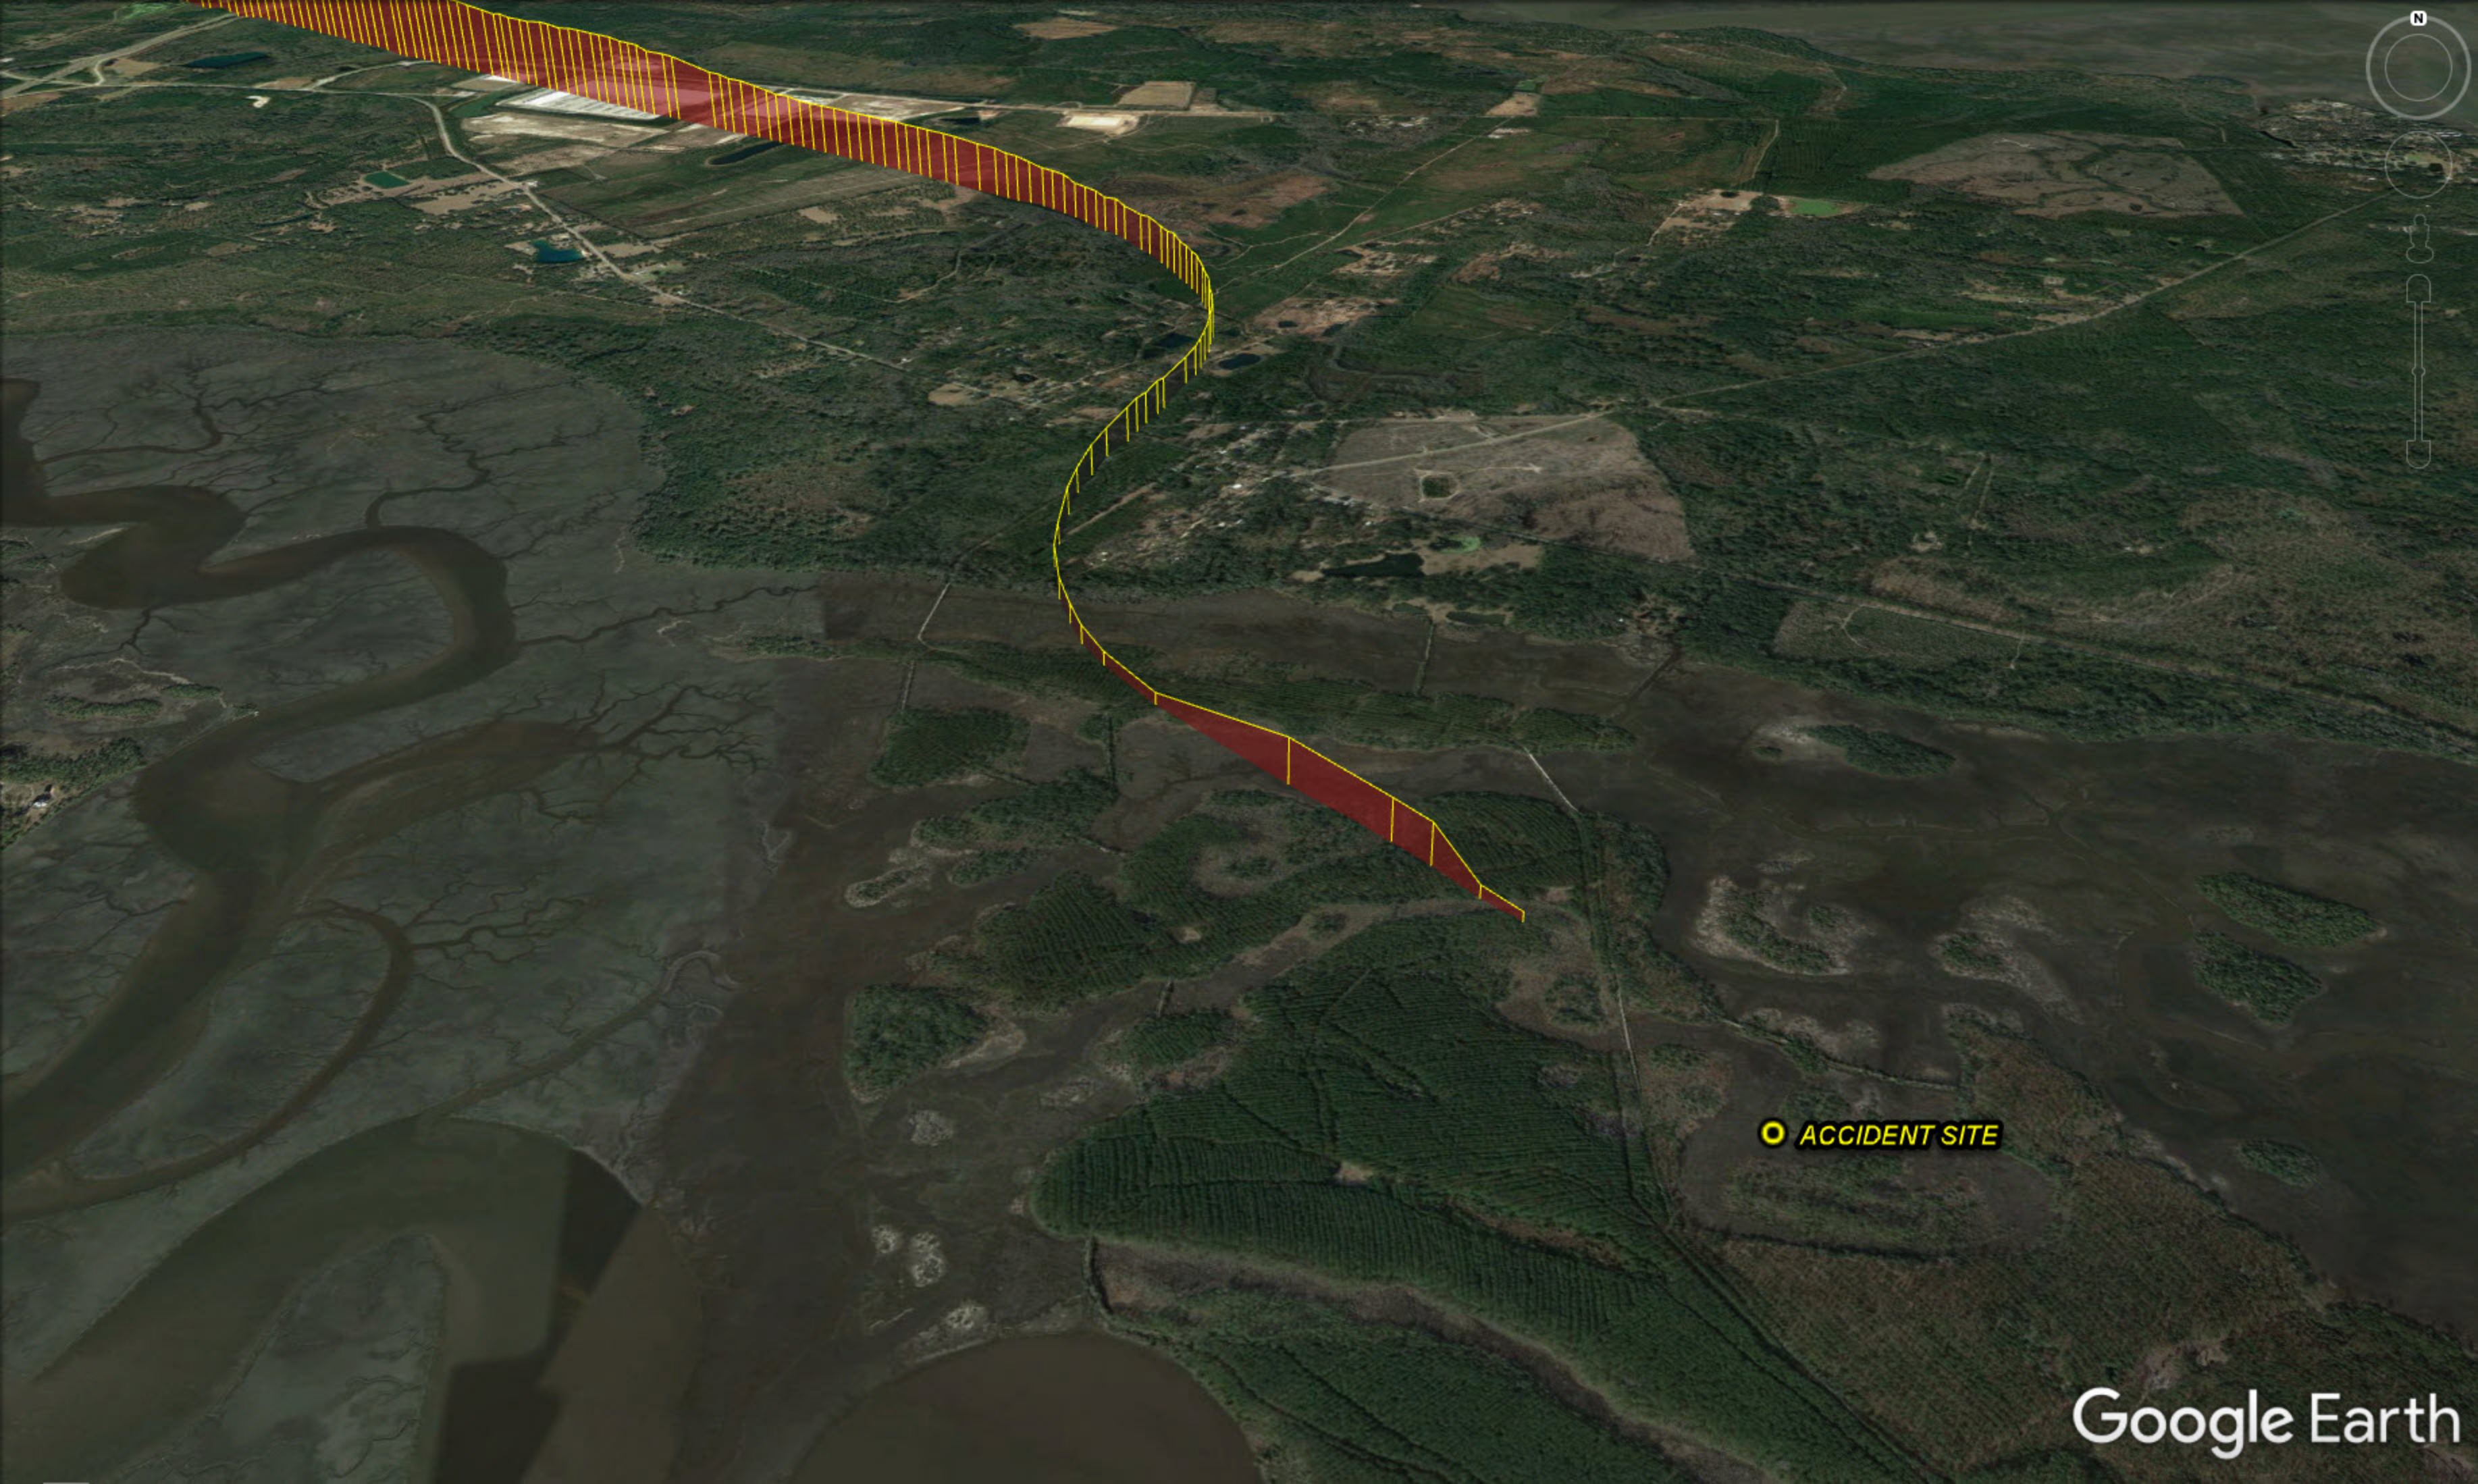
● ACCIDENT SITE

- 1** 2009:19 EST // 575 ft msl // 115 kts // H129
  - 2** 2009:31 EST // 525 ft msl // 111 kts // H132
  - 3** 2009:39 EST // 400 ft msl // 116 kts // H144
  - 4** 2009:47 EST // 425 ft msl // 112 kts // H156
  - 5** 2009:55 EST // 350 ft msl // 116 kts // H174
  - 6** 2010:03 EST // 300 ft msl // 120 kts // H193
  - 7** 2010:10 EST // 325 ft msl // 115 kts // H200
  - 8** 2010:15 EST // 300 ft msl // 113 kts // H197
  - 9** 2010:22 EST // 200 ft msl // 114 kts // H184
  - 10** 2010:29 EST // 150 ft msl // 110 kts // H165
  - 11** 2010:36 EST // 100 ft msl // 109 kts // H147
  - 12** 2010:43 EST // 325 ft msl // 106 kts // H133
  - 13** 2010:48 EST // 300 ft msl // --- kts // H---
  - 14** 2010:54 EST // 100 ft msl // 98 kts // H142

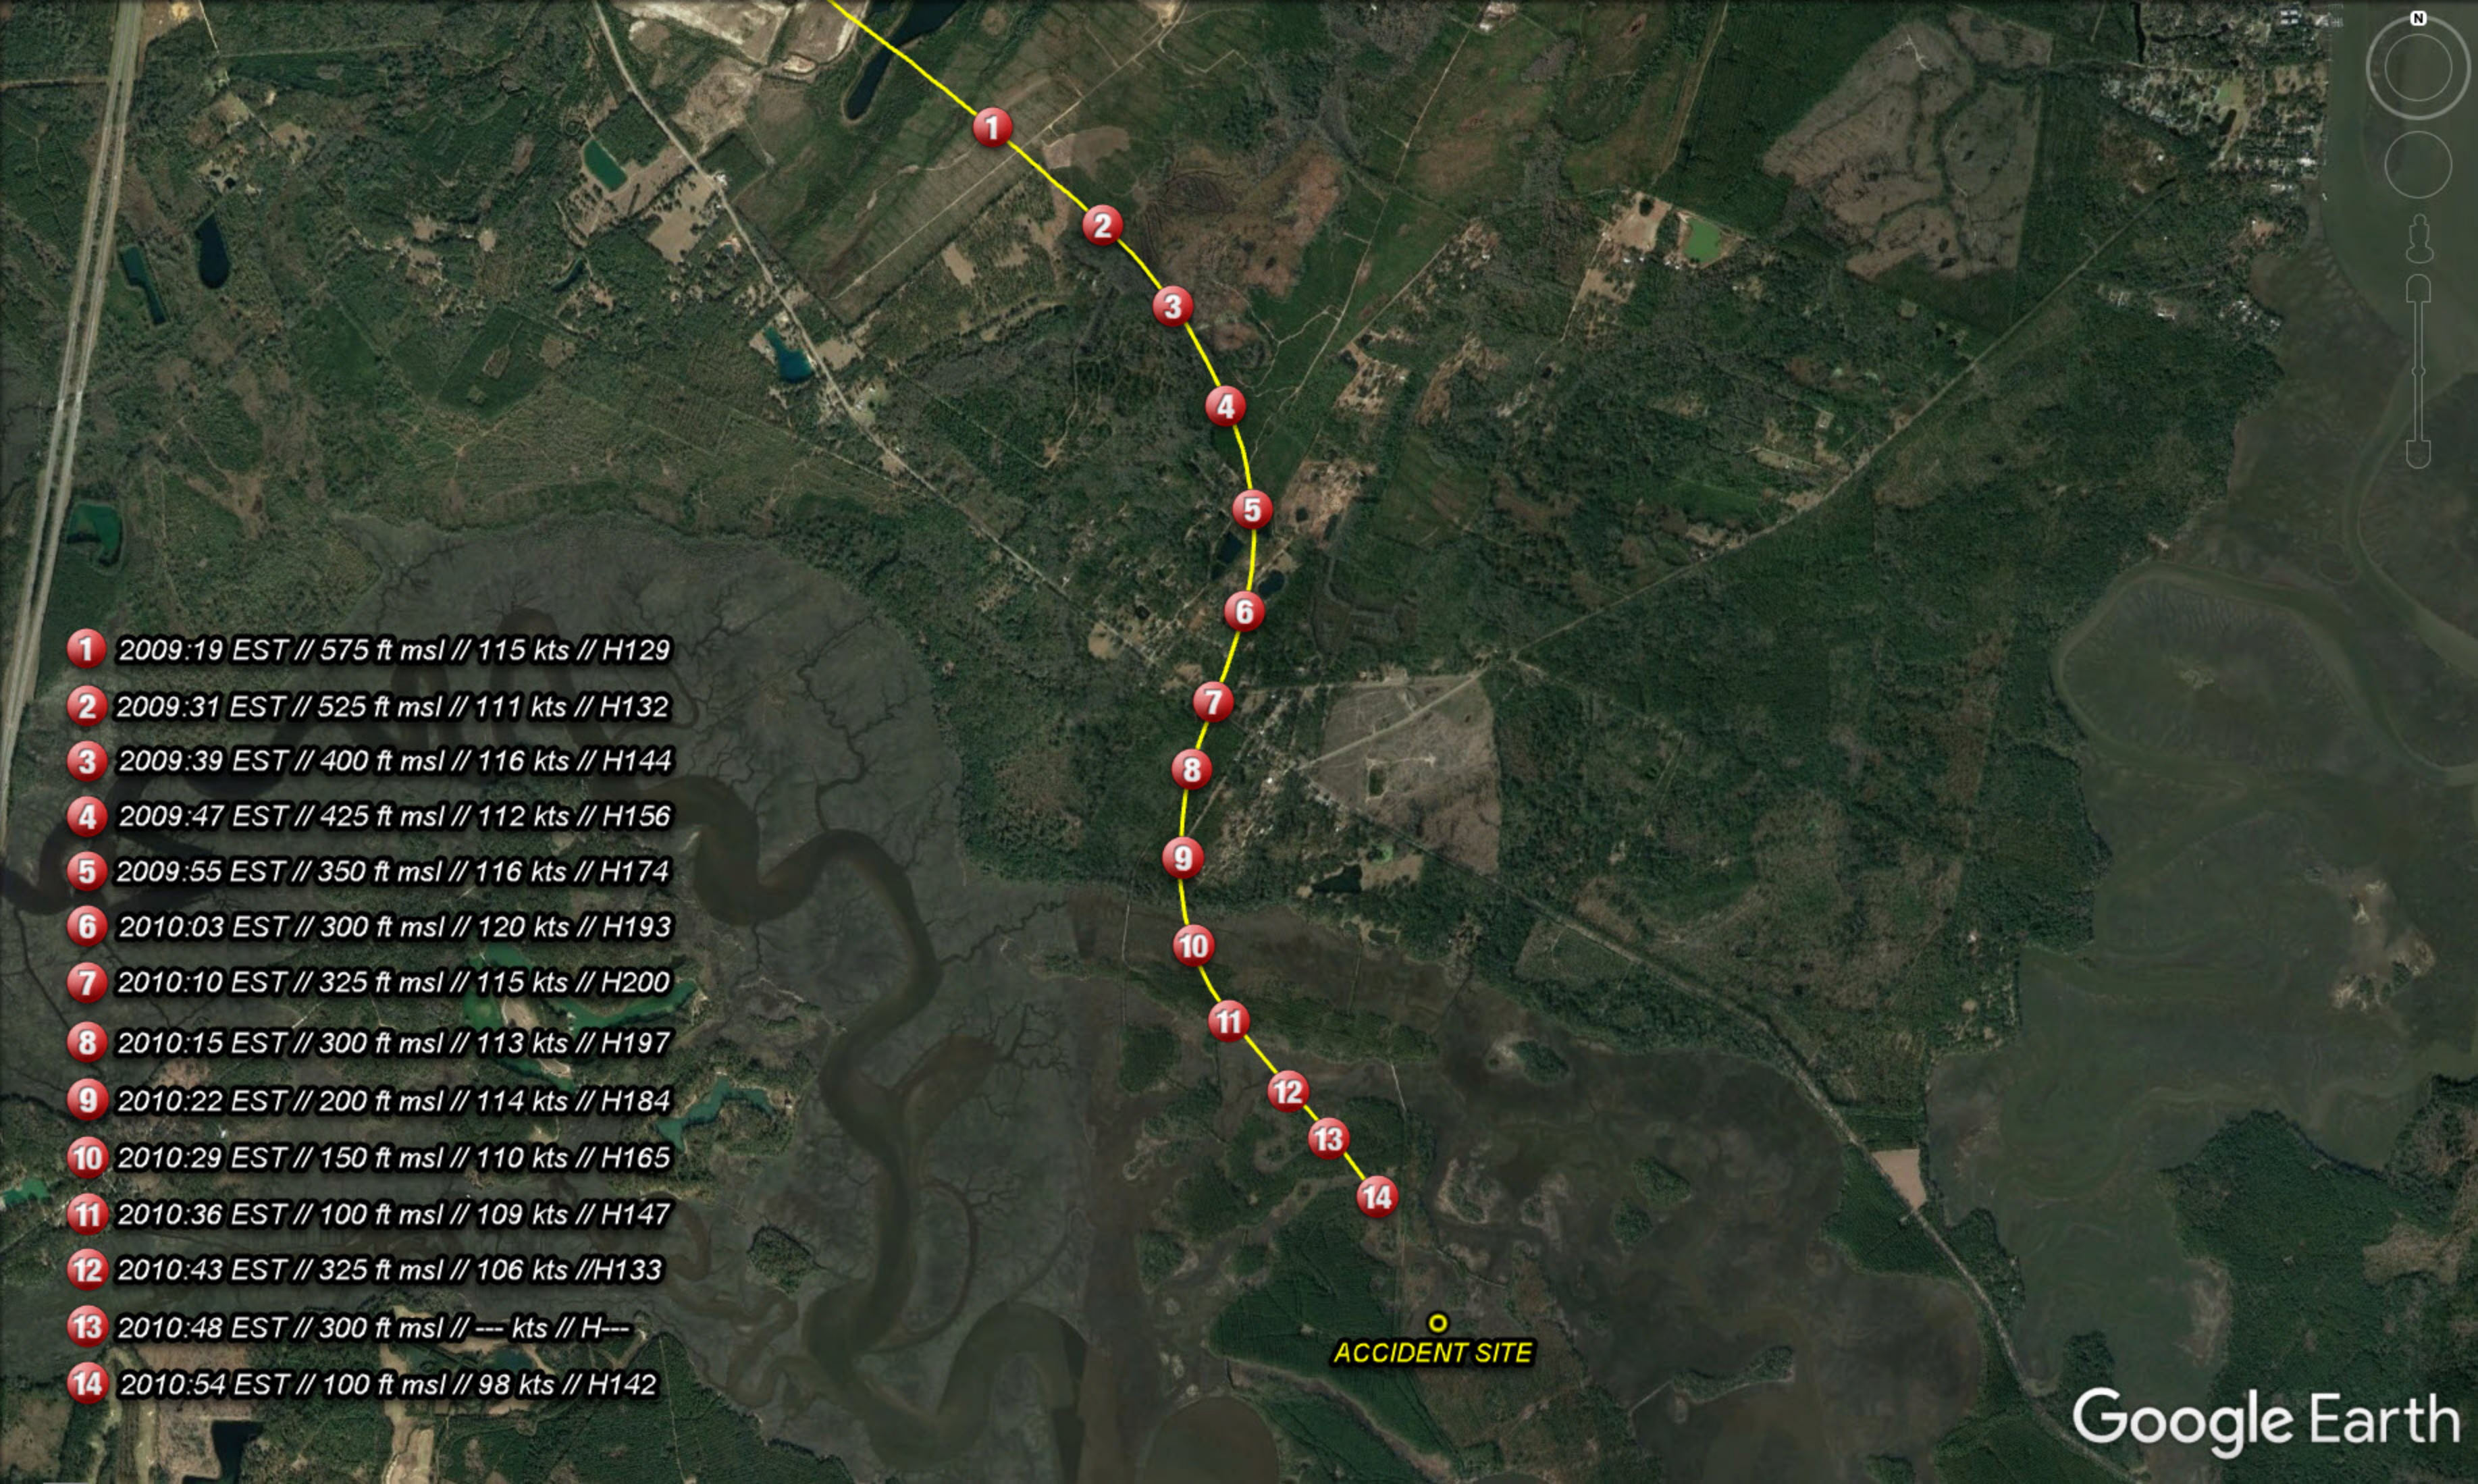
**ACCIDENT SITE**
