## **Airframe and Engine Examination Report**

NTSB ACCIDENT NUMBER: **ERA21LA091**

AIRCRAFT REGISTRATION: N8311X

AIRCRAFT TYPE: Cessna 172C

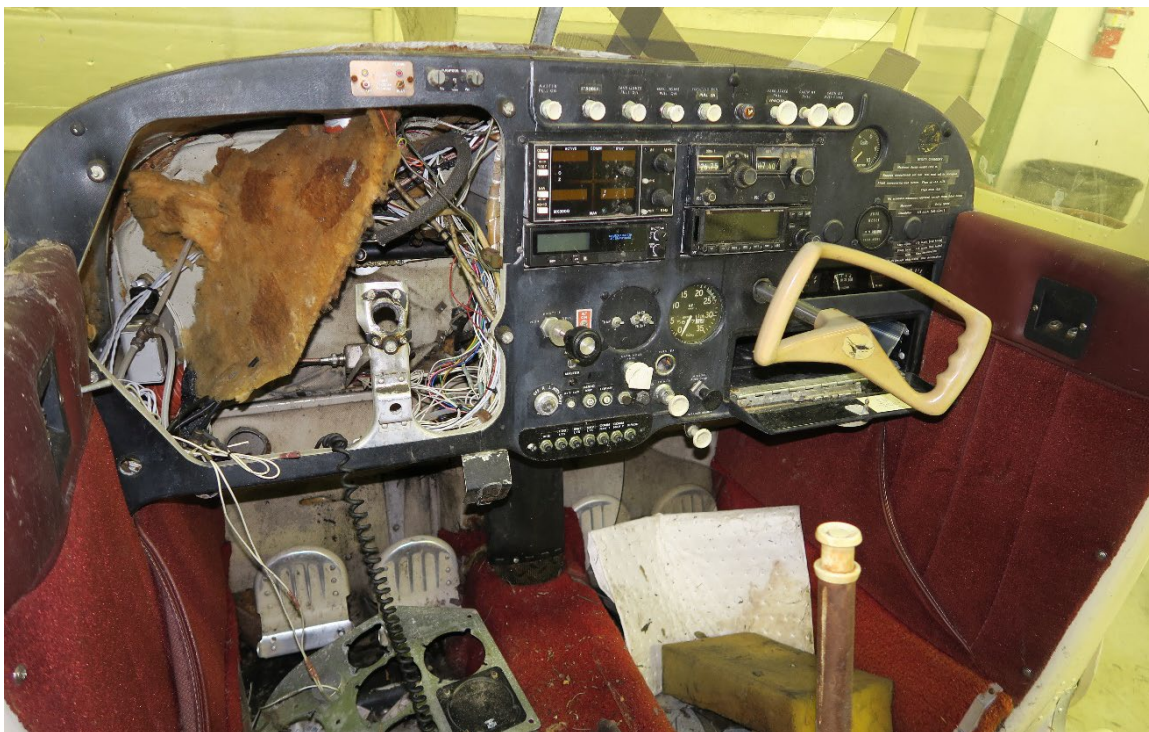
Figure 1: View of the instrument panel. (Photo courtesy of Textron)

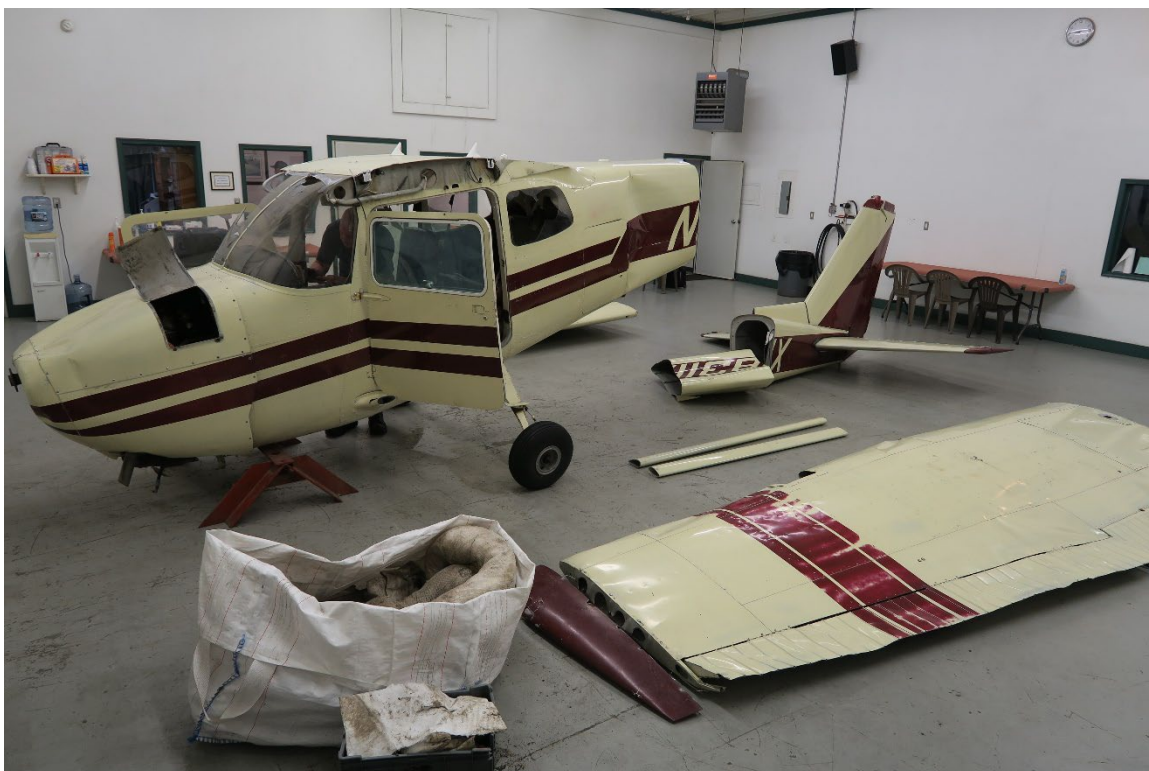
Figure 2: View of the airplane before examination. (Photo courtesy of Textron)

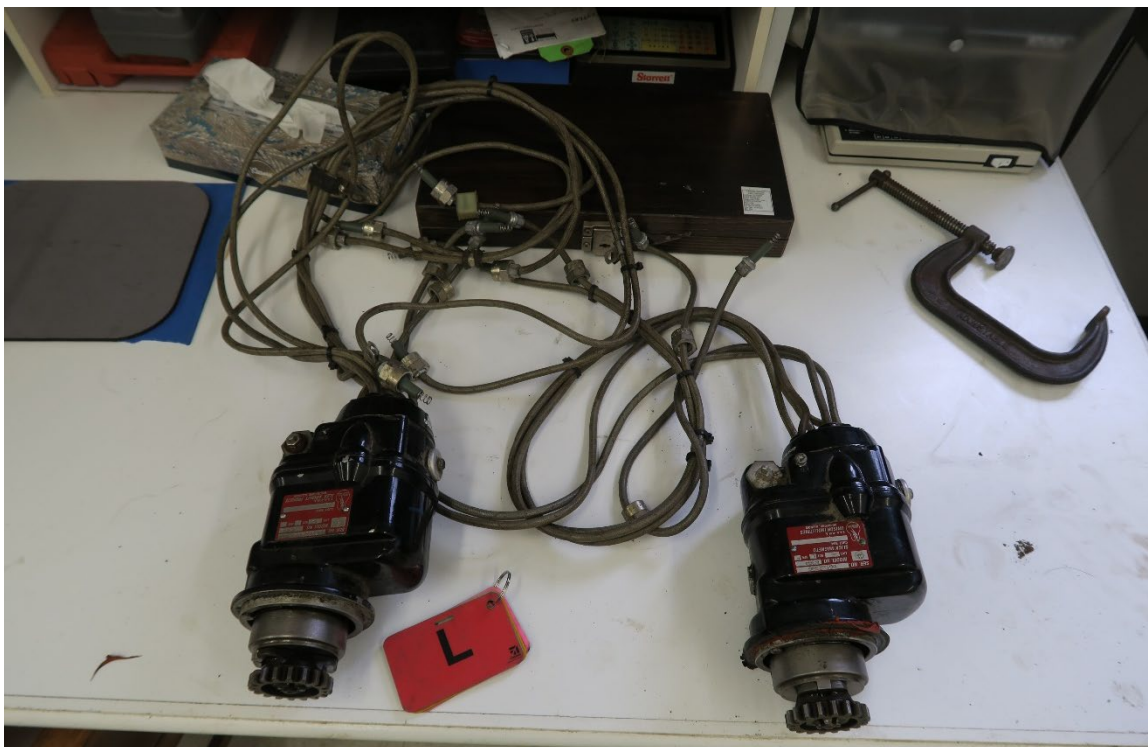
- The engine’s crankshaft was rotated by hand, and internal and valvetrain continuity was established. Examination of the cylinders with a lighted borescope revealed no anomalies.
- The impulse coupling magnetos did not produce spark when turned by hand. The magnetos were removed and placed on a test bench; neither magneto produced a spark.
- The cylinders and spark plugs were contaminated with dirt and debris from the swamp.
- An undetermined amount of fuel was drained from the wings. The fuel finger screens were clean. The fuel selector moved freely.
- The carburetor was removed and partially disassembled. The plastic floats, needle valve, and accelerator pump appeared normal. There was no residual fuel in the carburetor and there was no corrosion or debris observed in the bowl.

Figure 3: View of the left and right magnetos. (Photo courtesy of Textron)
