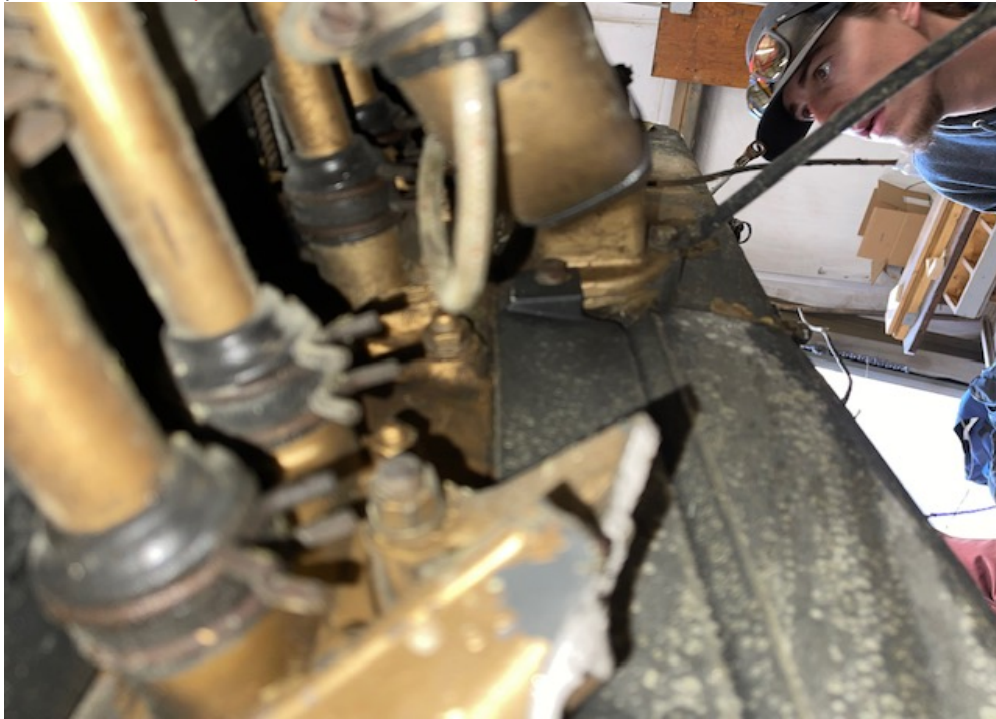
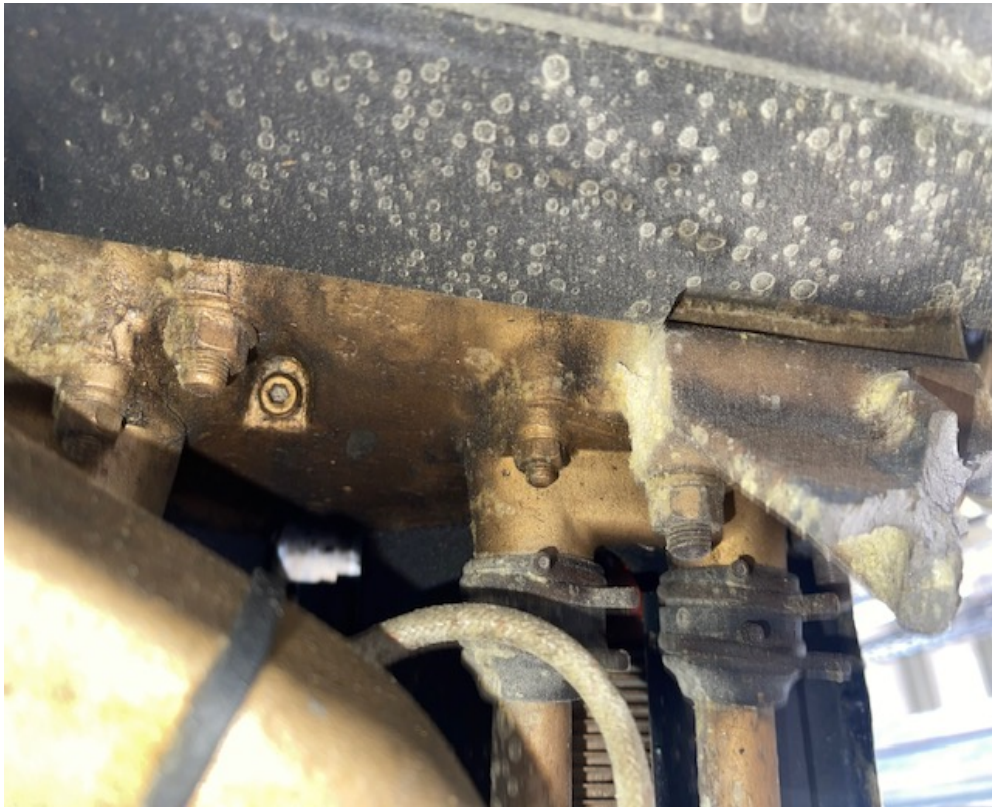
1. Examine each cylinder barrel between the barrel and crankcase noting any burned paint. **No burnt paint noted**

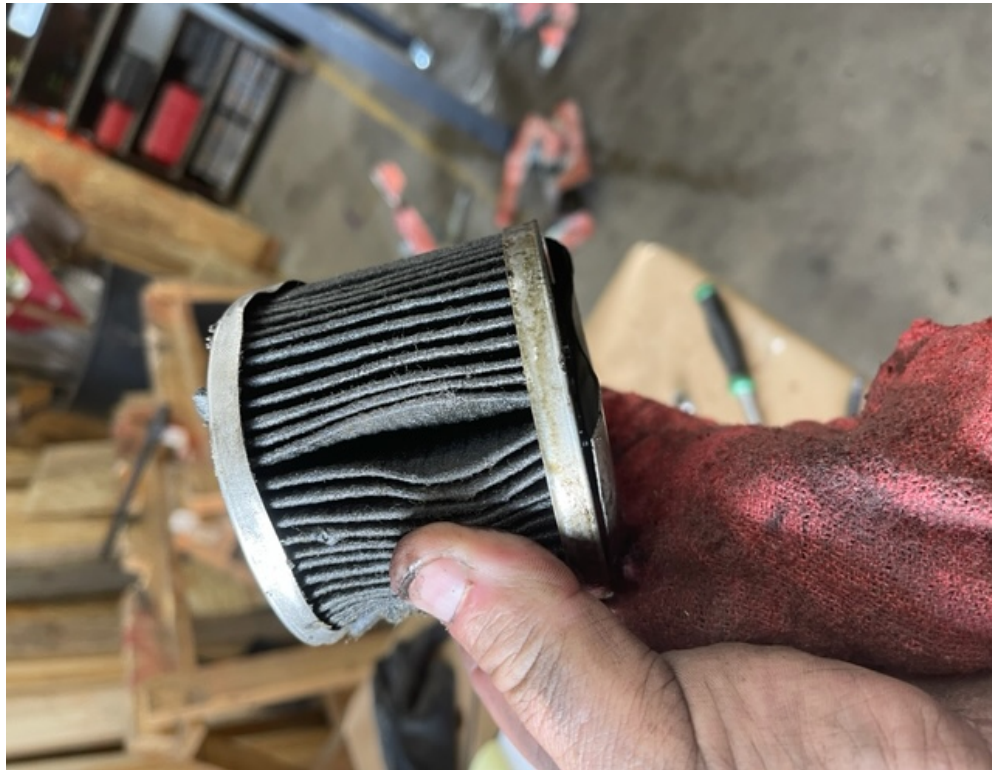
2. Tie in where the oil pressure comes off the engine and using shop air at low pressure, pressurize the lubrication path and document any leaks, etc., with soapy water. **Not able to accomplish due to condition of the engine**
3. Examine the oil pressure screen for contaminants. **Oil pressure screens had metal shavings contamination**
4. Examine the oil filter (if equipped) for contaminants. **Oil filter was free of any contaminants.**

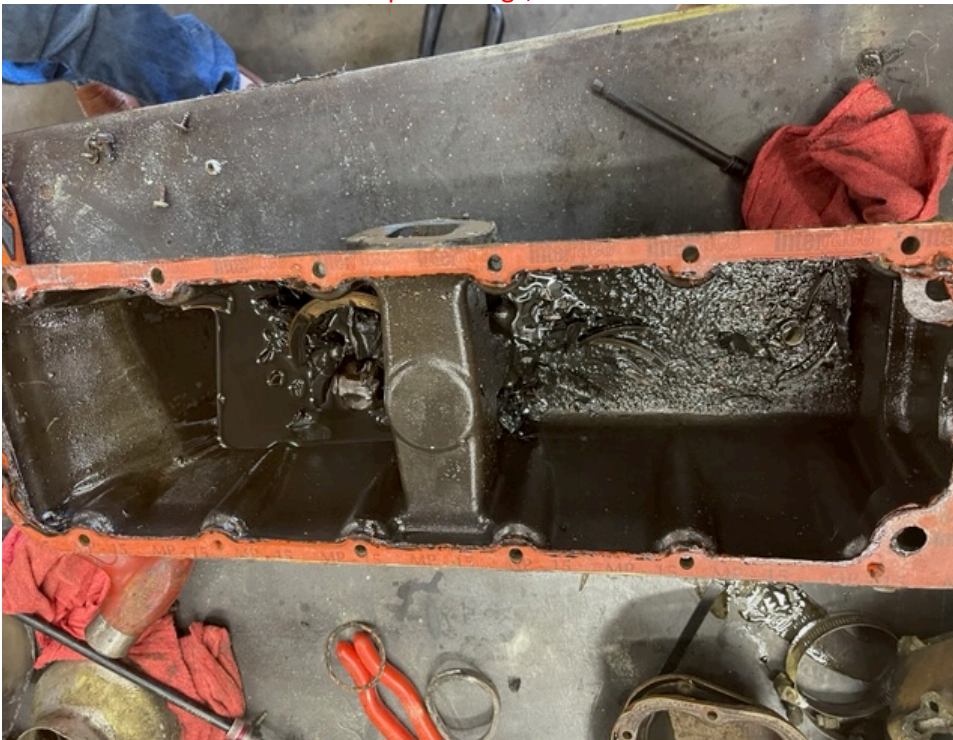
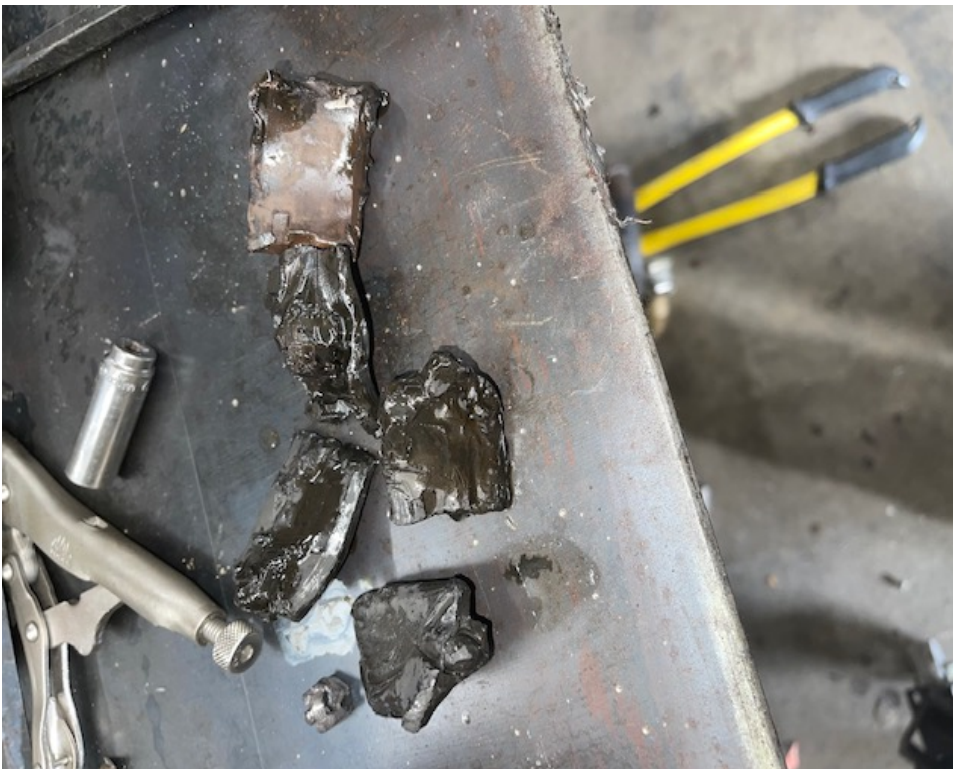
5. Document and retain any connecting rod parts in the oil sump. Oil sump had numerous metal chunks to include piston rings, thrust washers

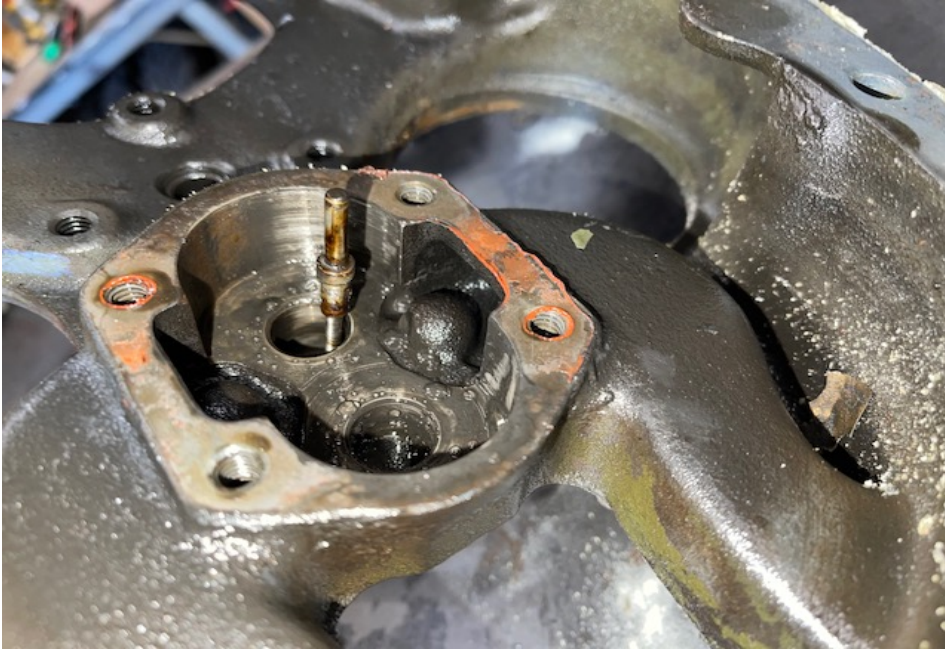
6. Examine oil pump for hard particle passage and any issues with the gears. **No issues noted, gear looked good no damage.**

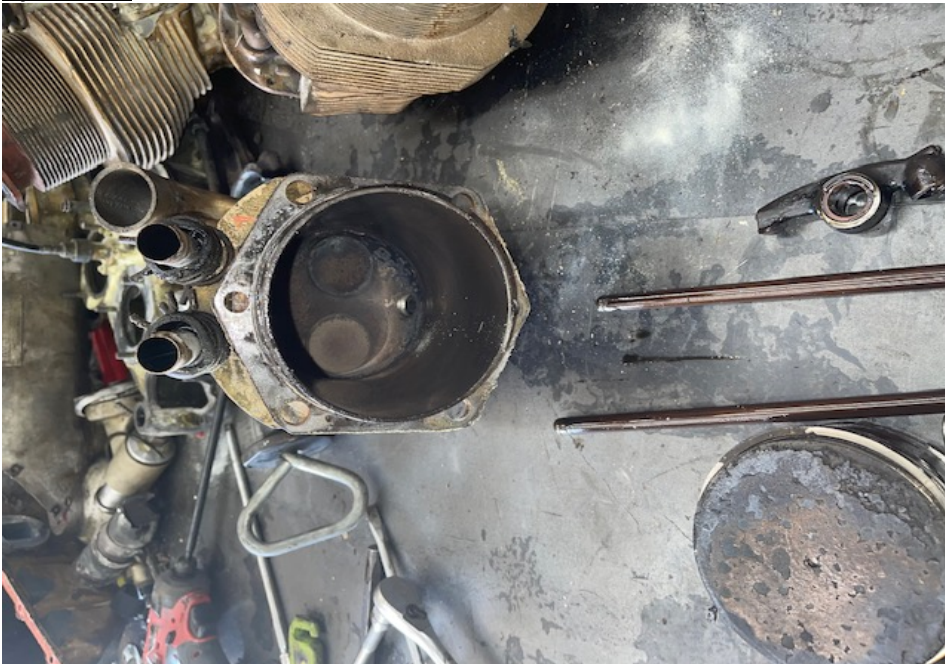
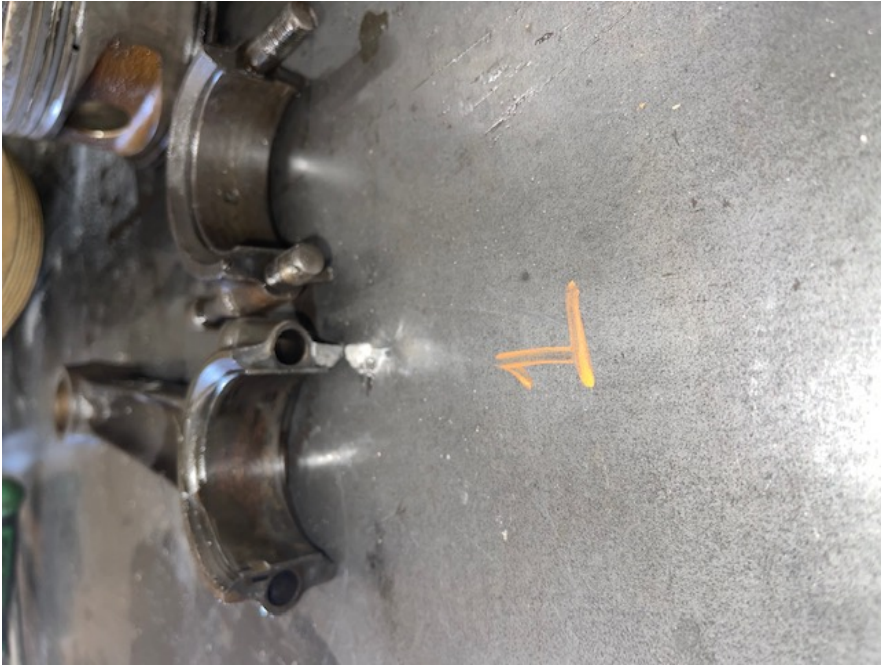
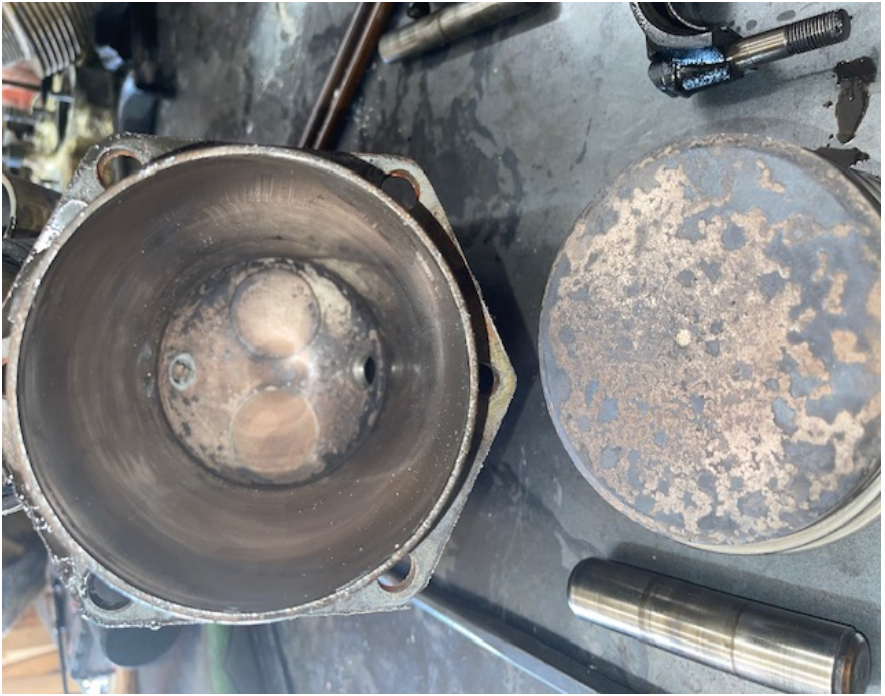
**Cylinder 1:**

7. Examine the main and connecting rod bearings for signs of oil exhaustion and/or starvation. **Oil starvation is evident in "ALL" connecting rod bearings.**

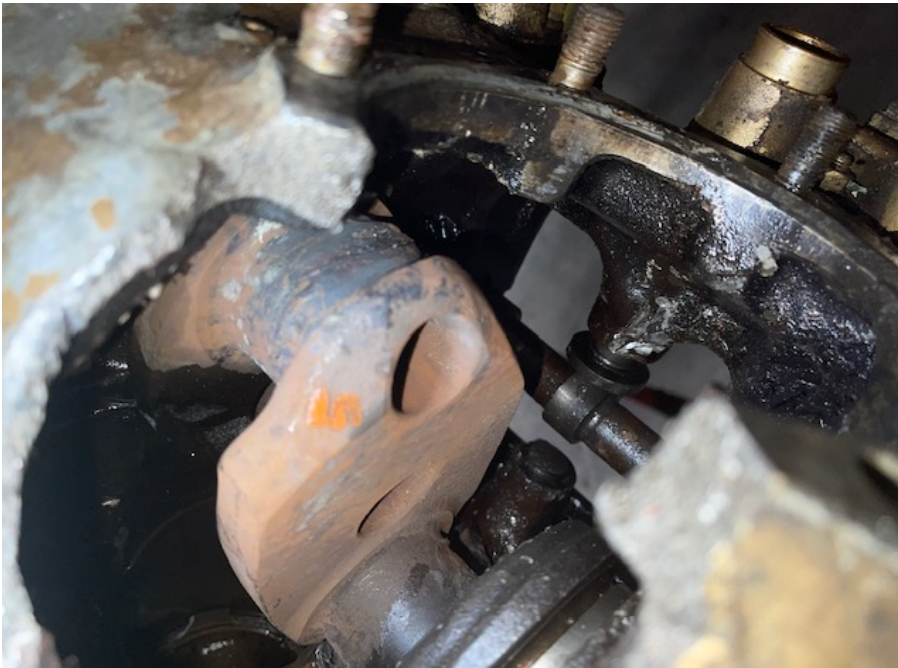
Cylinder #5

Was not able to remove cylinder due to connecting rod damage; photo of crank journal damage
