## RECORD OF CONVERSATION

**Date: April 27, 2022**  
**Person Contacted: Gloria Smith**  
**NTSB Accident Number: ERA22LA208**

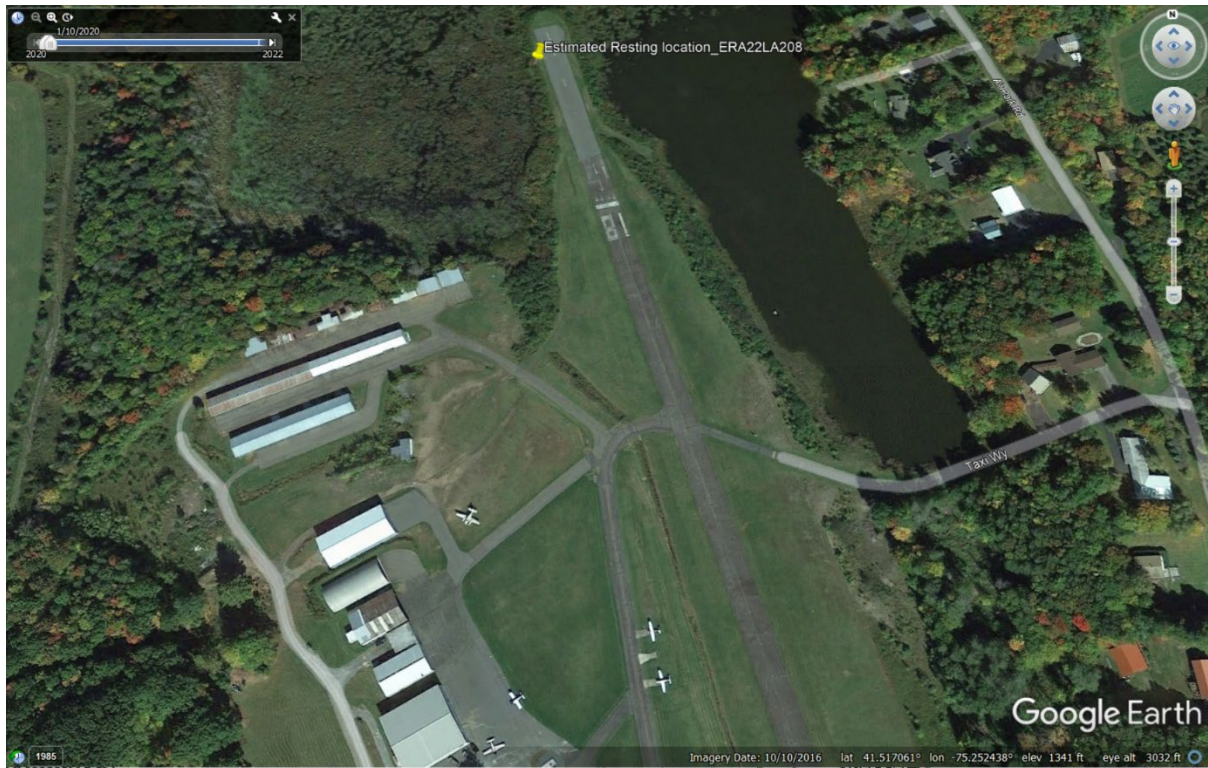
Figure 1: Google Earth View of Portion of N30 Runway, taxiway location, and estimate resting Position of the Airplane.

She performed a complete preflight inspection and checked the fuel tanks for contaminants; none were found. She intended to depart from runway 18, but because of the location of the taxiway in relation to runway 18 (Figure 1), she taxied onto the runway and back taxied to the approach end of runway 18 on the narrow runway<sup>1</sup>. There is not a lot of room to turn around (Figure 2) and she began making a sharp left turn, but during the turn a Goose went from 1 side of the runway to the other and that caused her to release or relax the turn. The right main landing gear went off the edge of the runway onto soft grass. She added throttle to avoid sinking, but the airplane went down a steep slope on the right side of the runway. She described the edge of the runway being about 4 to 5 inches above the height of the ground in that area, and also an area where the edge was broken.

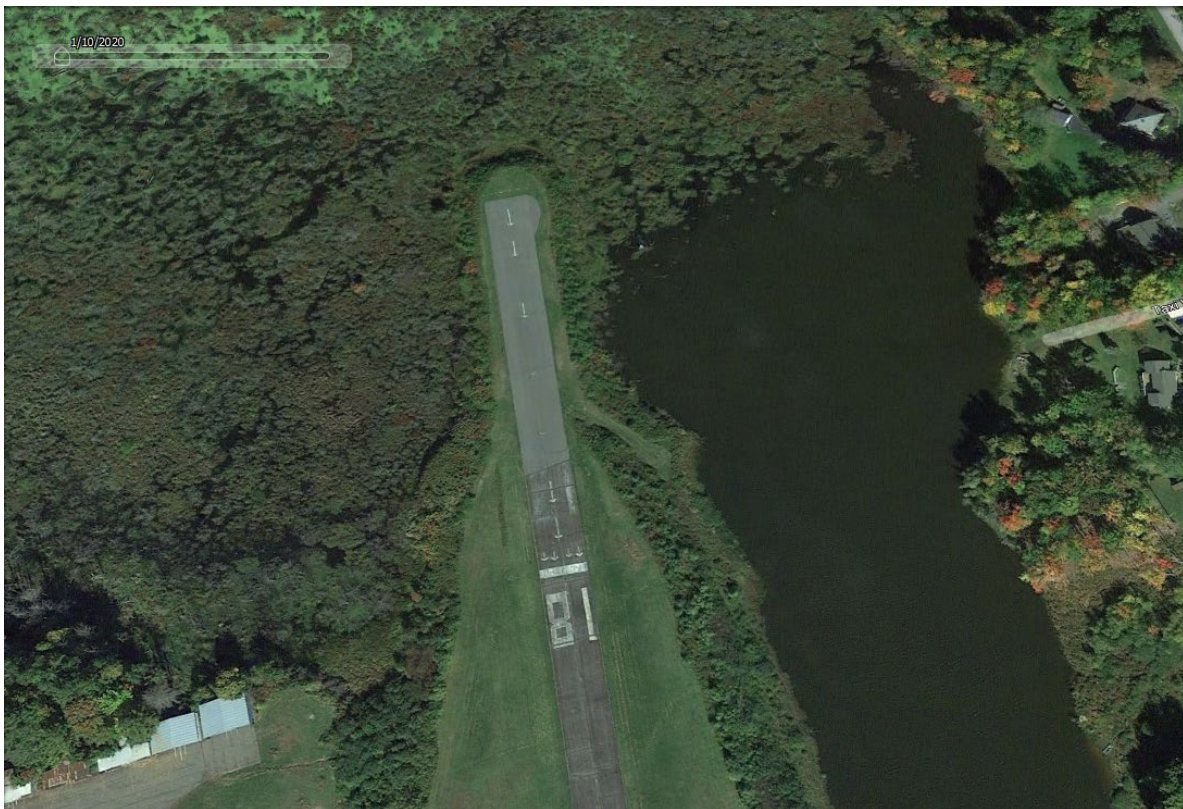
Figure 2: Google Earth View of the Approach End of Runway 18 and Small Turn-Around.
