**Subject:** ERA22LA265, FAA IIC email to NTSB IIC Photograph Descriptions

**FAA IIC STATEMENT (EMAIL)**

**A. ACCIDENT      ERA22LA265**

Location:            Stockbridge, GA  
Date:                June 11, 2022  
Aircraft:            Piper PA-30  
Registration:       N3477P

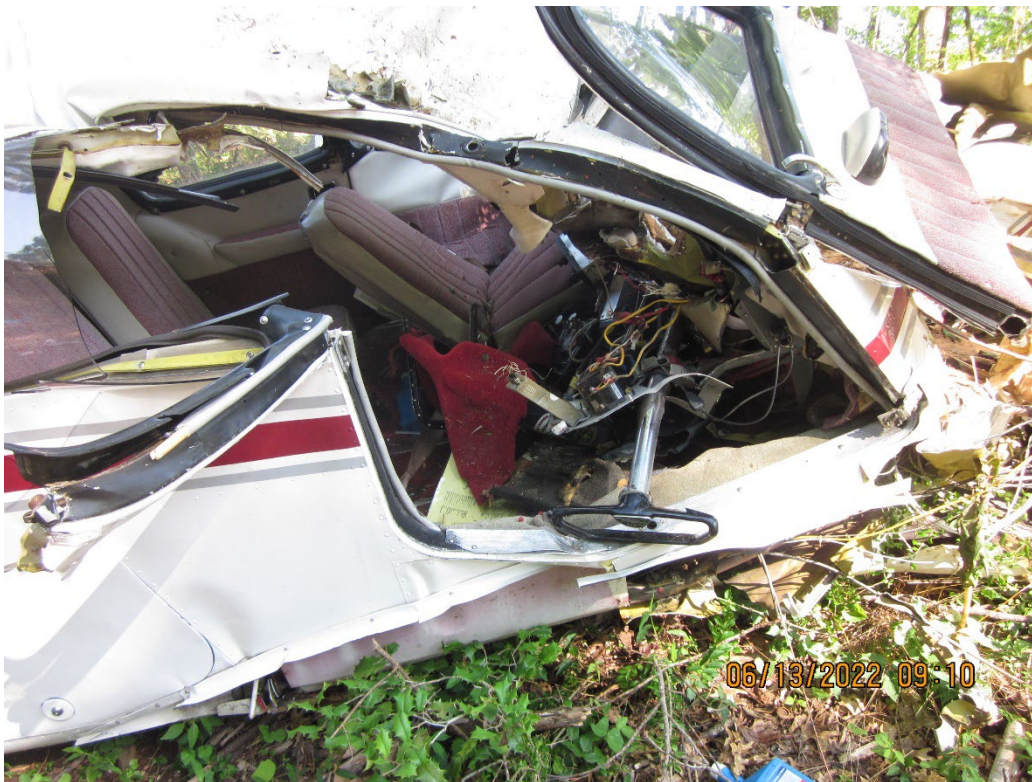
Photograph 2342

"1. 2342- Condition of cabin area

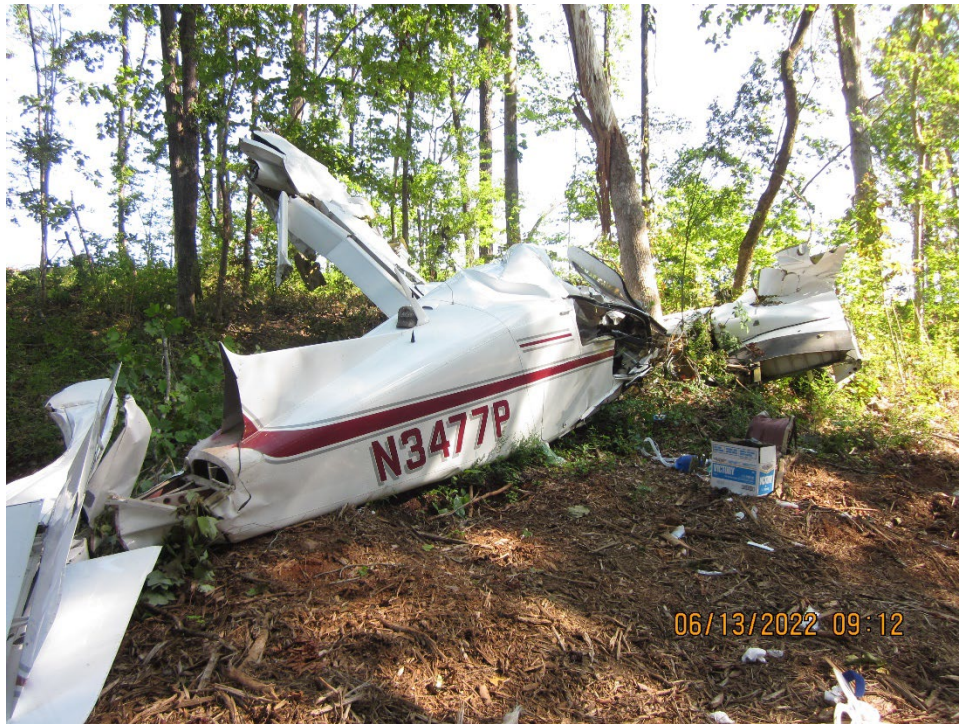
Photograph 2348

2. 2348- Notice about 10 feet above the plane the bark coming off the tree. They hit about 15 to 20 up the tree which broke the right wing off and when it hit slammed on the ground with the force it sheer the tail and bent upward the left wing and the only thing attached was the wiring and cables.

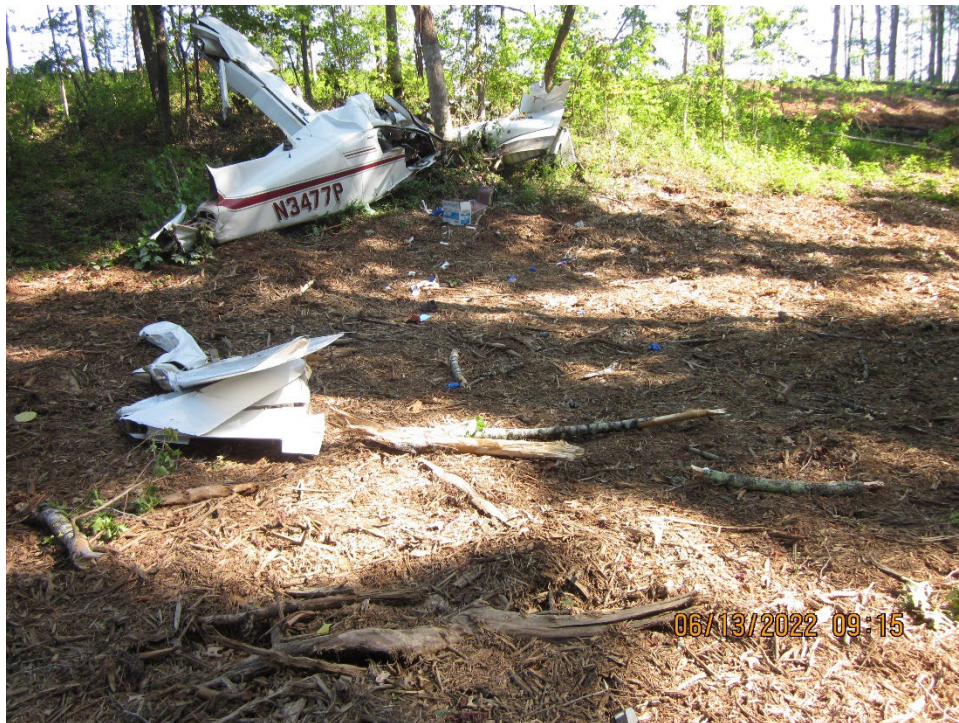
Photograph 2358

3. 2358- I wanted you to notice that the ground shows no sliding up the embankment the plane hit 20 feet up the tree down like a ton of bricks.

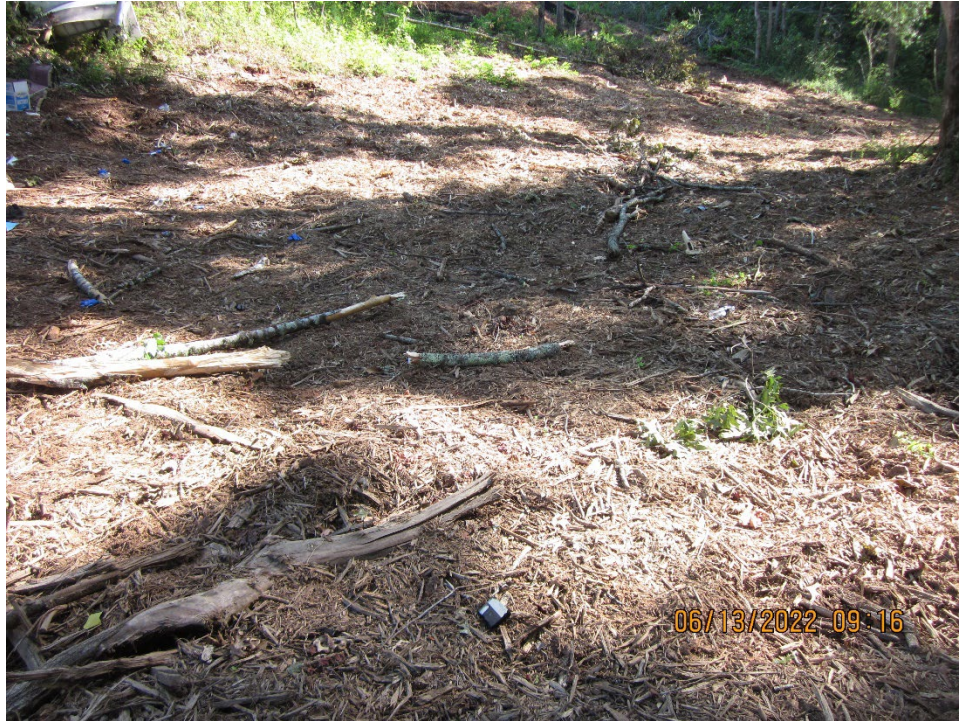
Photograph – 2359

4. 2359- Picture of the broken limbs from the tree they hit before hitting the one where the plane is at rest again notice no ground messed up from a sliding aircraft.

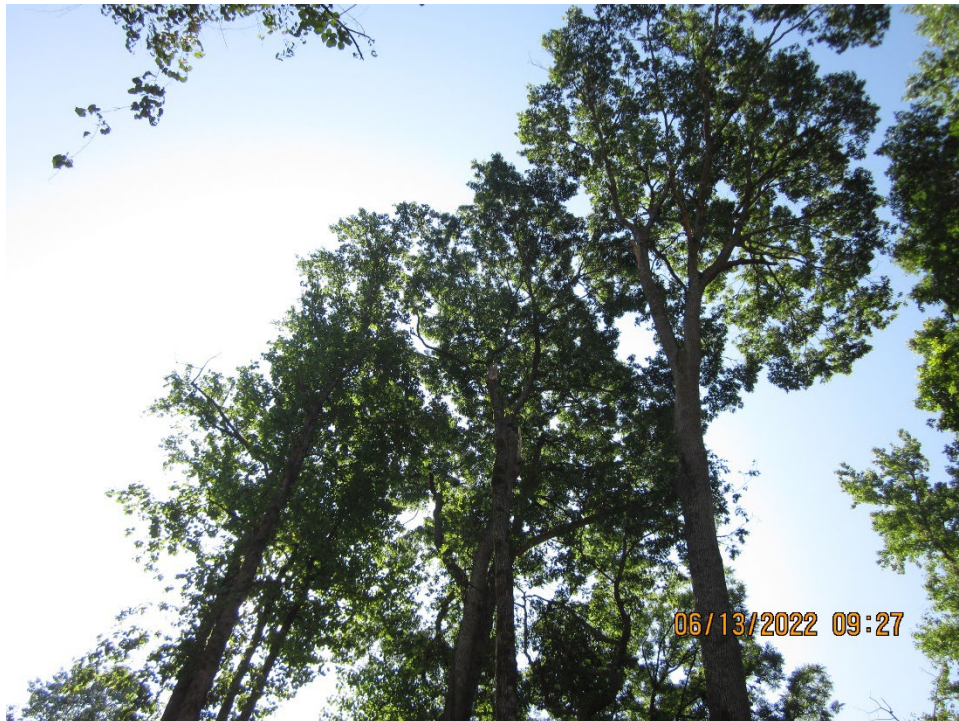
Photograph – 2361

5.2361 And 2362- Picture of the two trees the plane hit as it enter the woods the limbs on the ground came from the two trees in the picture. Those two trees are approximately 20 yards east of the aircraft resting

spot. I believe the plane hit the top of those two trees and cause the aircraft spin around and hit the tree where the plane came to rest."
