To: Mr. Adam Gerhardt, NTSB

From: Mr. Oswaldo Rodriguez, OZ A&P, LLC

Re: Statement pertaining to repairs to nose landing gear for N745EP

Date: 20 OCT 2022

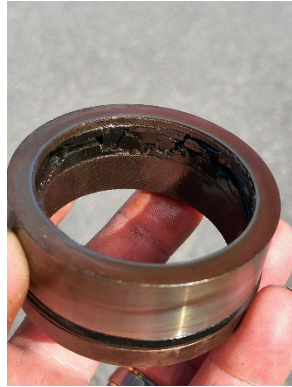
10. Removed lower piston barrel to get access to ring pack support. Figures 1 and 2 show the condition of seal as found.
11. Installed new packing, nose strut seals from kit P/N TC400NS-1, IAW Cessna 414 SM.

Figure 1. N745EP nose strut seal as found

12. Installed poly seal, shim spacer, stop bearing, and lock ring.
13. Re-installed lower strut assembly (piston barrel), scrap ring, ring pack retainer, and lock ring.

14. Installed lock ring and torque links. Bolt was torqued within limits and installed a new cotter pin.
15. Serviced the strut with hydraulic fluid Mil-PRF 5606 within limits.

16. Serviced the nose strut with nitrogen within limits IAW Cessna 414 SM.
17. Installed nose wheel assembly. Torqued bolt within limits and installed a new cotter pin.

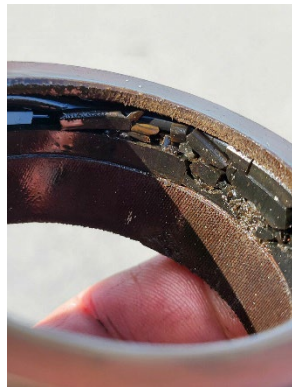
Figure 2. N745EP nose strut seal closeup as found
