# National Transportation Safety Board

ERA23FA380

## VIDEO FILE

Specialist's Factual Report

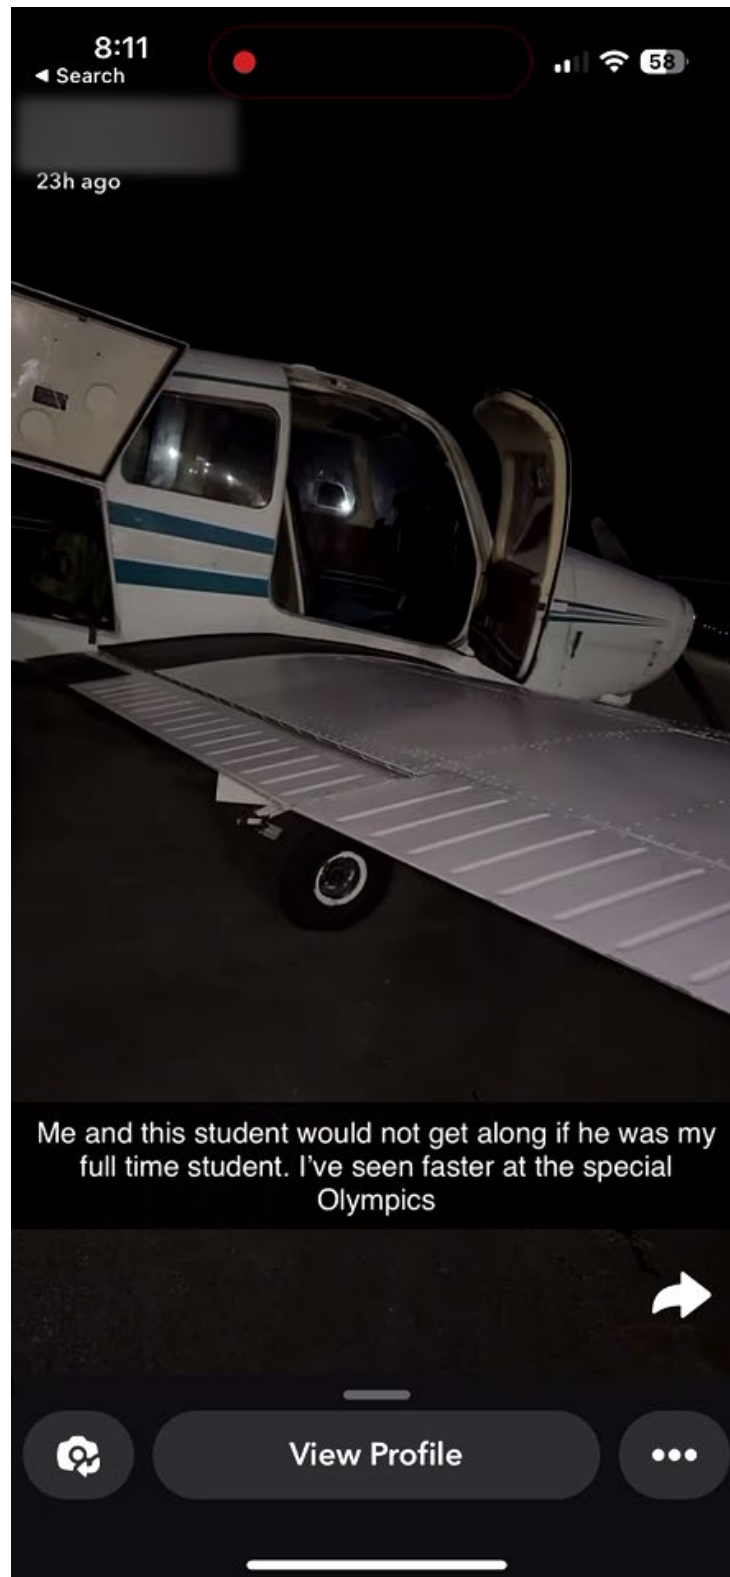
The instructor pilot had the camera pointed at themselves, in the front-facing view. There was text written by the instructor pilot that said, "Me and this student would not get along if he was my full time student. I've seen faster at the special Olympics." The instructor pilot looked annoyed and shook their head. Six seconds into the video, the camera view was changed to rear-facing. The camera panned from the instructor pilot's feet to the forward part of the aircraft. The pilot then turned the camera toward the aft portion of the aircraft, where the student pilot was reviewing a paper document with the flashlight from a cell phone. The aircraft was on the ground and not powered on, and it was dark outside. This set of clips ended shortly thereafter. Figure 1 is a screenshot from the first video Snapchat Story.

**Figure 1.** First Snapchat Story video clip with aircraft on the ground.

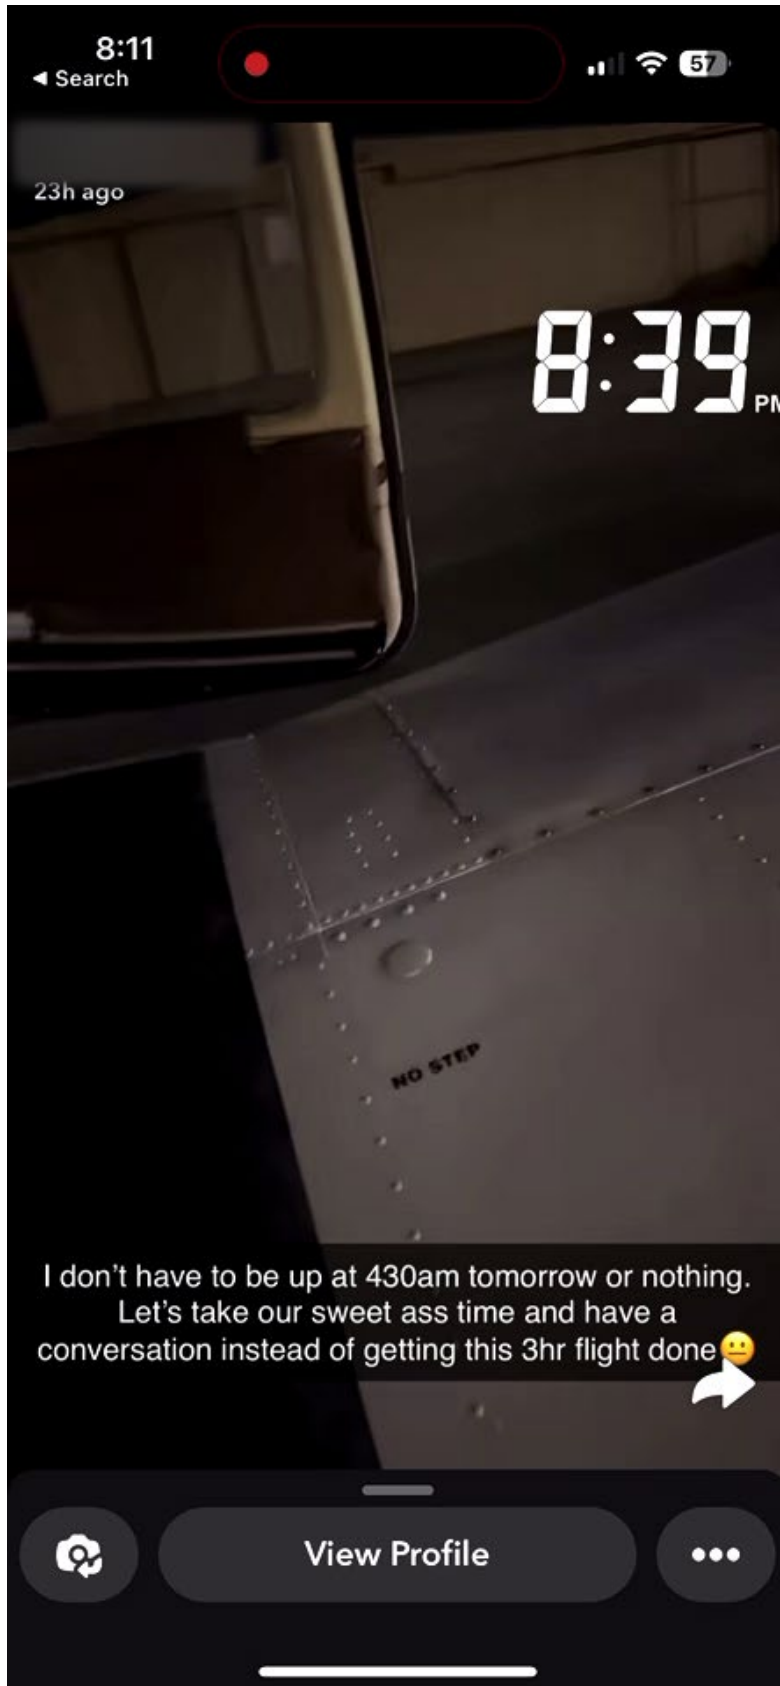
The instructor pilot had the camera in the rear-facing view. A timestamp of 8:39 PM was presented on the top right corner of the clips. There was text that said, "I don't have to be up at 430am tomorrow or nothing. Let's take our sweet ass time and have a conversation instead of getting this 3hr flight done 😞." The camera was pointed at the instructor pilot's left hand. The instructor was tapping their fingers against the fuselage. The camera panned to the front of the aircraft and showed the student pilot sitting in the right seat. The student pilot appeared to be using a cell phone's flash light and reading documents in their lap. The aircraft was on the ground and was not powered on. The instructor pilot continued to tap their fingers while recording. Seven seconds into this Snapchat story the instructor pilot said, "come on," in a low agitated voice. The camera panned to the right wing and then back towards the fuselage. The instructor pilot then changed from rear-facing to front-facing view. The instructor pilot facial appearance looked annoyed. The instructor pilot then shook their head. This set of clips ended shortly thereafter. Figure 2 is a screenshot from the second video Snapchat Story.

**Figure 2.** Second Snapchat Story clip with the student pilot still preparing the flight.

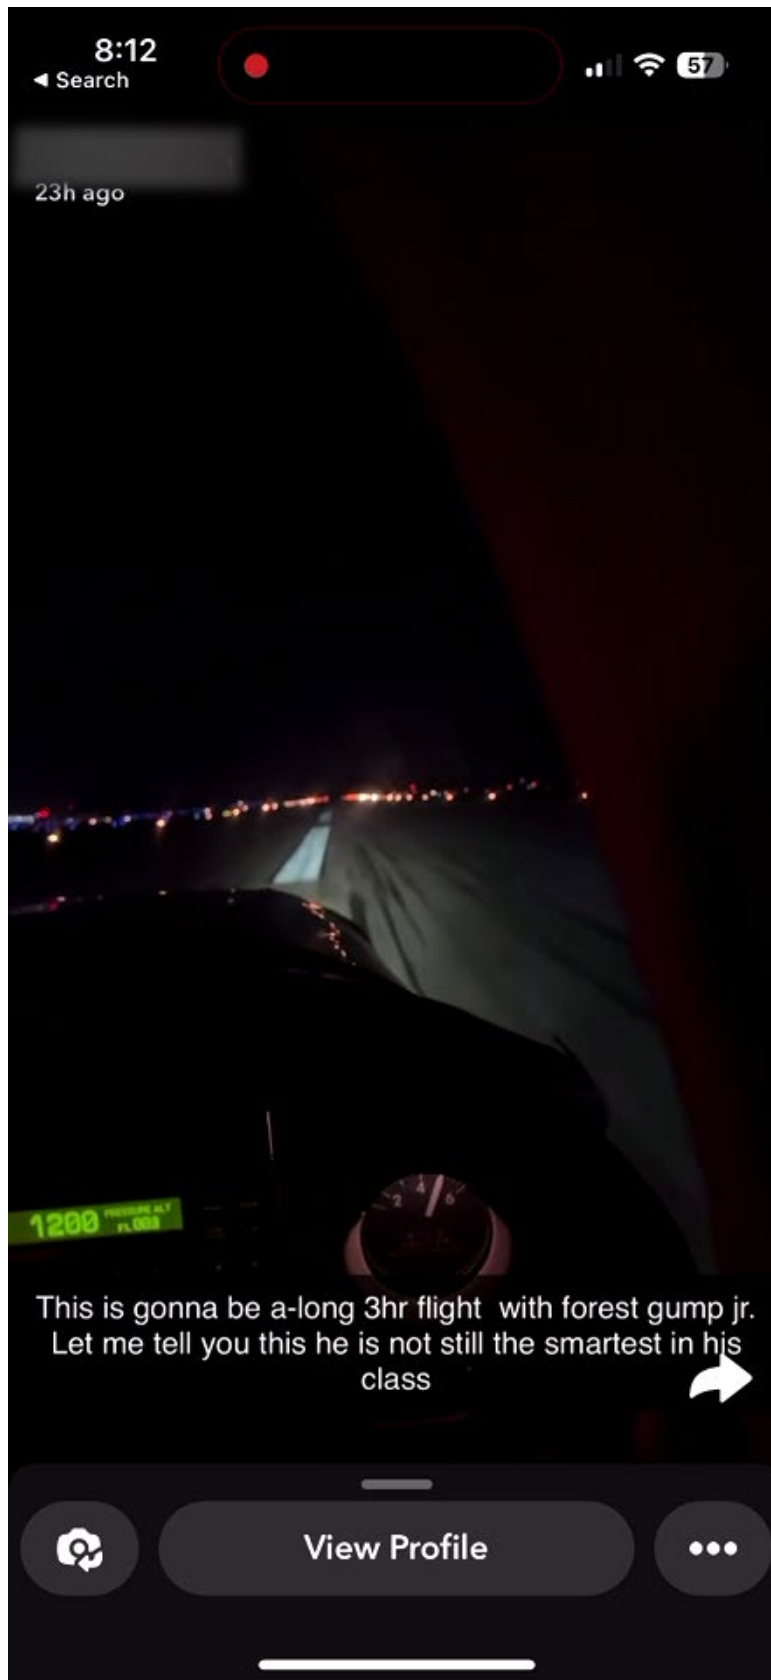
The instructor pilot was in the right seat. The aircraft was taking off. Approximately 8 seconds into the first clip of this Snapchat story, the aircraft rotated. There was text that said, "This is gonna be a-long 3hr flight with forest gump jr. Let me tell you this he is not still the smartest in his class." Two flight instruments were visible; the gyro suction gauge was between 4 and 6 inHg and a lighted display adjacent to gyro suction gauge was visible with ALT 1200 and Pressure ALT FL 004

displayed. The lights of the aircraft were visible and no abnormal engine noises were heard. Figure 3 is a screenshot from the third video Snapchat Story.

**Figure 3.** Third Snapchat Story clip with the aircraft in takeoff rollout.

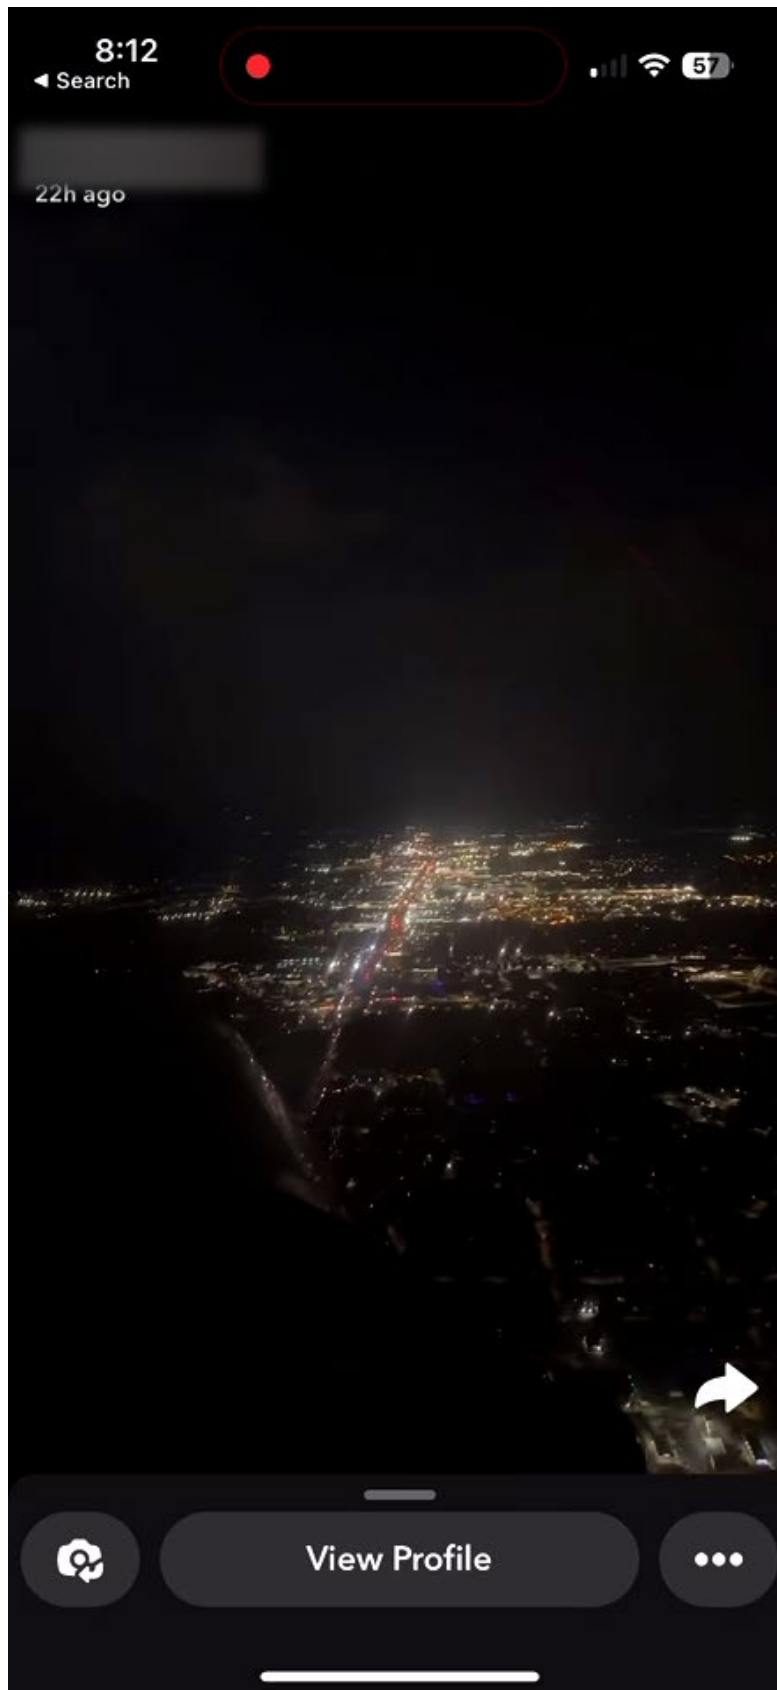
The instructor pilot was recording with a rear-facing view. The camera was pointed outside the aircraft. The aircraft was at altitude and flying, and no abnormal engine noises were heard. No views of the instrument panel were captured. From the altitude that the aircraft was flying, the ground was clearly visible. Visual meteorological conditions (VMC) were present. Figure 4 is a screenshot from the fourth video Snapchat Story.

**Figure 4.** Fourth Snapchat story clip with the aircraft in flight.

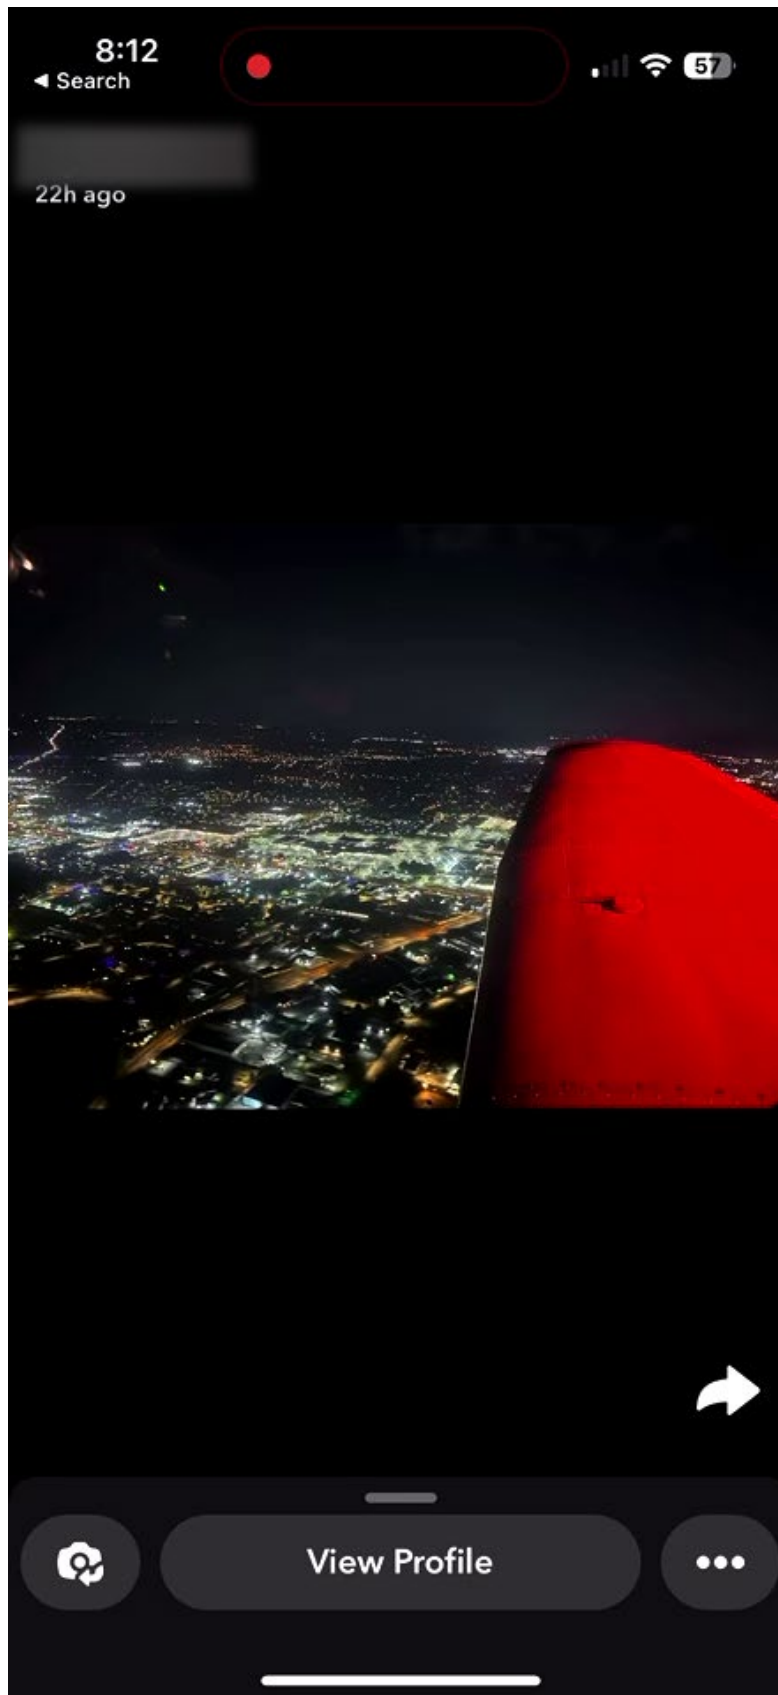
The instructor pilot took a still photo and posted to their story. The photo was taken with a rear-facing view, out the starboard side. The wing was lit up red when the still photo was taken, and lights from buildings and streetlights were clearly visible. VMC were present. Figure 5 is the still photo from the fifth Snapchat Story.

**Figure 5.** Fifth Snapchat story still photo with the aircraft in flight.

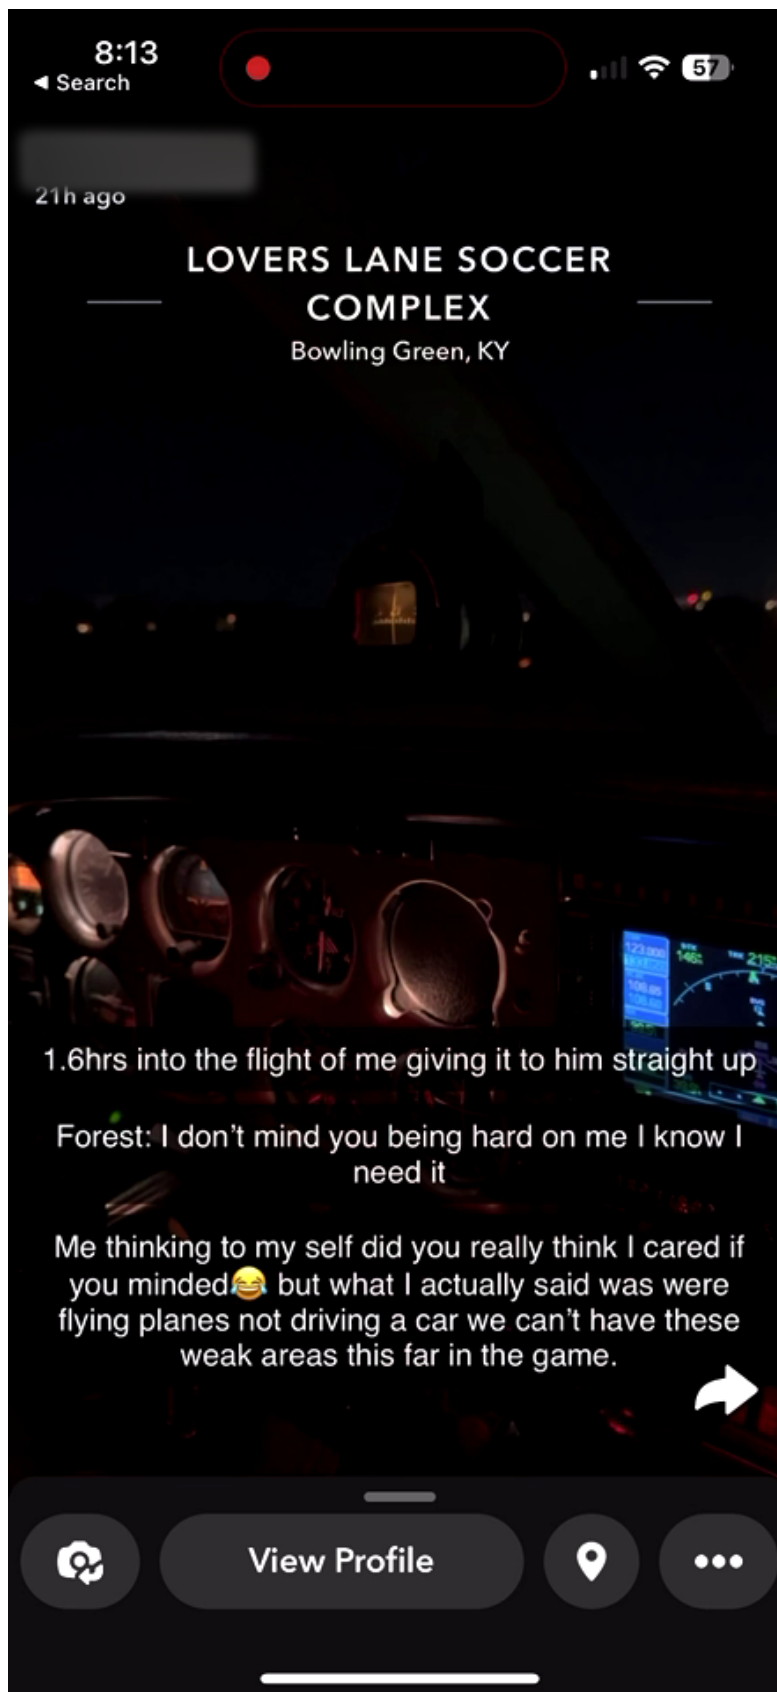
On the instrument panel, a track of 215 was observed on the navigation display. The only other visible flight instruments were the altimeter and the attitude indicator, which showed an approximate altitude of slightly greater than 500 feet and the artificial horizon was approximately wings level, respectively. All the other instruments and gauges were not visible or discernable. Figure 6 is the still photo from the sixth Snapchat Story.

**Figure 6.** Sixth Snapchat Story still photo with visual of instrument panel.

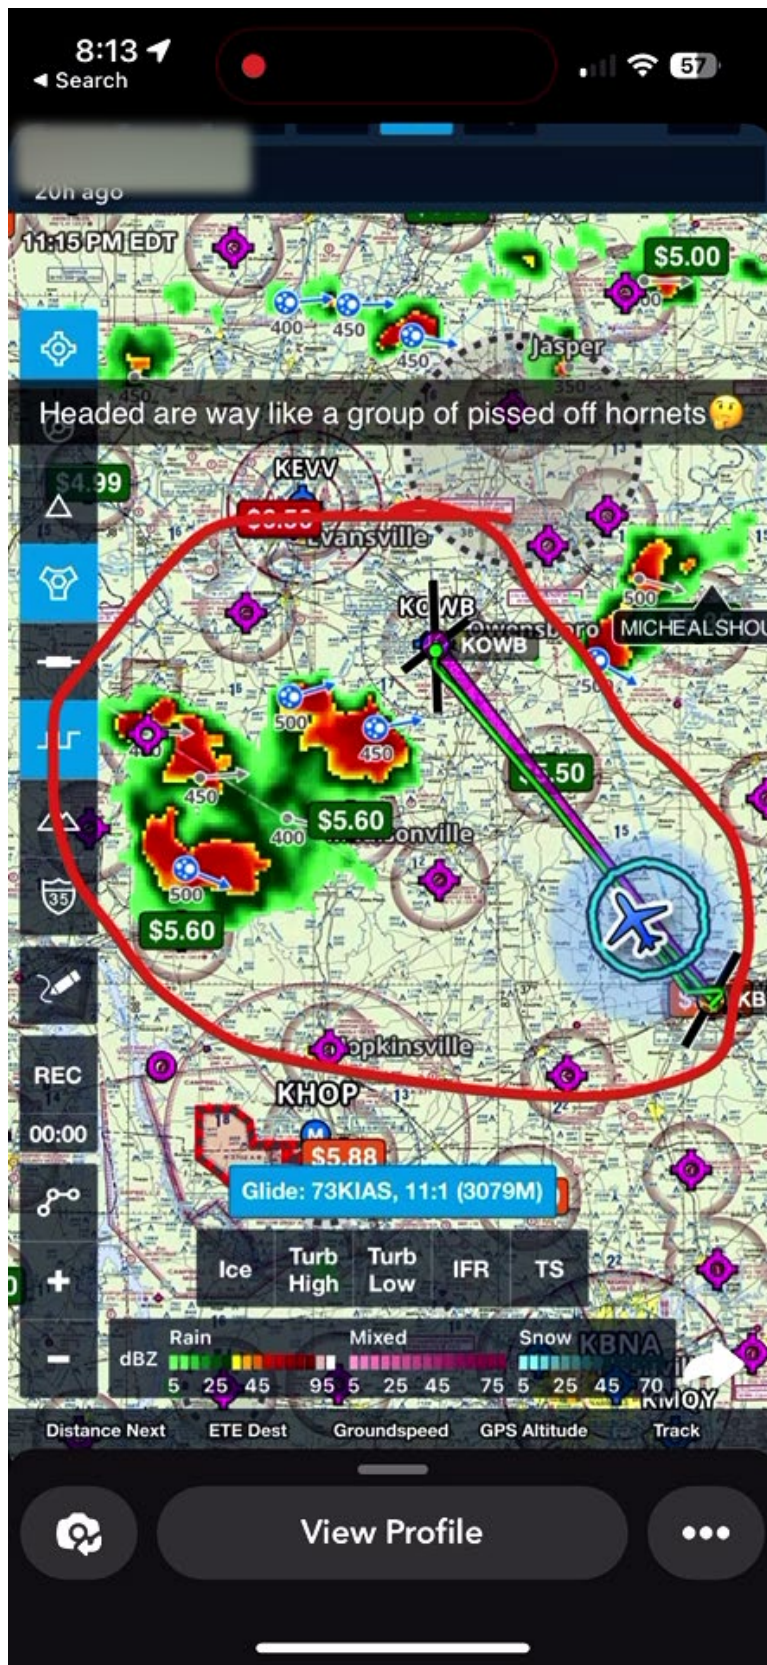
The instructor pilot took a screenshot of ForeFlight and uploaded to their story.<sup>6</sup> ForeFlight timestamps the chart when users access the application in the top left corner. The timestamp for this screenshot was 11:15 PM EDT (eastern daylight time), or 10:15 PM CDT.<sup>7</sup> There was text that said, "Headed are [sic] way like a group of pissed off hornets 🐝." A circle was drawn around the flight path and the weather band. The flight path was slightly east of the projected weather. A cyan circle was drawn around the aircraft. The aircraft was in the first third of the flight from KBWG (Bowling Green-Woodhurst Airport) to KOWB (Owensboro/Daviess County Regional Airport). The screenshot shows the weather was just northwest of Madisonville. In the ForeFlight weather screenshot, there is a large green area of precipitation. Inside of those green areas were 3 smaller red areas of precipitation, with numbers showing 400, 450, and 500 (weather tops out at flight level 400, 450, and 500, which is 40,000 feet, 45,000 feet, and 50,000 feet, respectively). From the red spots, there were arrows that pointed easterly, indicating that the weather was moving easterly toward the airplane's projected flight path. In addition to the weather just northwest of Madisonville, there was also weather shown in this screenshot east of Owensboro. On the bottom portion of the screenshot, ForeFlight displayed in a blue box, Glide: 73 KIAS, 11:1 (3079M). This was the last photo uploaded by the instructor pilot to their Snapchat story. Figure 7 is the still photo from the seventh Snapchat Story.

**Figure 7.** Seventh Snapchat Story screenshot displaying the weather in ForeFlight. Screenshot taken at 10:15 PM CDT (11:15 EDT).
