**MEMORANDUM FOR RECORD**

**Subject:** ERA23LA286, Damage Information and Total Wing Span

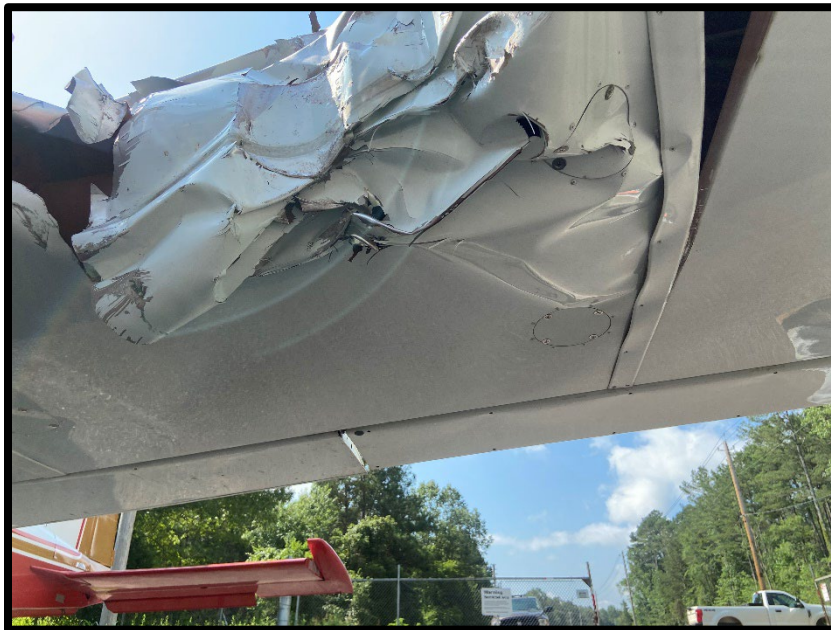
FAA inspector Richard Hudgins of the Vestavia Hills, Alabama Flight Standards District Office inspected the airplane and reported that the damage to the left wing leading edge measured 39 inches in length (Figure 1). The damage was from wing station (WS) 90 to WS 129, and was centered on WS 112.

**Figure 1: FAA Photograph. View Showing the span of Damage to the Left Wing Leading Edge.**

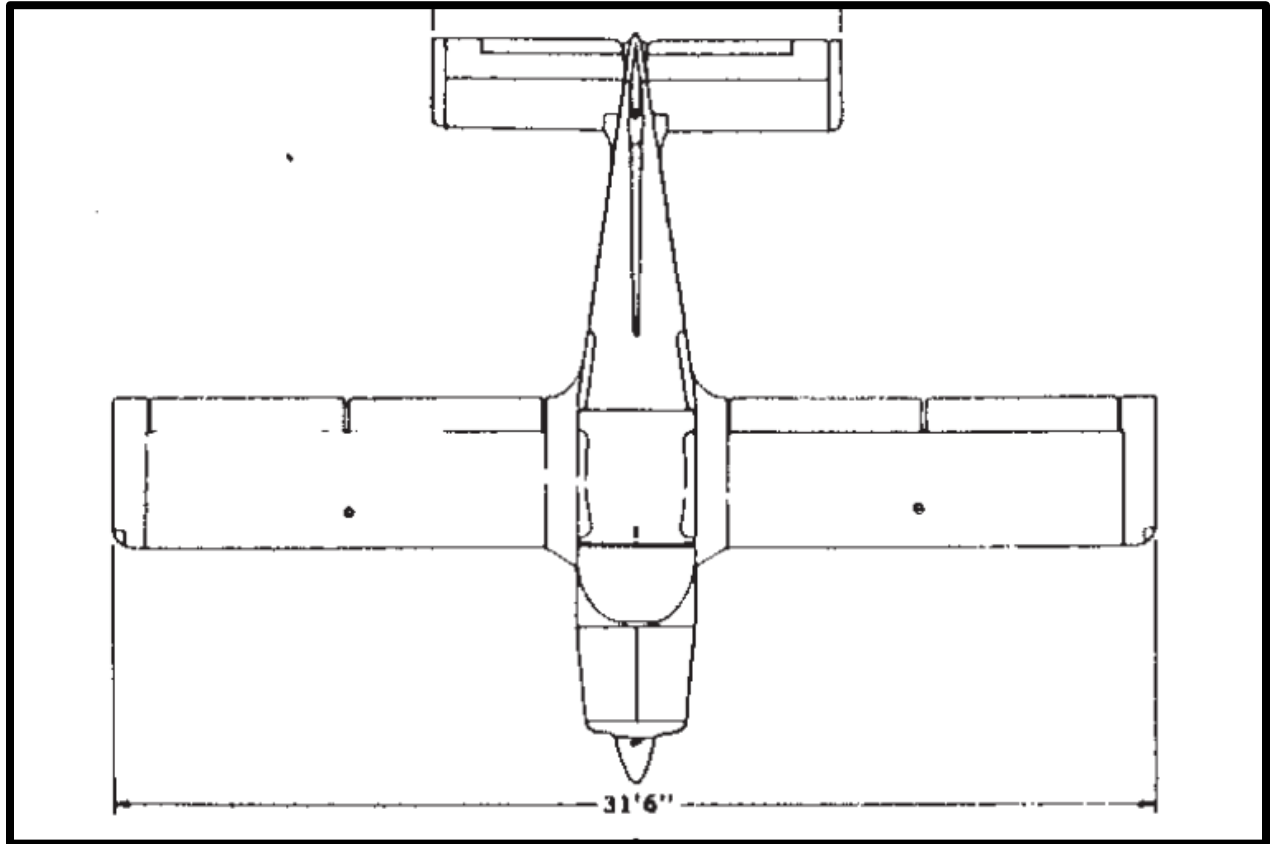
The FAA inspector also reported that the total wing span was 31 ft 6 inches (Figure 2).

**Figure 2: Wing Span Dimension from Pilot's Operating Handbook**
