# National Transportation Safety Board

ERA24FA136

## COCKPIT VOICE RECORDER

Group Chair's Factual Report

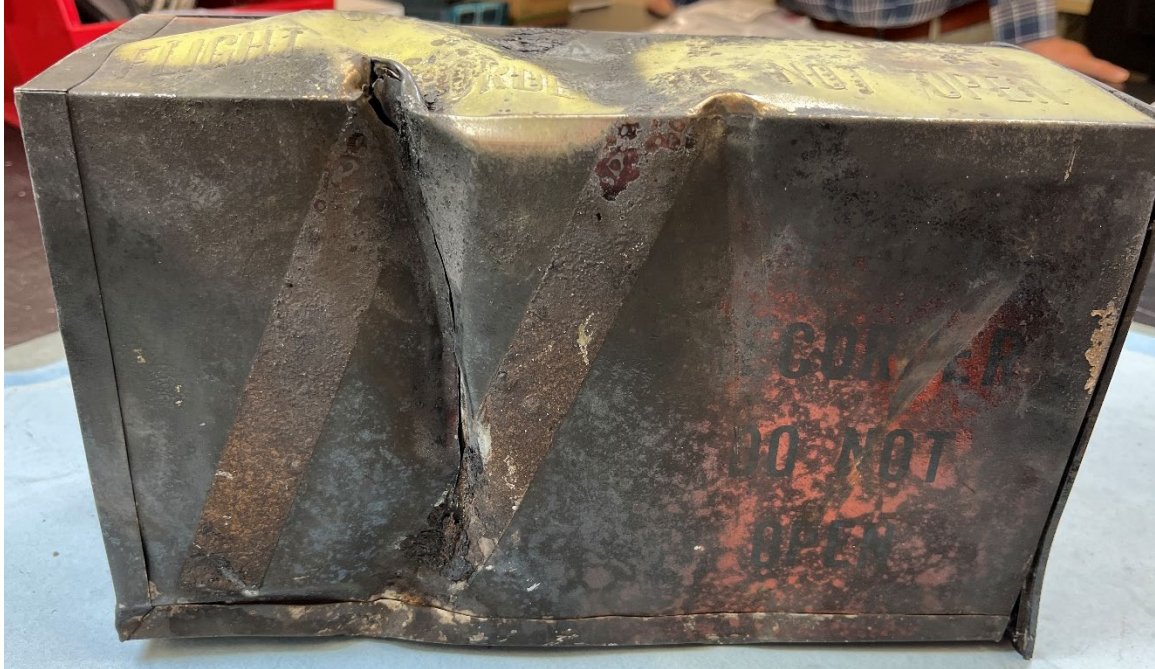
Upon arrival at the laboratory, it was evident that the exterior of the CVR had sustained some heat and structural damage as shown in figure 1. The outer case was removed, and the interior crash-protected case protecting the tape mechanism did not appear to have any heat or structural damage. The magnetic tape was retrieved from within the crash-protected case and was successfully read out using NTSB laboratory equipment.

**Figure 1.** Damaged exterior of CVR.
