Joshua Young  
Air Safety Investigator  
AS-ERA

**Subject:** ERA25FA201, Airport Information

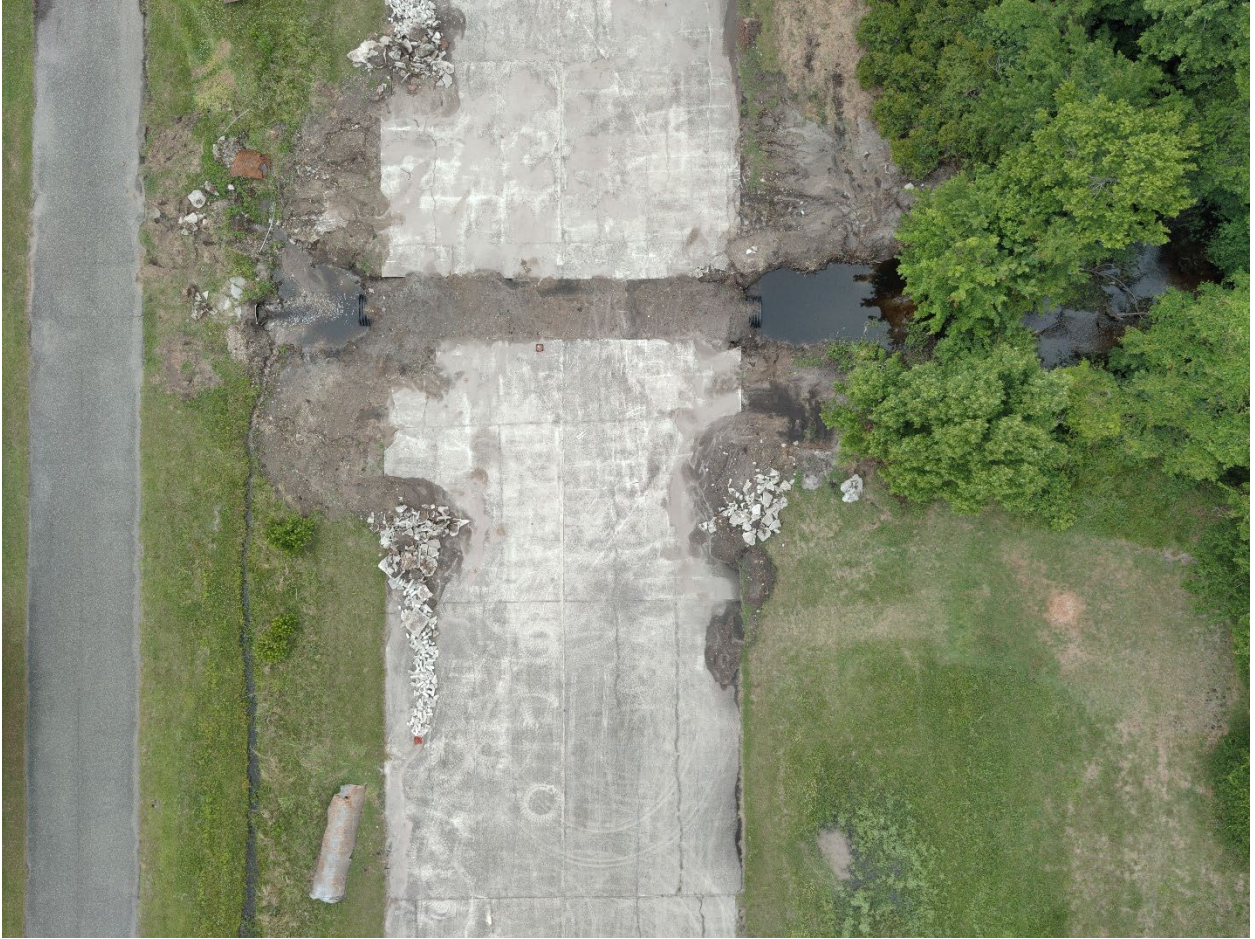
The IIC traveled to the scene of this accident and upon arriving at Nassau Airport (83FL), Yulee, Florida found that the runway was damaged. A witness who lived at the airport informed the IIC that the runway had been damaged the year prior when a culvert that ran beneath the runway had collapsed after a hurricane impacted the area (Figure 1). The IIC went and observed that the area was still damaged and would not have been usable for taxi or takeoff, thus shortening runway 12 from 3,150 ft to about 1,932 ft (Figure 2). A search of the NOTAM database found there were no NOTAMs issued for 83FL at the time of the accident. The pilot's spouse reported that the pilot was aware of the shortened runway and had flown into and out of the airport multiple times since the runway had been shortened.

*Figure 1: View of the damaged runway. (Courtesy of Nassau County Sheriff's Office)*

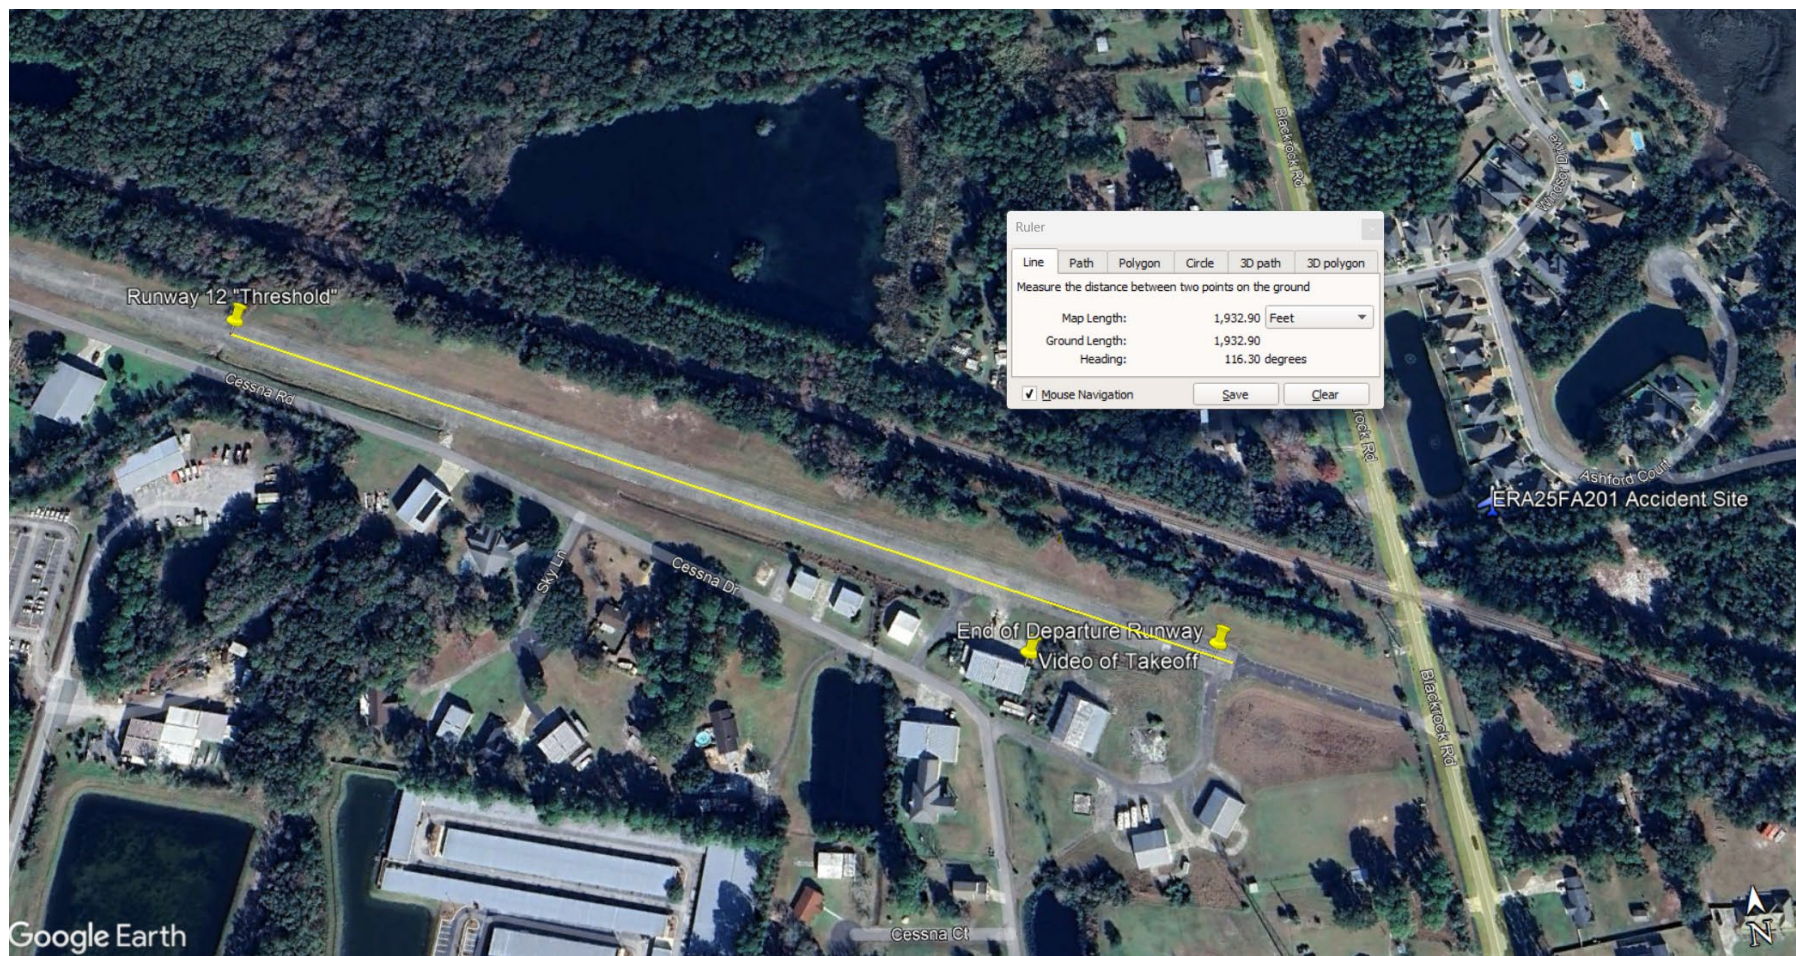
Figure 2: Google Earth View with the approximate runway length.
