**Subject:** ERA25LA115, Materials Laboratory Statement

The following is a statement of finding from the materials laboratory at the National Transportation Safety Board. The examination was performed in support of an investigation into an accident involving a Luscombe 8A, N77989 that occurred on February 11, 2025 in Hampton New Hampshire.

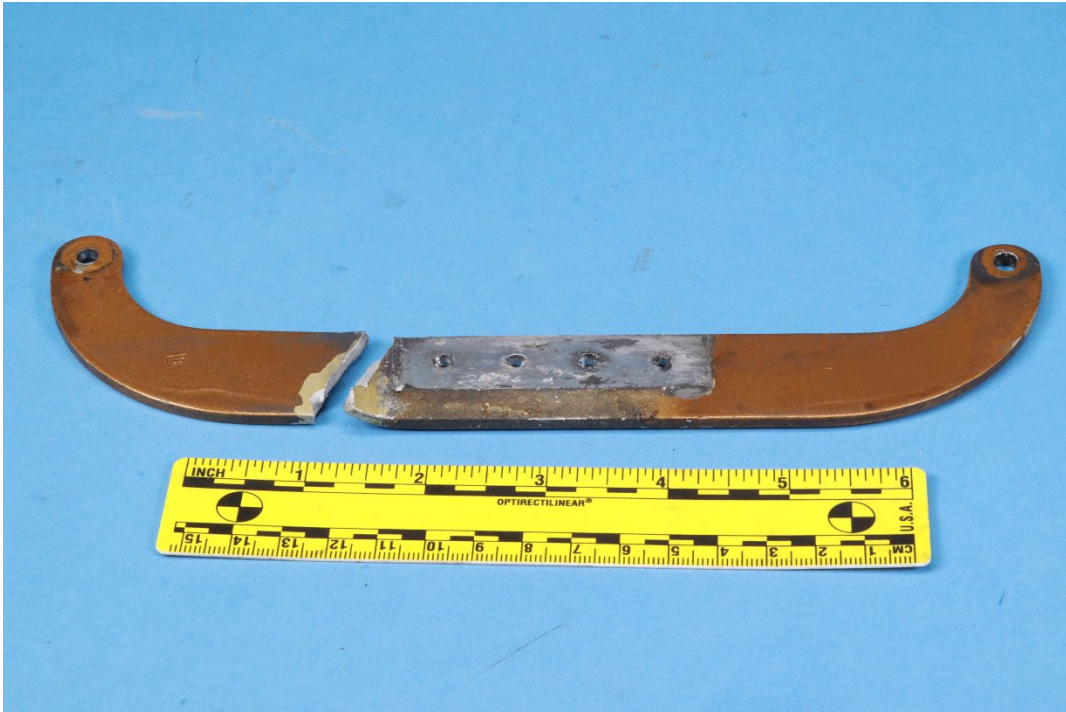
The aileron control bracket was received for examination as shown in the attached image. The fracture surface had matte gray features on slant planes consistent with ductile overstress fracture. The bracket was bent adjacent to the fracture consistent with fracture associated with out of plane bending loads. On the larger piece, the attachment hole at the curved end of the bracket (right side as viewed in the attached image) was elongated.
