## Last maintenance inspection e on Learjet cylinders

### Crew Oxygen

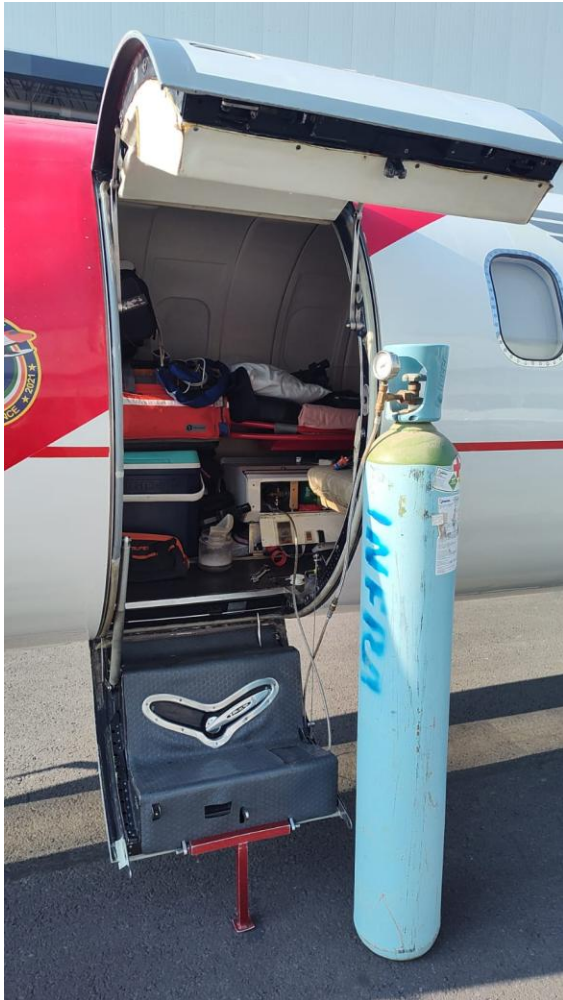
As these tanks were physically installed inside the aircraft, they were recharged via a reservoir tank, as shown in this photograph.

The date of the last inspection or manufacture is located on the neck of each tank, near the serial number. The inspections for both tanks were valid.
