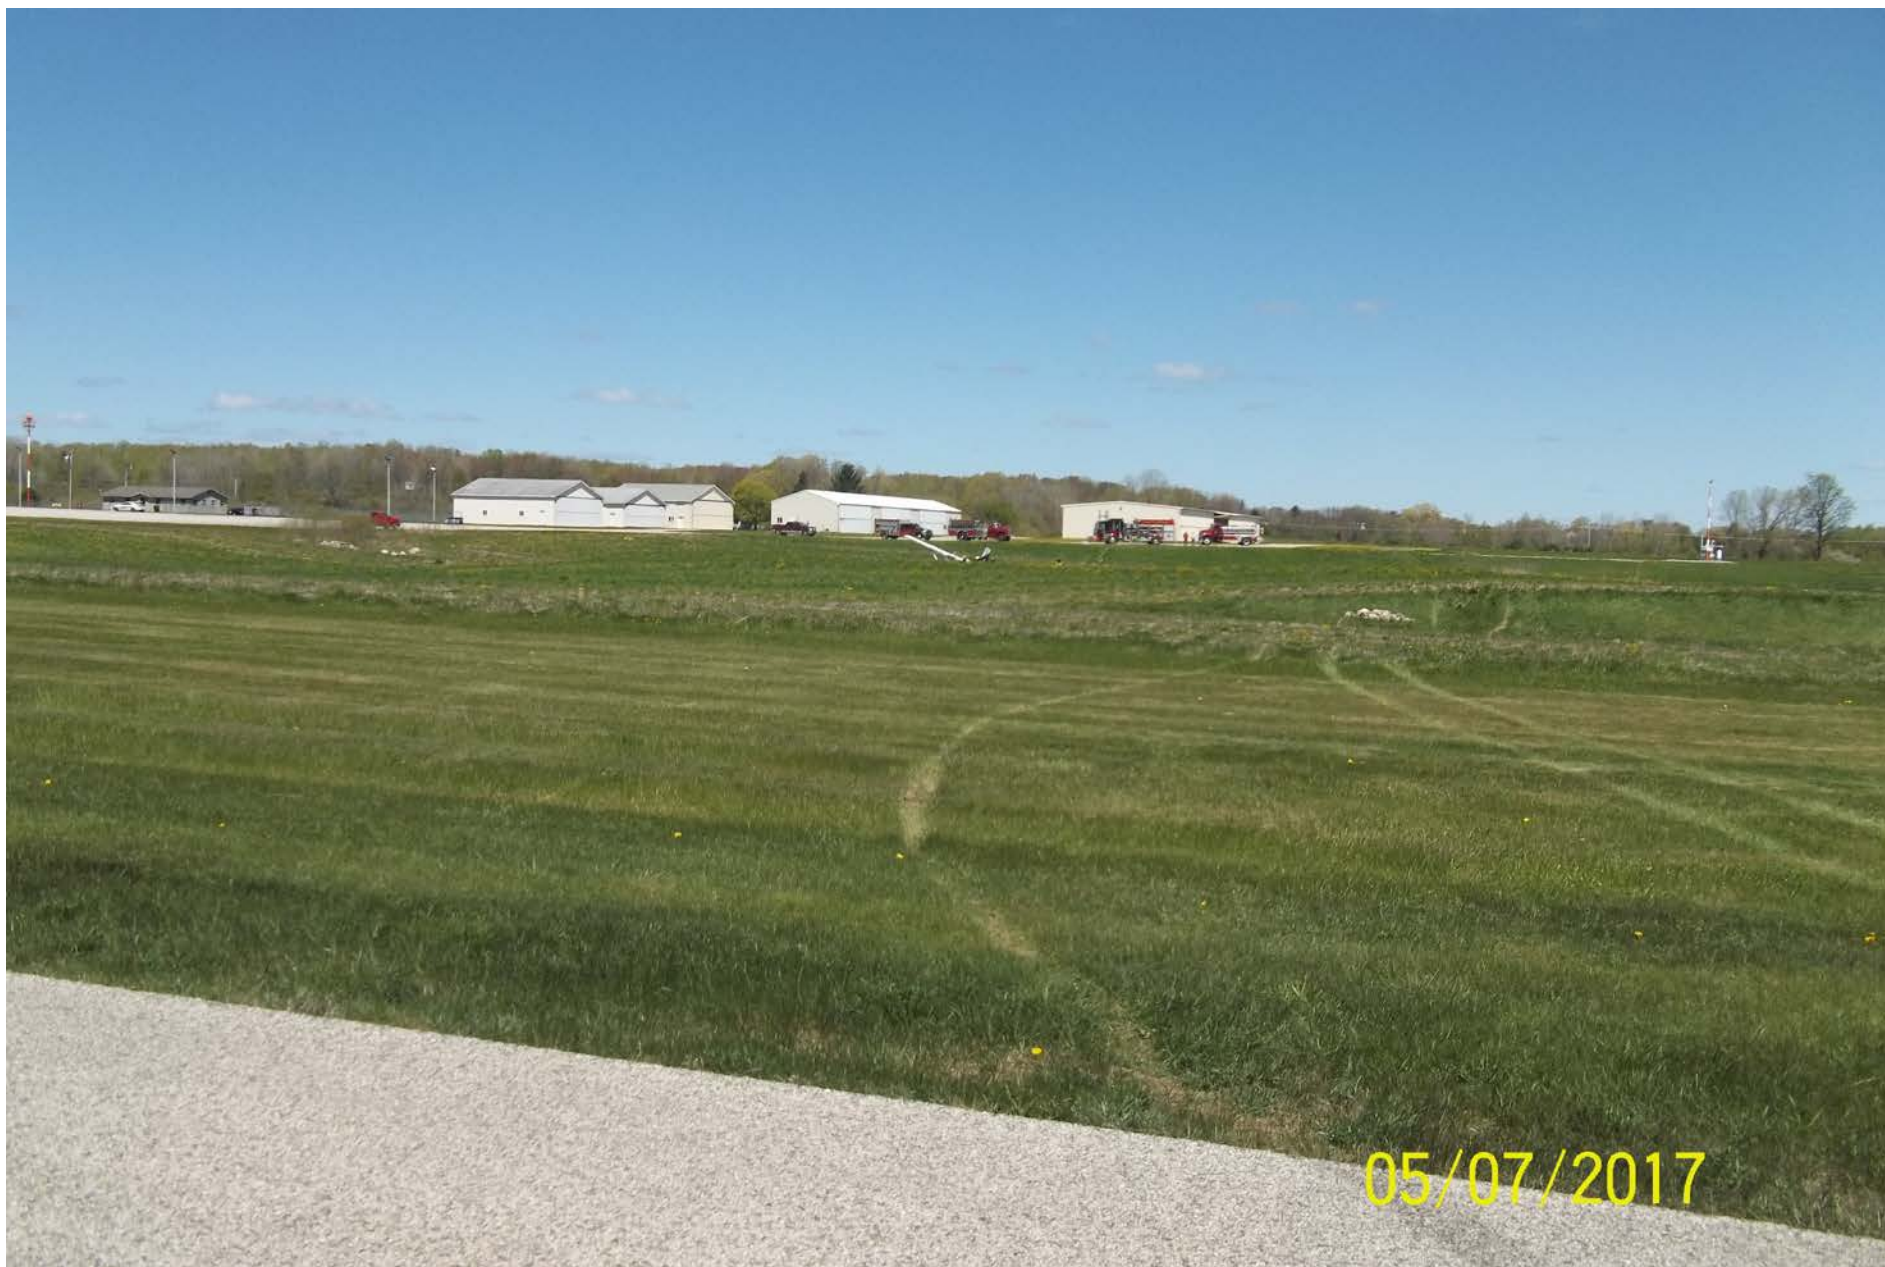
**Photo 1 – View of the airplane’s runway departure path (Courtesy of FAA)**

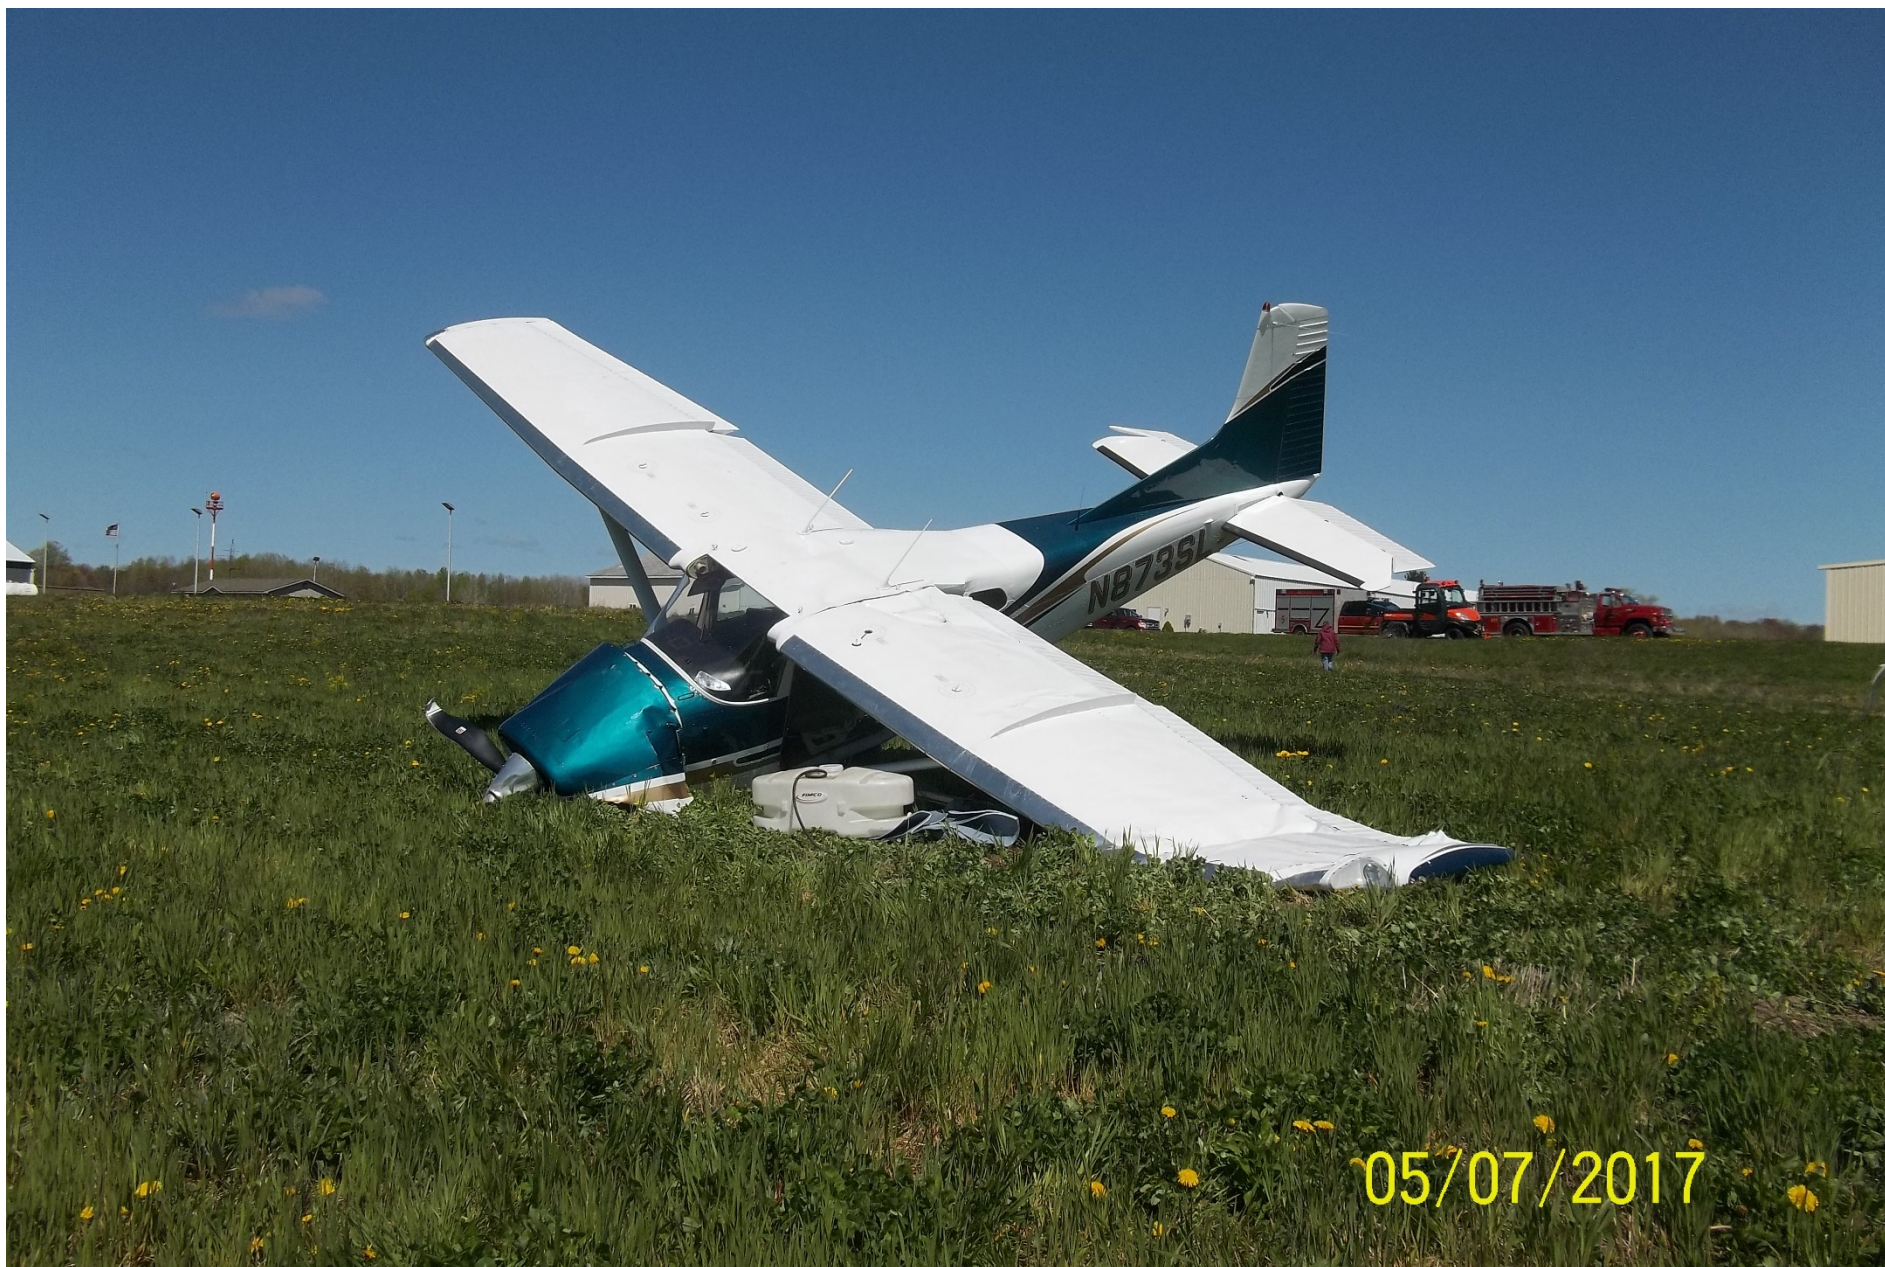
**Photo 2 – View of damage to the left wing spar (Courtesy of FAA)**
