## RECORD OF CONVERSATION

**Date: September 18, 2019**  
**Persons Contacted: Bradley Zweifel, pilot**  
**NTSB Accident Number: unassigned N6837E, Cessna 175 seaplane**

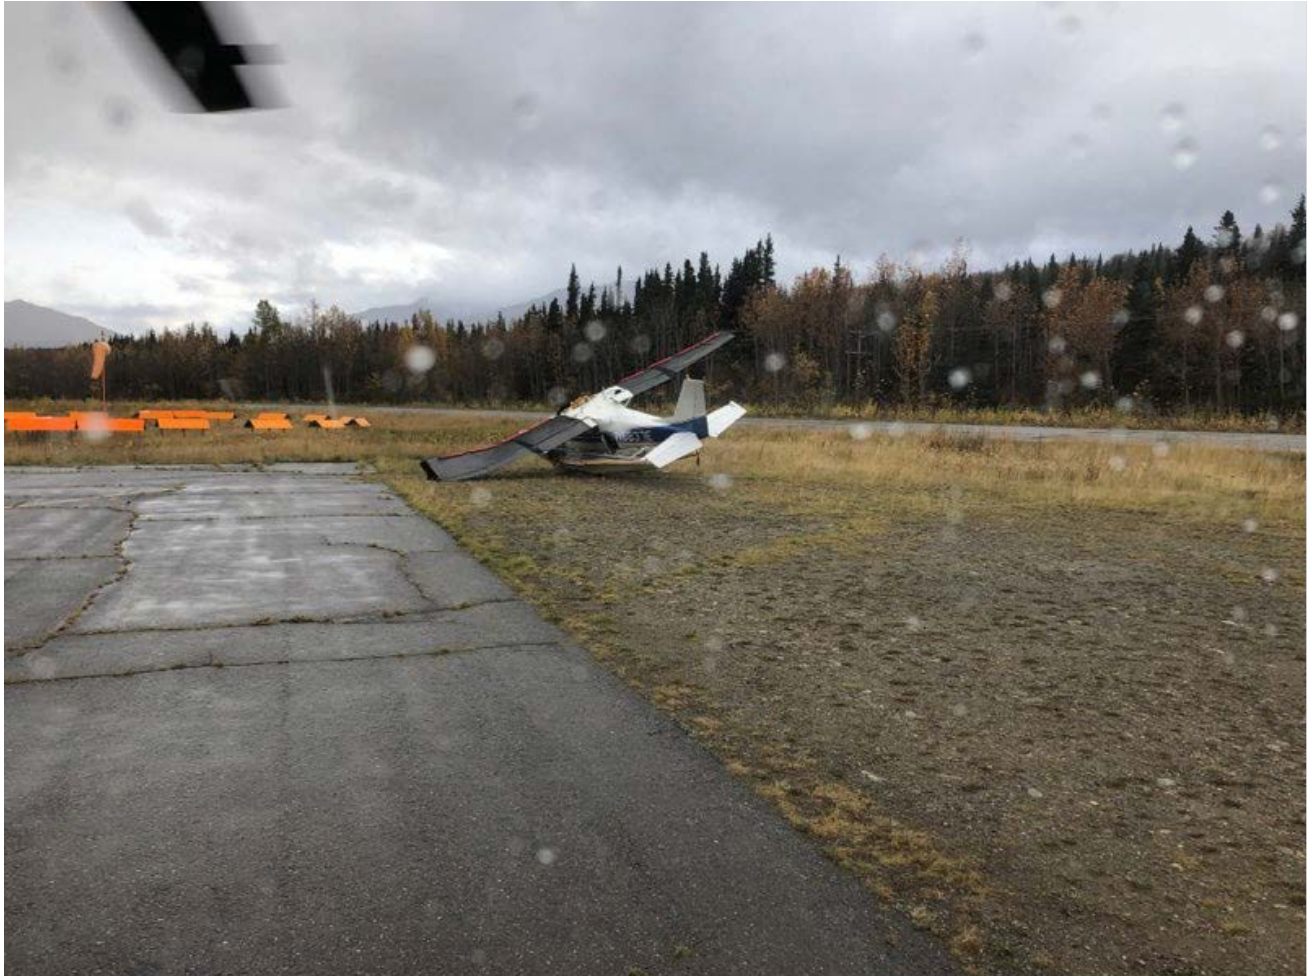
- Mr. Zweifel described the damage to propellers, engine, floats, left wing and left wing lift strut.
- He stated that there were no known mechanical issues with the airplane.

*Figure 1. N6837E C175 after accident recovery at Healy Airport*

- The NTSB duty officer released the wreckage for repair or sale, provided that pictures of the damage are provided. One photograph of the airplane after recovery was provided. Refer to figure 1.
