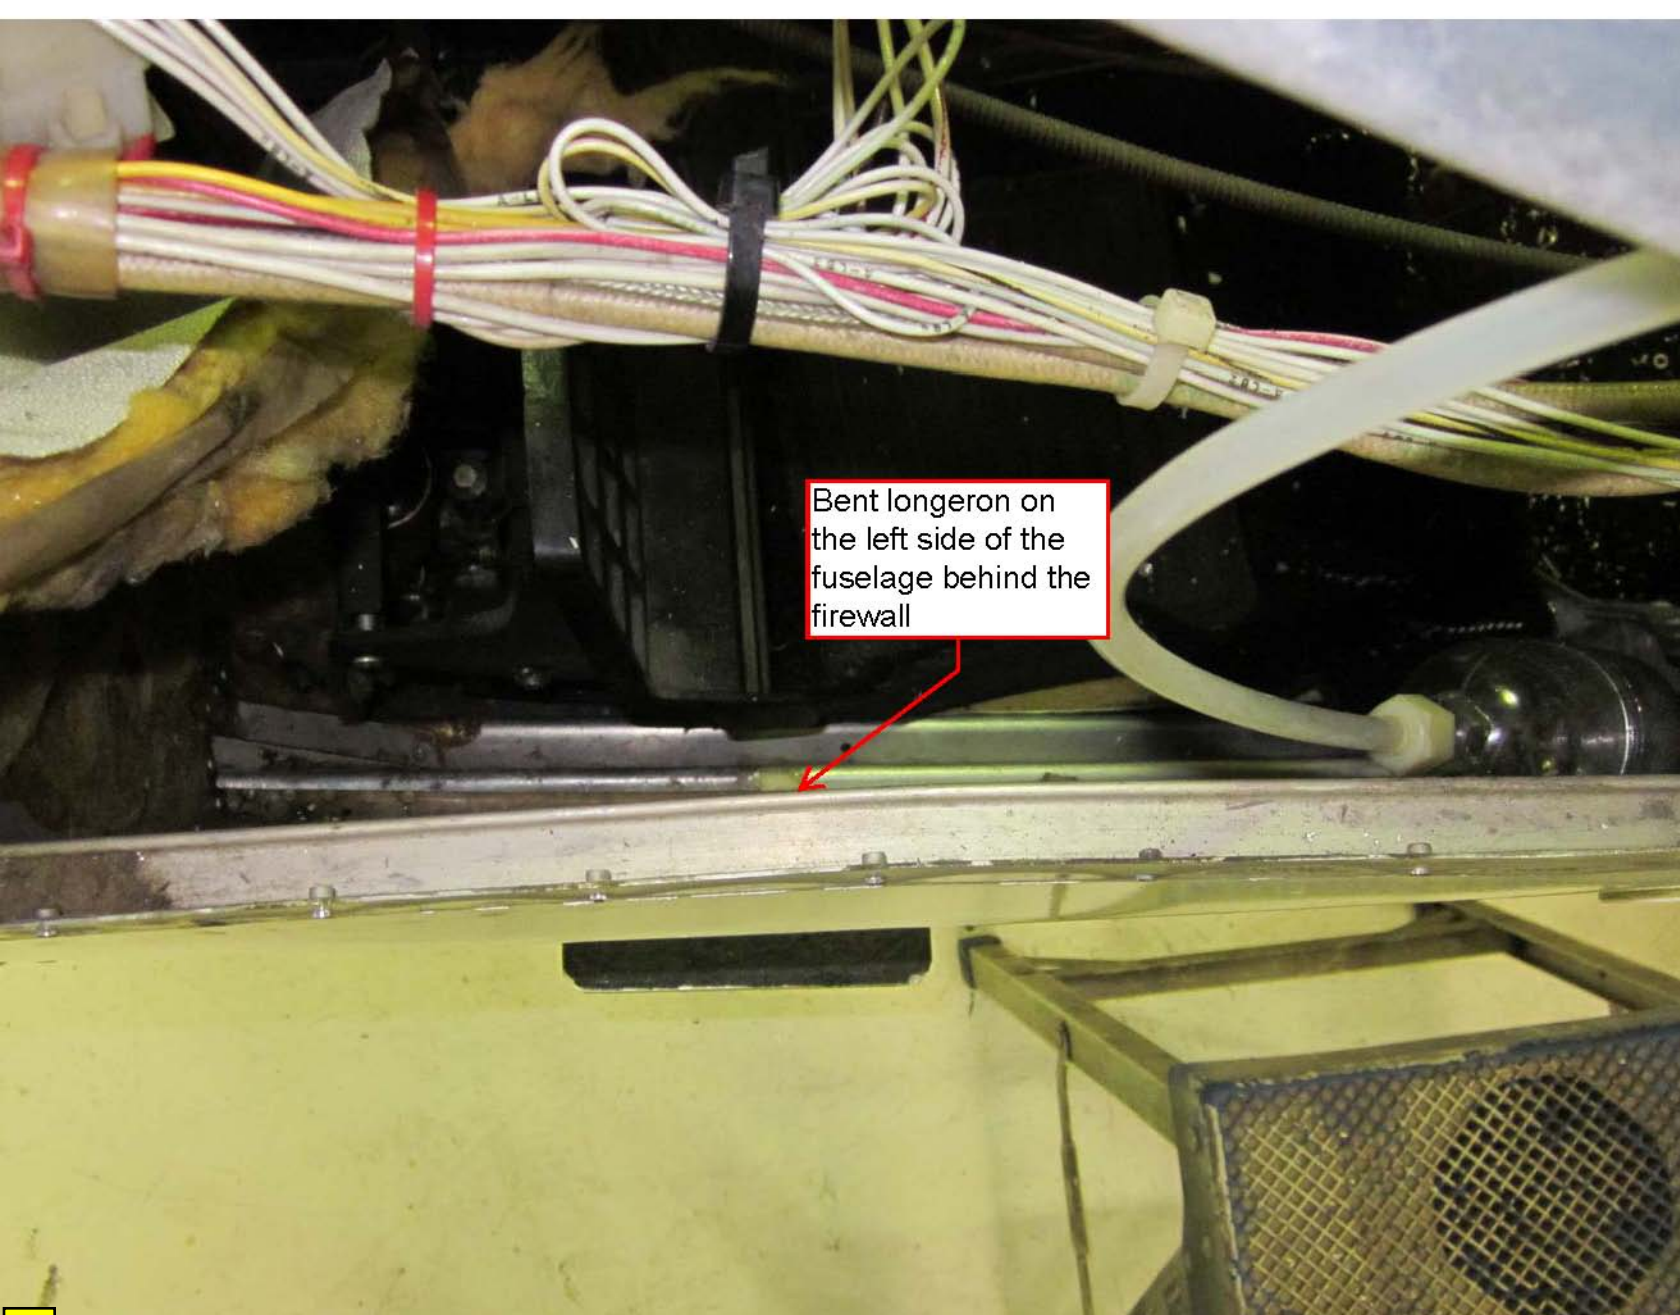
Photo 3. Bent Longeron Left Side (Provided by FAA)

Bent longeron on  
the left side of the  
fuselage behind the  
firewall
