# NATIONAL TRANSPORTATION SAFETY BOARD

## GPS Factual Report

Location: Port Townsend, Washington  
Date: September 28, 2015  
Aircraft: Cessna 150F  
Registration: N8529G  
Operator: Private  
NTSB Number: WPR15FA268

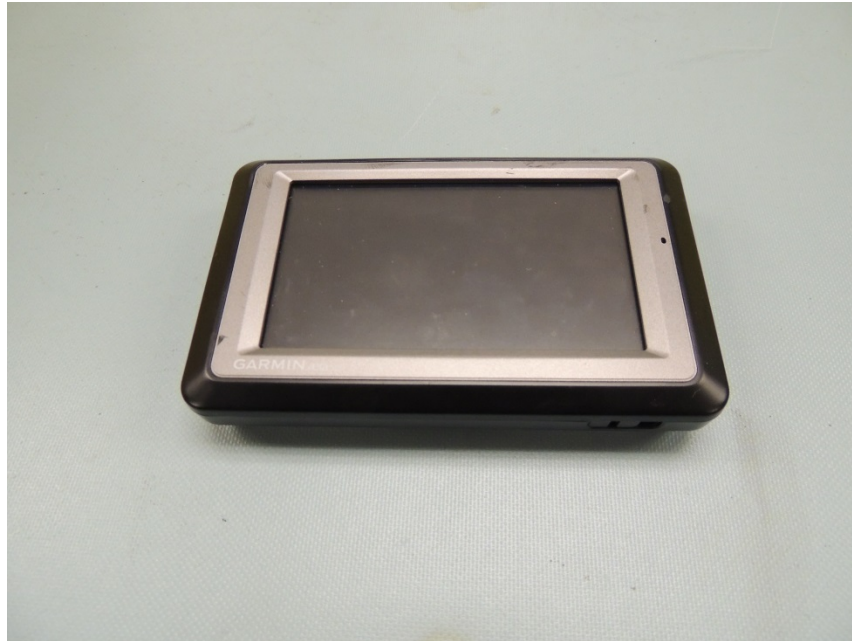
Upon arrival at the Vehicle Recorder Laboratory, an exterior examination revealed no substantial impact damage was sustained (figure 1). The unit was powered on and the memory was downloaded using the manufacturer's recommended procedure.

Figure 1. Photo of Garmin Aera 500 as received.

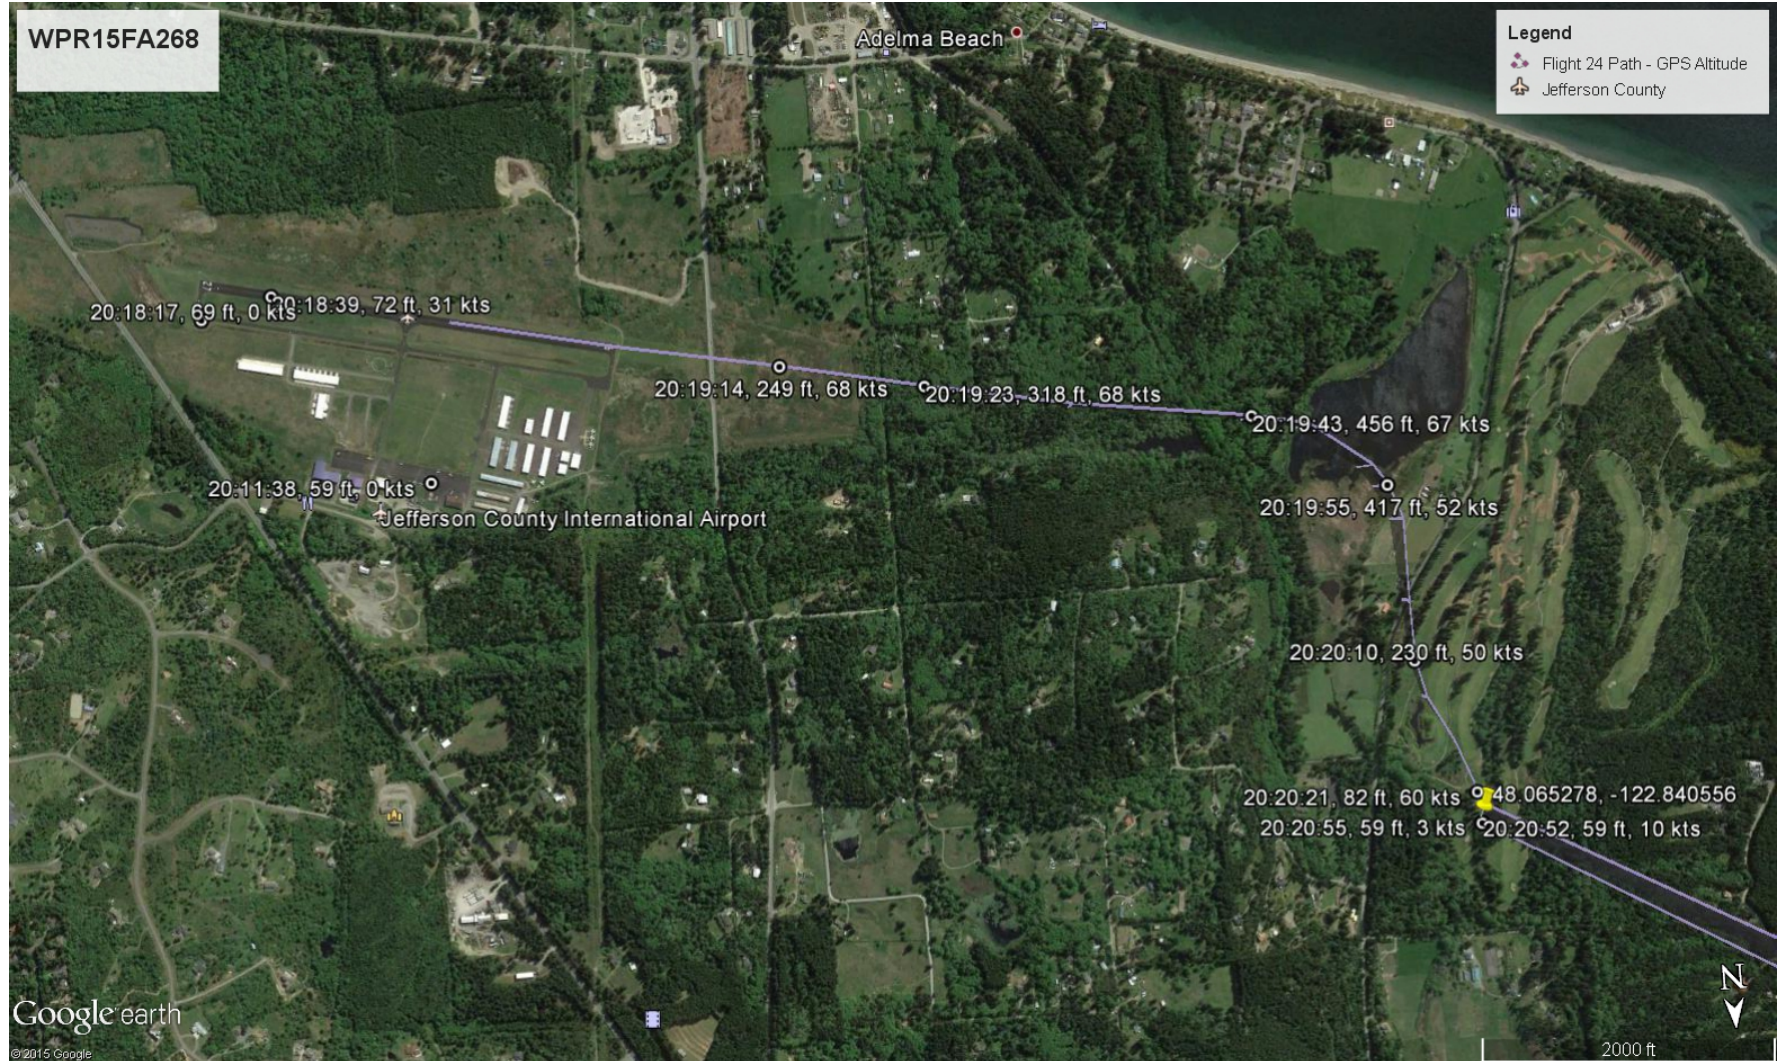
Figure 2 contains the recorded event flight spanning from the first and last recorded data points at 20:11:38 and 20:20:55 UTC, respectively. A yellow marker near the last recorded data point indicates the wreckage location, as provided by onscene investigators. Figure 3 is a side view of figure 2 that details the flight path of the event flight.

Figure 2. Top view of event flight.

The overlay shows that the aircraft began its take off from Jefferson County airport at 20:18:17 UTC. At 20:19:43 UTC, the aircraft began a descent continuing until the last recorded data point. At 20:20:41 UTC, an altitude of 214977 ft was recorded. This large value is consistent with errors induced from impact forces.

Tabular data used to generate figures 2 and 3, along with data not plotted from the previous flight, are included as Attachment 1. This attachment is provided in electronic comma-delimited (\*.CSV) format.

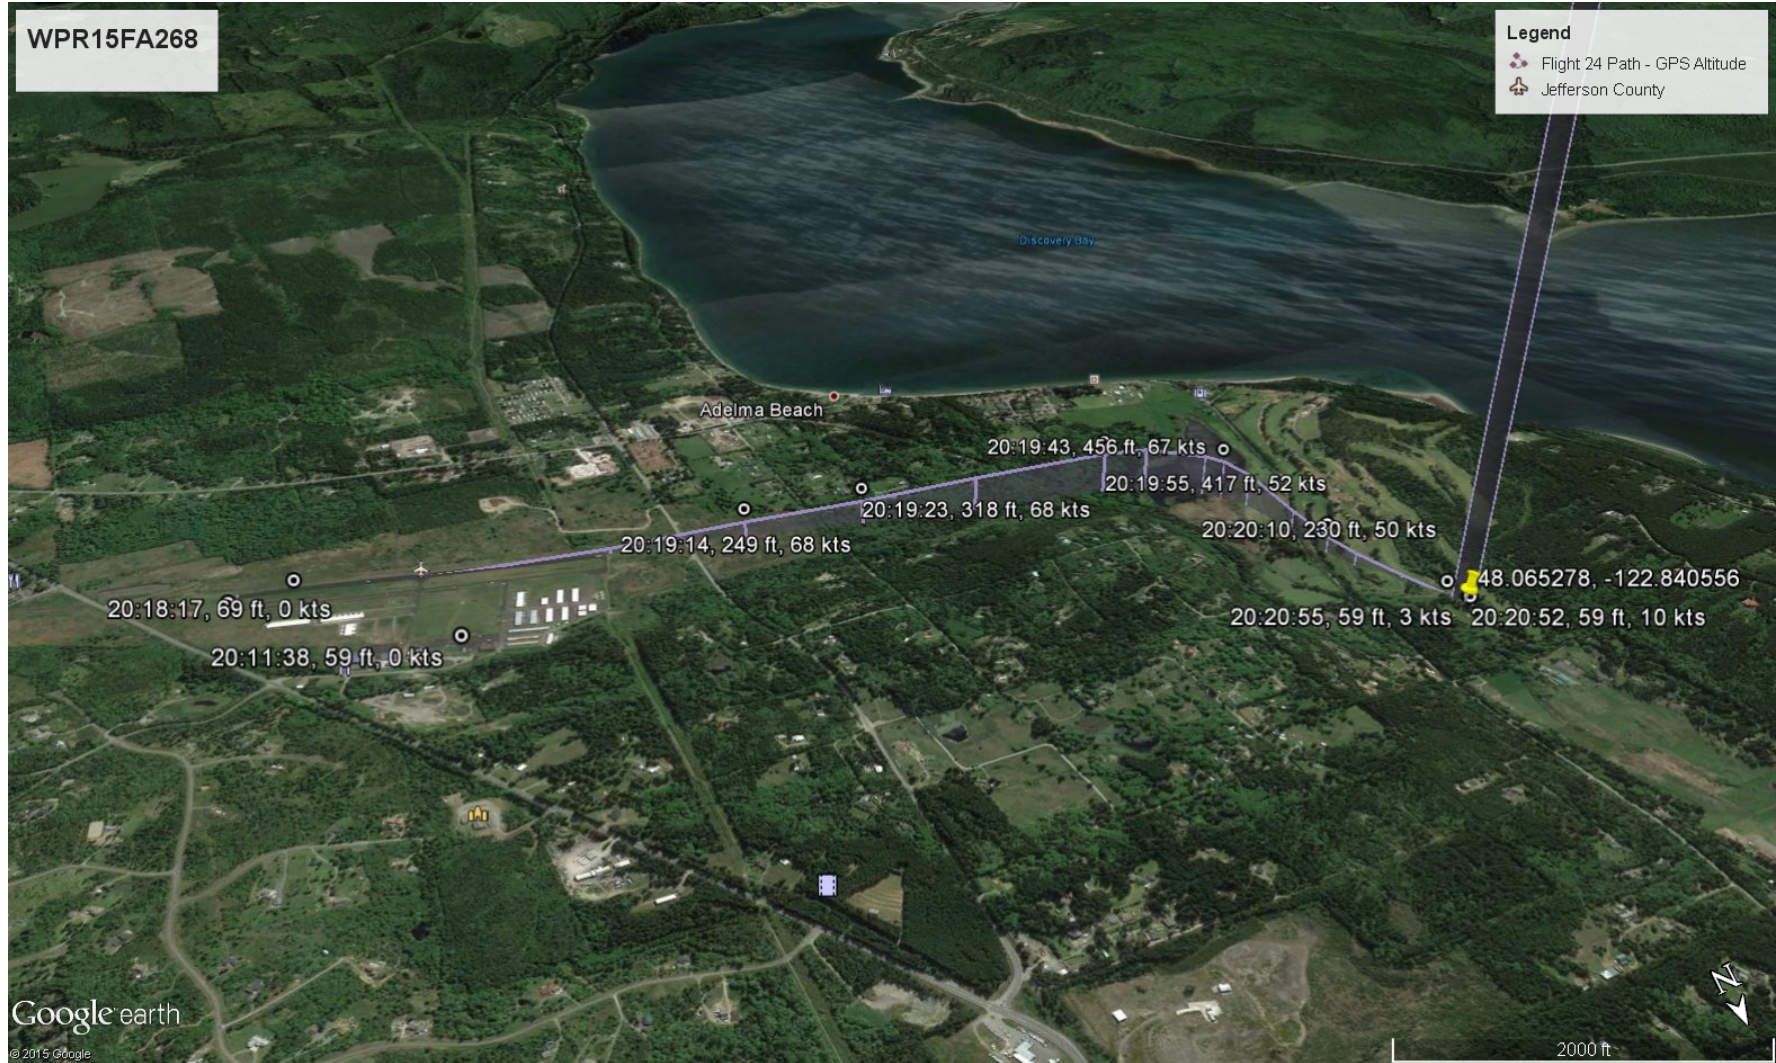
Figure 3. Side view of event flight.
