# NATIONAL TRANSPORTATION SAFETY BOARD

## Recording Devices

Specialist's Factual Report  
By Ben Hsu

Location: Sierraville, California  
Date: April 17, 2017  
Aircraft/ID: Socata TB-20 Trinidad / N28070  
Operator: Private  
NTSB Number: WPR17FA105

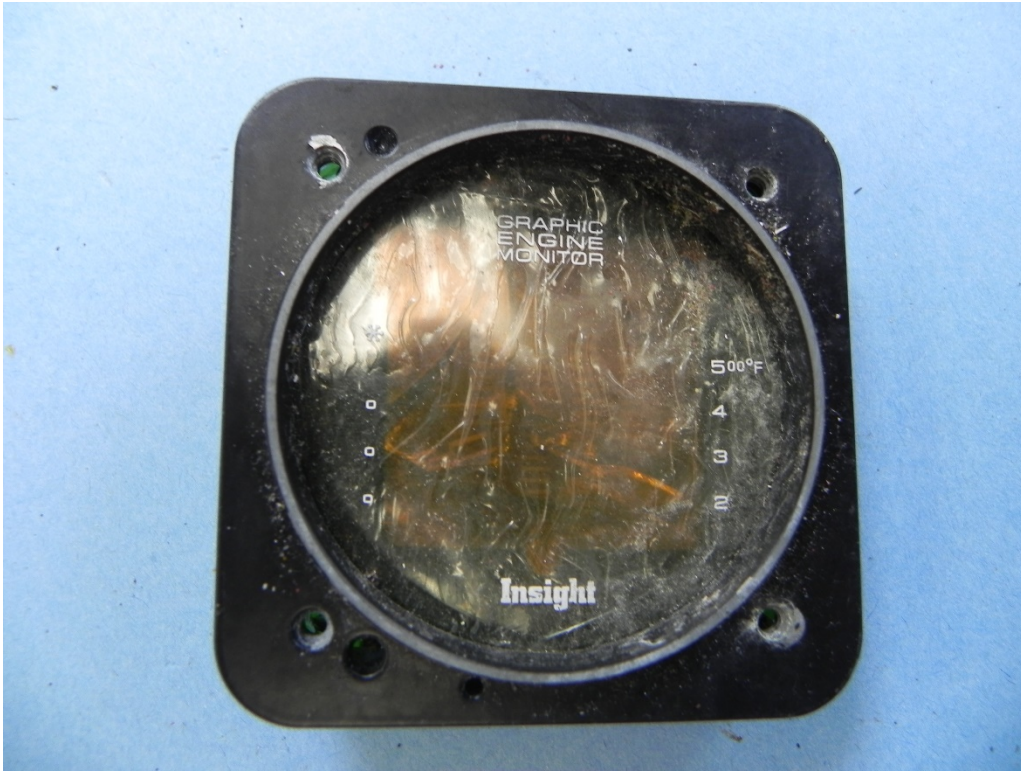
**Figure 1. Insight GEM**

Figure 1 shows the Insight GEM device as it arrived in the laboratory. Only the display portion of the device was recovered from the accident. No data storage components were recovered.

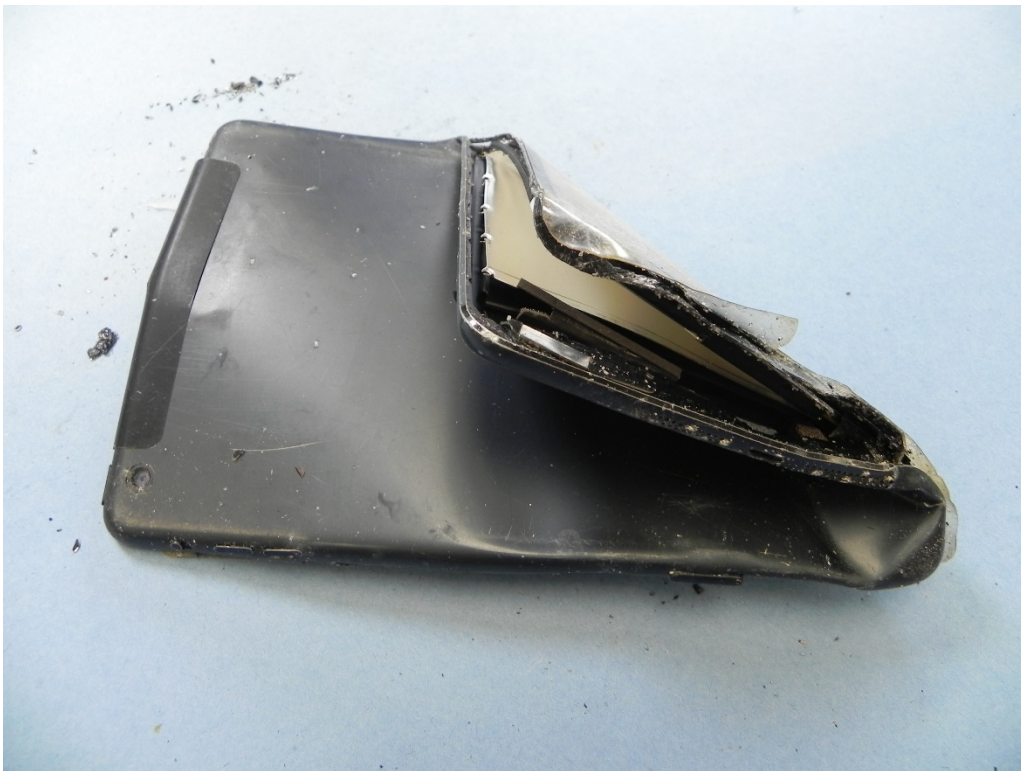
**Figure 2. iPad Mini**

Figure 2 shows the first iPad Mini as it arrived in the laboratory. Due to the damage, no data could be recovered from the device.

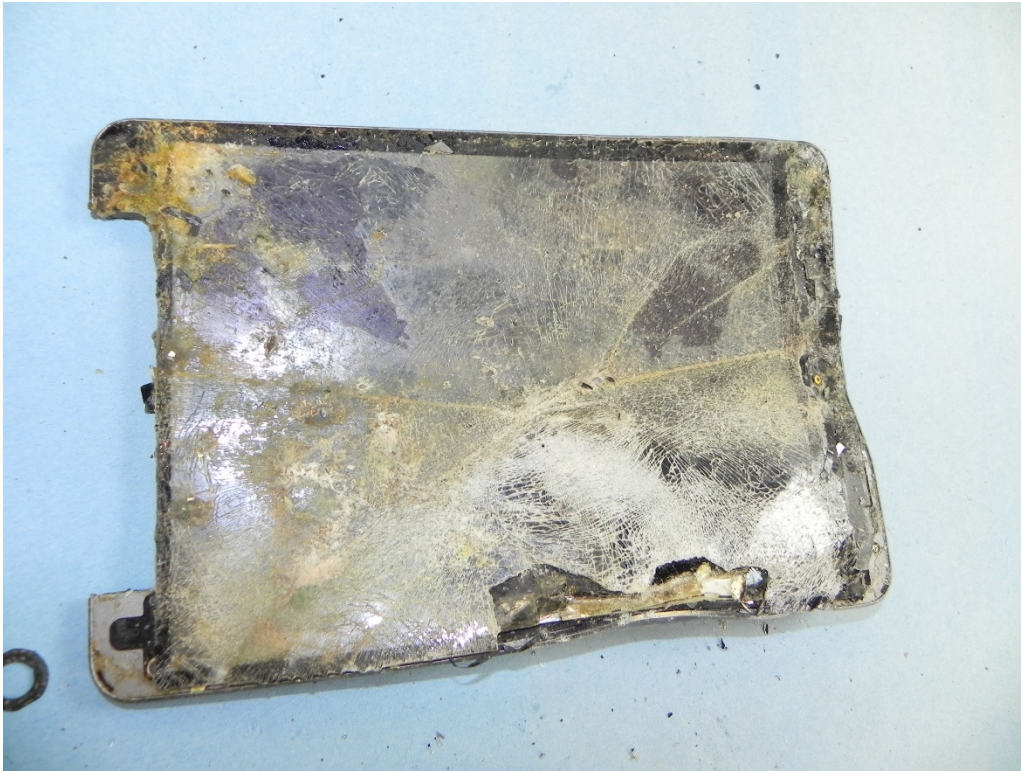
**Figure 3. iPad Mini**

Figure 3 shows the second iPad Mini as it arrived in the laboratory. The device's internal circuit board was placed in a surrogate unit, power was applied, and startup was consistent with normal behavior. The device was protected with a passcode. The NTSB Investigator-In-Charge (IIC) provided possible passcodes for the device, however, none were successful. No data was recovered from the device.

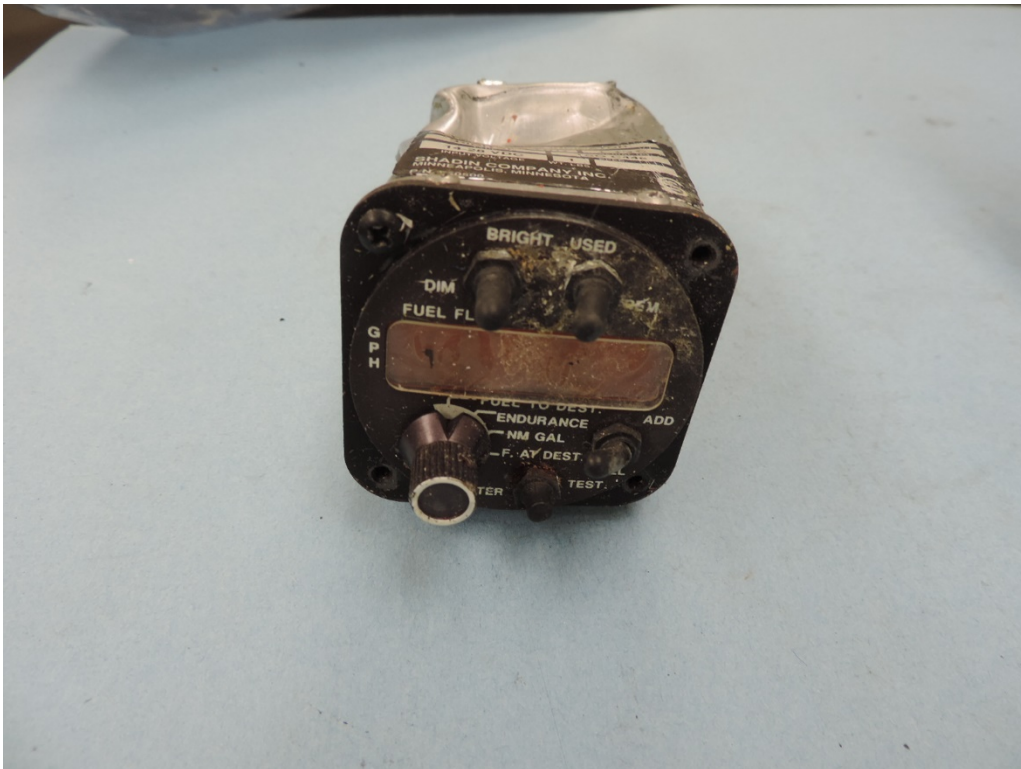
**Figure 4. Shadin Fuel Flow Indicator**

Figure 4 shows the Shadin Fuel Flow Indicator as it arrived in the laboratory. Due to the damage, no data could be recovered from the device.

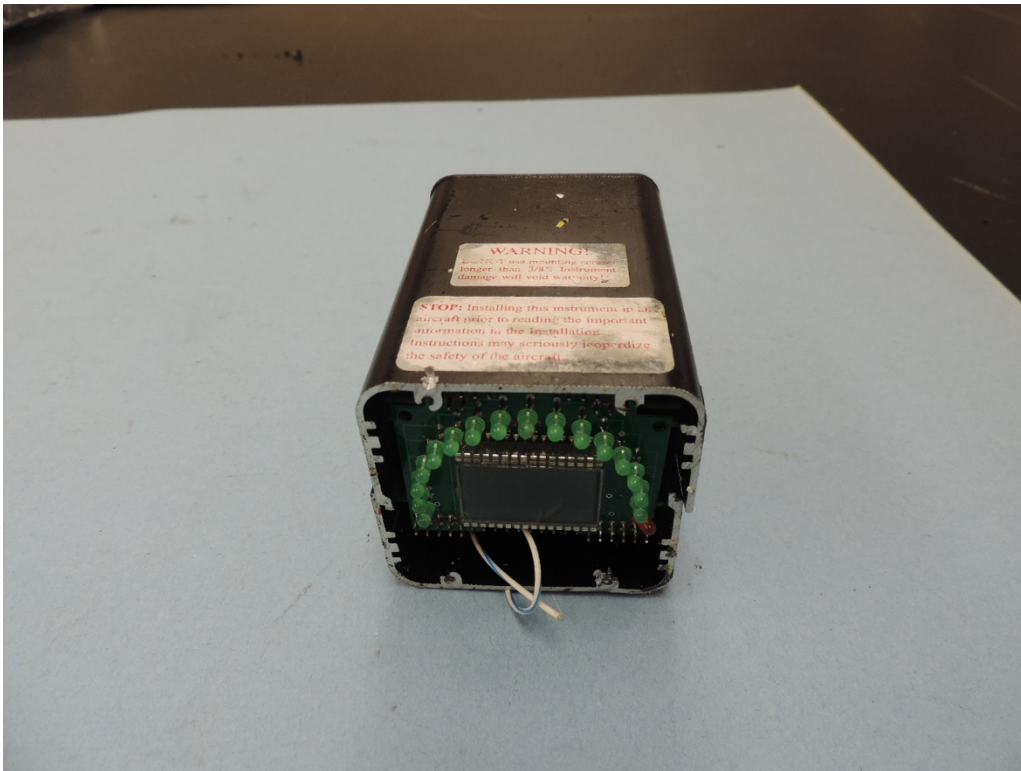
**Figure 5. Electronics International R-1**

Figure 5 shows the Electronics International R-1 device as it arrived in the laboratory. Due to the damage, no data could be recovered from the device.
