## MAPS AND DIAGRAMS

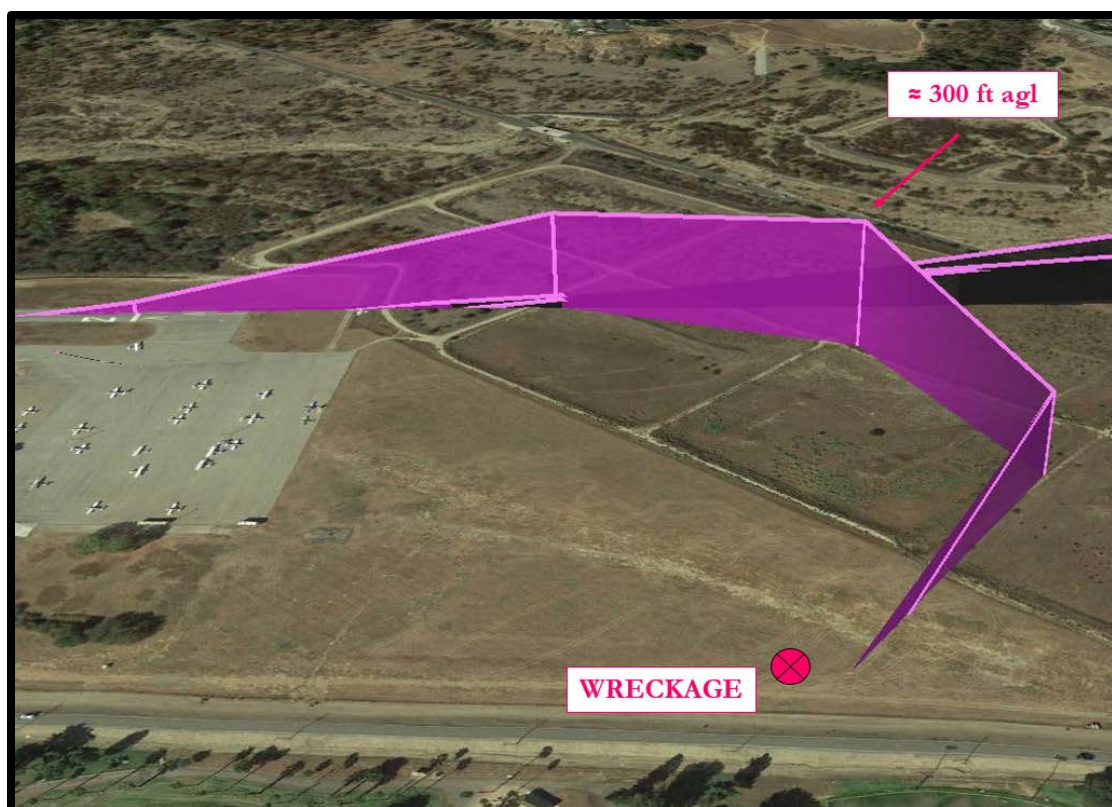
Picture 04: Accident Takeoff (reference to accident site)

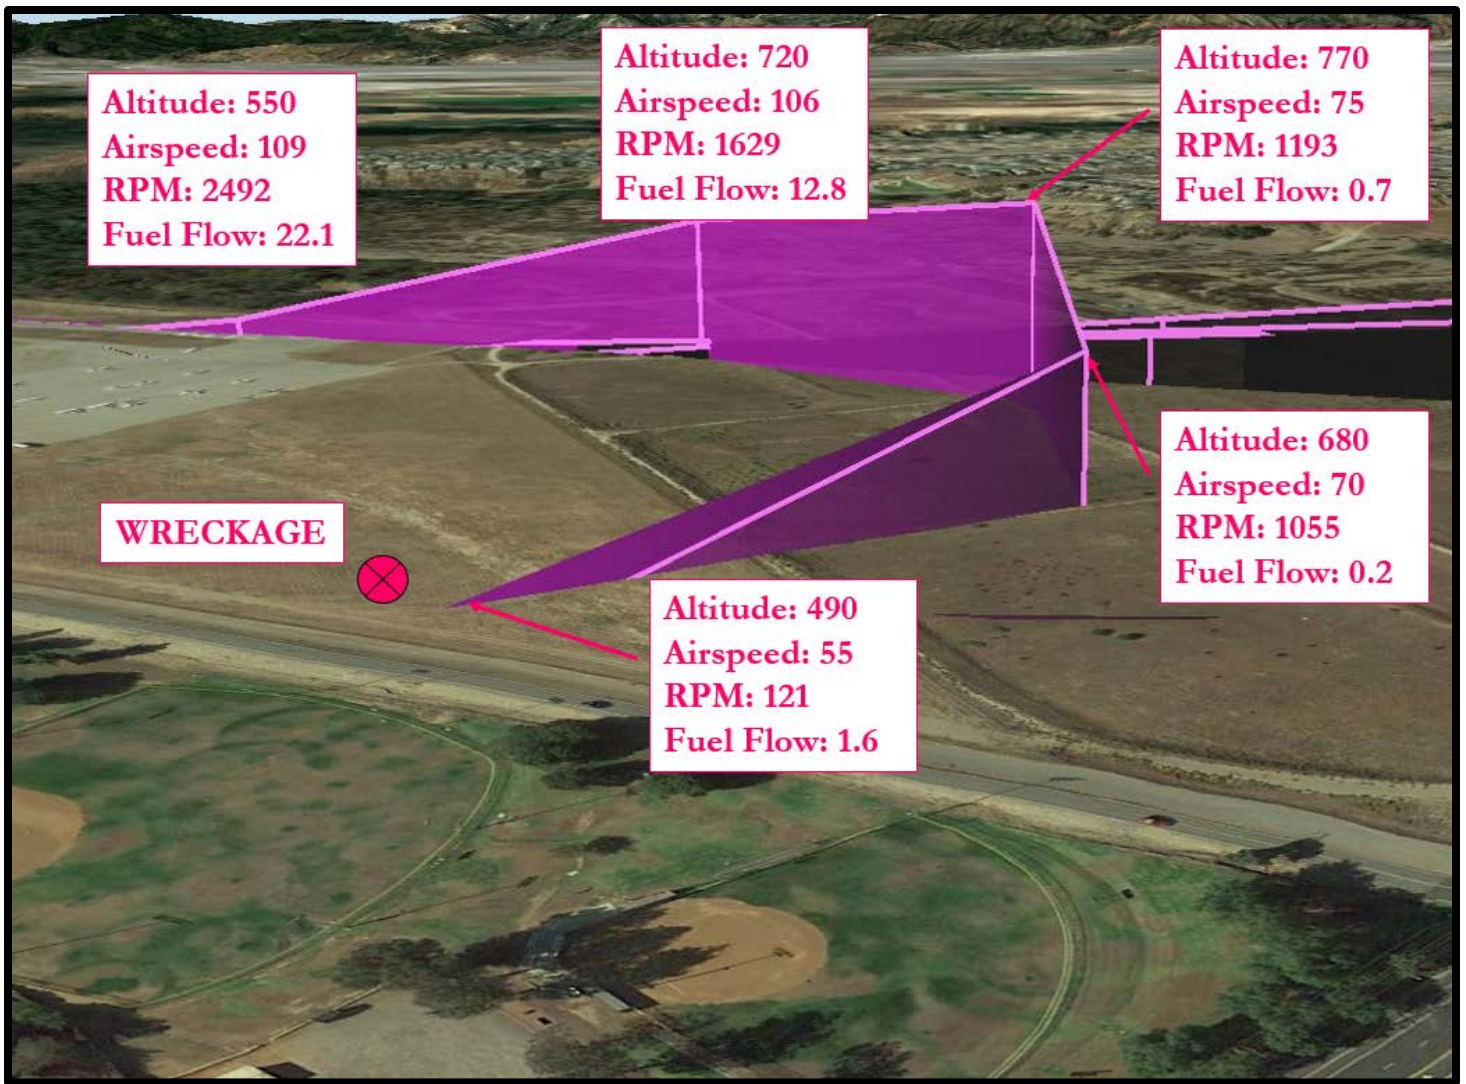
Picture 05: Accident Flight (showing parameters)
