# NATIONAL TRANSPORTATION SAFETY BOARD

## MATERIALS LABORATORY FACTUAL REPORT

Report No. 18-036

Place : San Diego, California  
Date : December 12, 2017  
Vehicle : Beech A36, N248SB  
NTSB No. : WPR18FA046  
Investigator : Maja Smith, AS-WPR

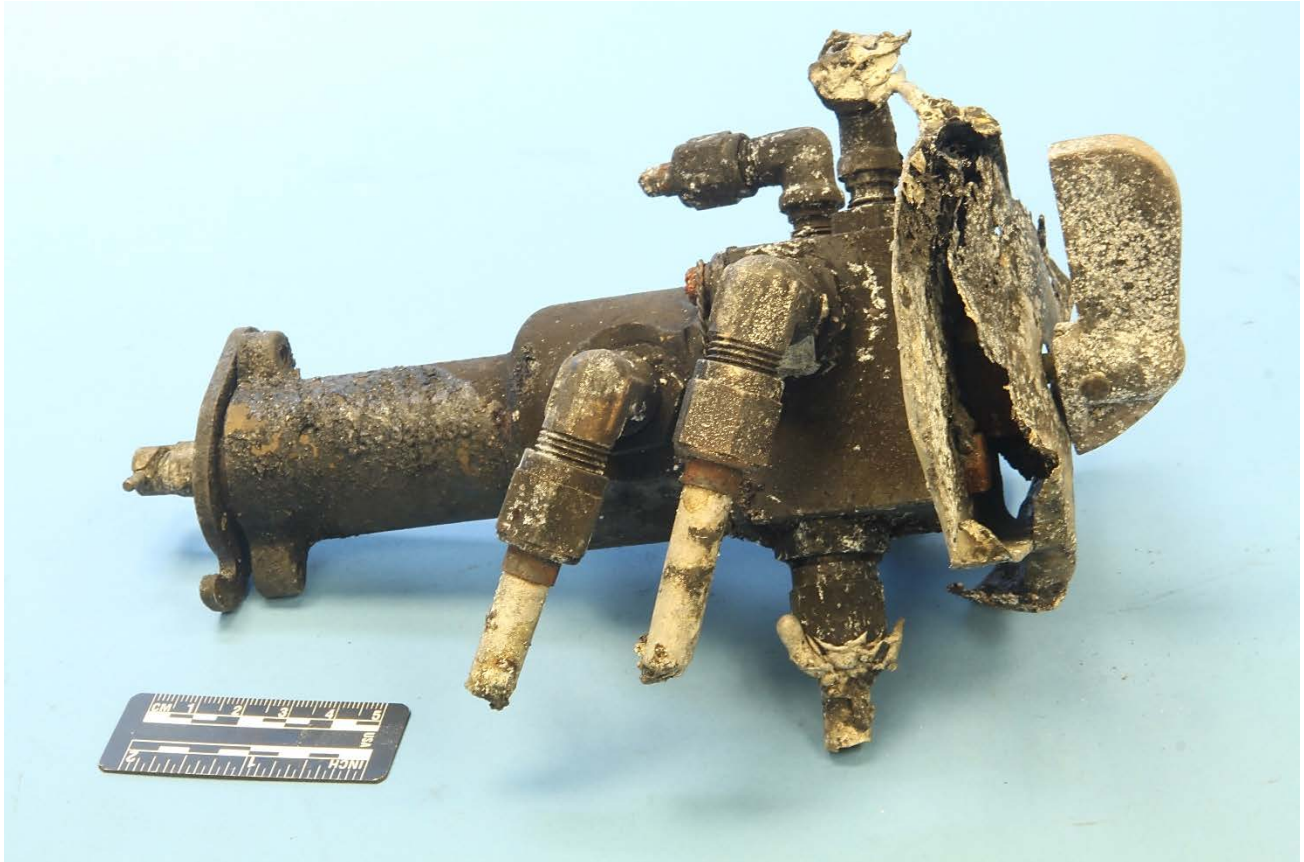
Figure 1 shows a photograph of the as-received fuel selector valve. The fuel selector valve was covered with black soot and the ends of various tubes had solidified consistent with exposure to heat from a fire. The exterior portion of the valve was rubbed with the end of a cotton swab. The end of the cotton swab was subjected to a phenolphthalein presumptive blood test.<sup>1</sup> The test produced a positive result, indicating the presence of blood.

Figure 1. Photograph of the as-received fuel selector valve.
