## PHOTOGRAPHS

# RECORDS

MAKE: Cessna  
MODEL: P210n  
S/N: P21000407  
REG. NO: 7546K  
WORK ORDER:  
3253-10-2010

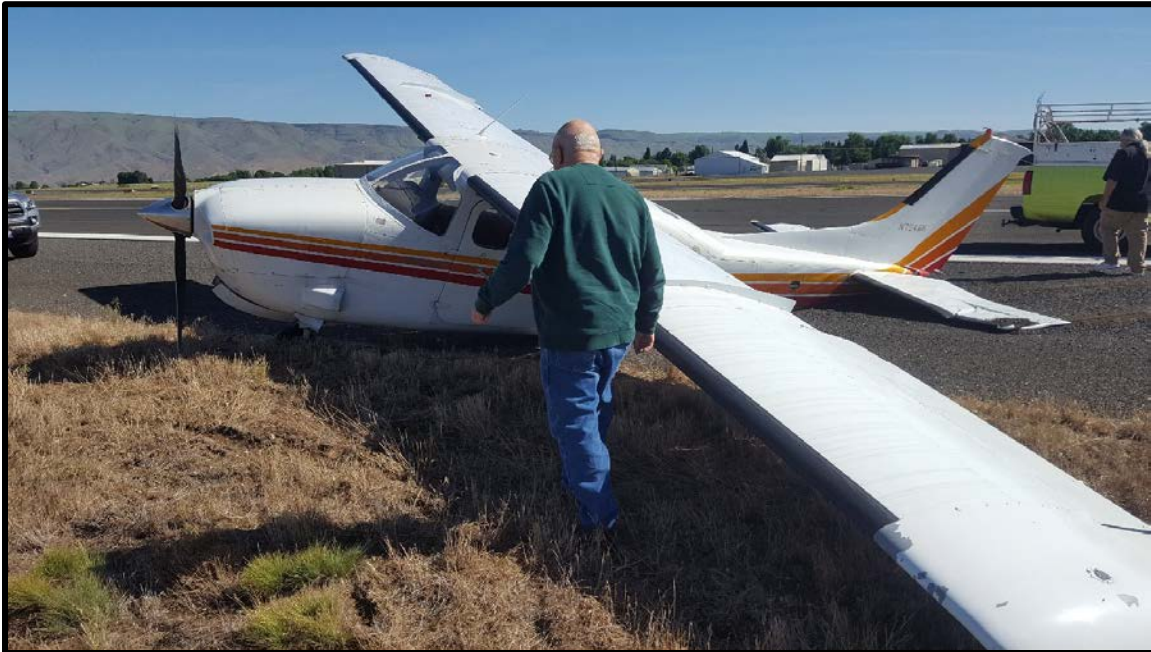
*Figure 1: Airplane on Side of Runway*

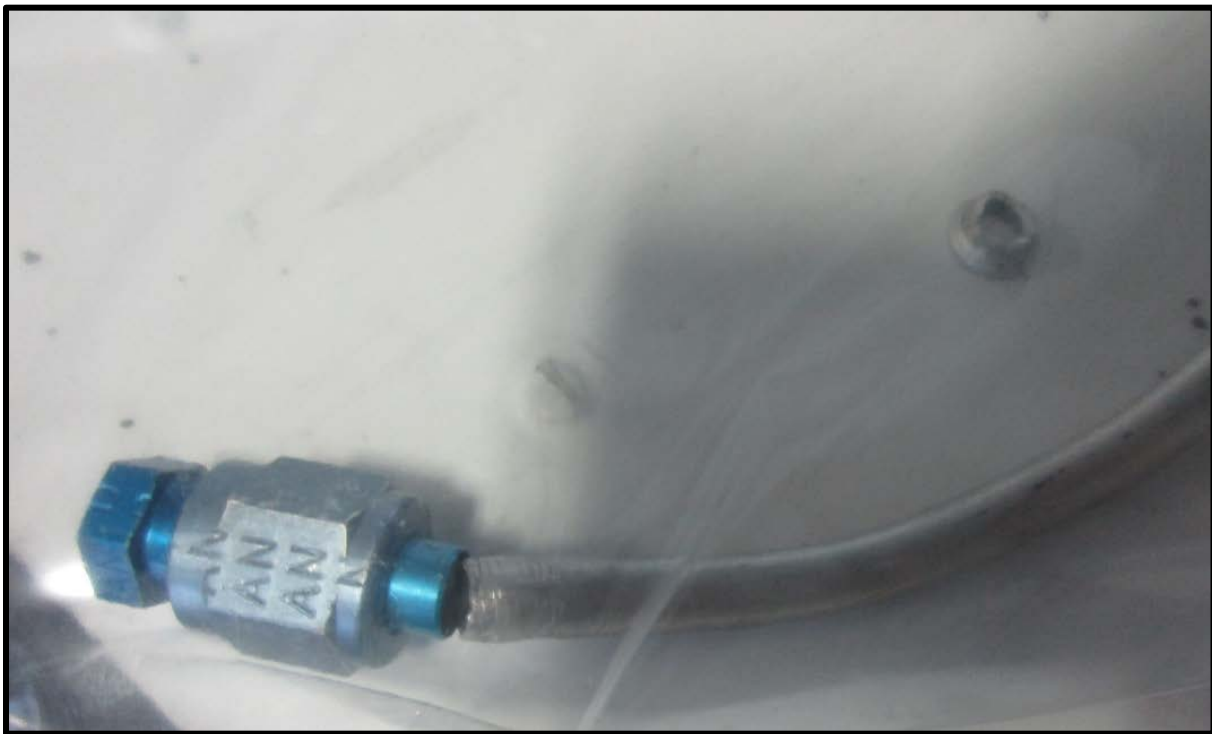
*Figure 2: Fuel Line*
