## Air Safety Investigations Aircraft Incident/Accident Technical Report

| <b>Aircraft Incident/<br/>Accident Information</b> | Year: 1980 | Make: Cessna | Model: 172N |
| | Serial number: 17273825 | | Registration: N5660J |
| Location: Afton, WY | | Date: 08-13-18 | Time: 0908 MDT |

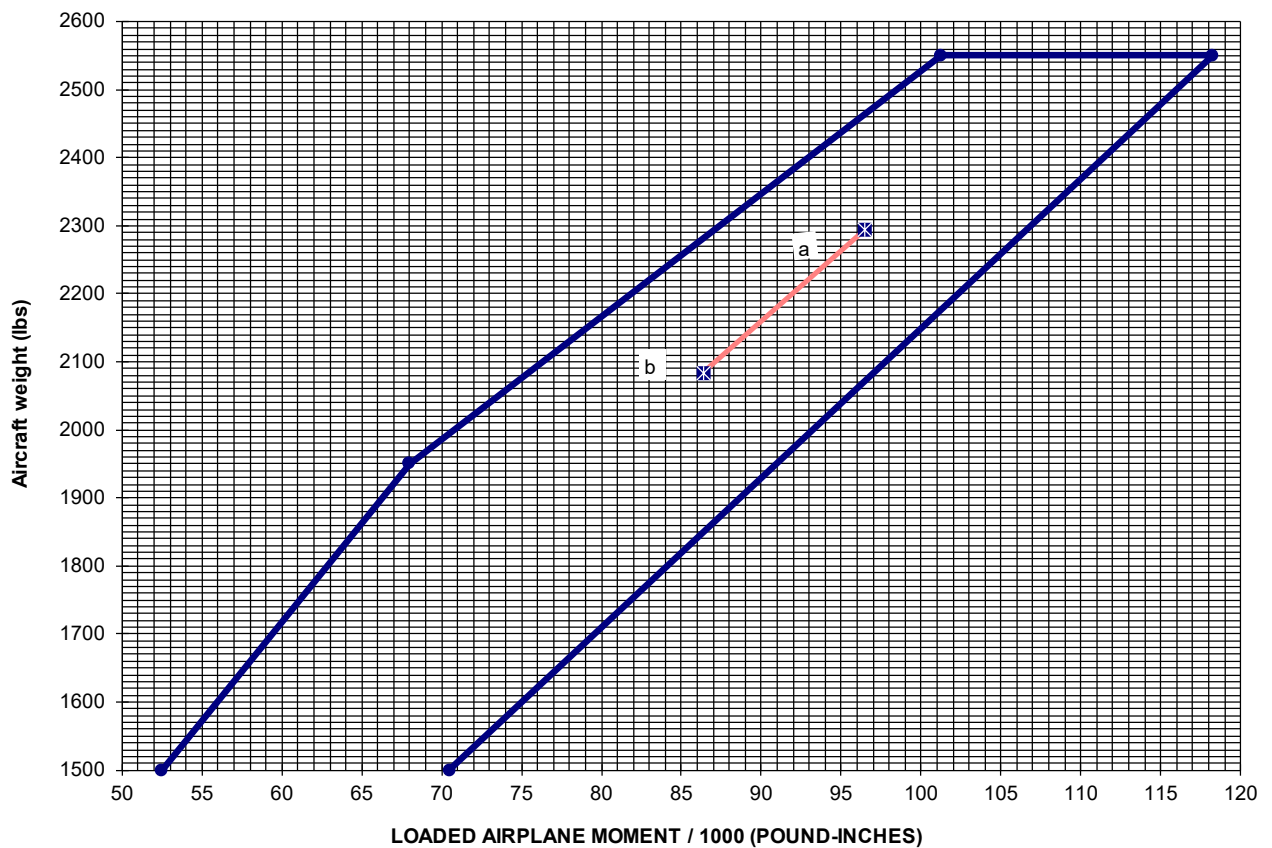
**CENTER OF GRAVITY MOMENT ENVELOPE WORKSHEET**

| | wt | arm | mom/1000 | C.G. |
|---|---|---|---|---|
| <b>Total Wt.</b> | <b>2294</b> | <b>42.05</b> | <b>96.5</b> | <b>42.1</b> |

**PLOT DATA**

| Envelope | | Actual Data | |
|---|---|---|---|
| 52.5 | 1500 | 96.5 | 2294 a |
| 68 | 1950 | 86.4 | 2084.0 |
