**DOT/FAA/AR-09/49**

# **Detection and Prevention of Carbon Monoxide Exposure in General Aviation Aircraft**

October 2009

Final Report

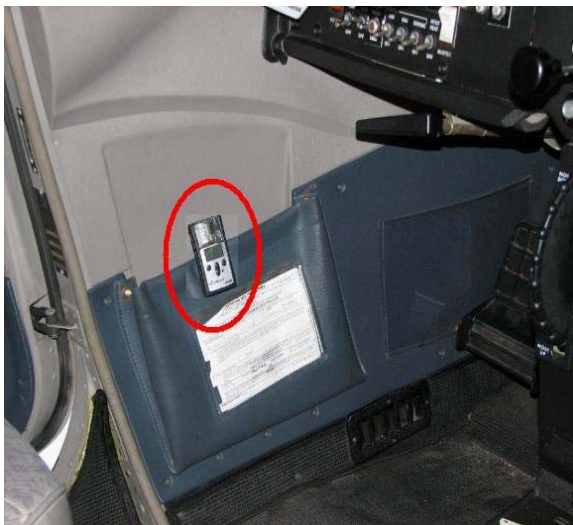
Figure B-2. Carbon Monoxide Detectors Attached to the Left-Door Pocket (a) and Right-Door Pocket (b) With Suspender Clips
