## MEMORANDUM FOR RECORD

**Weather Report – Madras Municipal Airport (S33), Madras, Oregon**  
**Date & Time: July 22, 2019; 1300 PDT**  
**NTSB Accident Number: WPR19LA198**

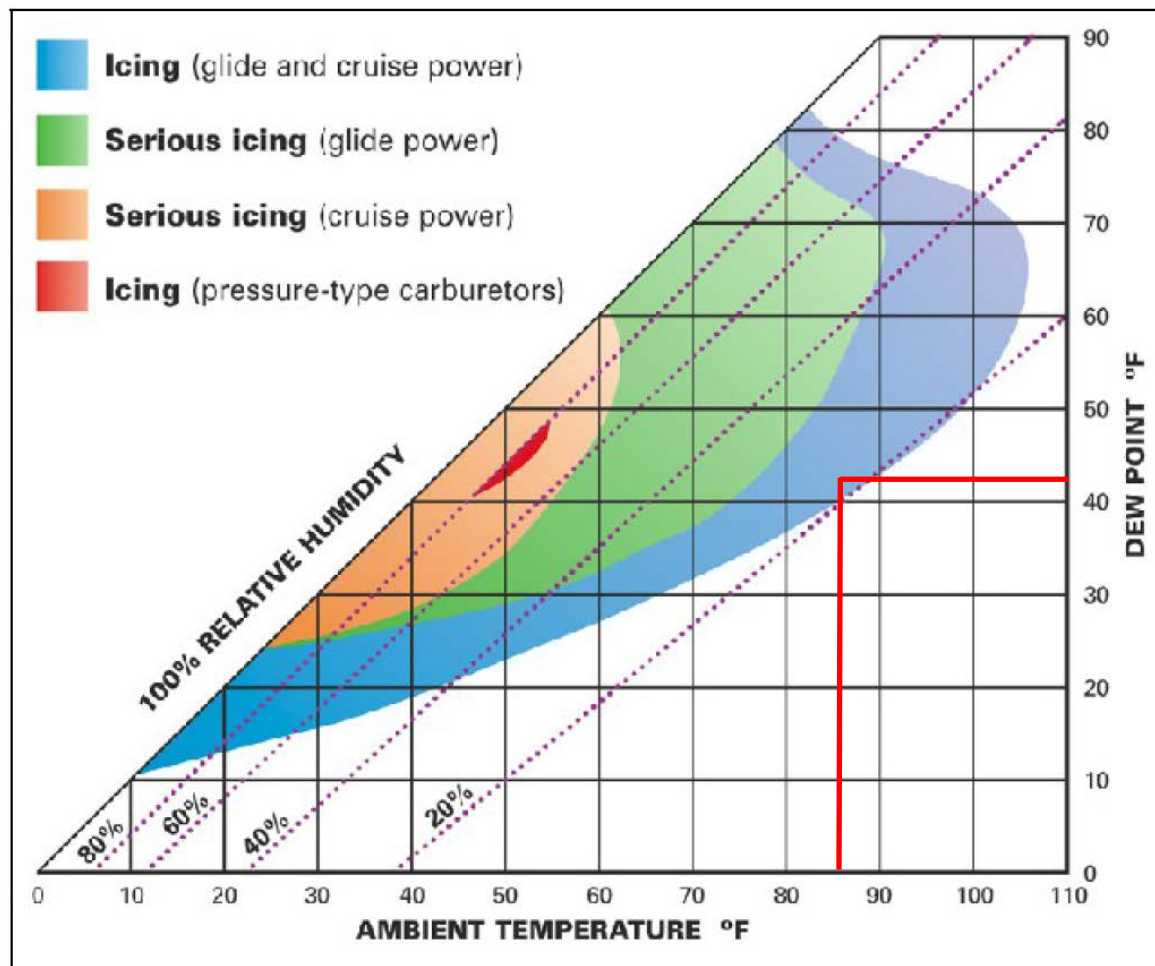
FAA SAIB CE-09-35 included a chart to determine the probability of carburetor icing. The plot below was based on the temperature and dewpoint at the time of the accident, 1955 UTC/1255 PDT, 86° F outside temperature, 43° F dewpoint.
