## SERVICE INSTRUCTION

# Purging of lubrication system for ROTAX® Engine Type 916 i (Series), 915 i (Series), 912 i (Series), 912 and 914 (Series)

ATA System: 79-00-00 Lubrication system

Purging of lubrication system for ROTAX® Engine Type 916 i (Series), 915 i (Series), 912 i (Series), 912 and 914 (Series).

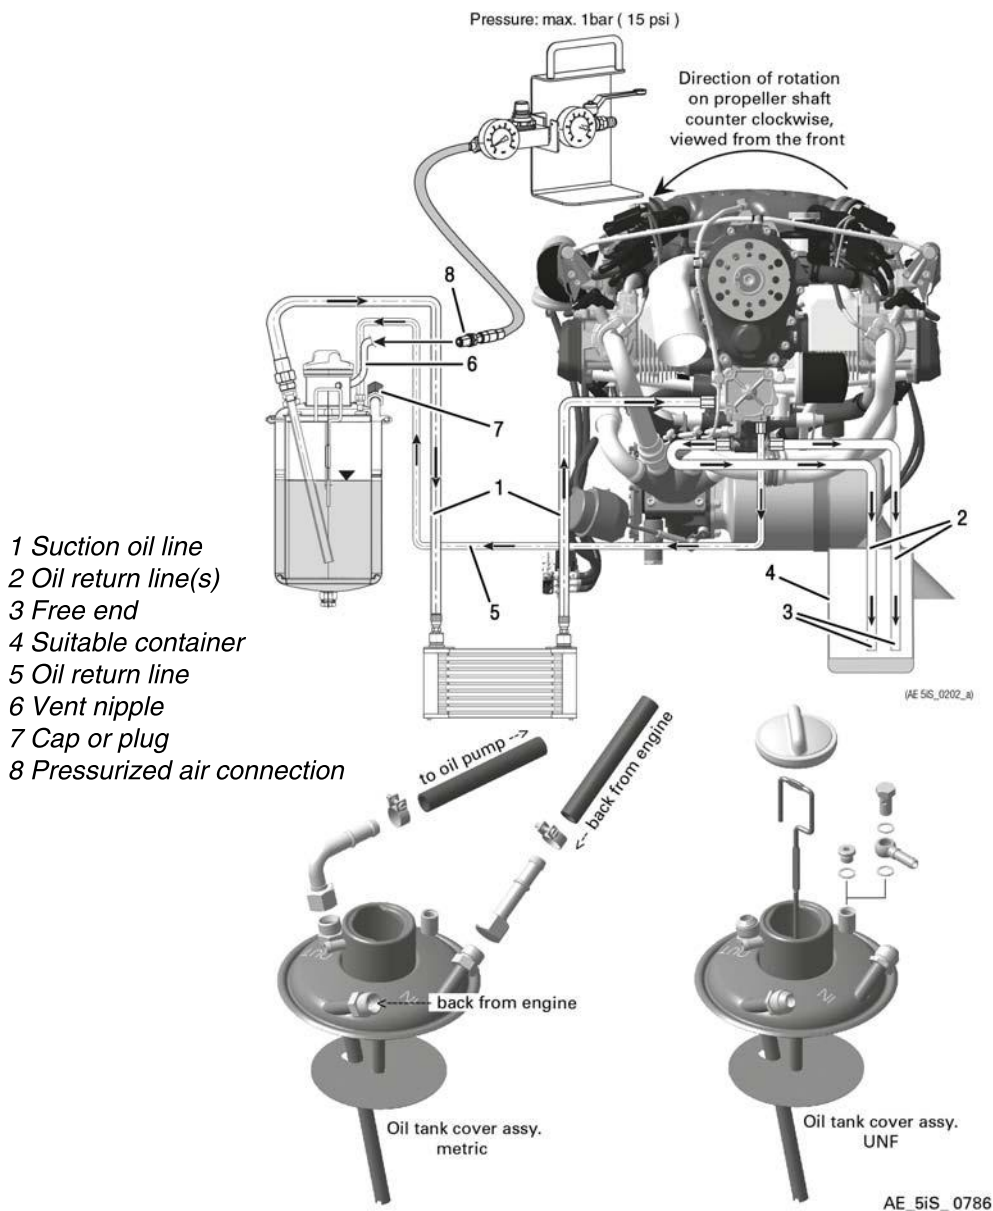
Fig. 1

Purging of oil system (916 i and 915 i Series)

- Verify that oil tank connections are connected correctly and secured, and that the oil cooler (if fitted) is in the suction line (pos. 1 on Fig. 1) between the oil tank and the oil pump inlet. Verify that the oil tank is filled up to the maximum level (to the top of the flat portion of the dipstick). Additional oil (up to 0.5 liter) may be added to the tank for the purpose of this procedure.

| Step | Procedure |
|---|---|
| 1 | Disconnect oil return line(s) (pos. 2 on Fig. 1) from the oil tank (915 i and 916 i: two return lines).<br><b>NOTE:</b> Do not disconnect the turbo scavenge return line. |
| 2 | Place the free end (915 i and 916 i with two free ends) (pos. 3 on Fig.1) of the return oil line into a suitable container (pos. 4 on Fig. 1) below the engine.<br><b>NOTE:</b> This step is a cleanliness precaution. Typically, during the purging procedure, oil does not come out from the hoses. |
| 3 | Plug open connection (pos. 7 on Fig. 1) (915 i and 916 i with two connections) on oil tank with suitable air tight cap or plug. |

| Step | Procedure |
|---|---|
| 6 Optional: | This step assists in the purging procedure but may be skipped if compressed air is not available. The procedure may take longer without air pressure.<br>Using a compressed air line, pressurize the oil tank through its vent nipple (pos. 6 on Fig. 1) (on the neck of the tank). Adjust the compressor outlet regulator so that the air line pressure is between 0.4 (5.8 psi) and 1 bar (15 psi). Do not exceed 1 bar (15 psi). |

| Step | Procedure |
|---|---|
| 9 | Remove the cap(s) (pos. 7 on Fig. 1) from the oil tank and reconnect the engine oil return line(s) (pos. 5 on Fig. 1) to the tank.<br><div><b>NOTICE</b></div> Ensure that the suction oil line (pos. 1 on Fig. 1) and oil return line(s) (pos. 2 on Fig. 1) are connected to the proper fittings on the oil tank. If the oil lines from the engine to the oil tank are incorrectly connected, severe engine damage may result. |

| Step | Procedure |
|---|---|
| 1 | Disconnect turbo oil return hose (pos. 2 on Fig. 1) from the oil tank (e.g. banjo bolt M10x1x19) and route the line to a separate container. |

| Step | Procedure |
|---|---|
| 4 | Fit the turbo oil return hose (pos. 2 on Fig. 1) on oil tank. See latest Maintenance Manual Heavy (MMH) for the respective engine type or instruction of aircraft manufacturer for ROTAX® 914, 916 i and 915 i Series. |

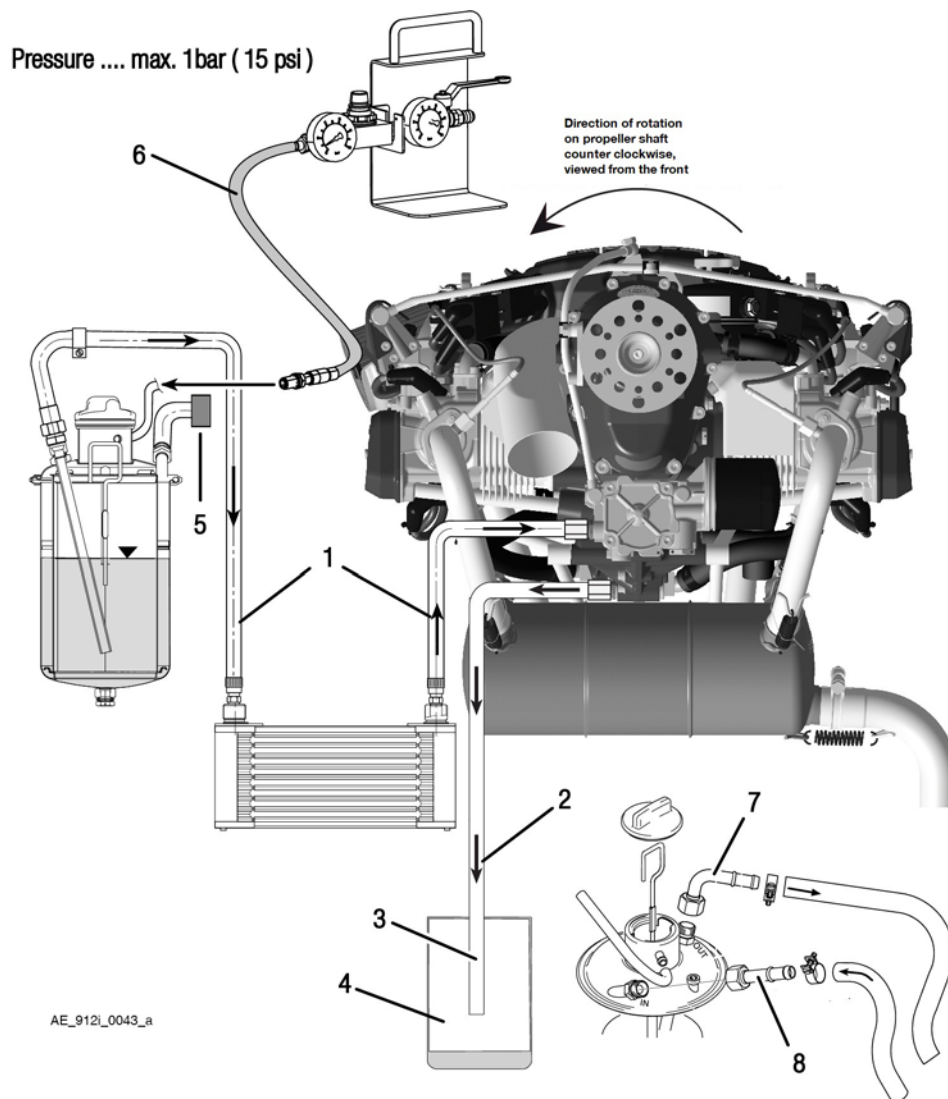
Fig. 2  
 Purging of oil system (912 i Series)

- 1 Suction line
- 2 Oil return line
- 3 Free end
- 4 Suitable container
- 5 Plug
- 6 Pressurized air connection
- 7 To oil pump
- 8 Return from engine

See Fig. 1 to Fig. 4.

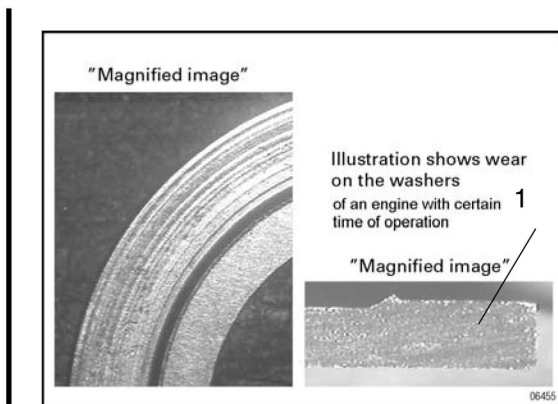
Fig. 6  
 Valve spring support

1 valve spring support  
 2 radial direction

| Step | Procedure |
|---|---|
| 1 | <p>Inspect valve spring support (1). Measure the wear referring to the reference surface (inner area of valve spring support) in radial direction (2) to outer side with a dial gauge. Value <math>t = \max. 0.04 \text{ mm (0.0016 in.)}</math>. See Fig. 6. An exceeding of <math>\max. 0.04 \text{ mm (0.0016 in.)}</math> is not acceptable.</p> <p>NOTE: The valve spring support indicates a possible malfunction of valve train caused by incorrectly or insufficiently purged hydraulic valve tappets. At standard conditions no wear is visible even after a long time of operation. If the visual inspection shows some wear on the valve spring support surface, measure the actual wear with a dial gauge.</p> |

If the valve spring support indicates wear, replace valve spring retainer, valve spring support, both valve cotter pins, valve and hydraulic valve tappet. Additionally perform a detailed visual inspection of relevant valve train components of push rod, rocker arm and valve spring for abnormal wear condition.
