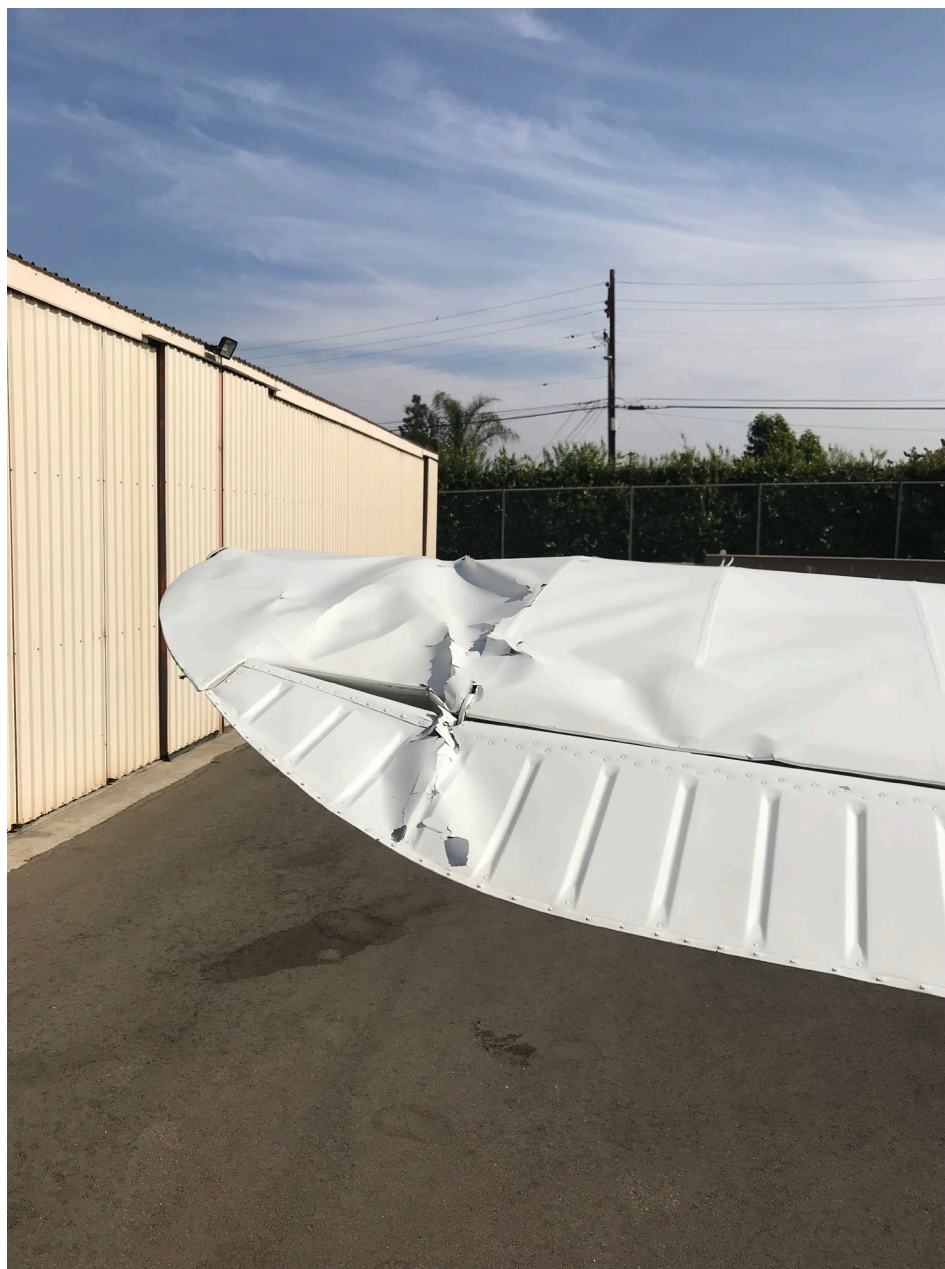
**Photo 1 – View of damage to the left wing and aileron (Courtesy of Pilot)**

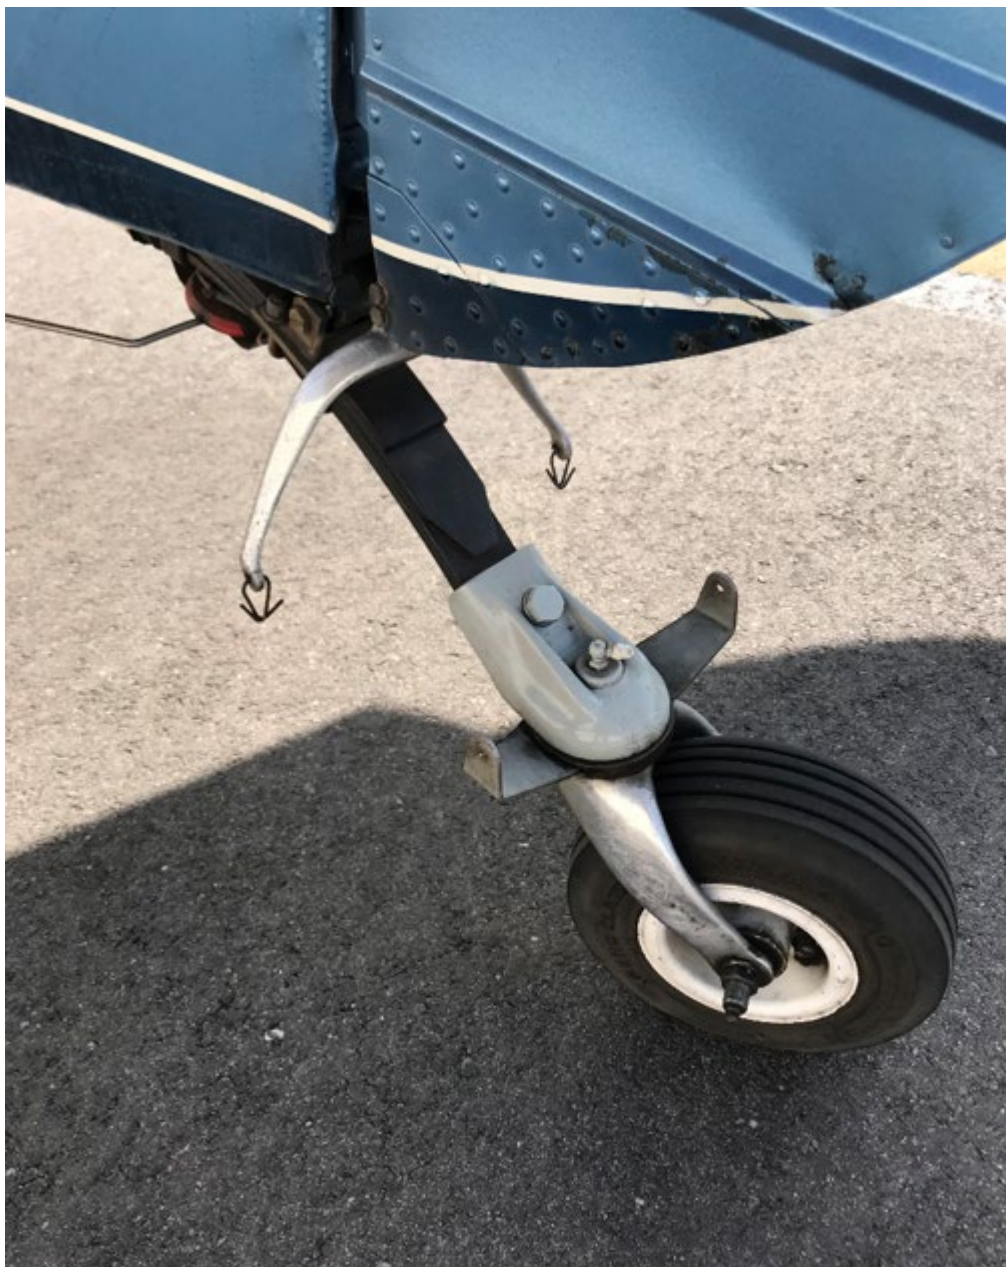
**Photo 2 – View of the post-accident tailwheel steering yoke with connector clips attached (Courtesy of El Monte Airport Operations)**

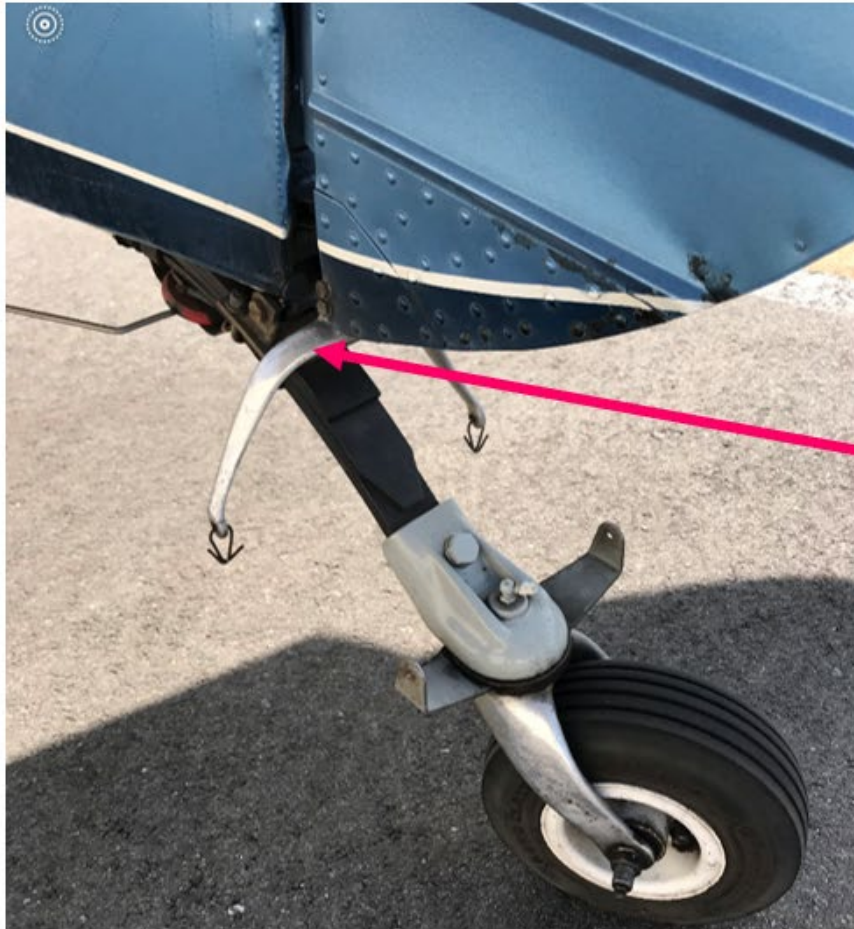
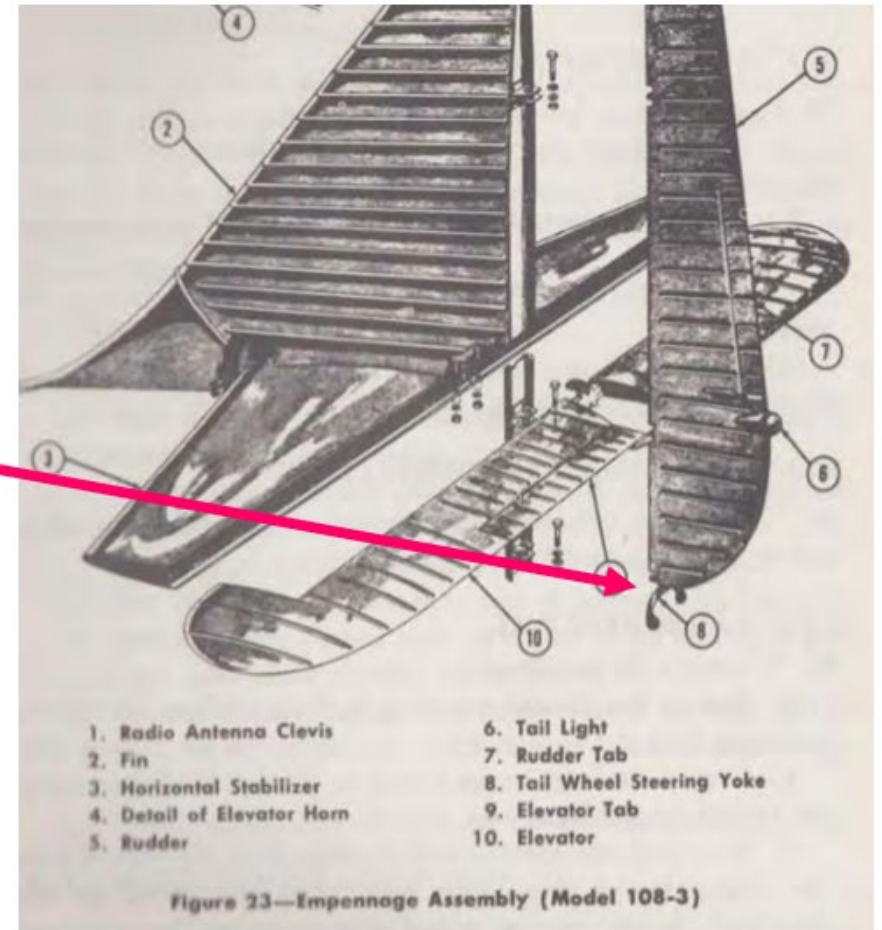
**Photo 3 – View of Stinson 108-3 Tailwheel Steering Yoke Assembly (Courtesy of Manufacturer)**

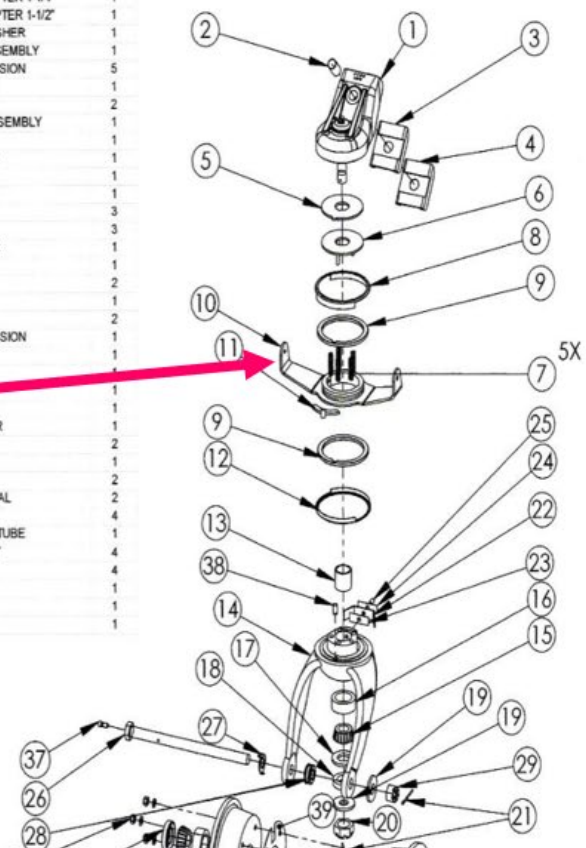
Photo 4 – View of the Stinson 108-3 Steering Arm Assembly (Courtesy of FAA PMA)
