## PHOTOGRAPHS/GRAPHS

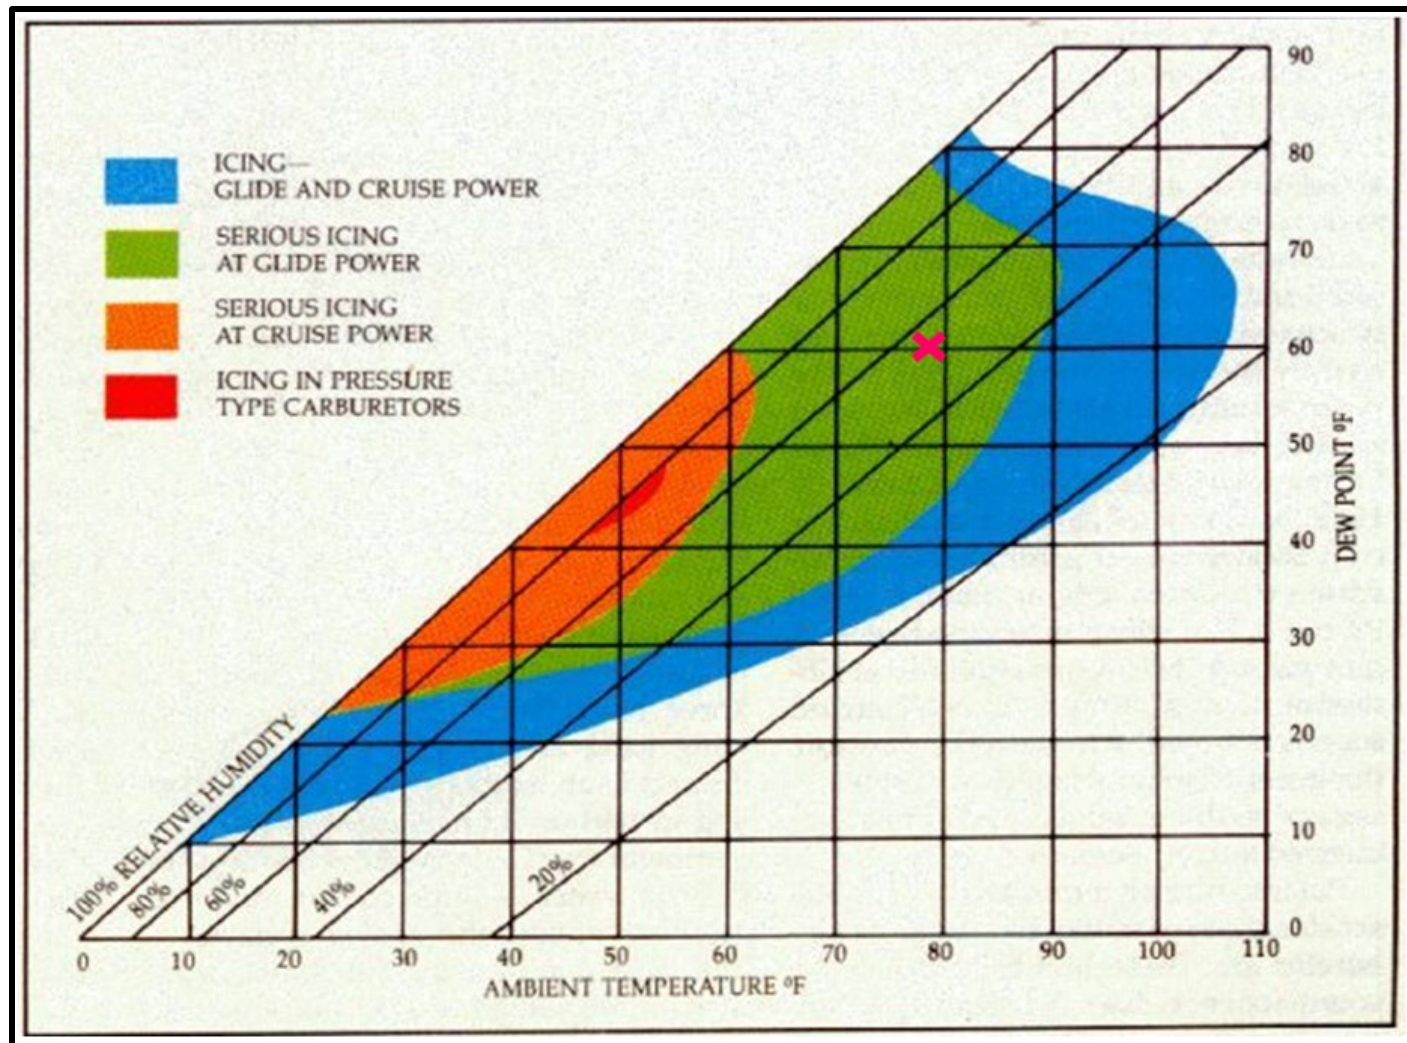
Figure 1: FAA Carburetor Icing Probability Chart

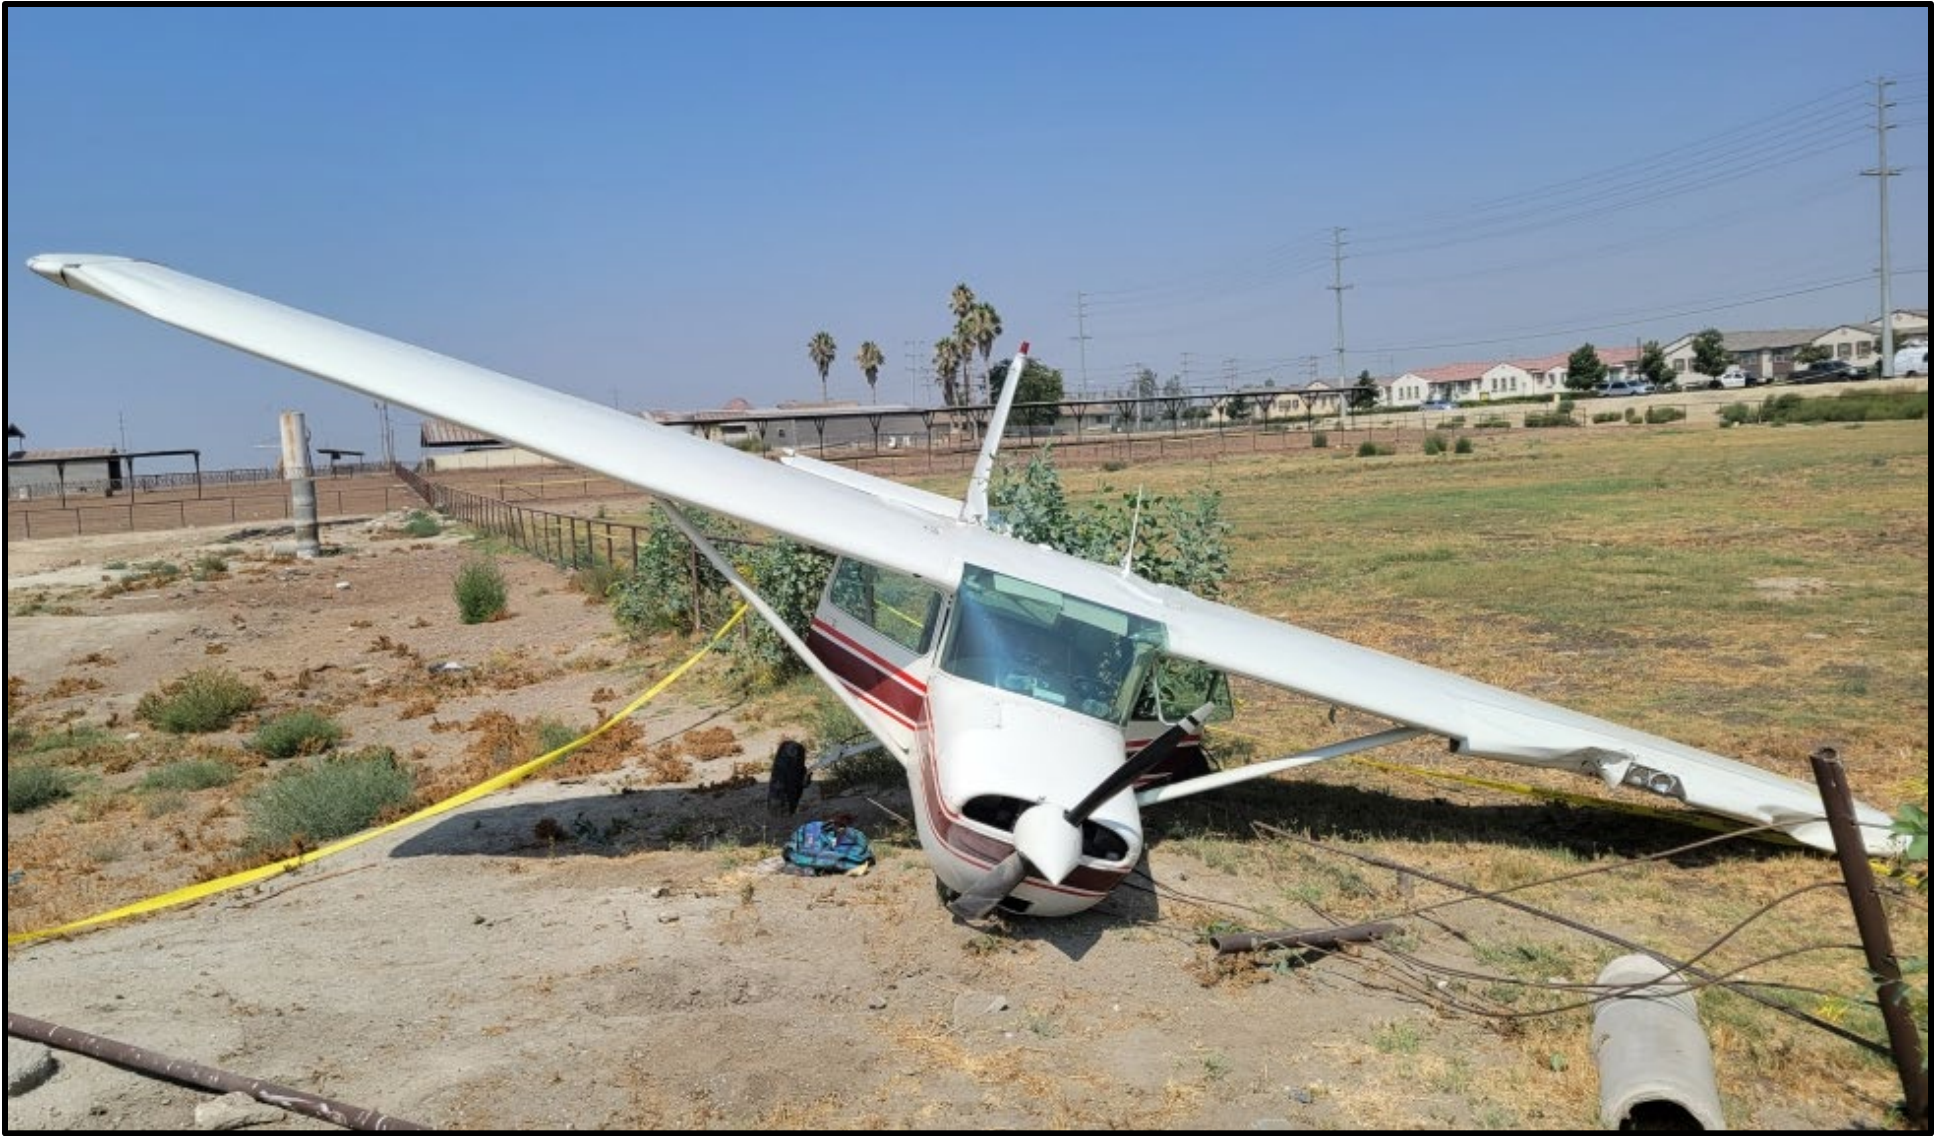
*Figure 2: Picture of the Airplane at the Accident Site (provided by FAA Inspector)*
