ACCIDENT AREA  
COLUMBIA AIRPORT  
(O22)

N10EZ FLIGHT TRACK

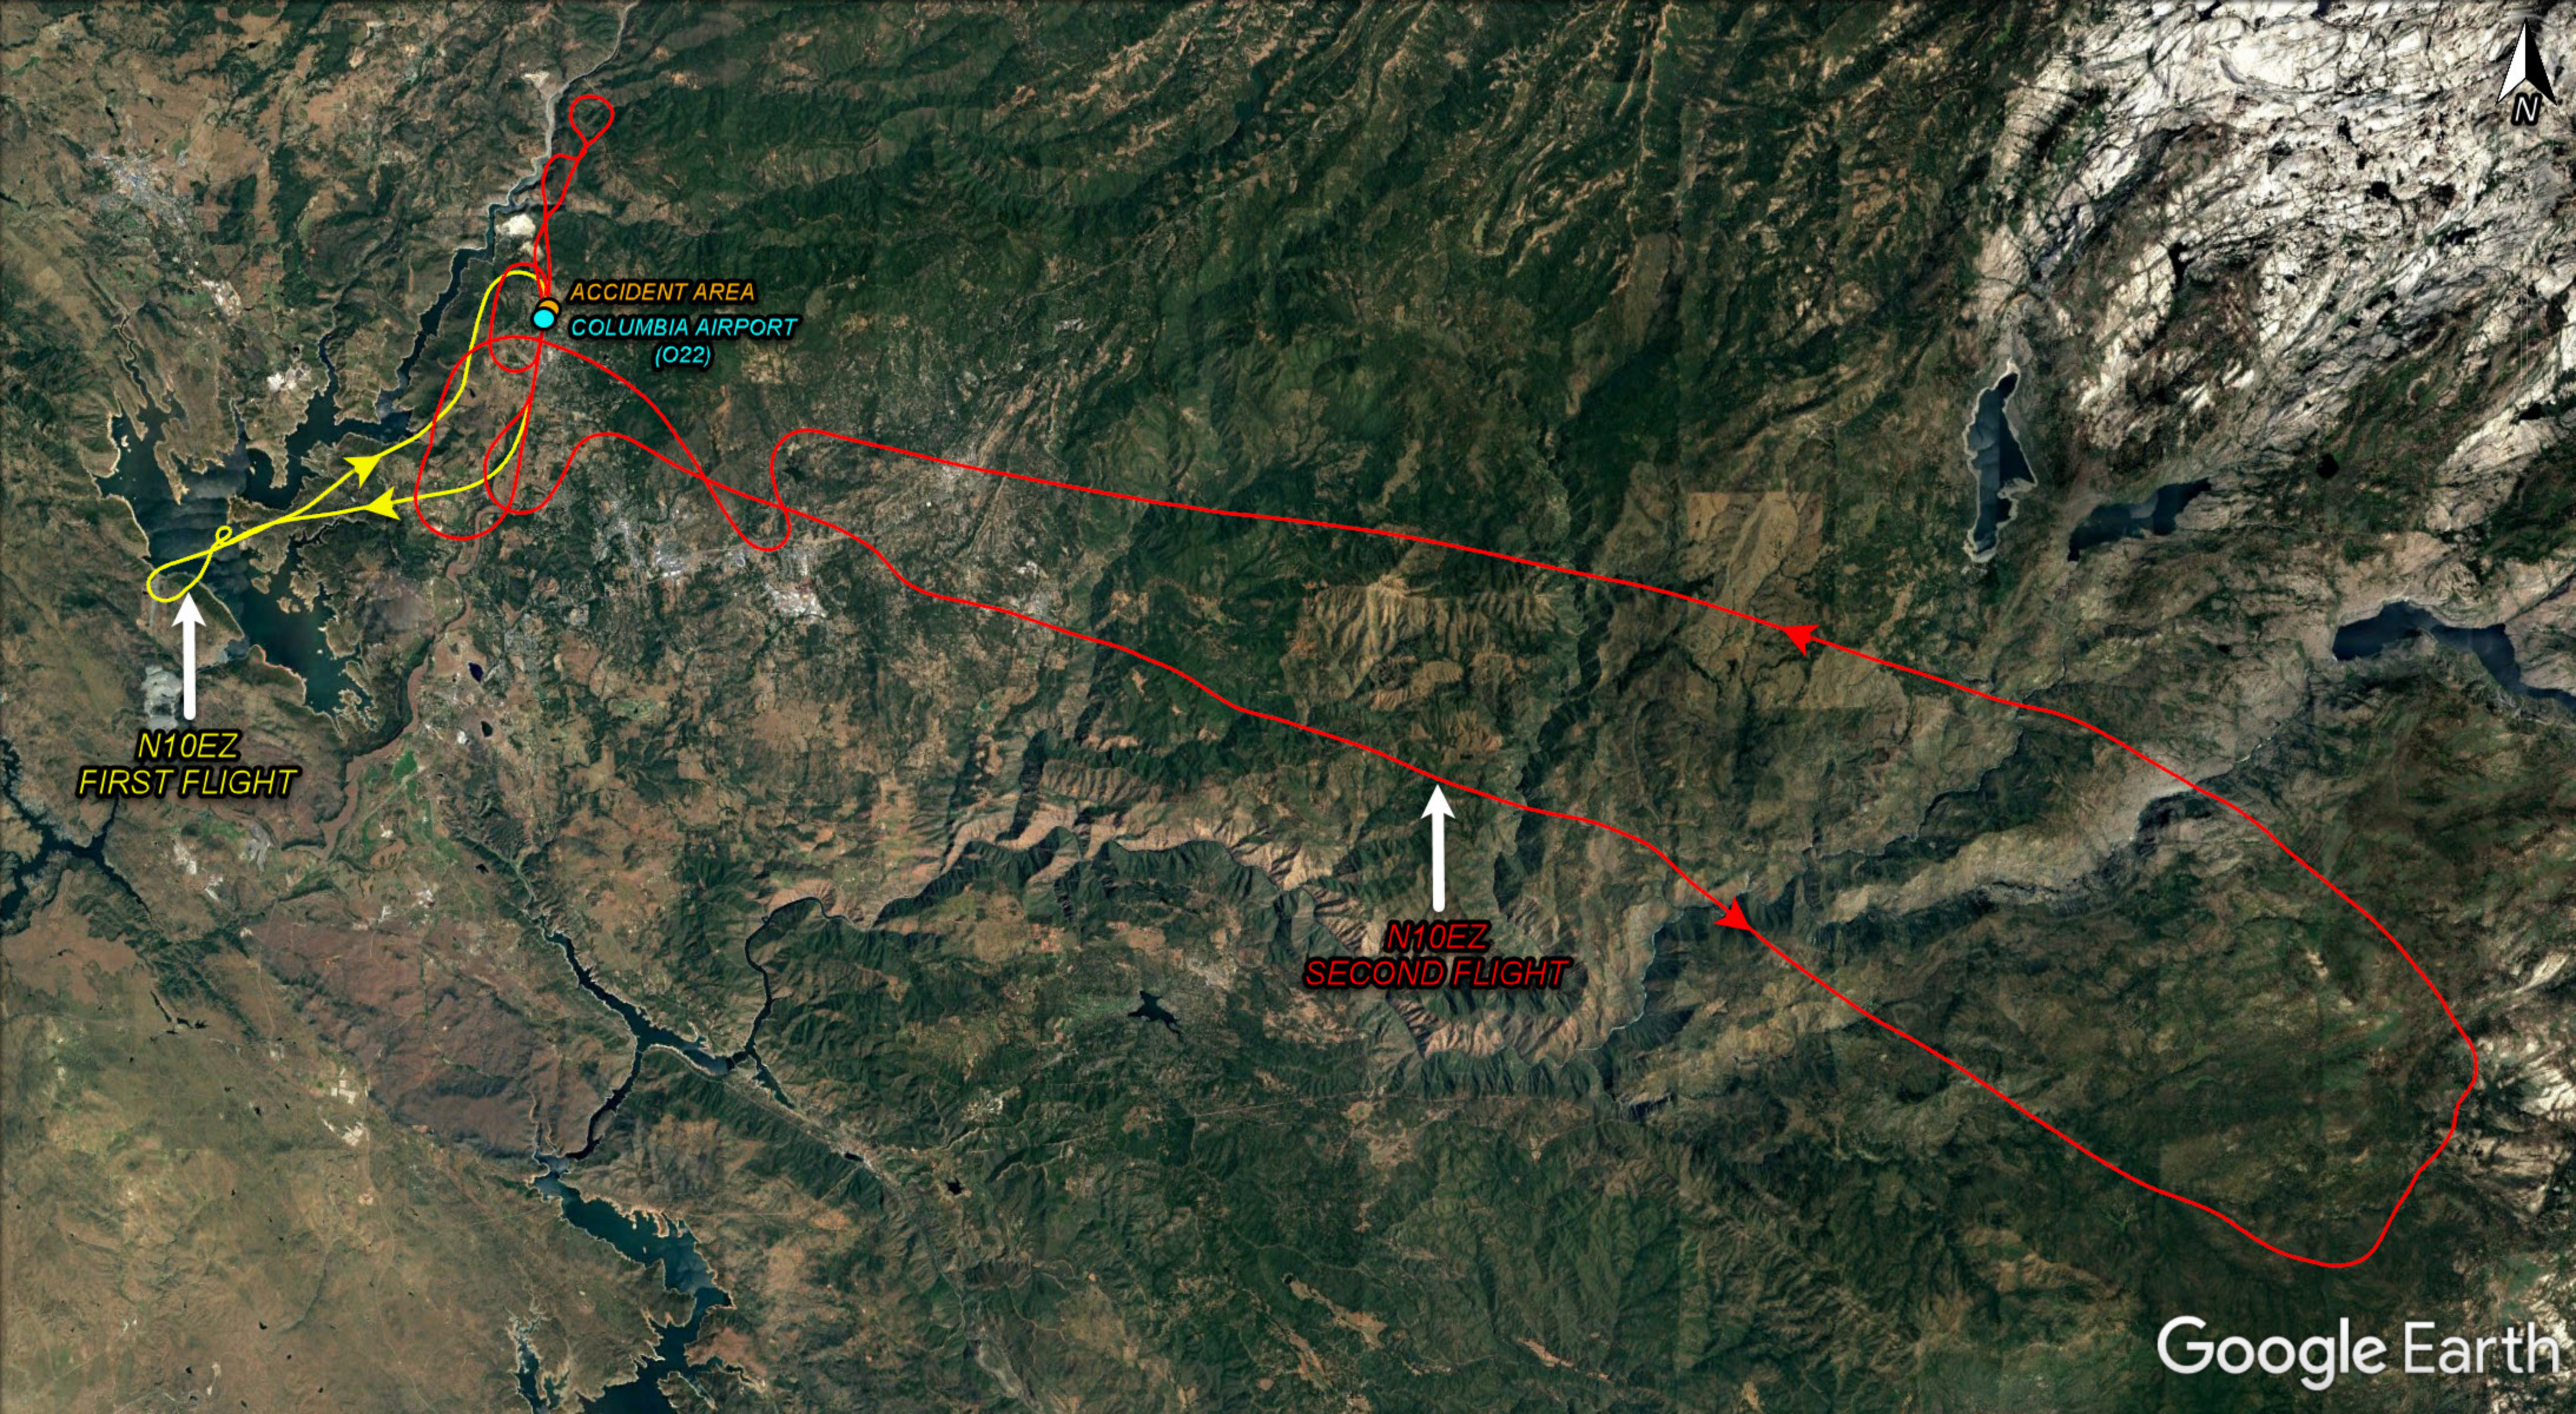
N10EZ  
FIRST FLIGHT

N10EZ  
SECOND FLIGHT

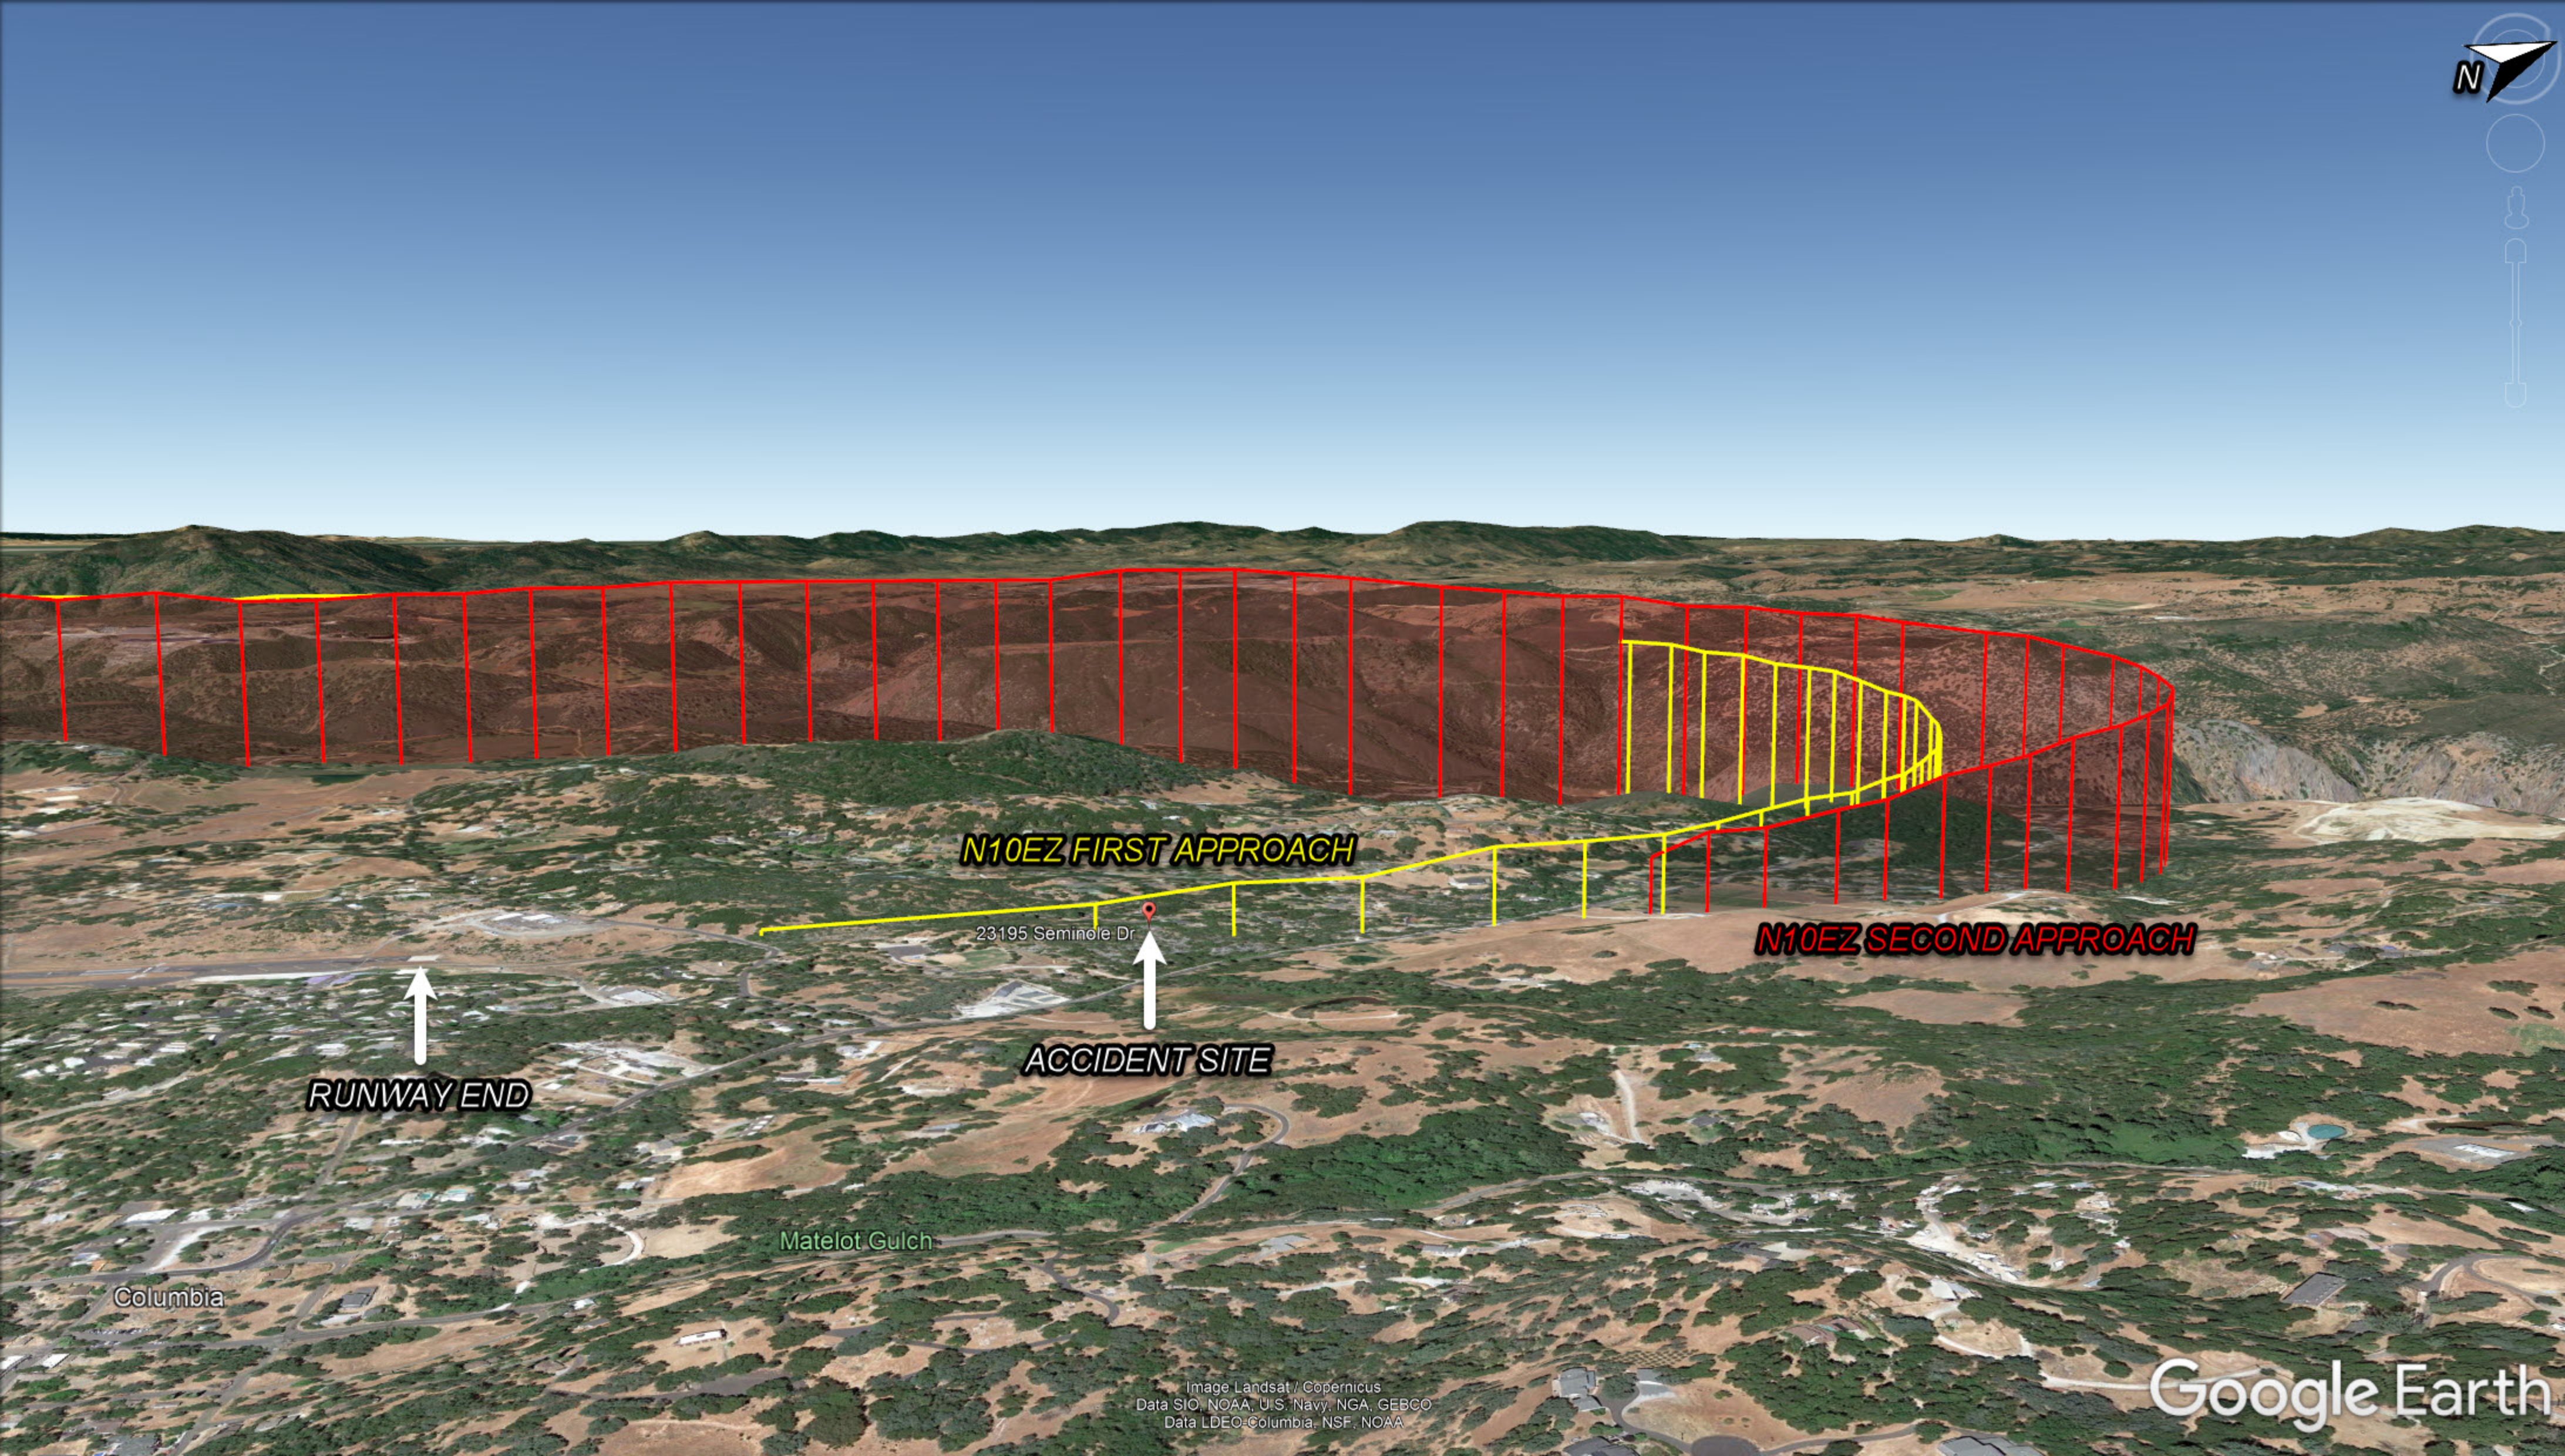
**RUNWAY END**

**N10EZ FIRST APPROACH**

**ACCIDENT SITE**

**N10EZ SECOND APPROACH**
