# National Transportation Safety Board

WPR23FA141

## RECOVERABLE DATA MODULE

Location: Oxbow, Oregon  
Date: April 2, 2023  
Time: 0950 Pacific daylight time (PDT)  
Airplane: Cirrus SR22, N424SW

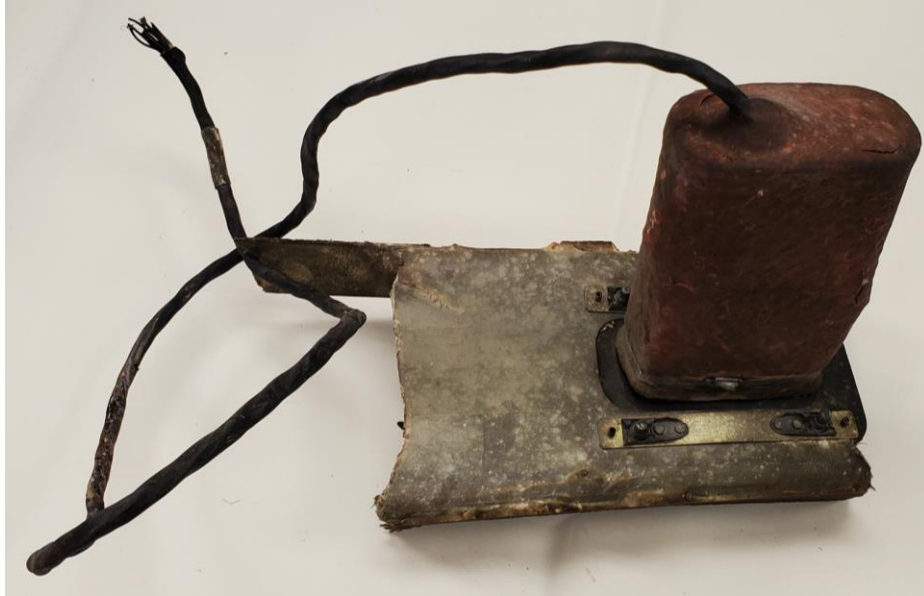
Upon arrival at the Vehicle Recorder Division, the Aerosance RDM was in very poor condition, as shown in figure 1. The outer shell had multiple tears. The internal CF memory card (Figure 2) was recovered and read out normally. However, all the data files stored on the CF memory card were recorded on December 31, 2000, and those data files could not be converted into engineering unit data due to data file corruption. When contacted, the manufacturer of the accident aircraft stated that it was a common issue with Aerosance RDMs, and that no data could be recovered in that situation. Thus, there was no data pertinent to the accident recovered from the device.

**Figure 1.** Aerosance RDM as received.

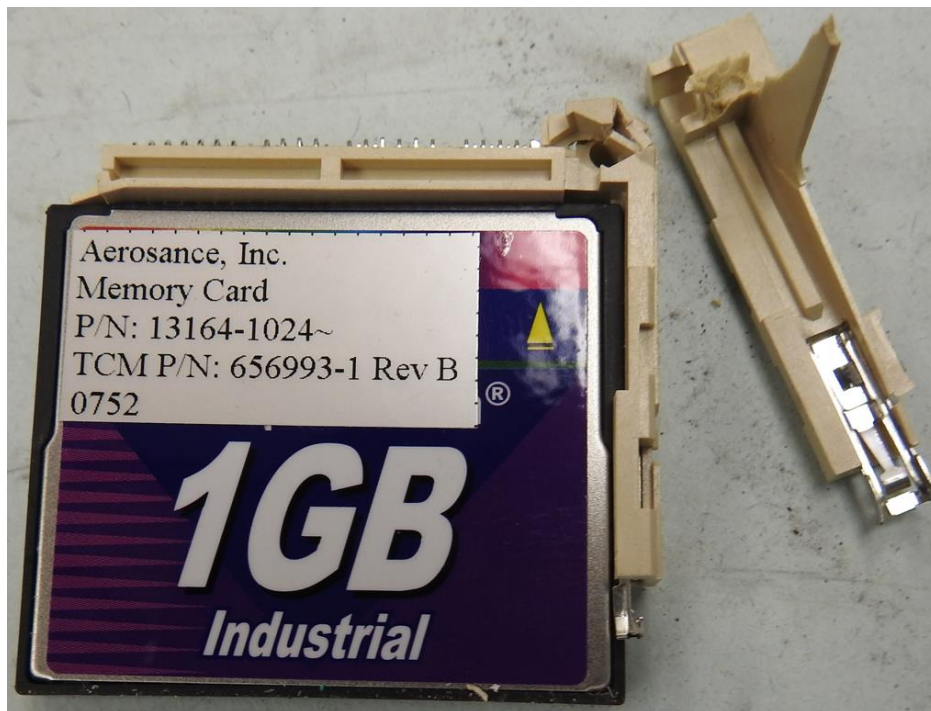
**Figure 2.** Recovered RDM CF memory card.
