**Stratus Tool Technologies, LLC**

**Service Bulletin: SB-001**

**SUBJECT: OIL FILTER ADAPTER GASKETS**

**Applicability:** Continental aircraft engines having any of the following F&M or Stratus oil filter adapters installed in accordance with STCs SE09356SC, SE8409SW & SE10348SC.

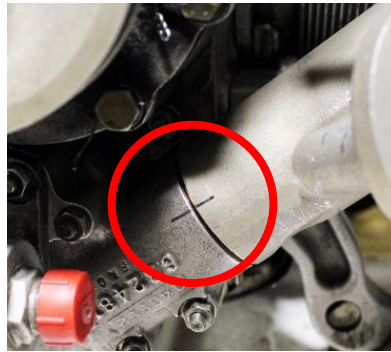
**Figure 5**

When the adapter is ready to be tightened, use a fine point felt pen to make a match mark on the body and oil pump housing as shown in Figure 5.

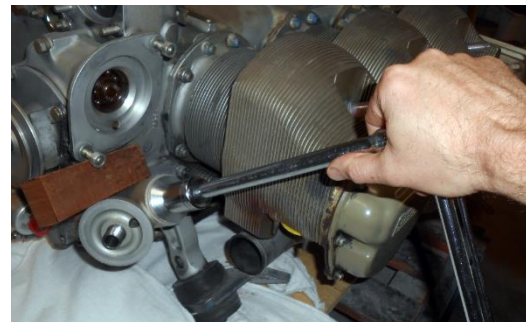
Fabricate a wooden block/wedge that will fit snugly between the oil filter mount flange and an adjacent structurally sound part of the engine or airframe that is competent to resist the turning forces encountered when tightening the oil transfer cylinder. Place the block so that as the oil transfer cylinder is tightened, the body cannot rotate with the oil transfer cylinder. See the exemplar arrangement in Figures 6 and 7.

Note: Because the oil filter adapters are used on many different aircraft, the block/wedge arrangement will be different in different aircraft.

With the block in place, tighten the oil transfer cylinder to 65 ft/lbs torque. If the match marks misalign by more than 1/32 inch after tightening the oil transfer cylinder, i.e., the body has moved relative to the oil pump housing, remove the adapter assembly from the engine as previously described. Replace both gaskets with new gaskets and reinstall the adapter in accordance with the instructions
