# National Transportation Safety Board

ANC22FA047

## COMPUTED TOMOGRAPHY

Location: Clear, Alaska  
Date: June 26, 2022  
Time: 1938 Alaska daylight time  
0338 coordinated universal time (UTC) June 27, 2024  
Helicopter: Bell UH-1B, N9970F

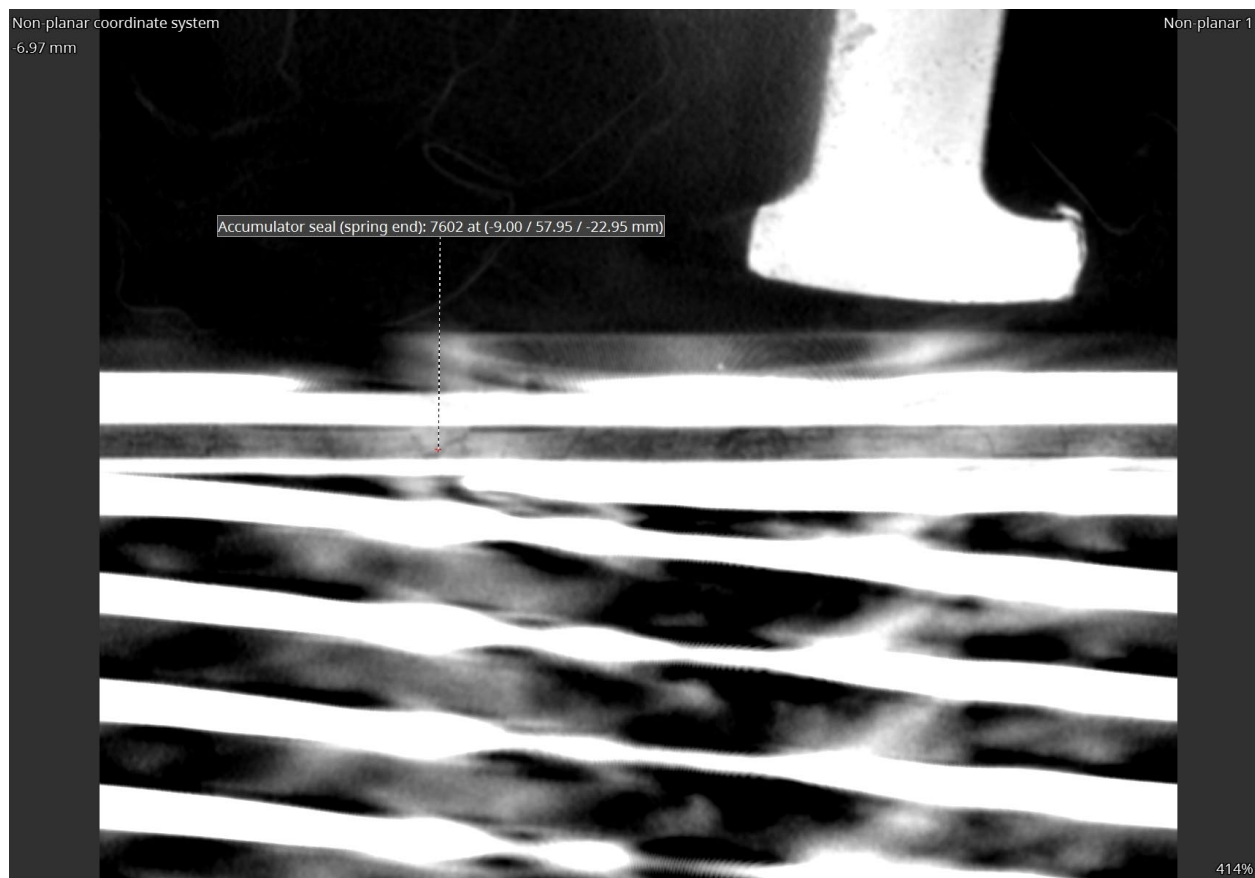
1. There were indications of a bulging cap for the sequence valve of the collective actuator irreversible valve assembly. (Figure 13)
2. There were indications of gaps and distortions in the seals in the collective actuator cylinder assembly and the irreversible valve assembly. (Figures 21, 22, 23, 24, 45, 46, 49, and 50)
3. There were indications of medium density particles and/or material inside the piston rod of the collective actuator cylinder assembly and irreversible valve assembly. (Figures 25 and 53)
4. There were indications of cracks in the irreversible valve housing near the accumulator spring end. (Figures 26 and 27)

**Figure 22.** Collective actuator - irreversible valve - accumulator seal unrolled at spring end. (450 kV)

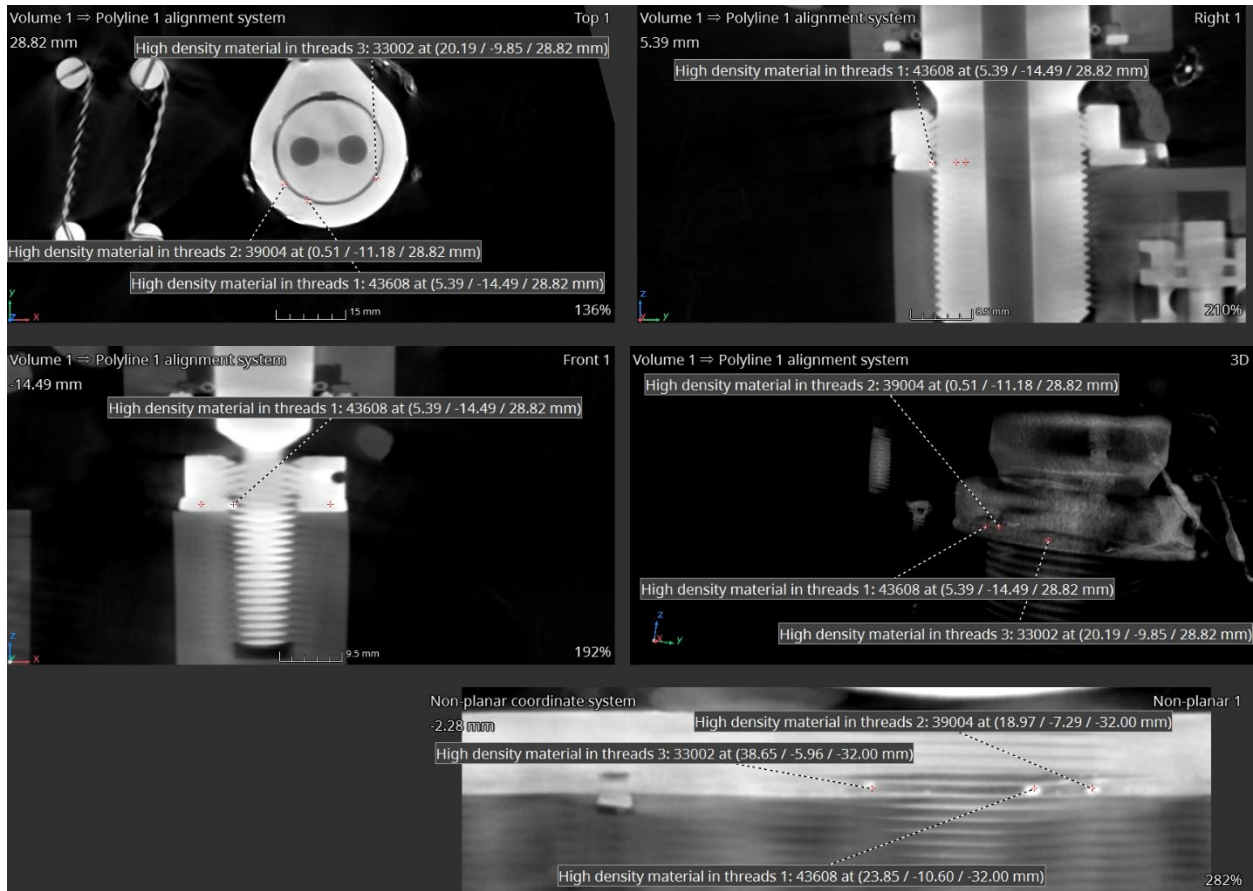
5. There were indications of low density particles and/or material in the hydraulic passage 1 inlet of the collective actuator cylinder assembly. (Figure 36)
6. There were indications of high density particles and/or material in the threads of the piston rod of the collective actuator cylinder assembly. (Figure 40)
7. There were indications of medium density material between the cylinder and ball joint retainer of the collective actuator. (Figure 43)

**Figure 40.** Collective actuator - cylinder assembly - high density material in threads of the piston rod. (450 kV)

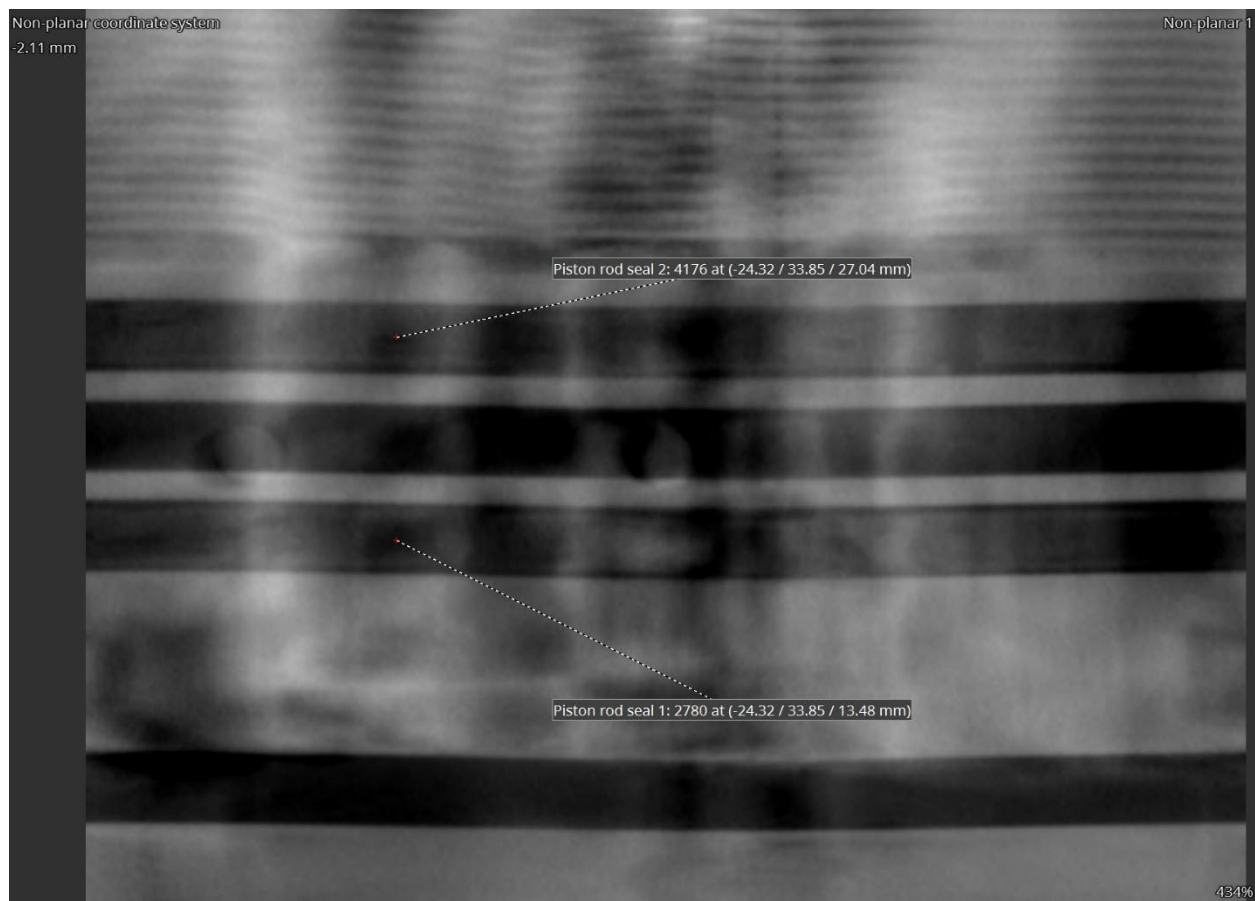
**Figure 79.** Right lateral actuator - cylinder assembly - piston rod seals 1 and 2 unrolled. (450 kV)

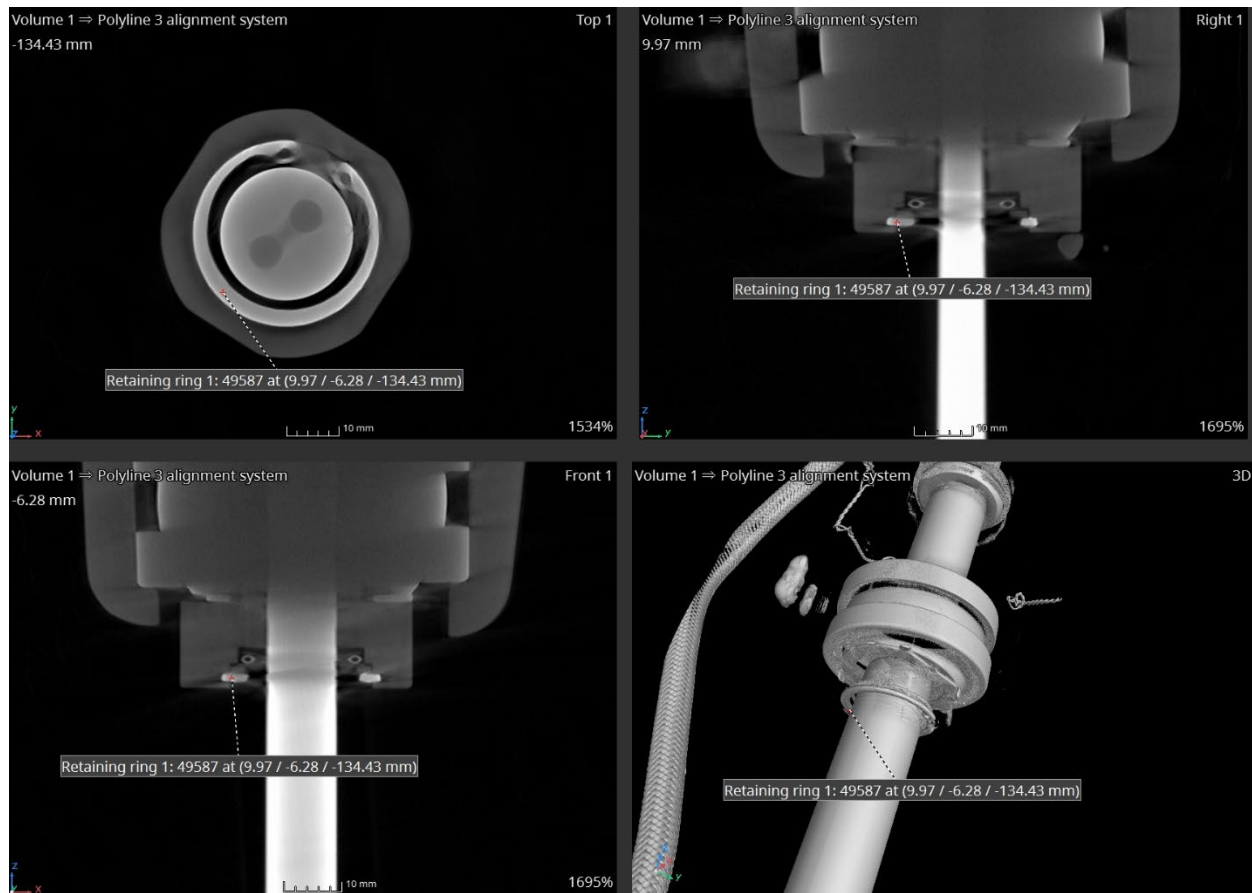
**Figure 85.** Right lateral actuator - cylinder assembly - retaining ring 1. (225 kV)
