Re: CEN14FA300, 1985 Piper Malibu PA-46-310P, S/N 46-8508088, N2428Q (JetPROP conversion SN 002)  
Autopilot equipment examination at Honeywell, 2/11, 2/12 & 3/23/2015 (Olathe, Kansas)  
Flight Computer crystal examination at Honeywell, 4/13/2015 (Phoenix, Arizona)

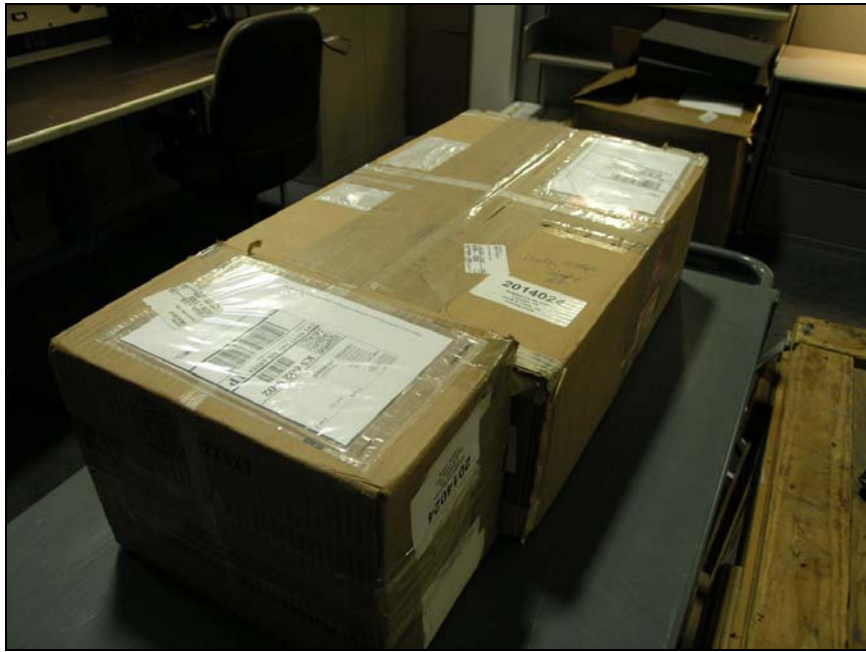
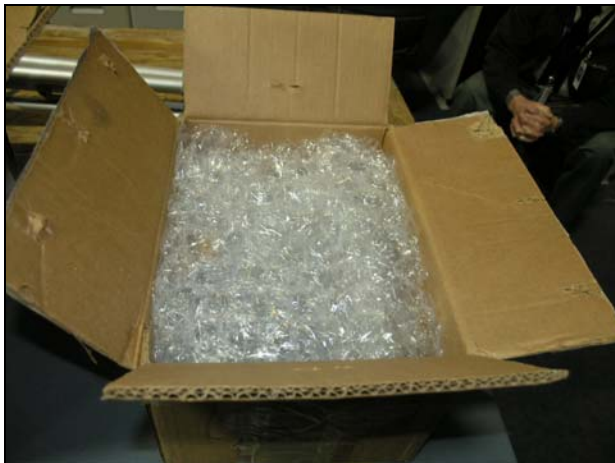
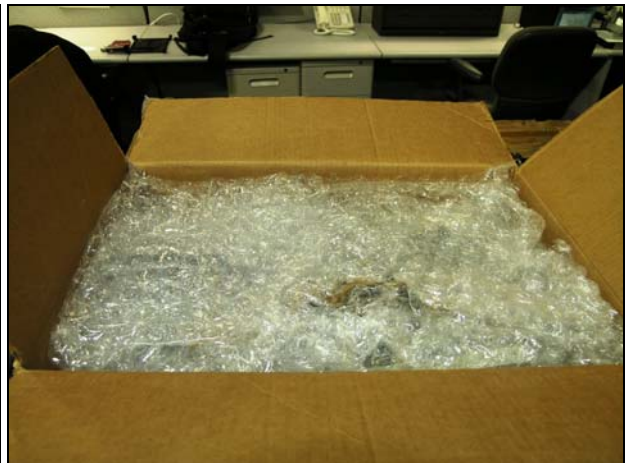
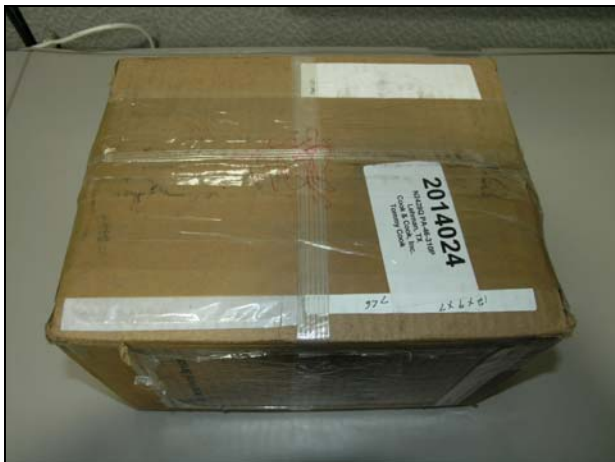
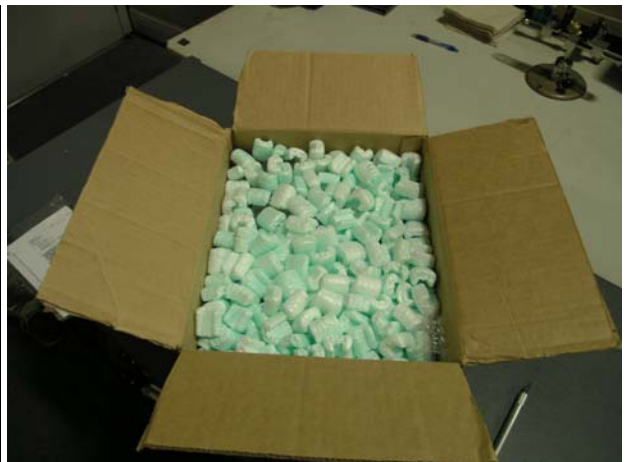
Equipment received in sealed boxes – good protective packaging

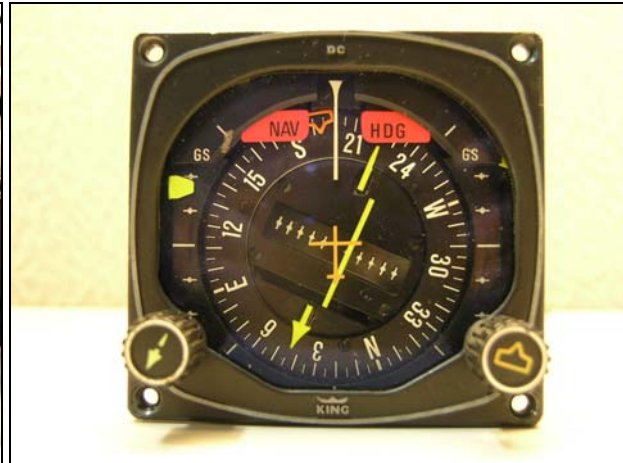
KI 525A front view

The displayed heading is approximately 200 degrees, a course setting of approximately 45 degrees, and the heading bug is set to approximately 193 degrees. The glideslope needle is in view on the left side and partially visible on the right side. The course deviation bar is offset from center about 2 degrees.

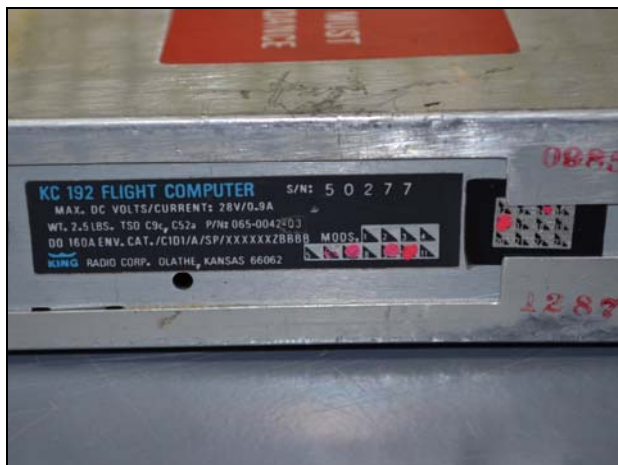
KC 192 dataplate: P/N 065-0042-03, S/N 50277, date code 0985

The bottom cover is dented inward – no other physical damage noted other than cosmetic (minor dents/scratches). The unit was opened to allow internal inspection – none detected. The unit was connected to a KC 192 test panel and power was applied. The test panel indicated “AP” invalid and the KC 192 would not preflight test. Trouble shooting revealed that the processor clock signal from Y101 crystal was bad -- replaced Y101. Unit then passed preflight test; however, many mode annunciators failed to illuminate (YD, FD, ALT, APR, AP – all have broken filaments, no coil stretching detected). None of the bulb filaments have the “snaking” or “spaghetti” appearance consistent with being on during impact. The KC 192 was subjected to functional testing – pitch and roll command, servo drive, and pitch trim are satisfactory. All modes engaged/disengaged satisfactorily except ALT hold – ALT will not engage. The ALT hold mode fault was traced to a bad output from I120 – I120 and/or circuit board fault/damage. No further troubleshooting was conducted.

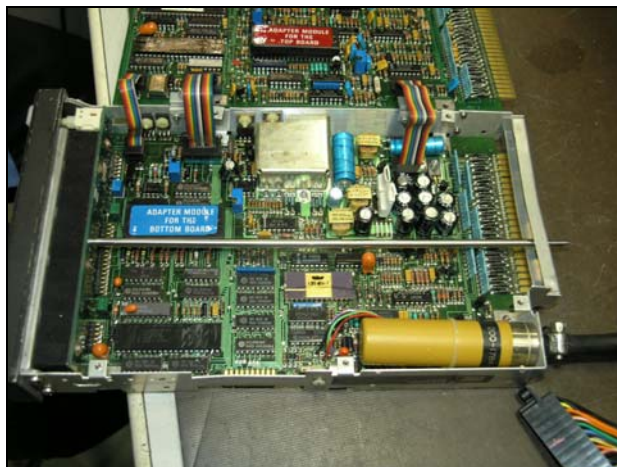
KC 192 top board – no damage detected

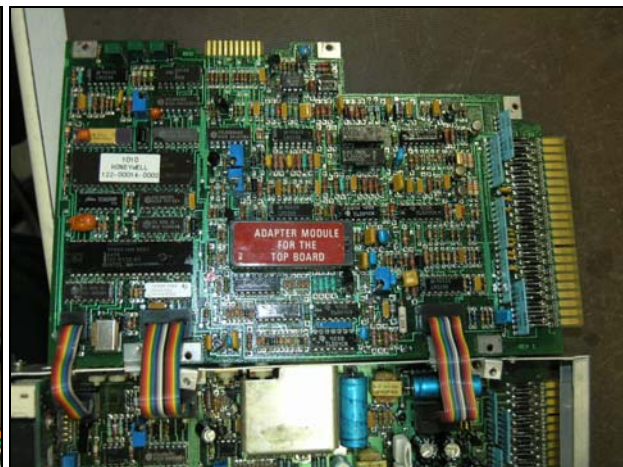
KC 192 bottom board – no damage detected

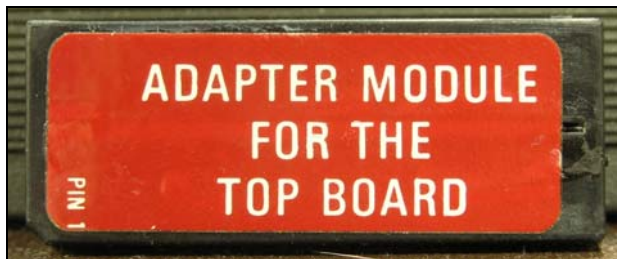
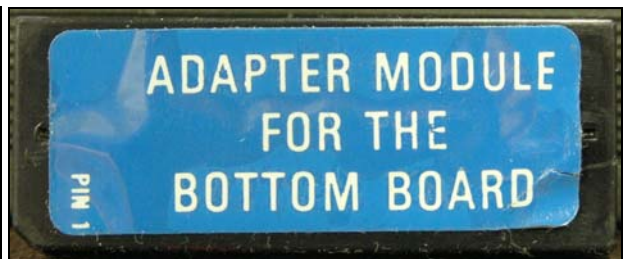
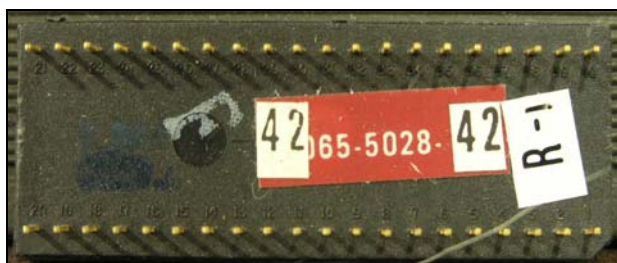
Top board adapter module: P/N 065-5028-42

The installed Adapter Modules are correct for the PA-46-310P installation, STC SA1778CE-D

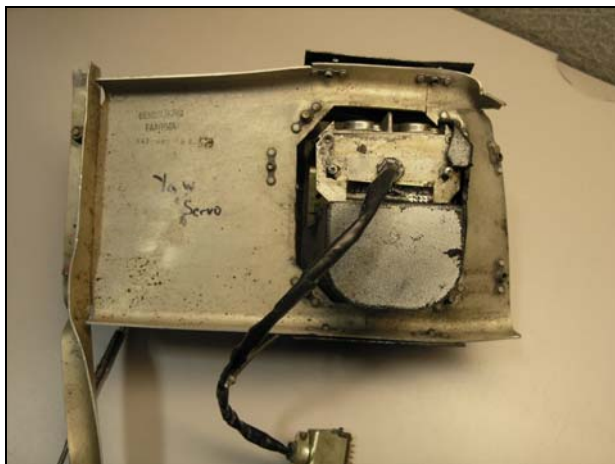
The KS 271A Primary Servo (yaw) was received in a “not engaged” state and attached to aircraft mounting bracket. The dataplate is damaged which precludes part number and serial number identification. The correct part number for the yaw servo installation is 065-0060-04. The servo is impact damaged – cover broken and partially missing. The unit was subjected to final acceptance tests – no defects observed.

KS 271A Primary Servo (Yaw): received attached to aircraft bracket

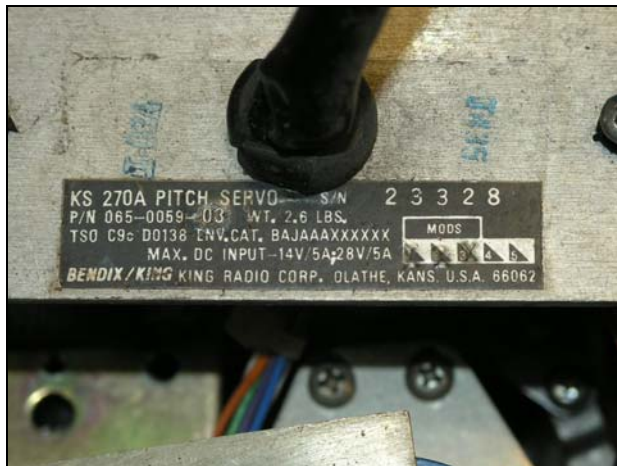
KS 271A Pitch Servo dataplate: P/N 065-0059-03, S/N 23328

The Pitch Servo is impact damaged. The unit was visually and electrically inspected with the following observations noted:

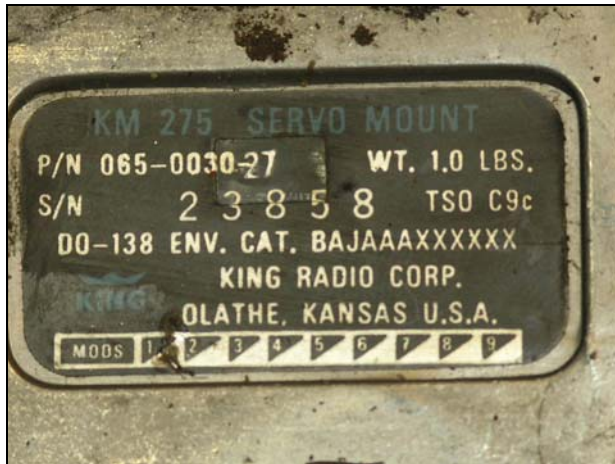
KM 275 Pitch Servo dataplate: P/N 065-0030-27, S/N 23858

- The KM 275 Pitch Servo Mount was received attached to associated Pitch Servo – separated to allow visual inspection and testing.
- Capstan turns freely
- Cable guard damaged – one leg broken away.
- The slip clutch was tested – measured 30 in-lbs in the clockwise (CW) direction and 28 in-lbs in the counter-clockwise (CCW) direction. The specified limit is 22 +/- 2 in-lbs. The out-of-tolerance condition would not adversely affect proper function.

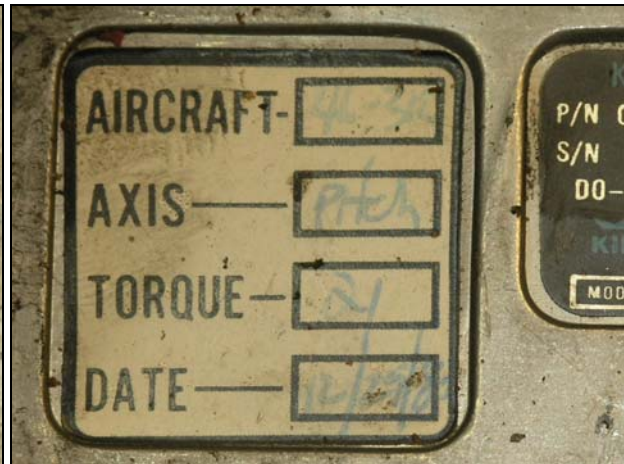
KM 275 Servo Mount torque setting recording

The slip clutches for the pitch, roll, yaw, and trim KM 275 Servo Mounts were tested. The KM 275 Roll Servo Mount meets specification. The Pitch, Yaw, and Trim KM 275 Servo Mounts were marginally out-of-specification as noted in this report. These out-of-tolerance conditions would not adversely affect proper operation.

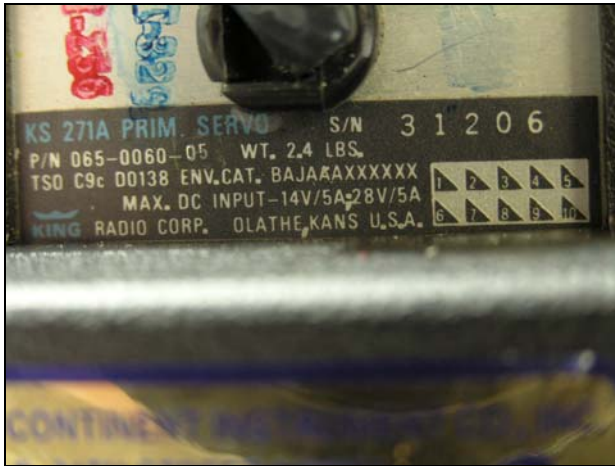
KS 271A Primary Servo (Roll) dataplate: P/N 065-0060-05, S/N 31206

The Roll Servo is impact damaged. The unit was visually and electrically inspected with the following observations noted:

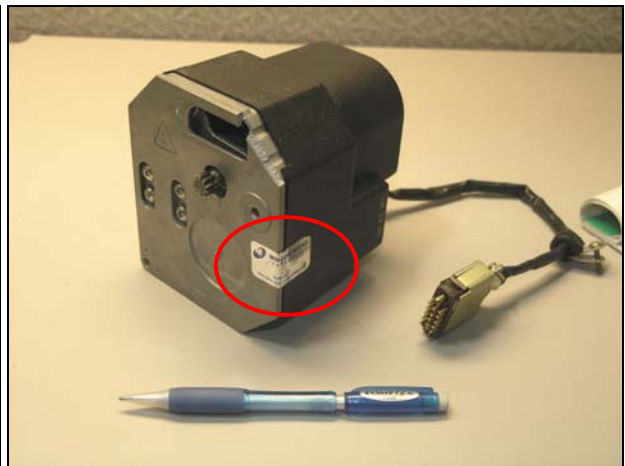
KS 271A Roll Servo: Midcontinent Instruments integrity seal intact

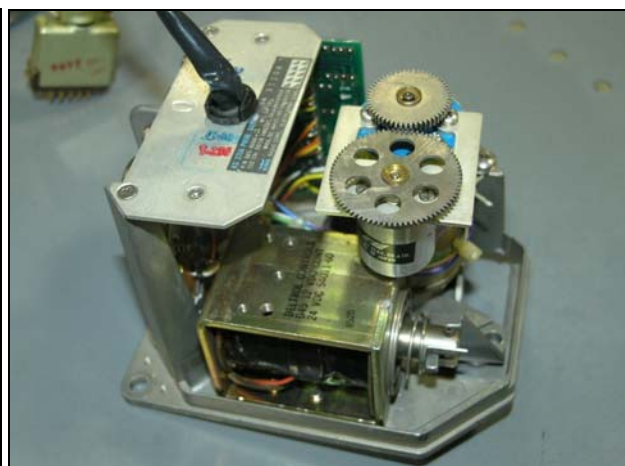
KS 271A Roll Servo - cover removed

- Plastic cover for servo damaged.
- Roll Servo received in a "not engaged" state.
- Servo baseplate partially broken away – mounting ear.
- Midcontinent maintenance integrity seal intact.

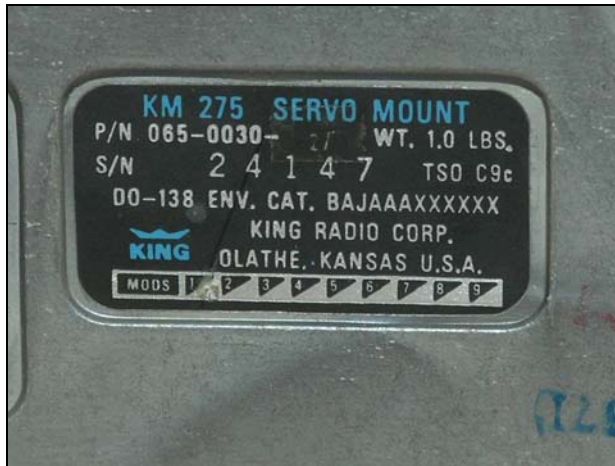
KM 275 Roll Servo dataplate: P/N 065-0030-27, S/N 24147

- The KM 275 Roll Servo Mount was received attached to the associated aircraft bracket – separated to allow visual inspection and testing.
- Capstan turns freely.
- Bridle cable attached to capstan.
- The slip clutch was tested – measured 21 in-lbs in the CW and CCW directions. The specified limit is 22 +/- 2 in-lbs.

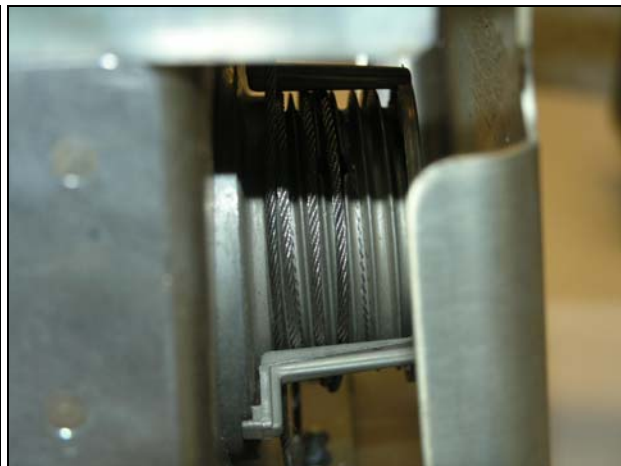
KM 275 Roll Servo Mount capstan with bridle cable

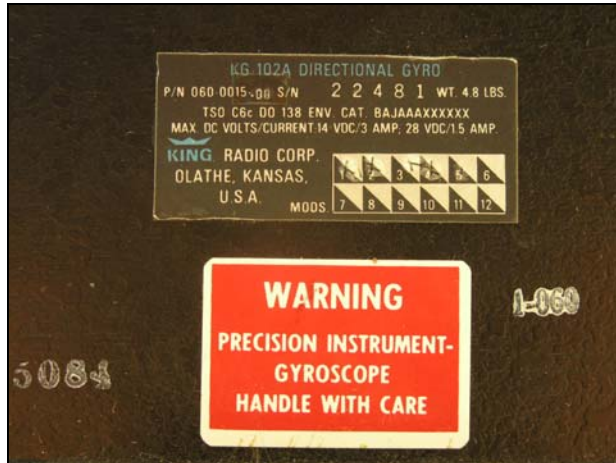
KG 102A Directional Gyro: P/N 060-0015-00, S/N 22481, D/C 5084

The KG 102A Directional Gyro was visually inspected – no physical damage detected. The unit was subjected to functional testing – no defects observed. The unit was subjected to the specified drift test where it failed with an 8° drift after a 10 minute period. The drift limit is 4° maximum. The out-of-tolerance condition would not adversely affect proper function.

The KG 102A Directional Gyro, KC 296 Yaw Computer, and KRG 331 Rate Gyro were subjected to functional testing – no defects were noted. Additionally, the KG 102A Directional Gyro was subjected to a ten minute drift test where it exceeded the maximum drift limit of 4° with a drift of 8°. This condition would not adversely affect proper operation.

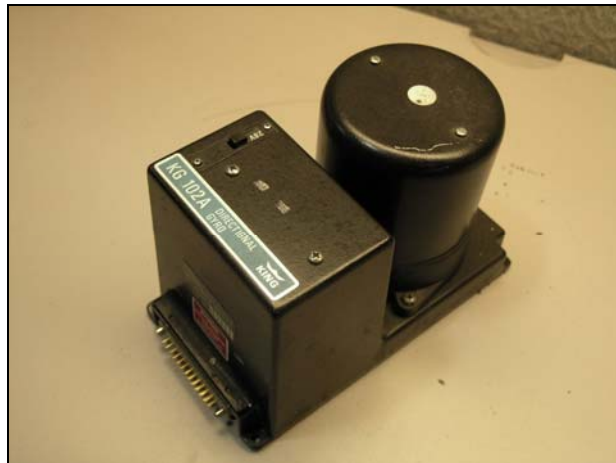
KG 102A Directional Gyro – top and side views

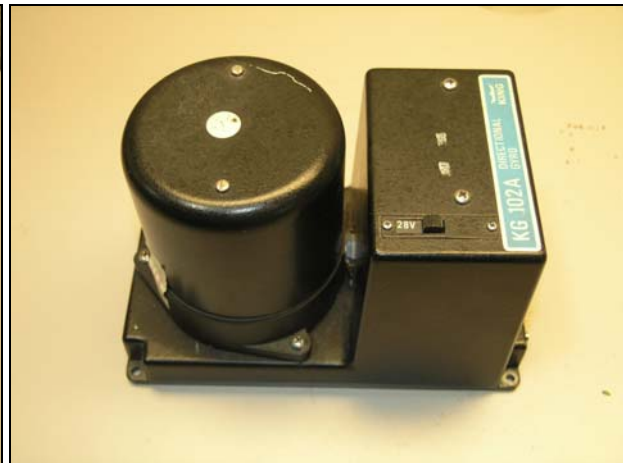
KG 102A Directional Gyro: gyro can seal intact

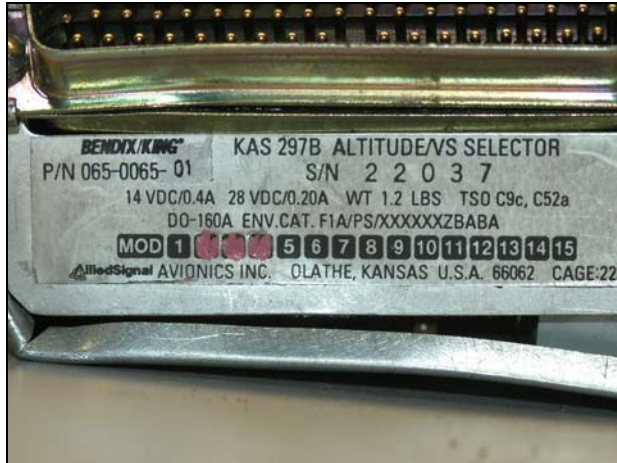
KAS 297B dataplate: P/N 065-0065-01, S/N 22037

The KAS 297B is impact damaged – bezel and rear connector damaged. The testing was limited to data recovery from the non-volatile memory (NVM). The KAS 297B stores the last altitude and vertical speed selected by the flight crew. The unit covers were removed to allow removal of the NVM device, I316. I316 was installed into an exemplar unit. Upon power-up, the last selected altitude of 27,000 feet with a vertical speed descent of 500 feet/minute was displayed.

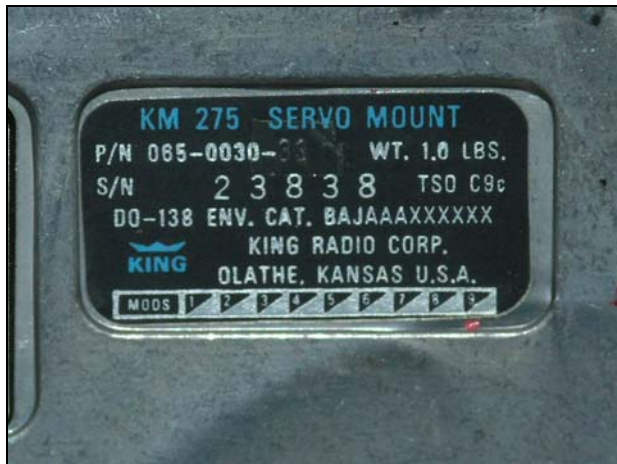
KM 275 Yaw Servo Mount dataplate: P/N 065-0030-33, S/N 23838

- Capstan turns freely.
- Bridle cable attached to capstan.
- Foreign substance consistent with oil on servo mount.
- The slip clutch was tested – measured 45 in-lbs in the CW and CCW directions. The specified limit is 40 +/- 4 in-lbs. The out-of-tolerance condition would not adversely affect proper function.

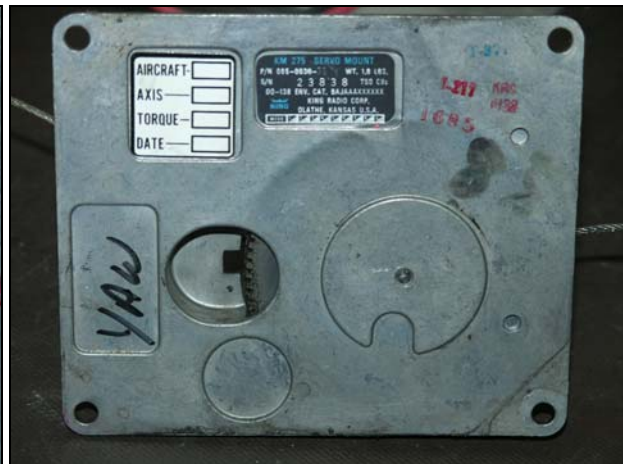
KM 275 Yaw Servo Mount – rear view

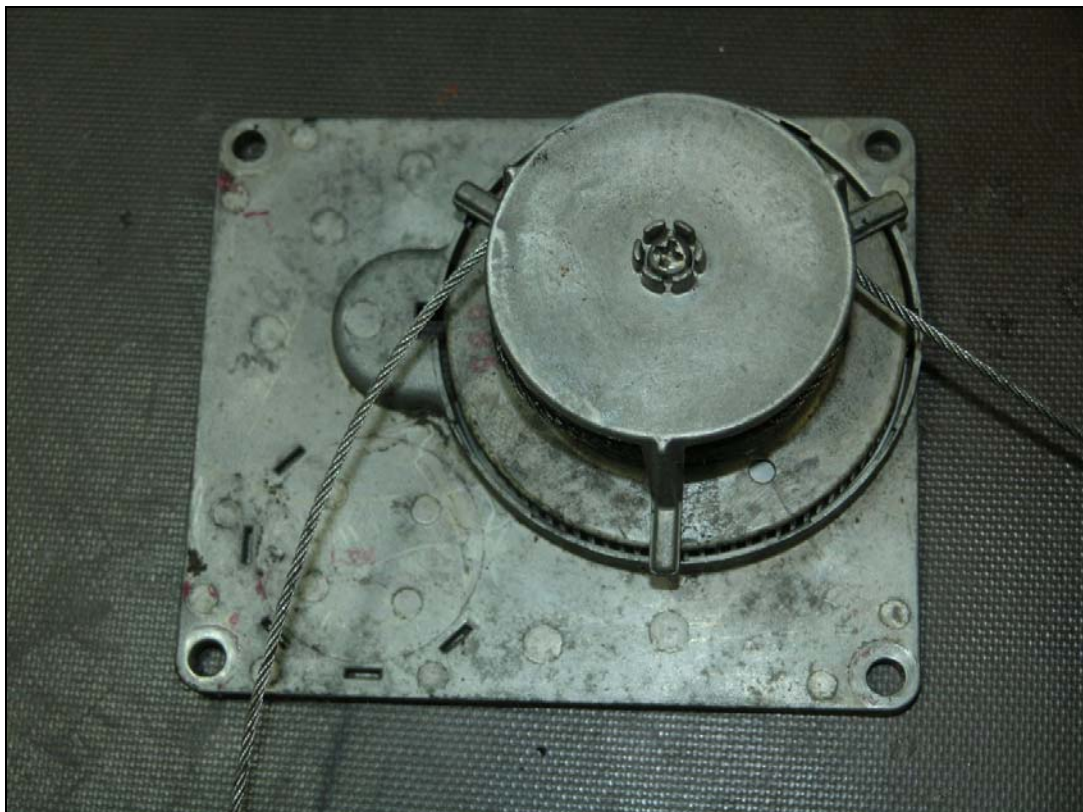
KM 275 Yaw Servo Mount – rear view

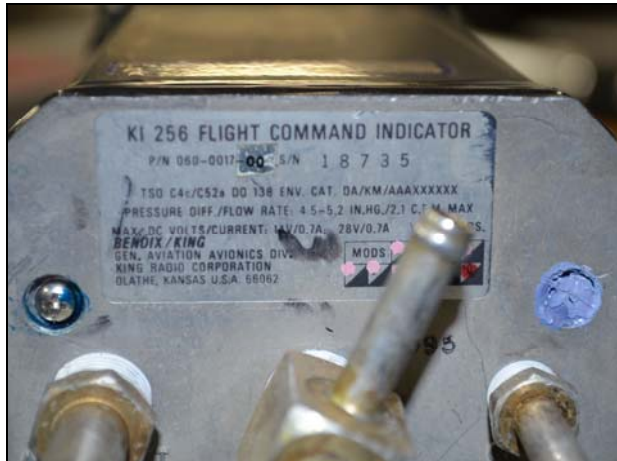
KI 256 FCI dataplate: P/N 060-0017-00, S/N 18735

The KI 256 was impact damaged and could not be tested. The following observations were observed:

- The cover was removed to allow visual inspection. The Outer Gimbal shaft is bent downward and will not move freely -- consistent with impact forces.
- The fast erect vanes were dislodged from impact forces.
- The gyro assembly was removed for visual inspection. The rotor turns freely. No rotational scoring observed on the rotor or rotor housing.

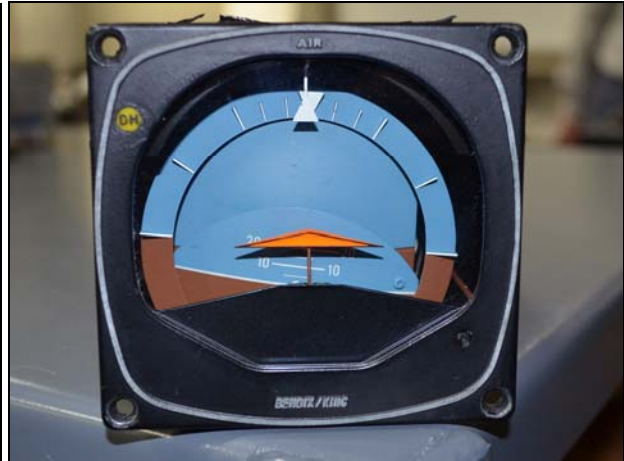
KI 256 Flight Command Indicator: front view

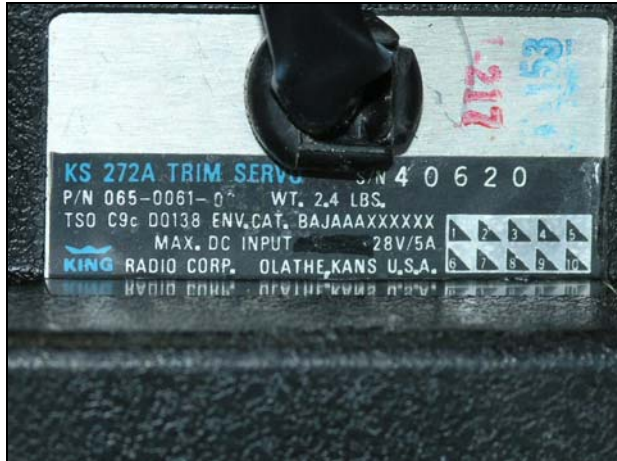
KS 272A Trim Servo dataplate: P/N 065-0061-06, S/N 40620

- Plastic cover for servo damaged.
- Trim Servo received in a “not engaged” state.
- Removed cover to allow visual inspection. Found the engage plate, P/N 073-00513-0003, broken. Relay K201, P/N 032-00029-0001, displaced (mounting bracket/tab bent).
- Unit was subjected to functional testing – solenoid engages/disengages, motor runs in both directions; Manual trim CW inop, autotrim inop – found K201 bad (consistent with impact forces).

The KS 272A Trim Servo was impact damaged and only limited testing was possible. The KS 272A Trim Servo was subjected to functional testing. The clutch engage solenoid engaged/disengaged and the motor runs in both directions. The clutch engage plate is broken and will not physically engage the servo as a result; however, the electrical operation of the solenoid was confirmed. Manual trim CW and autotrim were inoperative. These faults were traced to a defective mechanical relay, K201 (consistent with impact forces).

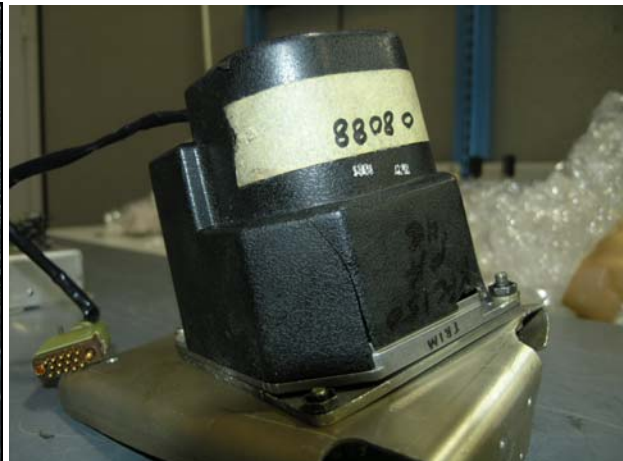
KS 272A Trim Servo: received with KM 275 mount and aircraft bracket

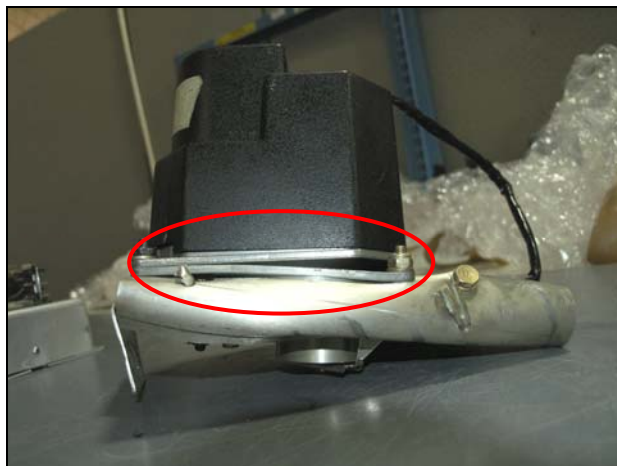
KS 272A Trim Servo and KM 275 mount: mount twisted

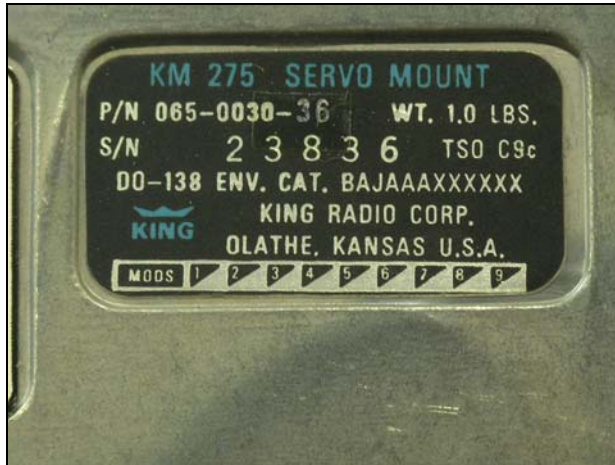
KM 275 Servo Mount dataplate: P/N 065-0030-36, S/N 23836

- Received attached to KS 272A Trim Servo and aircraft bracket.
- Capstan turns freely.
- Baseplate bent/deformed
- The slip clutch was tested – measured 38 in-lbs in the CW and 40 in-lbs in the CCW directions. The specified limit is 35 +/- 4 in-lbs. The out-of-tolerance condition in the CCW direction would not adversely affect proper function.

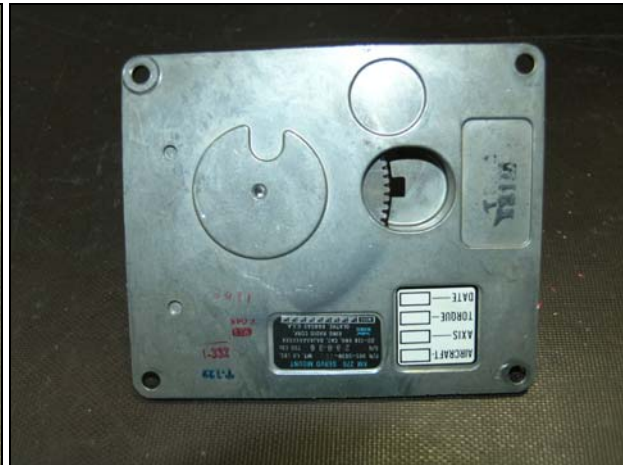
KM 275 Servo Mount: rear view

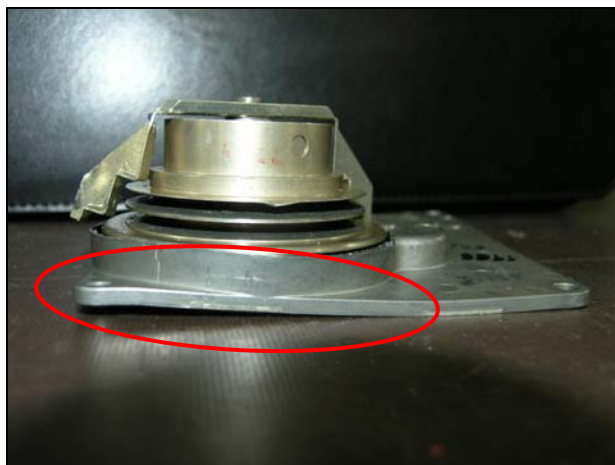
KM 275 Servo Mount: side view, base plate distorted as shown

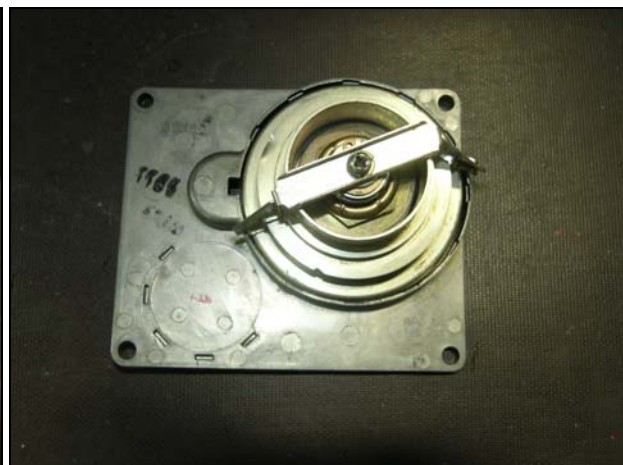
KM 275 Servo Mount: front view

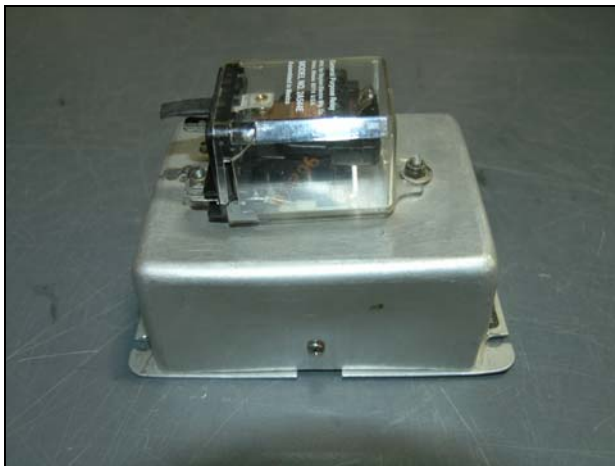
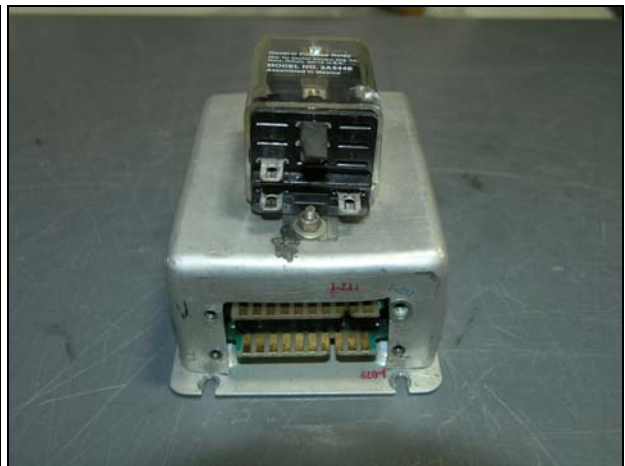
KC 296 Yaw Computer: relay attached to the cover is NOT part of the KC 296 Yaw Computer

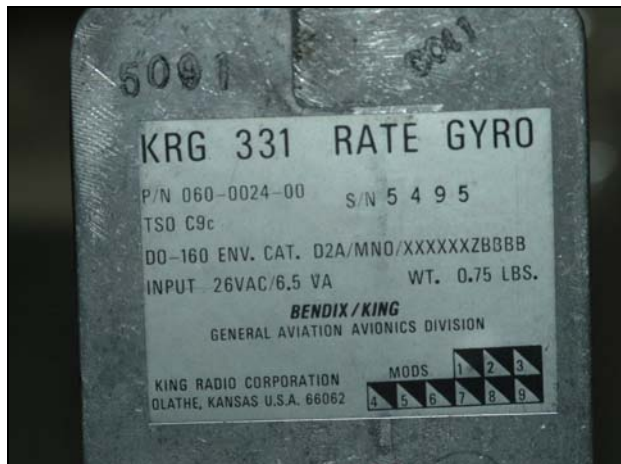
KRG 331 Rate Gyro (Yaw) dataplate: P/N 060-0024-00, S/N 5495

The KRG 331 rate gyro was visually inspected – no damage noted. The unit was subjected to functional testing – power supply outputs meet specification; unit passes functional testing.

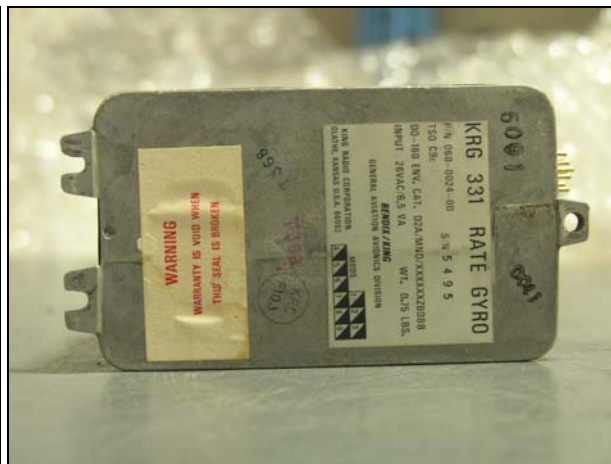
KRG 331 Rate Gyro: bottom view

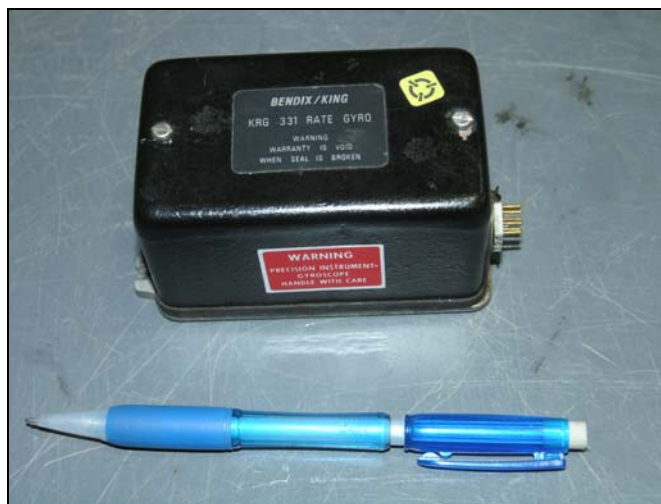
KRG 331 Rate Gyro: passes functional testing
