# Continental Motors

## ENGINE FIELD INSPECTION REPORT

| ENGINE MODEL | IO520B (6B) |
| CMI FILE NUMBER | 15-676 |

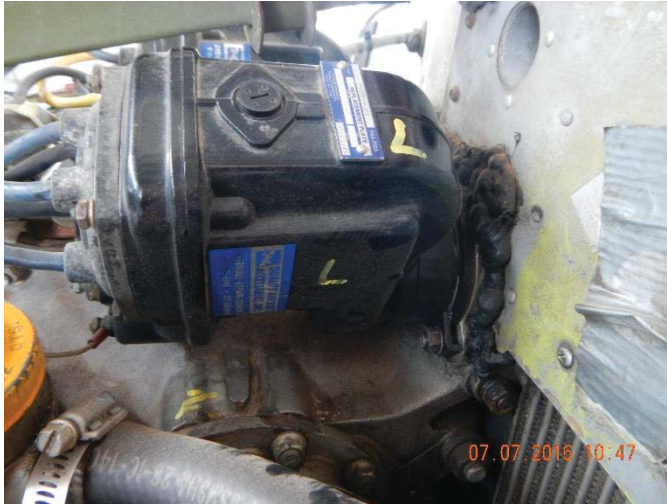
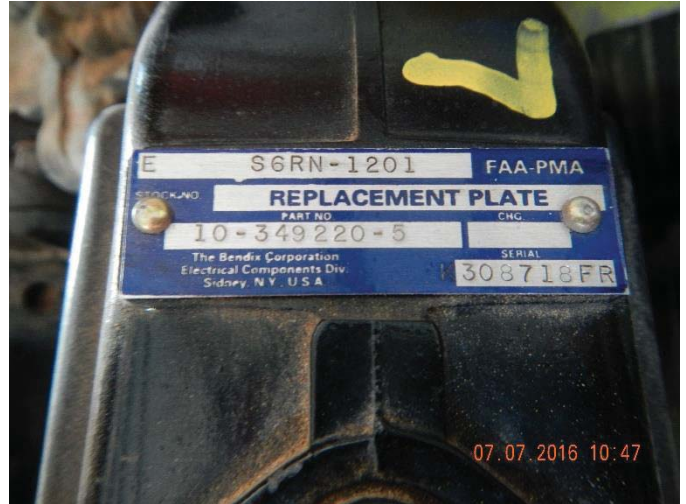
| <b>LEFT MAGNETO</b> | Manufacturer: Bendix-Overhauled by Quality Aircraft Accessories, Inc. | P/N: 10-349220-5 | S/N: 308718-FR |

| Condition: | No damage was noted | | |

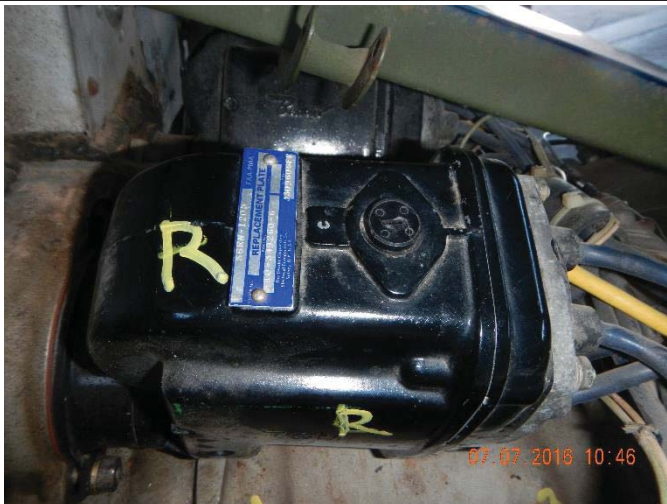
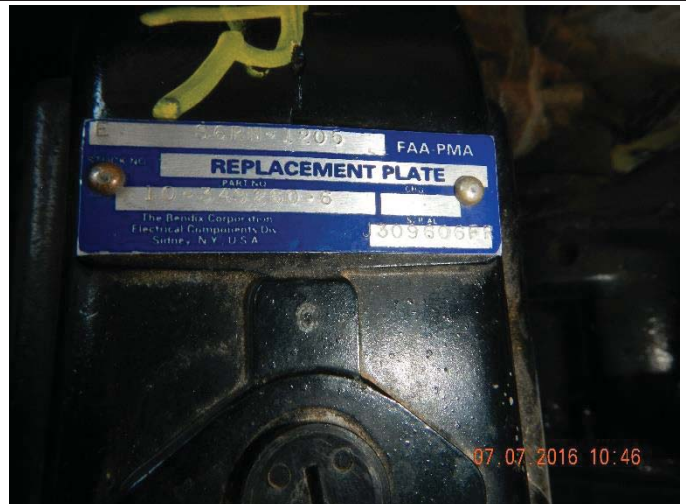
| <b>RIGHT MAGNETO</b> | Manufacturer: Bendix-Overhauled by Quality Aircraft Accessories, Inc. | P/N: 10-349260-6 | S/N: 309606FR |

| Condition: | No damage was noted | | |

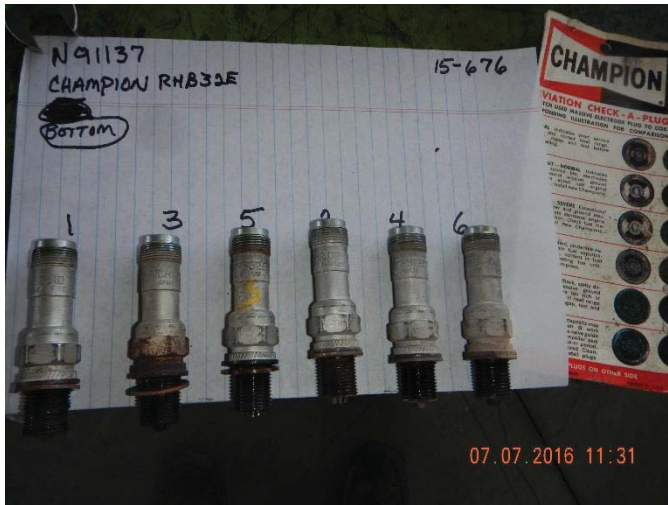
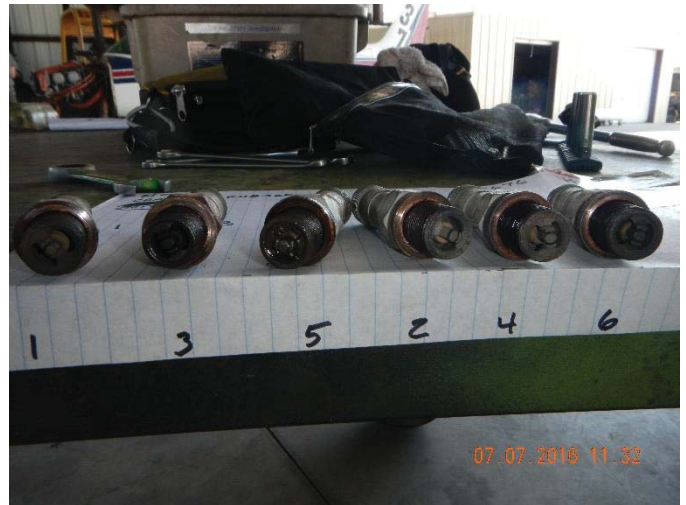
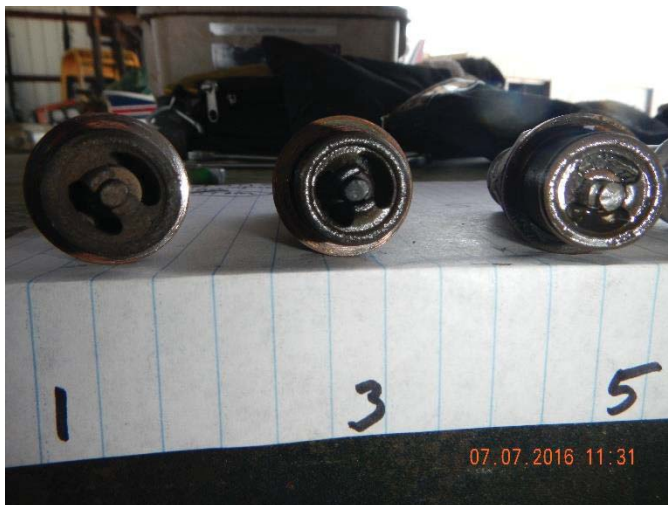
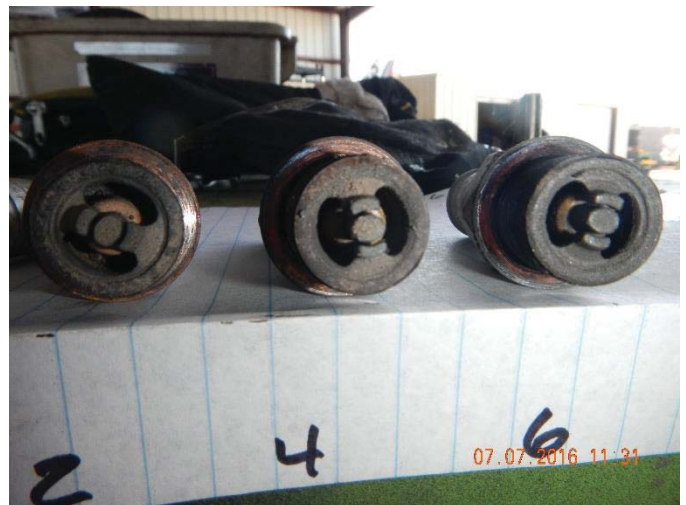
When compared to images on a Champion Check A Plug chart, the wear patterns best match *normal to worn out normal*. The top sparkplug from cylinder # 5 displayed mechanical damage and metal contamination was present.

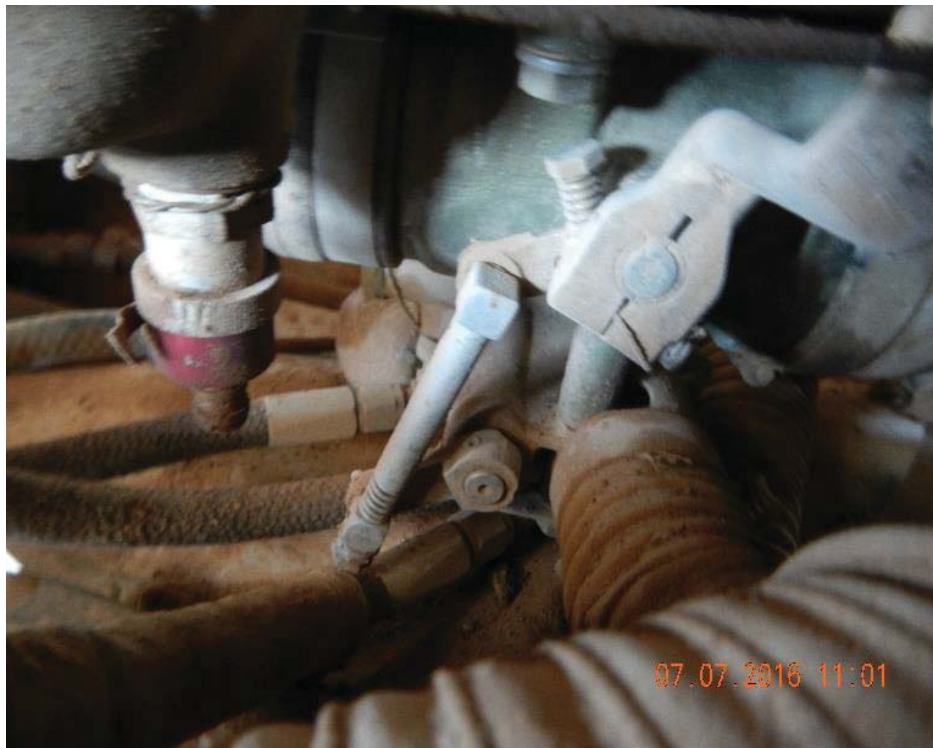
**THROTTLE  
BODY  
METERING UNIT**Manufacturer:  
Undetermined

No damage was noted.

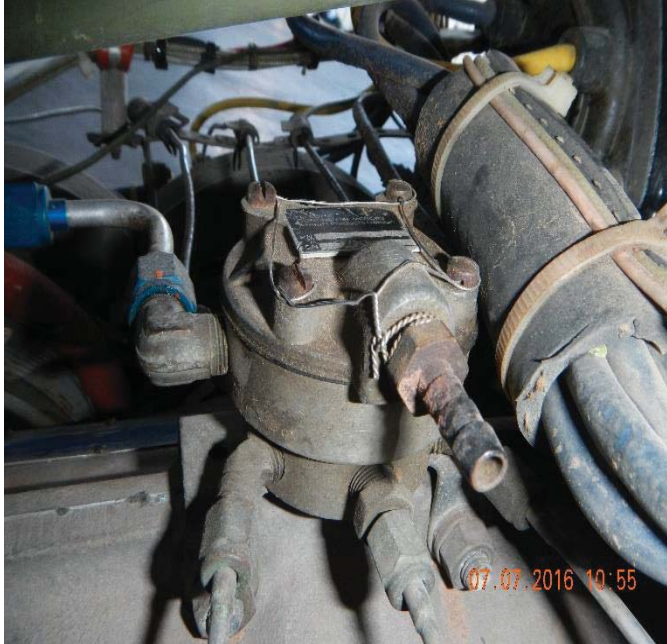
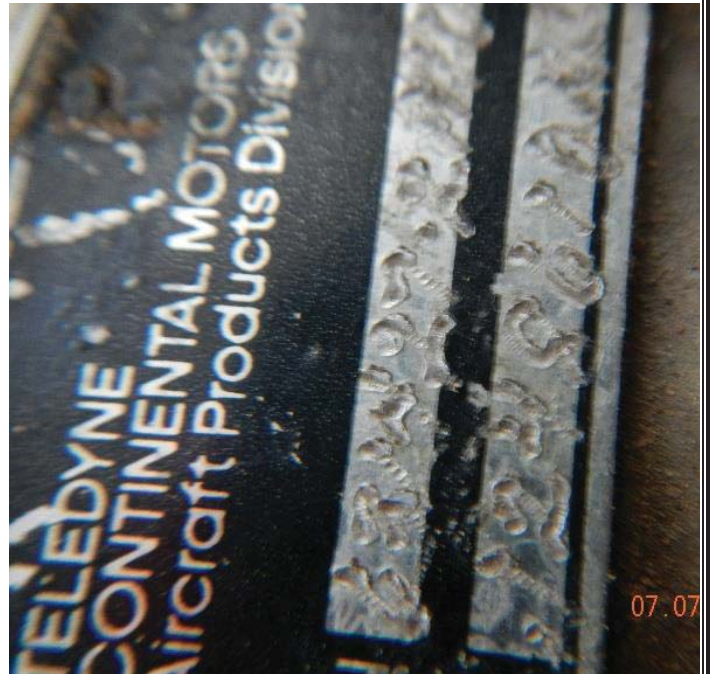
## FUEL MANIFOLD VALVE

Condition: No damage was noted. Data plate unintelligible

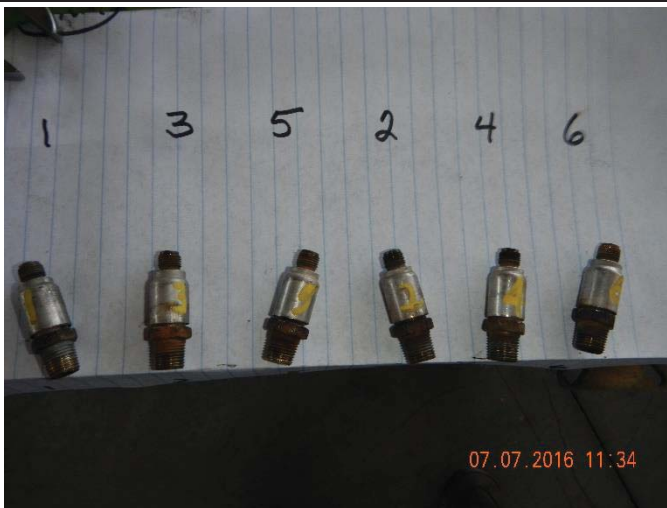
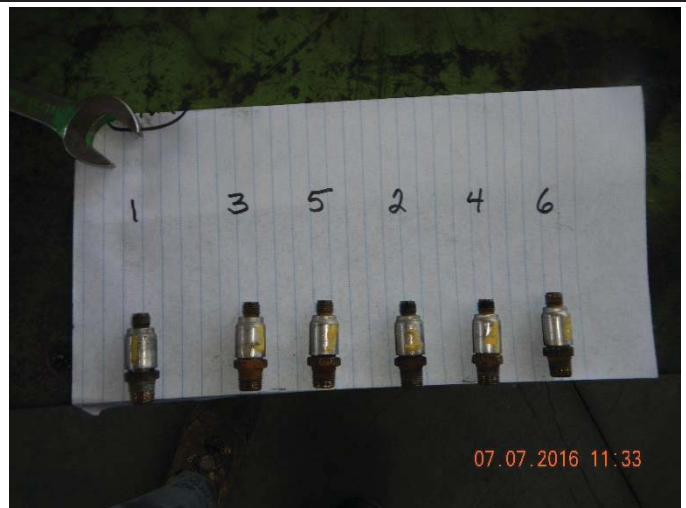
## FUEL NOZZLES AND LINES

Condition: All six fuel injectors were open. No damage or contamination was noted.

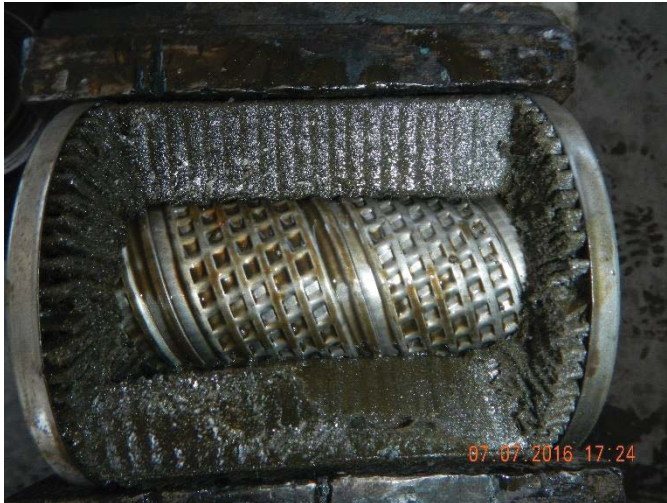
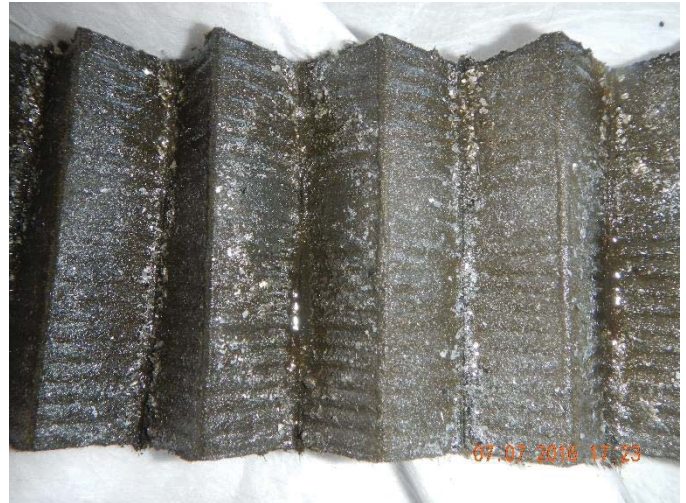
Condition: When opened for inspection, the filter was contaminated with metal.

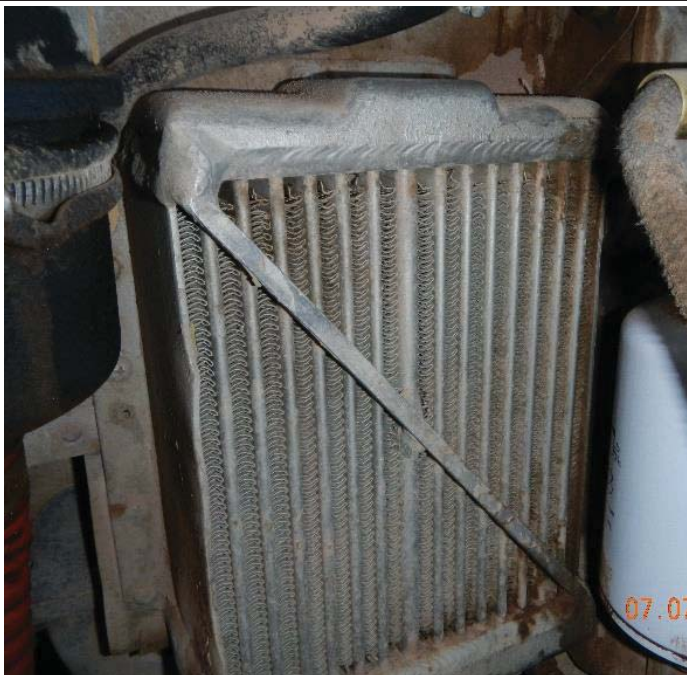
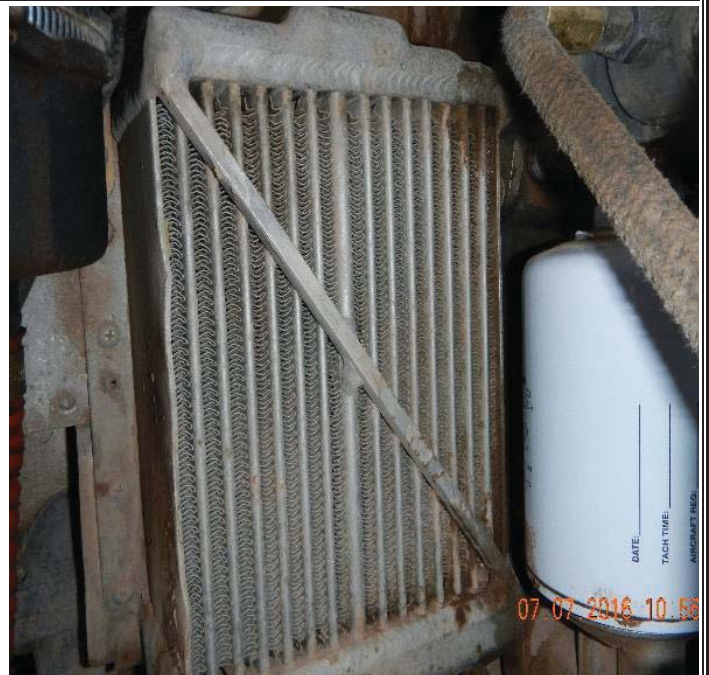
**OIL COOLER**

No damage was determined.

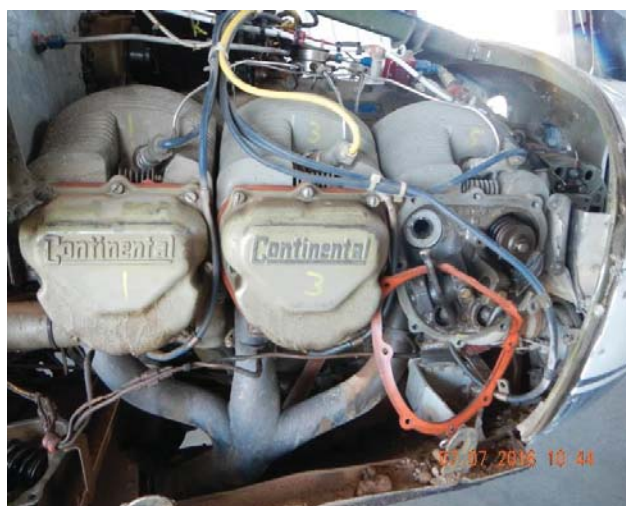
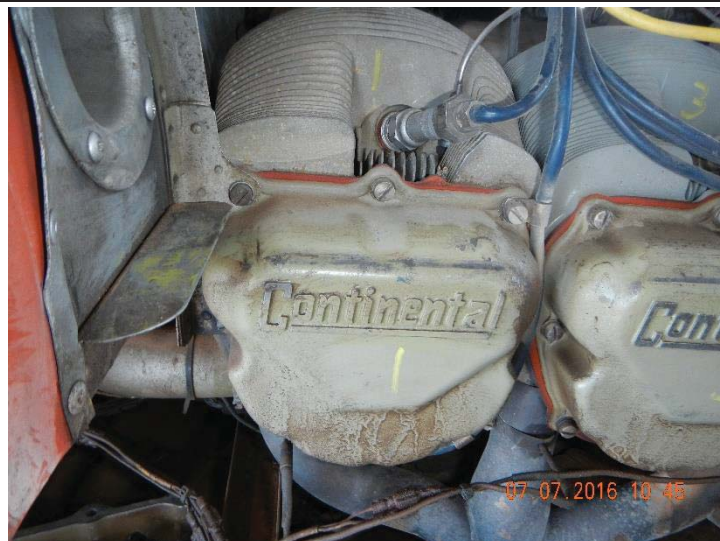
| Condition: | No damage was noted. | | |

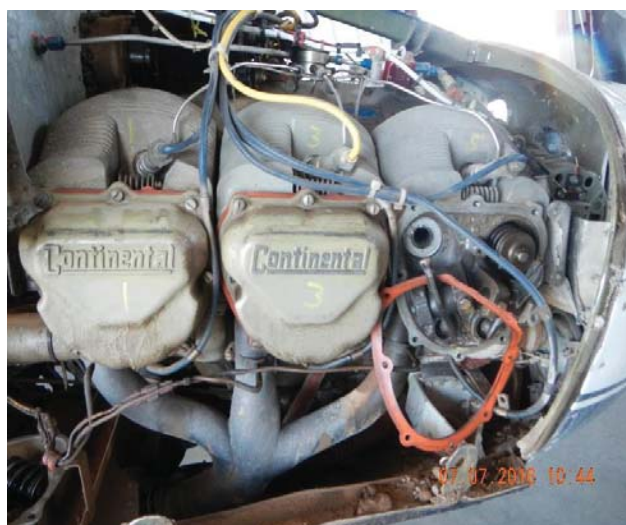
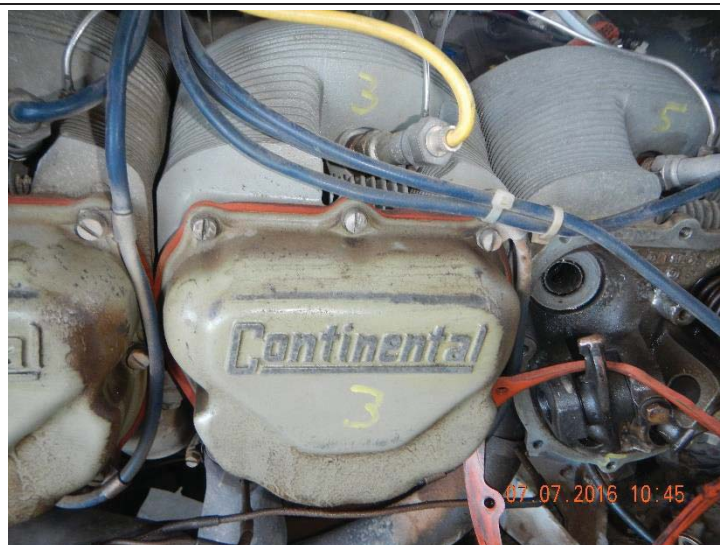
| <b>CYLINDER #3</b> | P/N: Undetermined | S/N: Undetermined | Head Date:<br>Undetermined |

| Condition: | No damage was noted. | | |

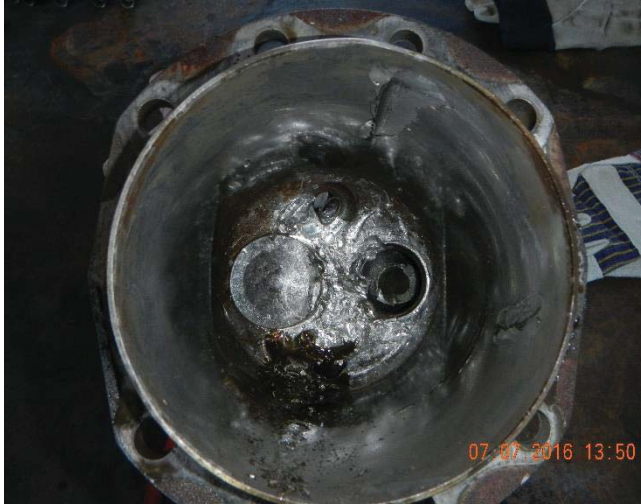
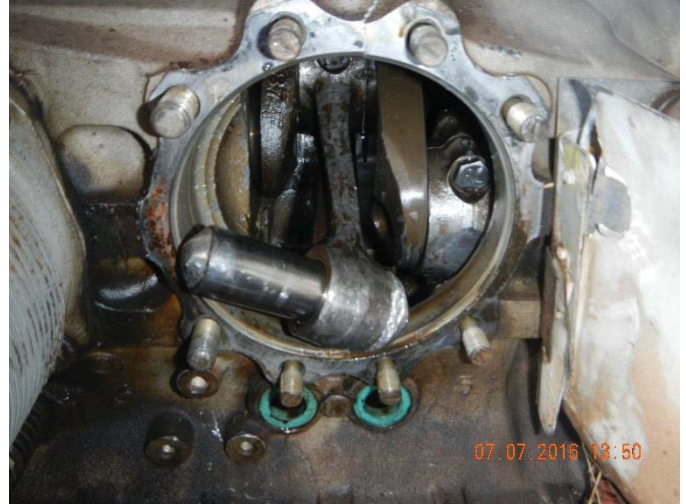
Rocker cover exhibited damage directly over the exhaust valve and valve spring assembly. Exhaust valve separated. Inner and outer valve springs, damaged valve spring keys, exhaust valve guide, valve spring retainers and rocker box screws were found in the previously removed rocker box cover. The intake push rod was bent. The cylinder was removed. The piston separated leaving only the piston pin and damaged connecting rod. The damaged piston and rings were found in the oil sump. The exhaust valve head was located in the oil sump with approximately 1/2" of valve stem protruding.

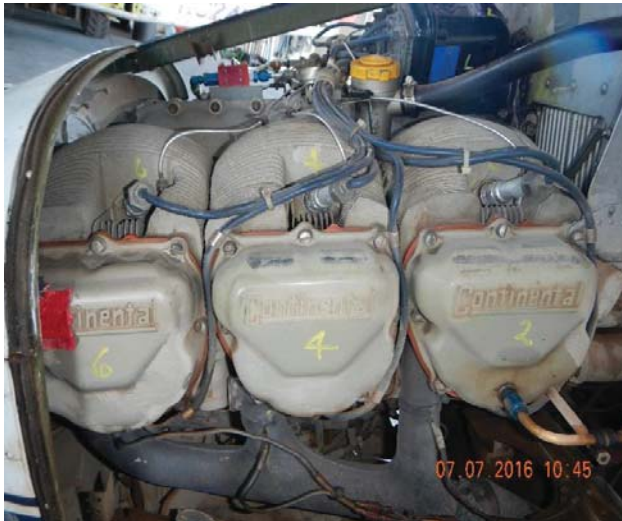
No damage was noted.

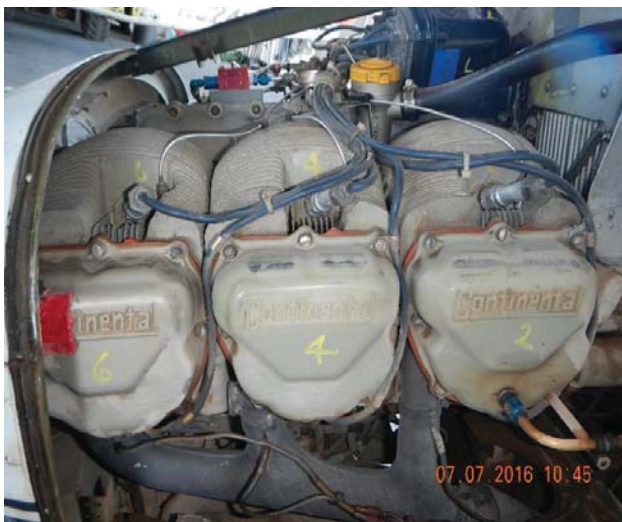
CYLINDER #4

No damage was noted.

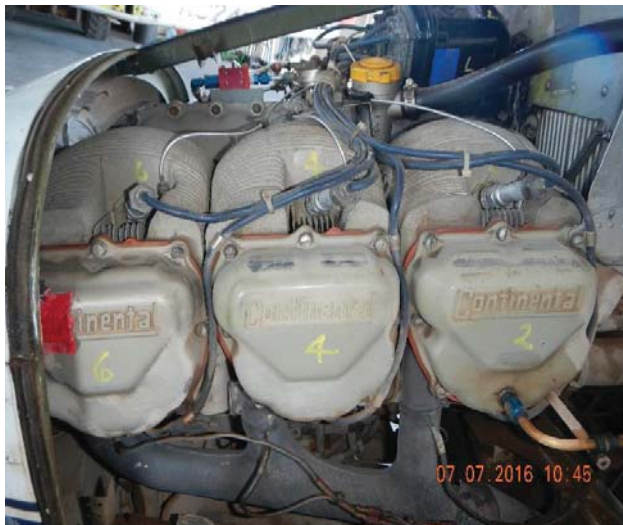
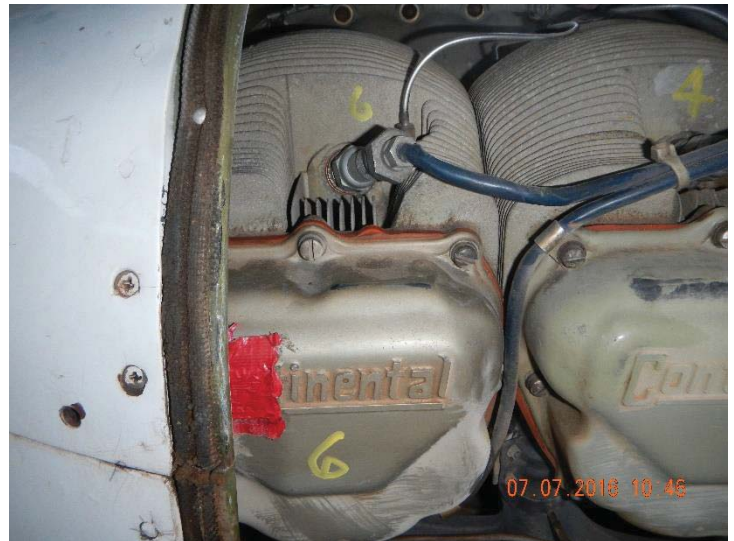
No damage was noted.

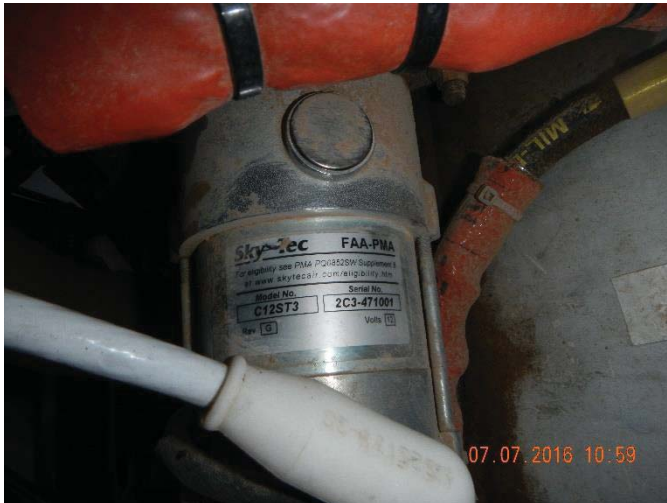
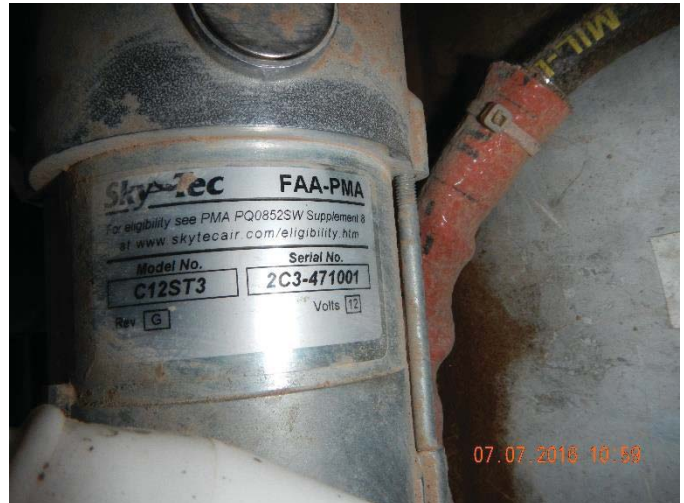
No damage was noted

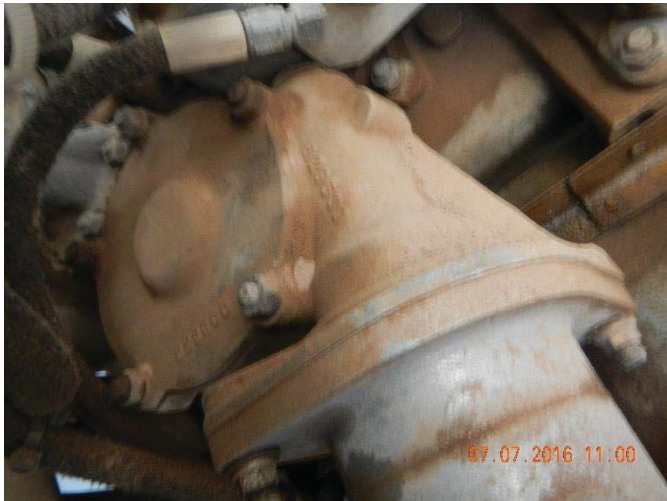
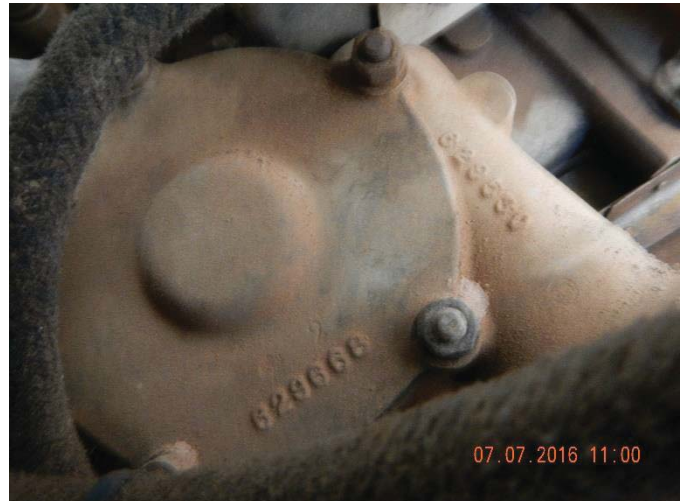
### STARTER ADAPTER

No damage was noted

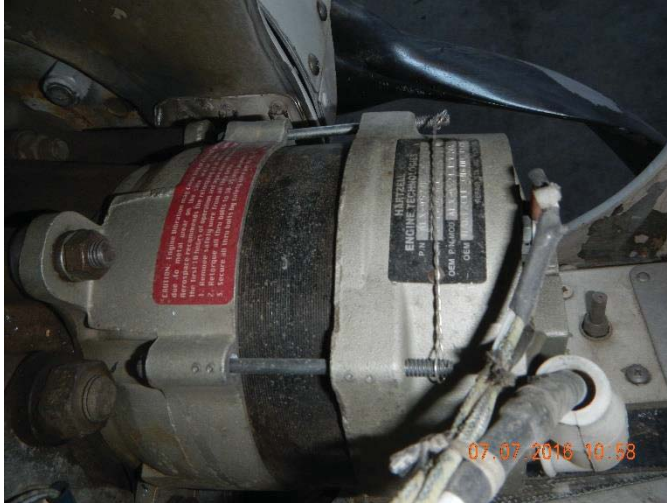
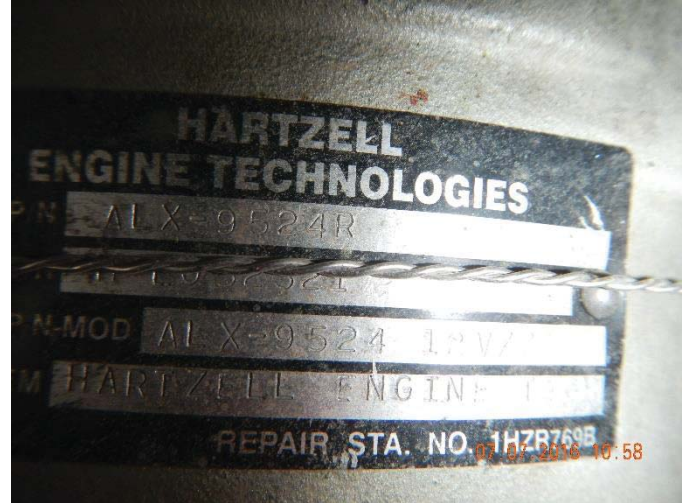
| <b>ALTERNATOR</b> | Manufacturer: Hartzell | P/N: ALX-9524R | S/N: H-L052321 |

| Condition: | No damage was noted. Logbook entry indicates a recent replacement of the alternator drive coupling for undisclosed reasons. |

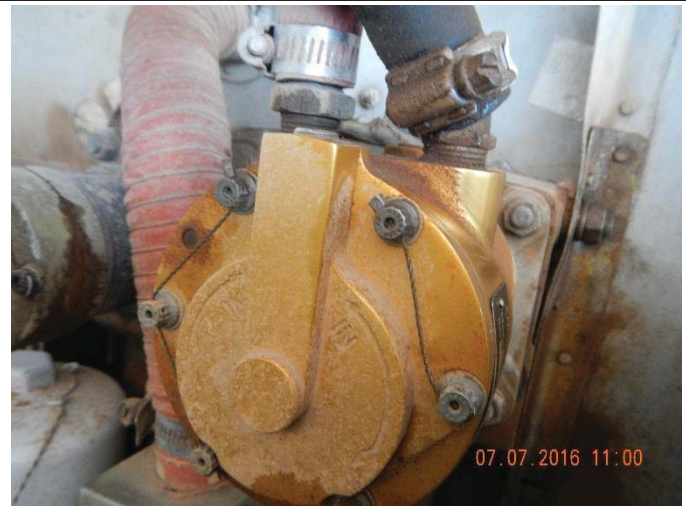
## VACUUM PUMP

| Condition: | No damage was noted. |
