# Continental Motors

## ENGINE EXAMINATION REPORT

| ENGINE MODEL | IO520K (1A) |
| FILE NUMBER | 16-327 |

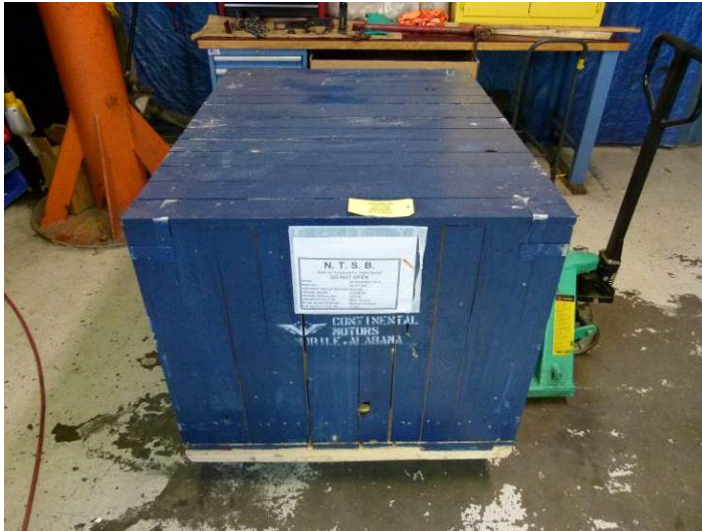
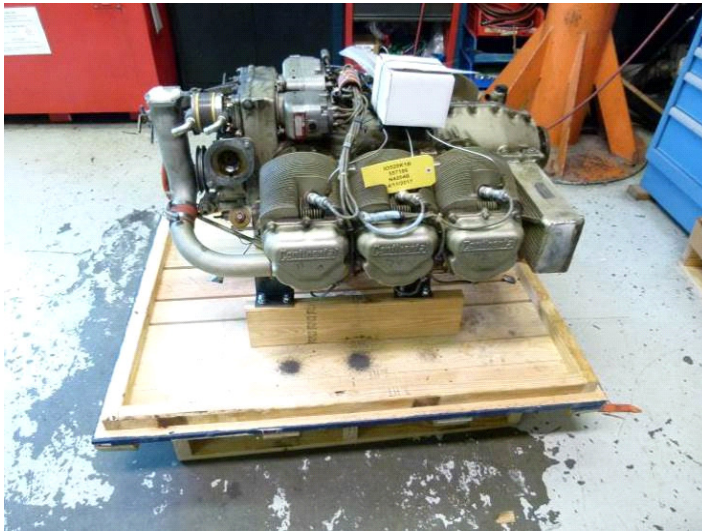
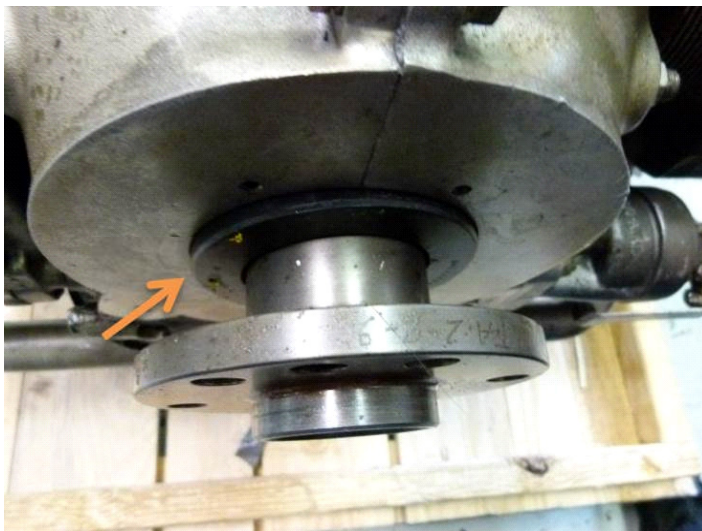
- 1) The electric starting motor was missing
- 2) The top portions of the right and left crankcases were broken-out and material was missing. Damaged internal engine components were visible.
- 3) The engine data plate was missing. The upper right crankcase was damaged where the data plate had been attached. An engine data plate with serial number **557186** was later located in a box shipped with the engine.
- 4) The nose seal assembly was protruding from the crankcase. The oil seal retainer plates and attaching hardware were not installed.

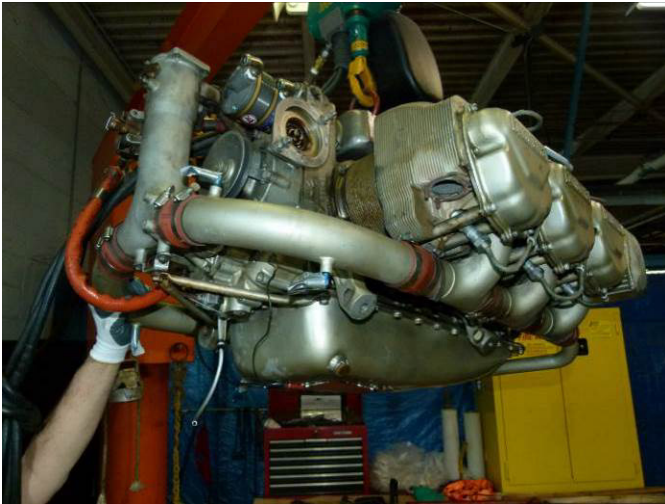
All induction components were intact and did not exhibit damage

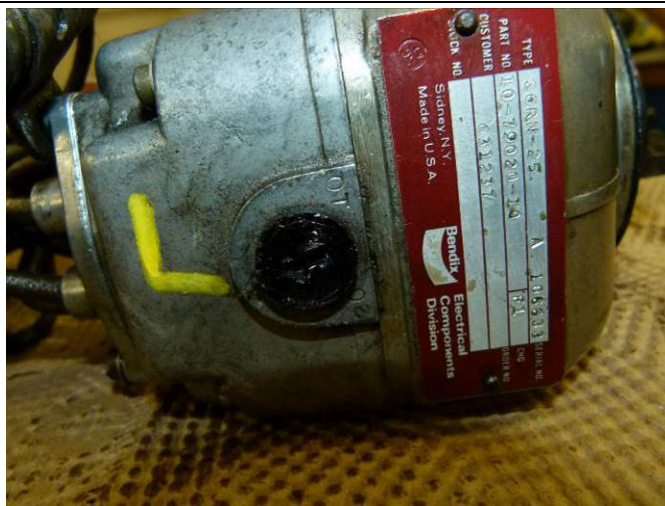
The magneto was bench tested and performed satisfactorily

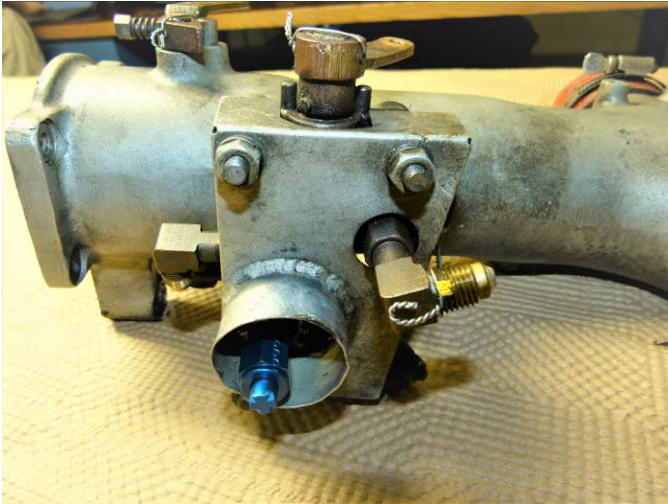
Condition: Control arms were secured correctly. The throttle plate operated correctly. The fuel screen was uncontaminated. A small amount of fuel drained from metering unit when storage caps were removed.

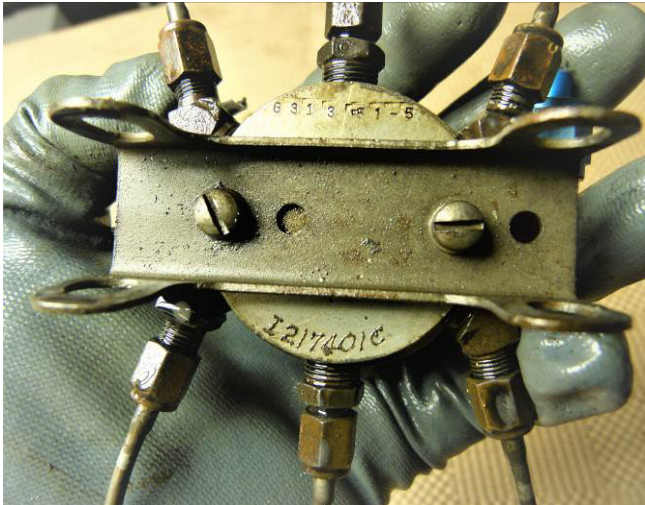
| FUEL MANIFOLD VALVE | Manufacturer: Undetermined | P/N: 631351-5 | S/N: I217401C |

| Condition: | Assembly screws were secured and a lead seal was in place. Data plate missing. | | |

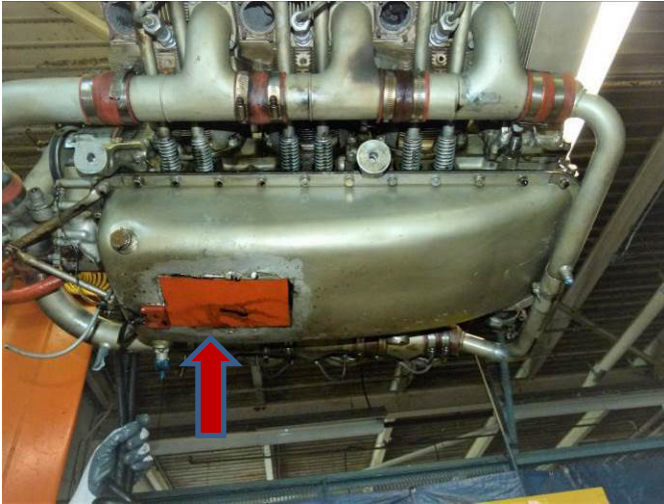
#### OIL SUMP

Condition: The oil sump was undamaged. Metal contamination was exhibited when the oil sump was removed. **NOTE:** The oil sump heat pad was tested and found operational. Red arrow points to installed oil sump heat pad.

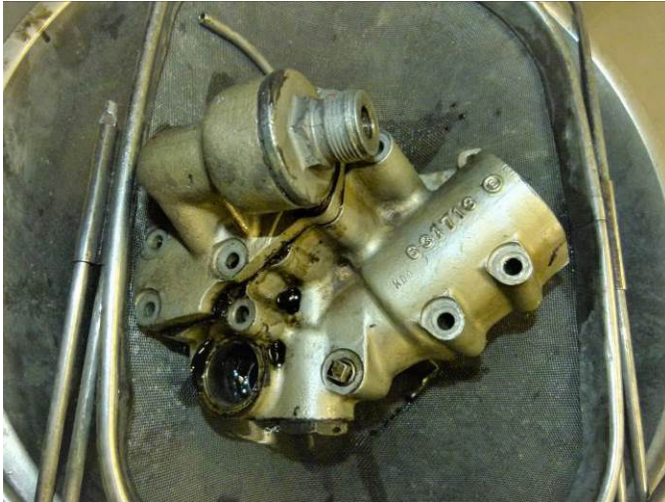
The oil pump was disassembled and inspected. The sealant on the parting surface does not appear to be sealant used by CMI at this location. The pump chamber and cover plate exhibits evidence of hard partial passage and pitting. Pump gears indicated wear and light scratches from metal contamination.

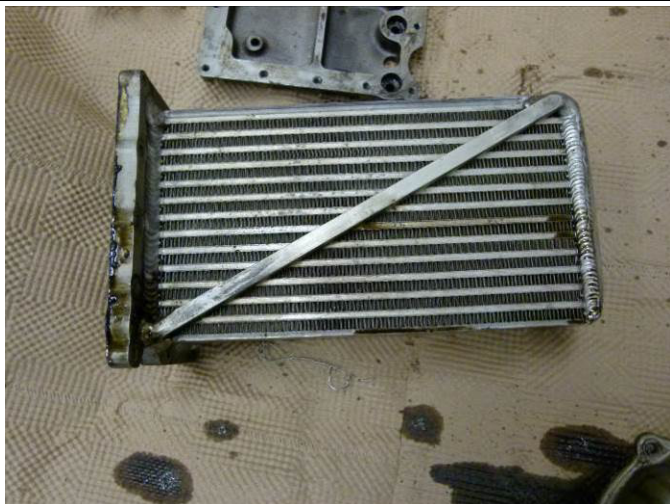
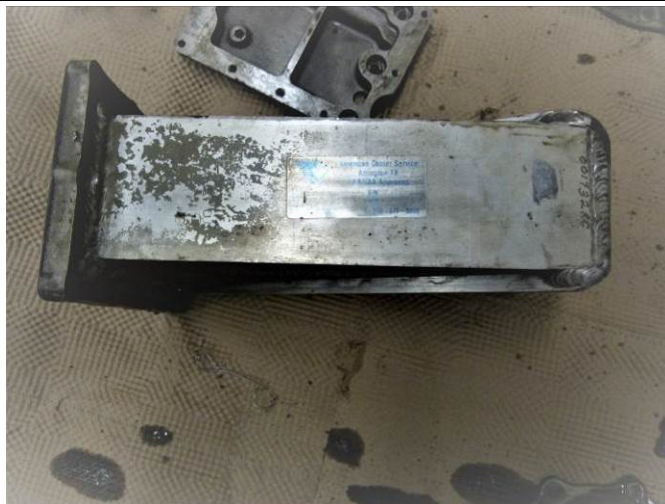
Condition: The oil cooler did not exhibit damage

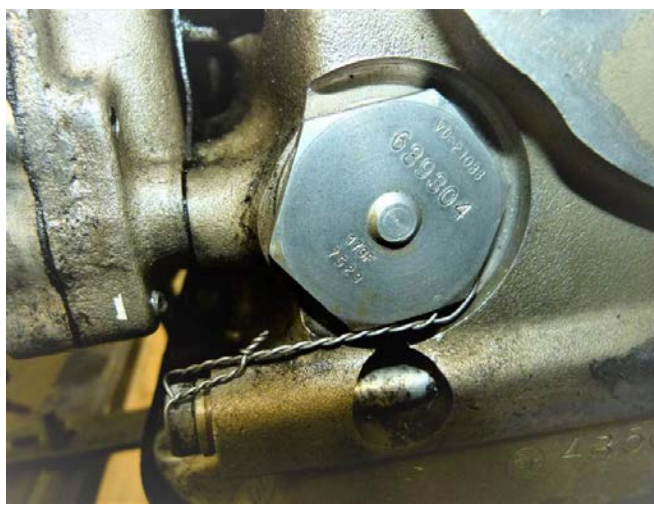
## VERNATHERM

Condition: The vernitherm was removed and functionally tested. When heated in liquid, the spring extends fully at 178 °F. Specified travel range is from 3 inches to 3.262 inches. This component met specifications during the functional test.

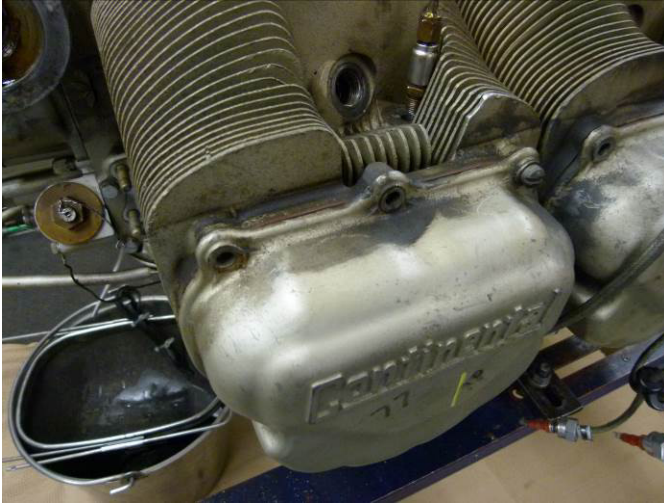
| Condition: | Externally, cylinder 1 did not exhibit impact damage. | | |

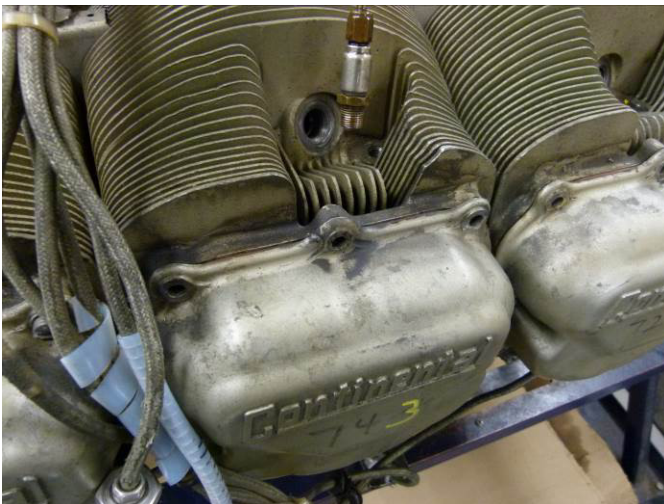
| <b>CYLINDER #3</b> | P/N: 639272D | S/N: Undetermined | Head Date: 9/74 |

| Condition: | Externally, cylinder 3 did not exhibit impact damage. Internally, the cylinder skirt was damaged by released rotating components. | | |

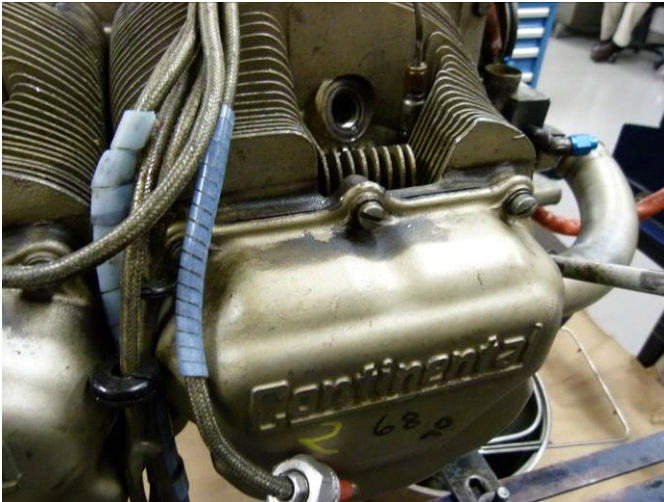
| <b>CYLINDER #2</b> | P/N: 639272D | S/N: Undetermined | Head Date: 9/74 |

| Condition: | Externally, cylinder 2 did not exhibit impact damage. | | |

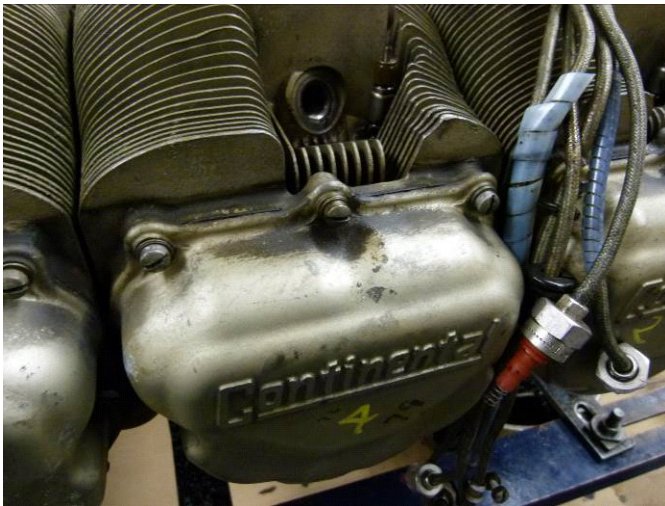
Externally, cylinder 4 did not exhibit impact damage. Internally, the cylinder skirt was damaged by released rotating components.

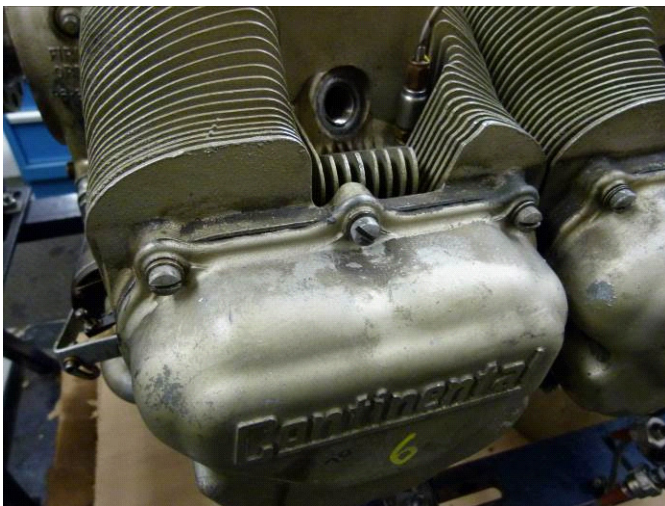
## CYLINDER #6

Externally, cylinder 6 did not exhibit impact damage.

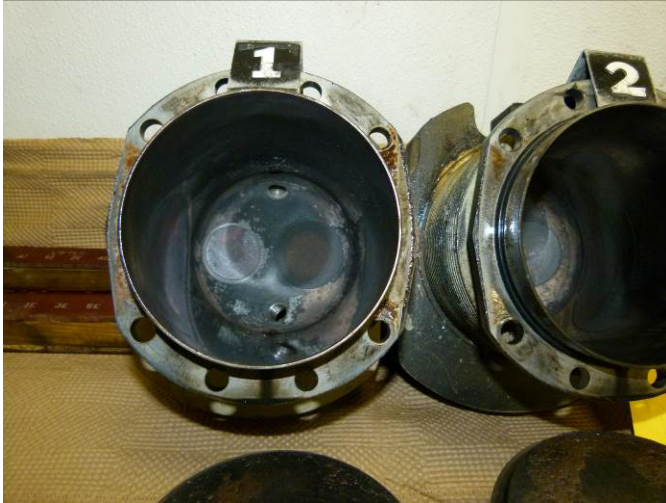
All valves were intact with normal combustion signatures. No photo available for cylinders 3 or 4

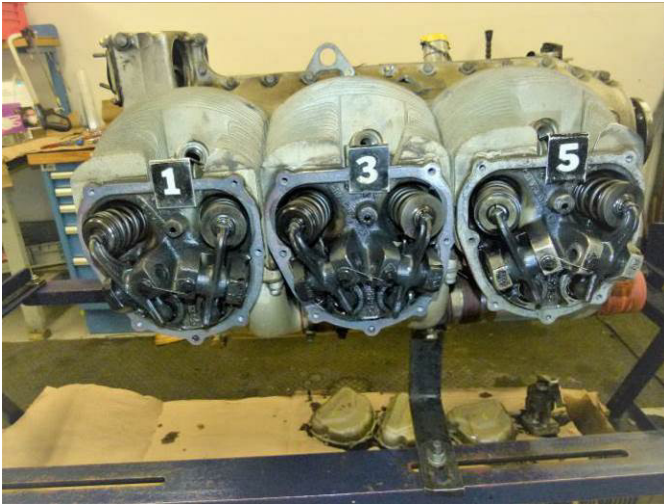
All rocker arms and shafts were intact and did not exhibit damage.

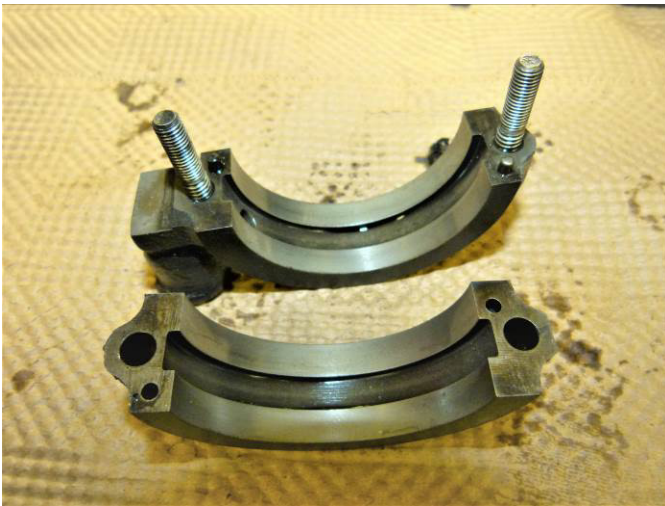
## TRANSFER COLLAR

The transfer collar exhibited normal wear patterns.

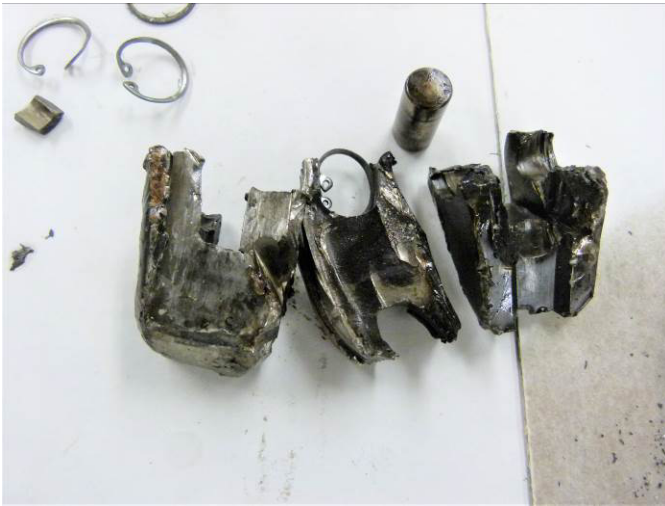
The rear counter weights were intact and free to move on pins. One of the forward counter weights released for undetermined reasons. The opposing forward counterweight remained attached to pins but was damaged.

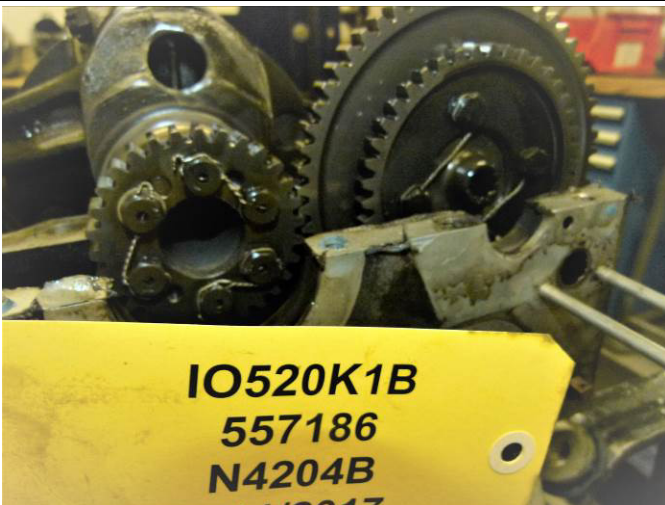
### INTERNAL TIMING

The internal timing marks aligned when piston 1 was positioned at top dead center

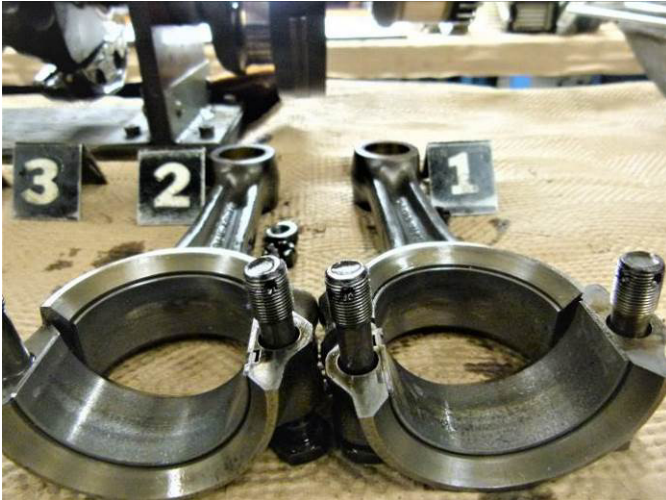
Condition: The bearing exhibited hard particle passage and contamination embedded in the Babbitt layer.

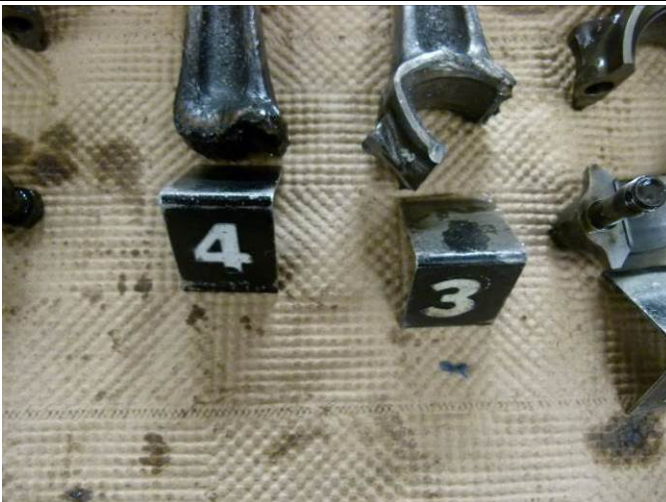
## #3 CONNECTING ROD

Condition: #3 rod was damaged and the rod cap separated.

Condition: #3 rod bearing was extruded and destroyed from mechanical damage.

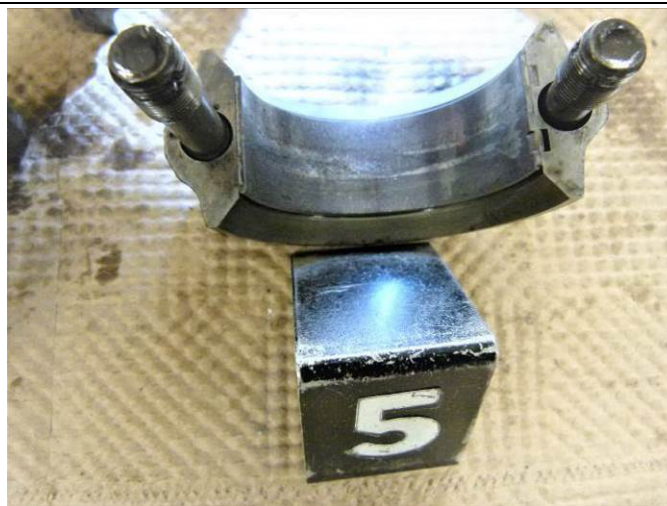
Condition: The bearing exhibited hard particle passage and contamination embedded in the Babbitt layer.

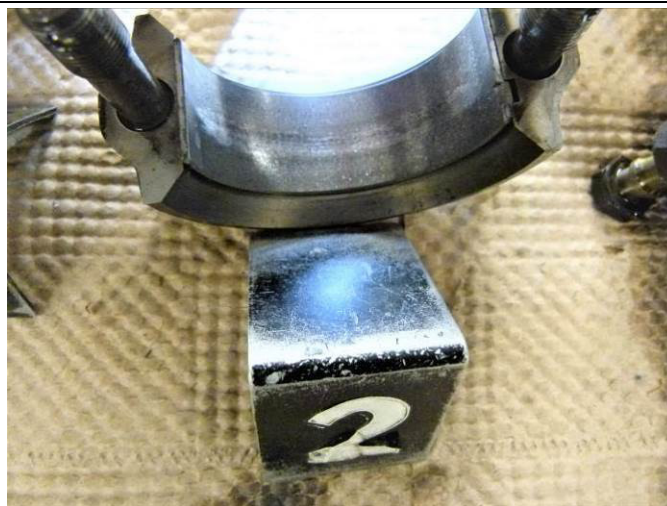
Condition: The bearing exhibited hard particle passage and contamination embedded in the Babbitt layer.

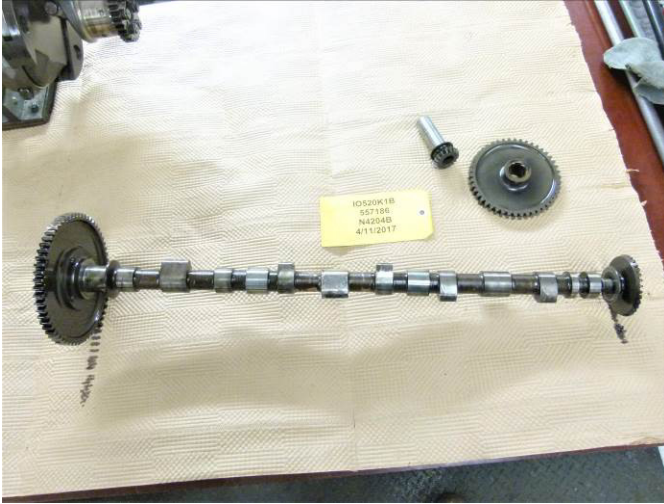
| <b>Condition:</b> | The camshaft received impact damage from released counter weight. |

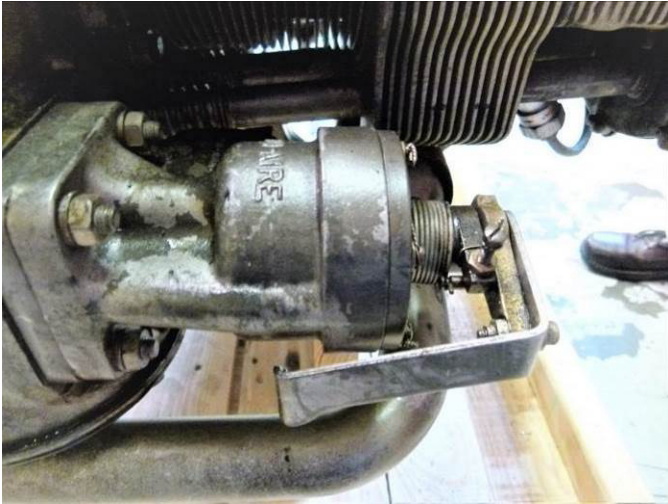
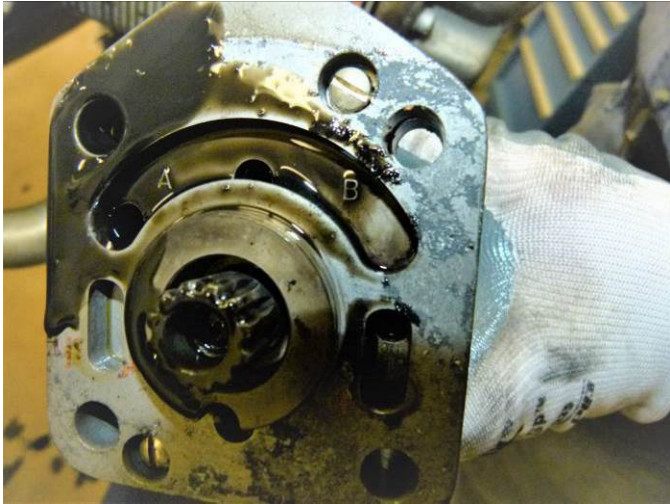
| Condition: | The propeller governor did not exhibit damage. The installation gasket was incorrect. A shipping gasket was installed instead of the required gasket with an integral screen. | | |
