# ENGINE EXAMINATION REPORT

| AIRCRAFT MAKE & MODEL | Beechcraft 58 Baron |
| FILE NUMBER | 18-383 |

| EXAMINATION | | ACCIDENT DATA | |
|---|---|---|---|
| <b>DATE</b> | 10-8-2019 | <b>NTSB ACCIDENT #</b> | CEN19FA124 |

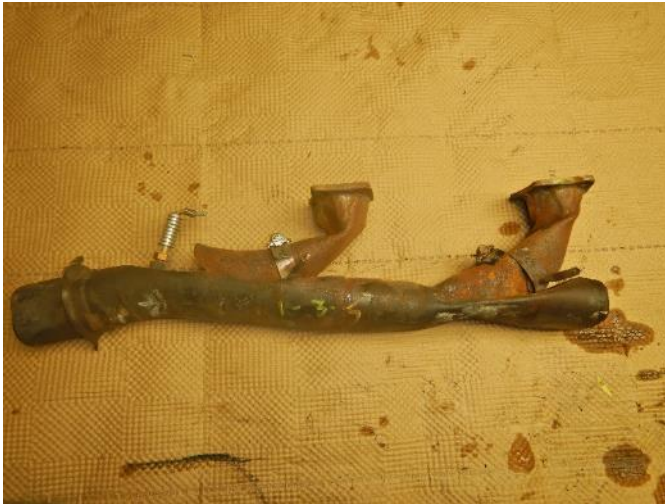
#### EXHAUST SYSTEM

Condition: The left and right exhaust collector and risers exhibited crushing impact damage

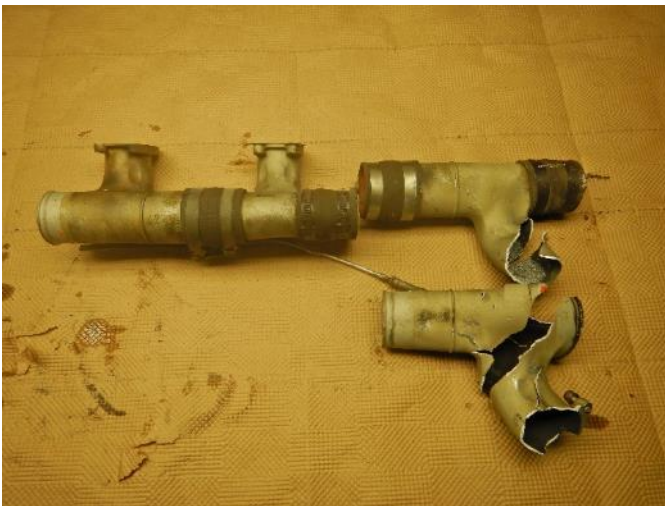
#### INDUCTION SYSTEM

Condition: Induction elbows and connectors exhibited impact damage

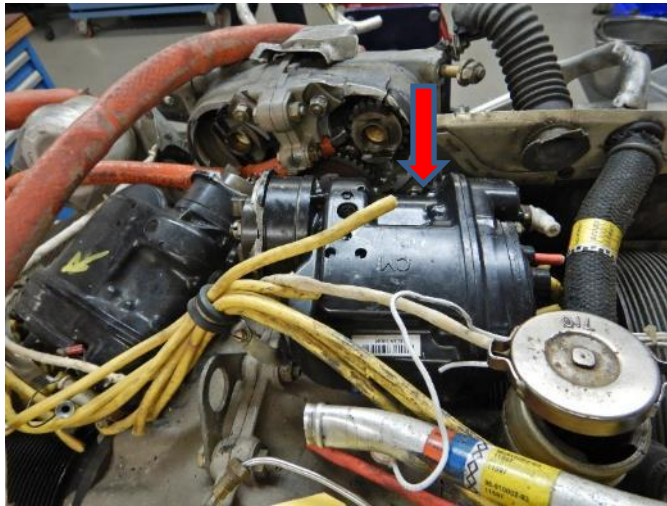
The magneto mounting ring was impact damaged, but the magneto operational test was normal producing spark at each ignition lead.

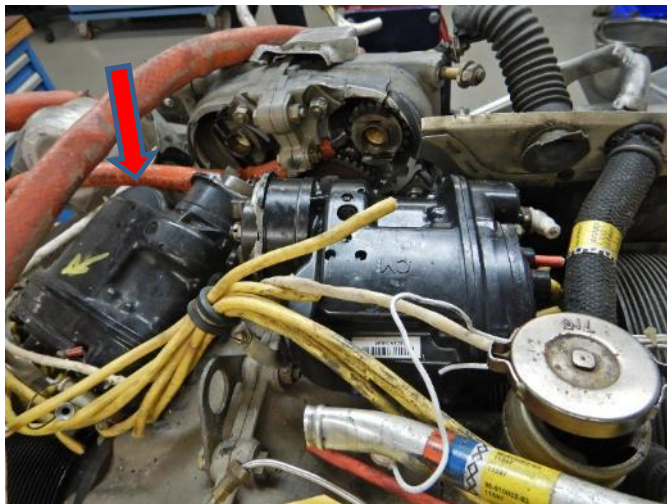
### RIGHT MAGNETO

The magneto mounting ring was impact damaged, but the magneto operational test was normal producing spark at each ignition lead.

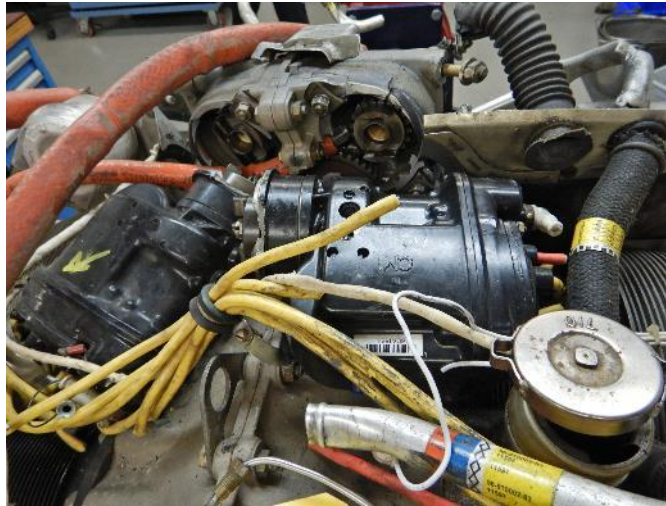
Condition: Several individual ignition leads exhibited impact damage with leads cut and pinched.

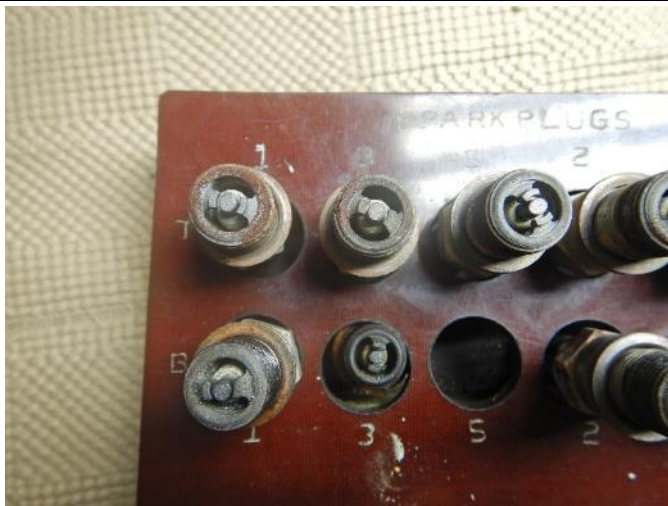
## SPARK PLUGS

Condition: Minimal combustion deposits were present consistent with a lean fuel/air mixture. The sparkplug condition was normal to worn-out normal when compared to a Champion Check-A-Plug chart. Sparkplugs from # 4 (top) and # 3 & 5 (bottom) were impact damaged.

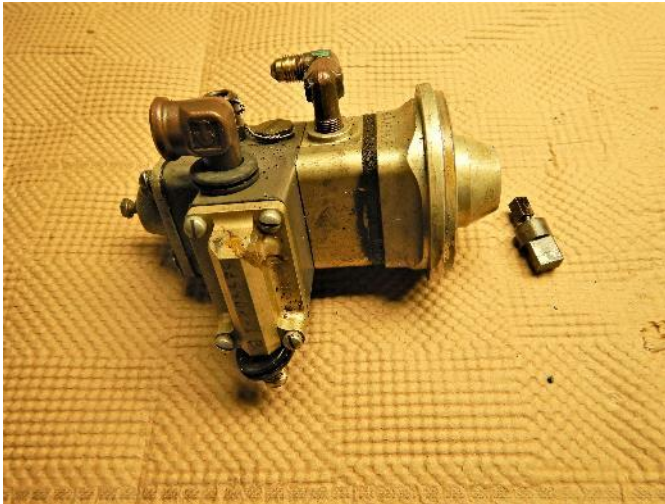
| FUEL PUMP | Manufacturer: Continental | P/N: R646212-55A1 | S/N: B16CA080R |
|---|---|---|---|
| Condition: | According to <i>Field Notes</i> from the accident site, "The coupling was intact, and the pump operated smoothly when manually rotated." At the Analytical Exam, the pump shaft would not slide from the fuel pump case due to light corrosion. Otherwise, the pump was normal in appearance. Pump impellers were intact. | | |

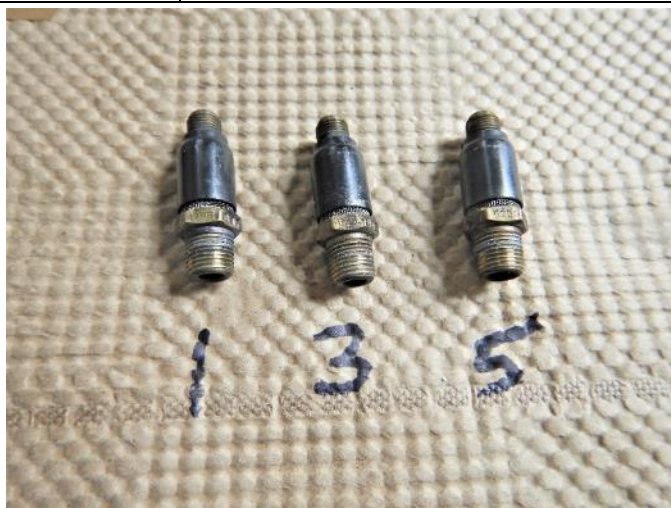
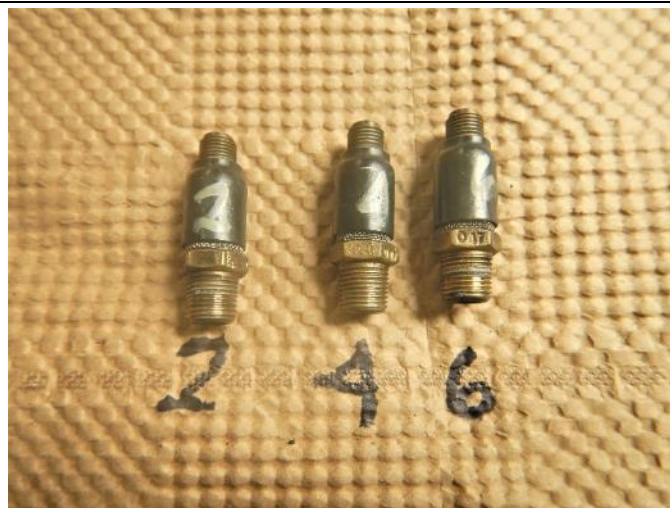
## FUEL NOZZLES AND LINES

Condition: #4 exhibited impact damage. All other were undamaged and open.

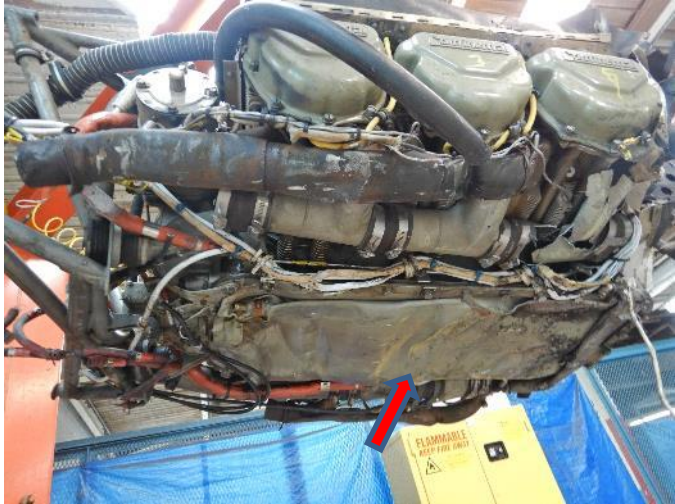
#### OIL SUMP

Condition: The oil sump was impact crushed.

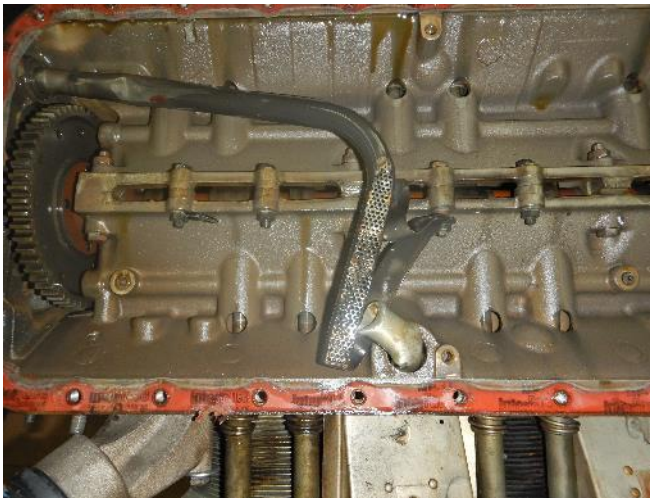
#### OIL PICK-UP TUBE & SCREEN

Condition: The pickup tube was clean, and the suction tube was impact damaged.

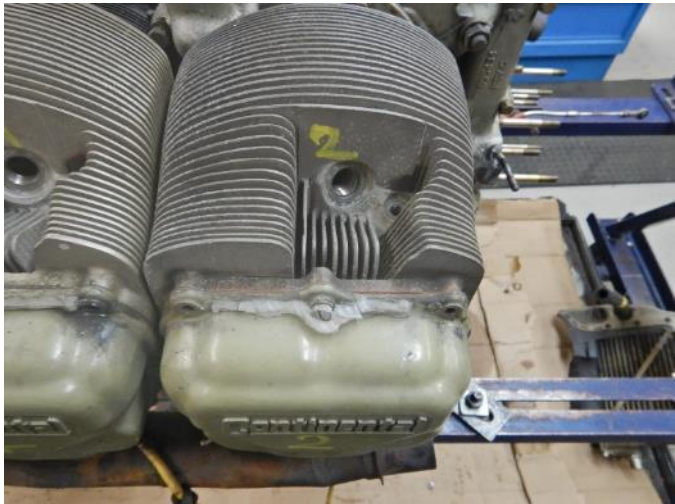
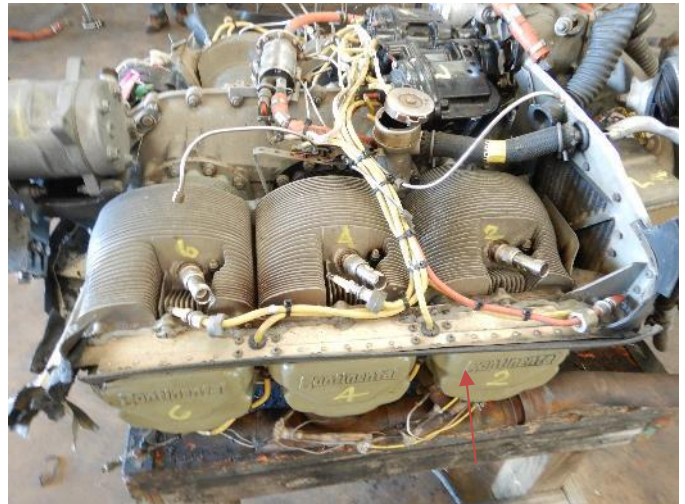
| Condition: | No damage to the cylinder was noted. |

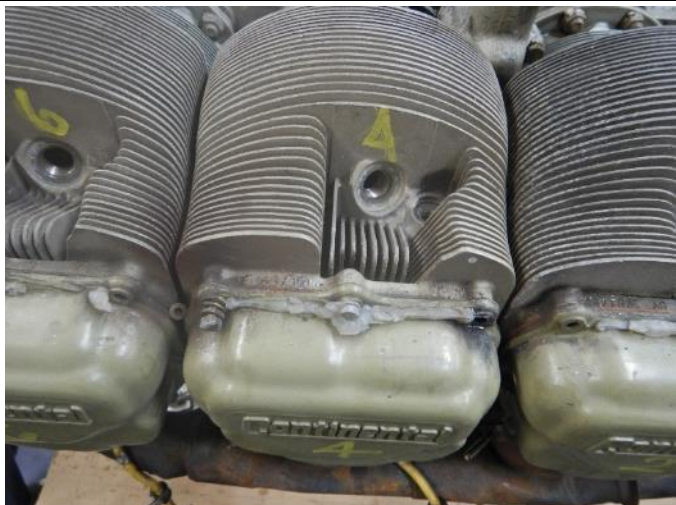
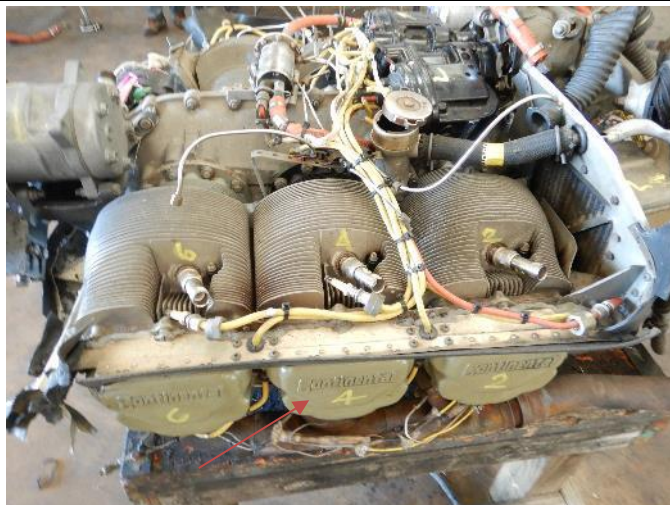
| Condition: | No damage to the cylinder was noted. |

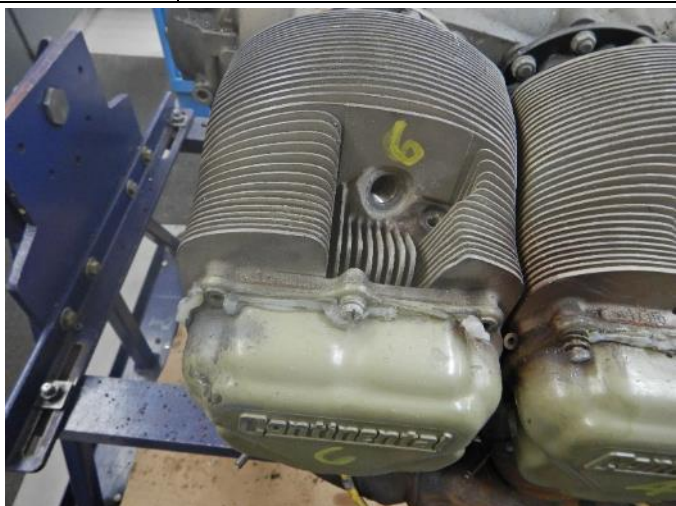
| <b>CYLINDER #6</b> | P/N: 658552A1 | S/N: AC16BA109 | Head Date: 3/16 |

| Condition: | No damage to the cylinder was noted. |

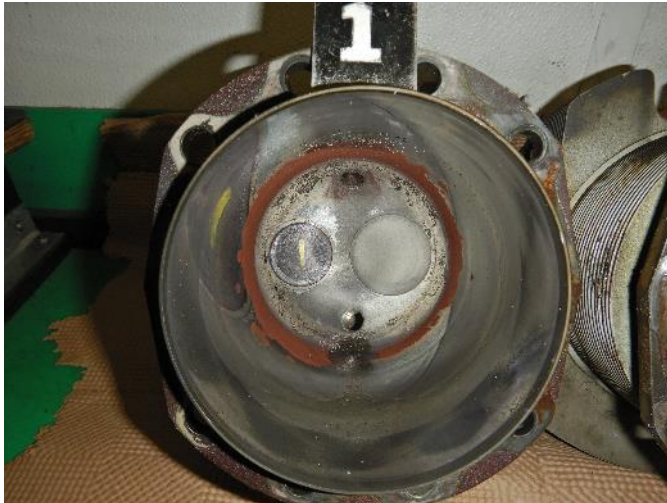
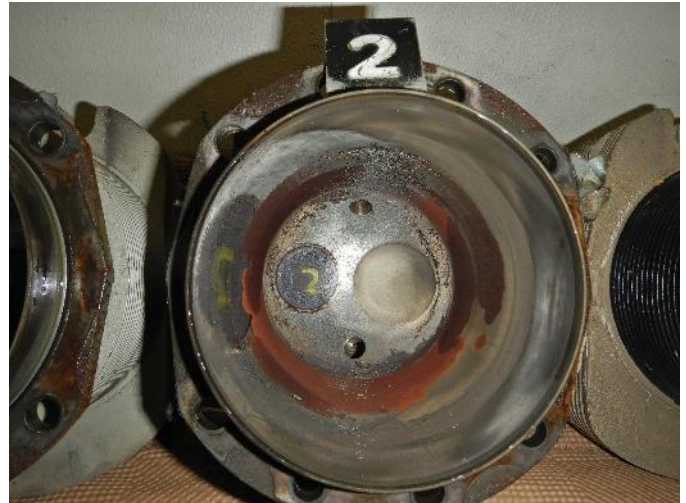
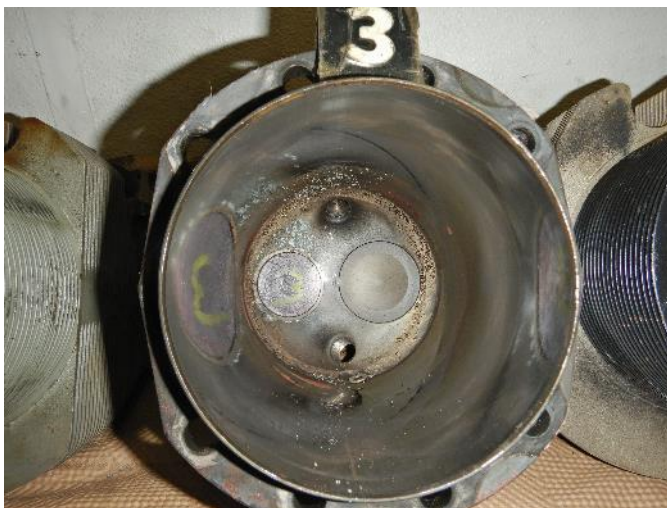
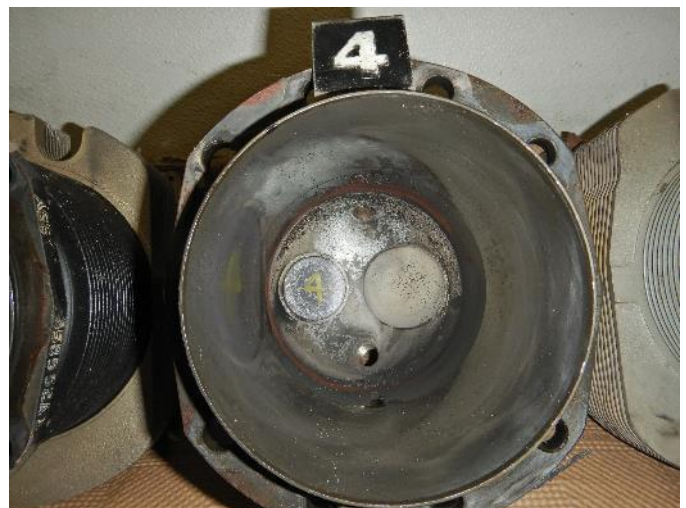
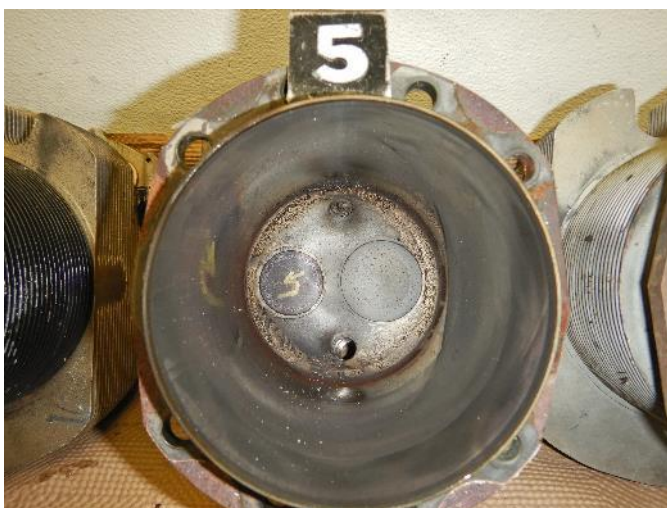
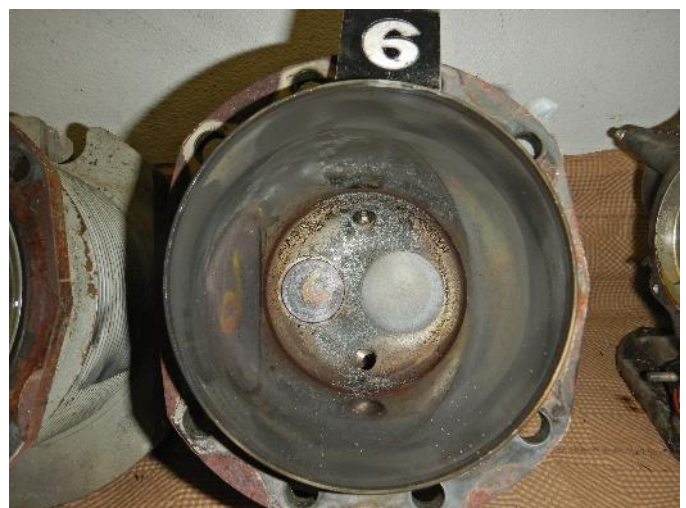
All valves were intact and exhibited normal combustion signatures and deposits.

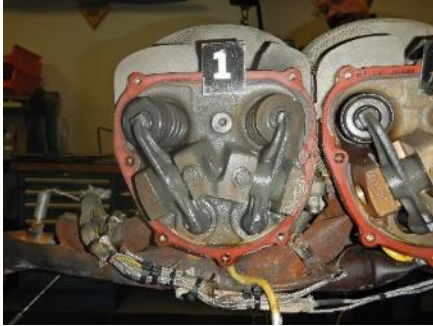
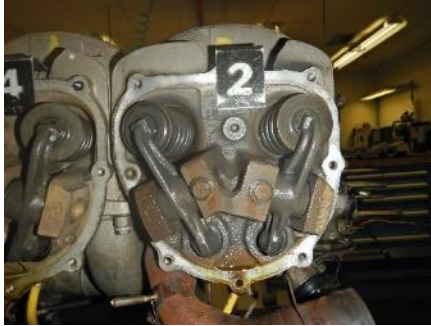
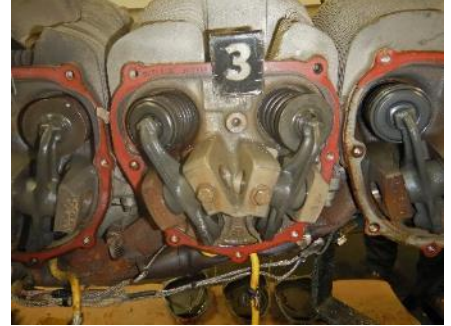
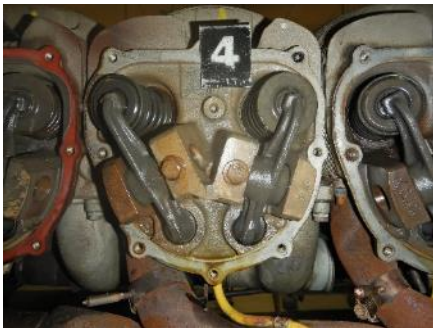
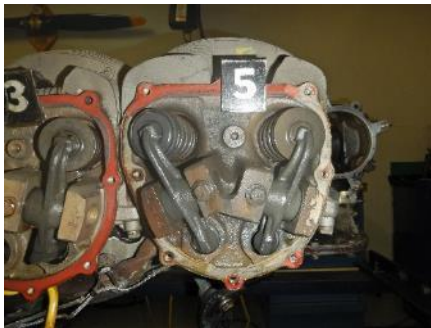
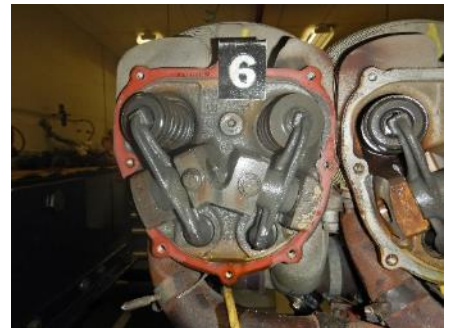
All rocker arms and shafts were intact and in proper position

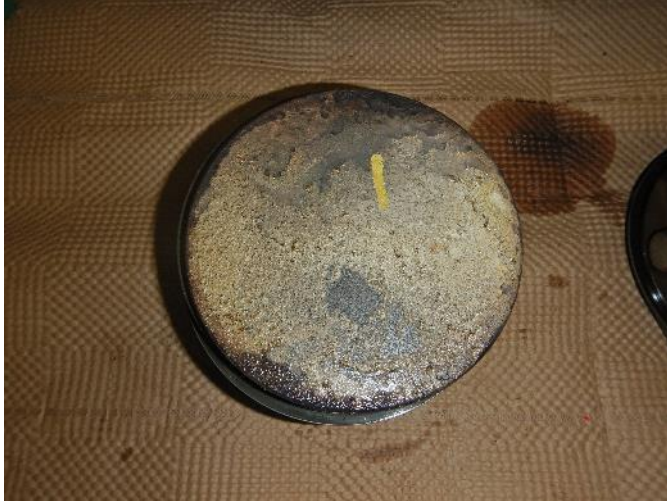
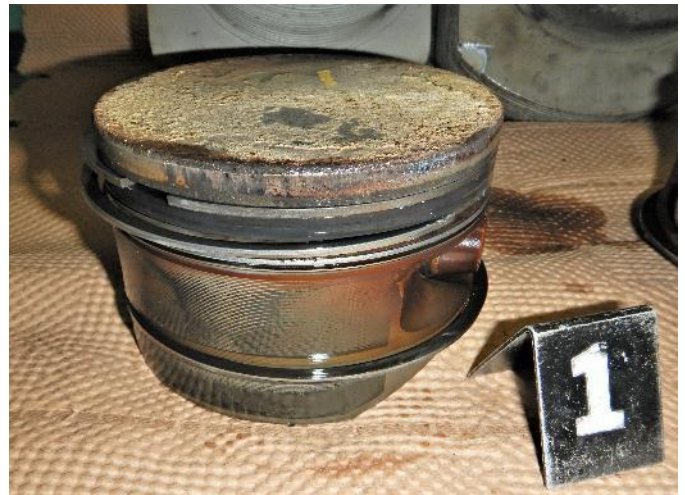
Piston exhibited normal combustion deposits. Rings were intact and free in their grooves.

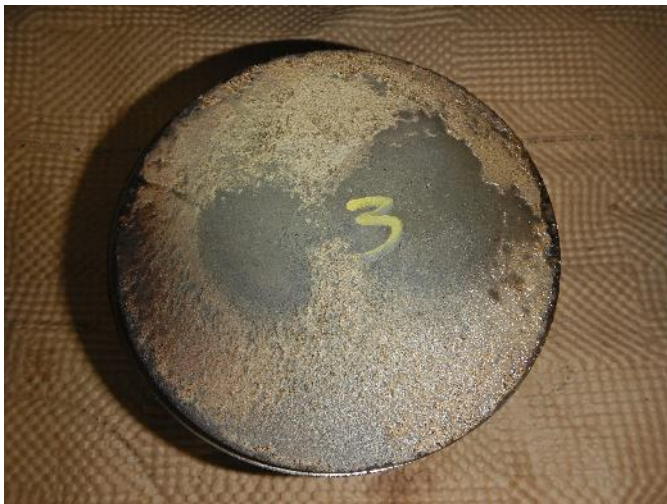
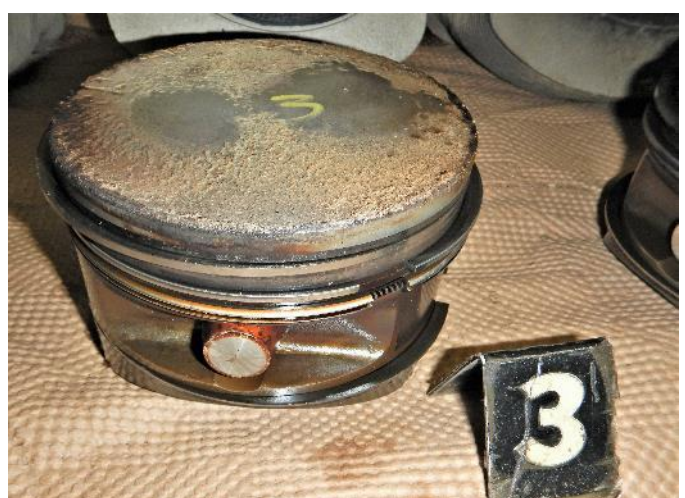
## #3 PISTON & RINGS

Piston exhibited normal combustion deposits. Rings were intact and free in their grooves.

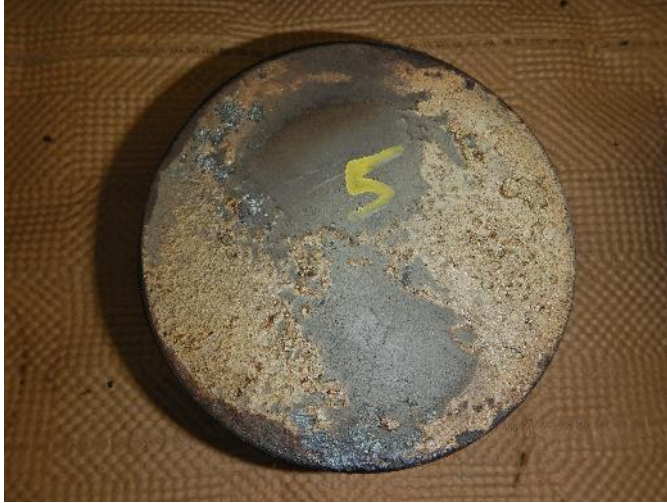
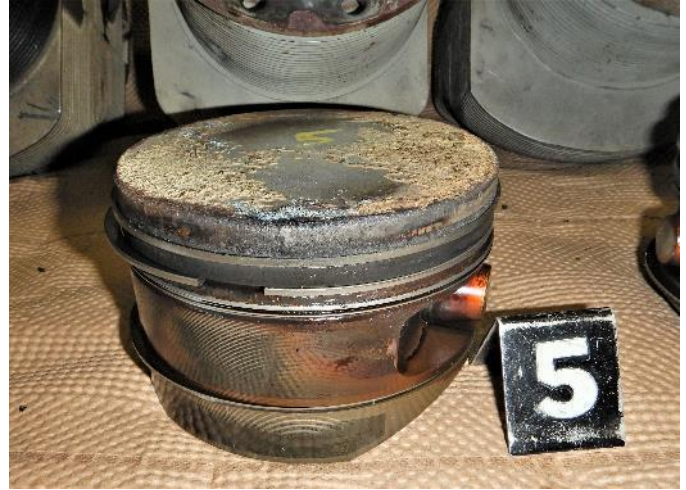
Piston exhibited normal combustion deposits. Rings were intact and free in their grooves.

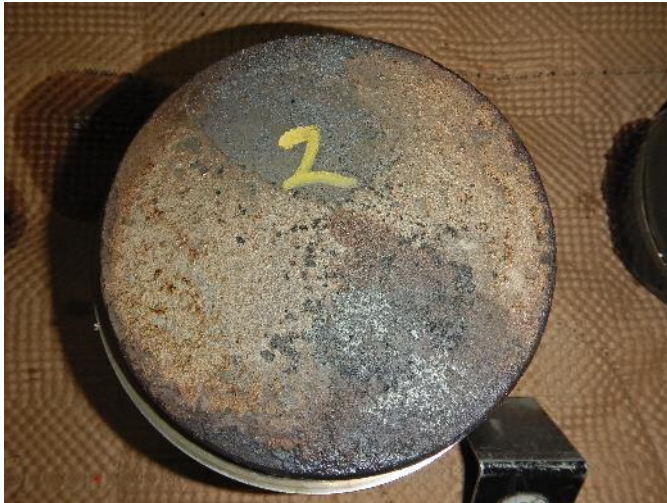
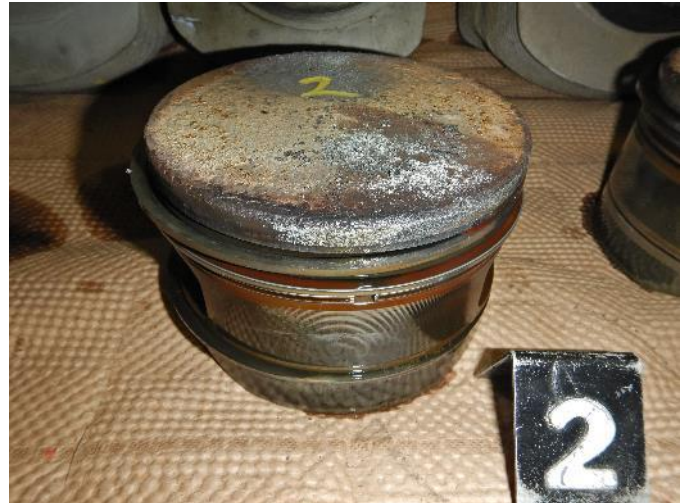
## #2 PISTON & RINGS

Piston exhibited normal combustion deposits. Rings were intact and free in their grooves.

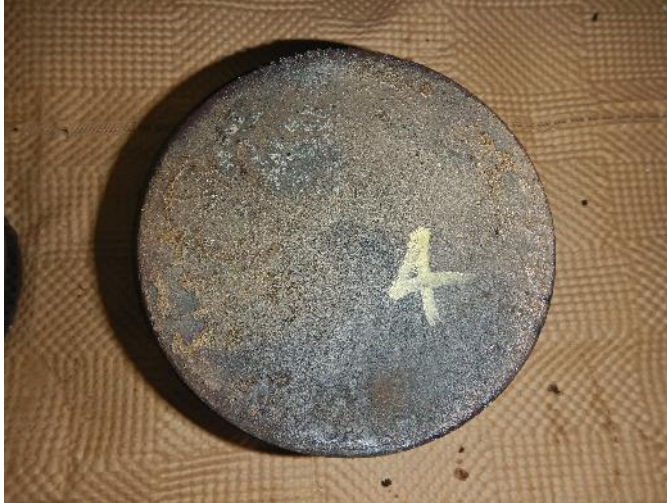
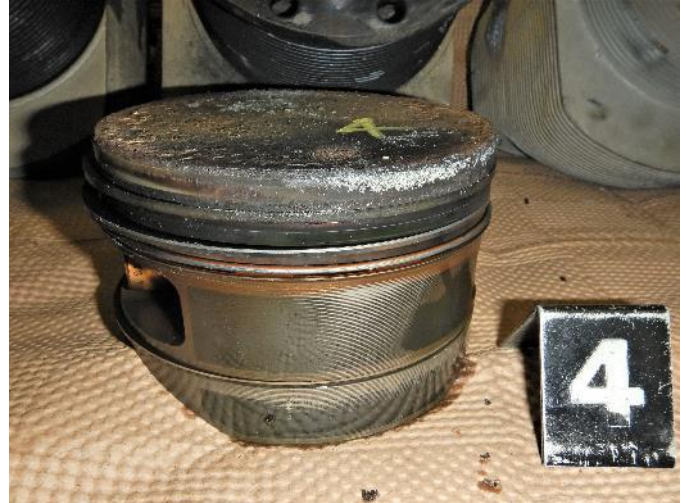
Piston exhibited normal combustion deposits. Rings were intact and free in their grooves.

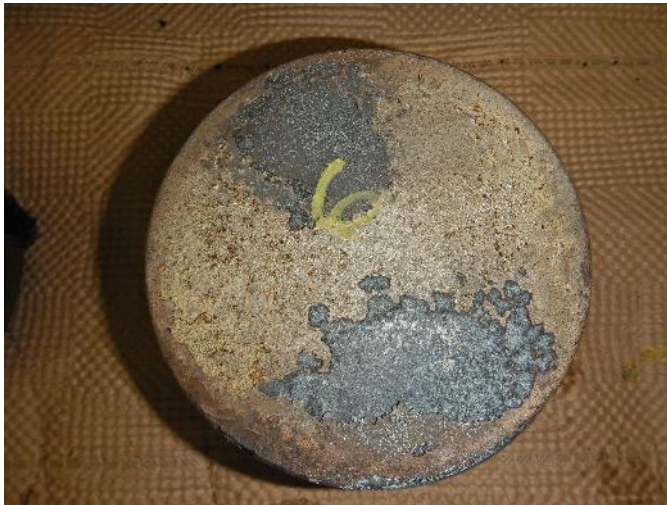
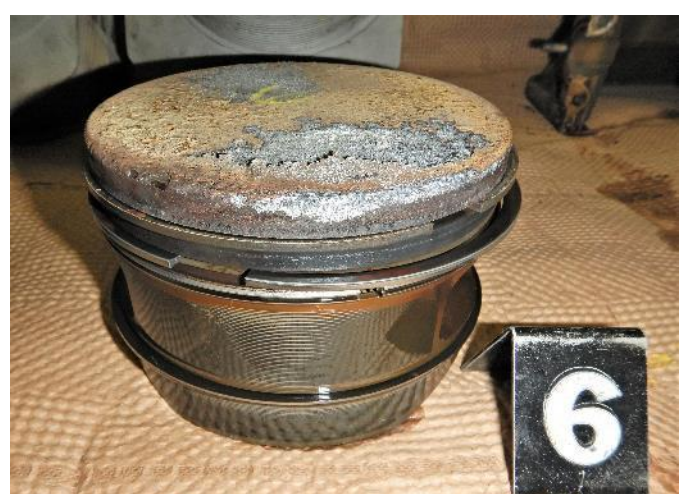
## #6 PISTON & RINGS

Piston exhibited normal combustion deposits. Rings were intact and free in their grooves.

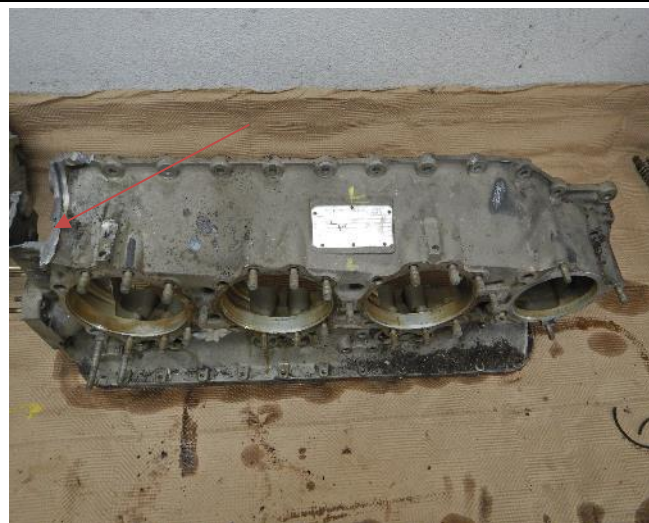
The top rear portion of the crankcase halves separated during disassembly of the engine due to impact damage near the magneto mounts. Otherwise, the crankcase was unremarkable. See red arrows.

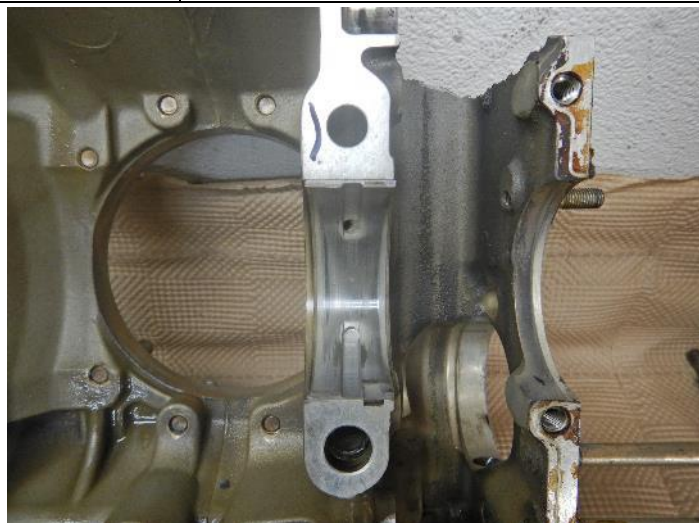
Condition: Bearing exhibited normal signatures.

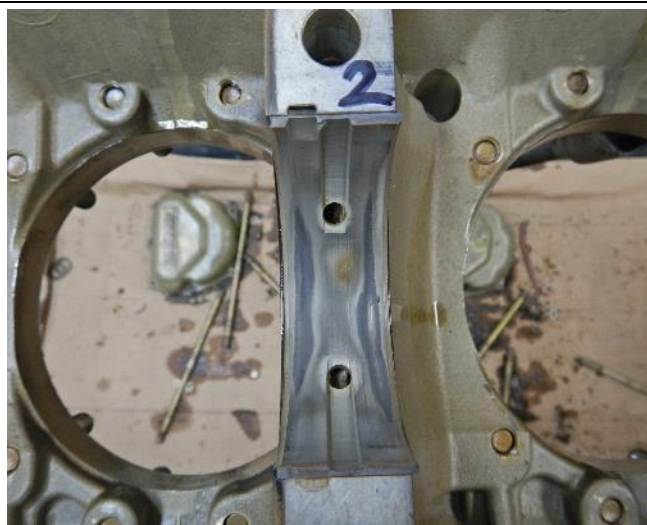
## #2 MAIN BEARINGS

Condition: Bearing exhibited normal signatures.

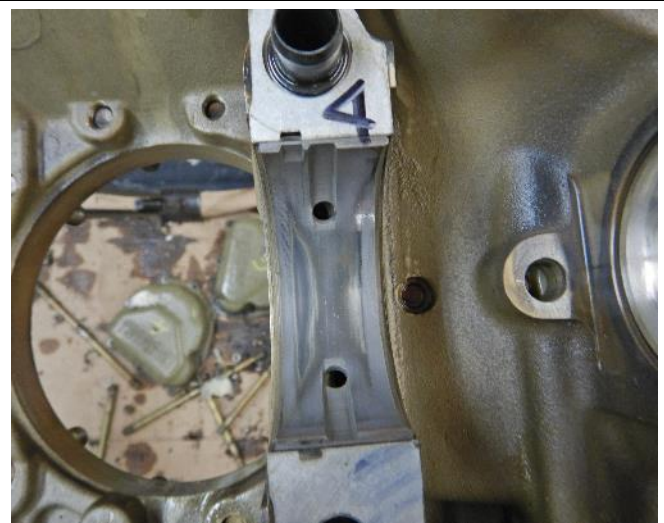
## #4 MAIN BEARINGS

Bearing exhibited normal signatures.

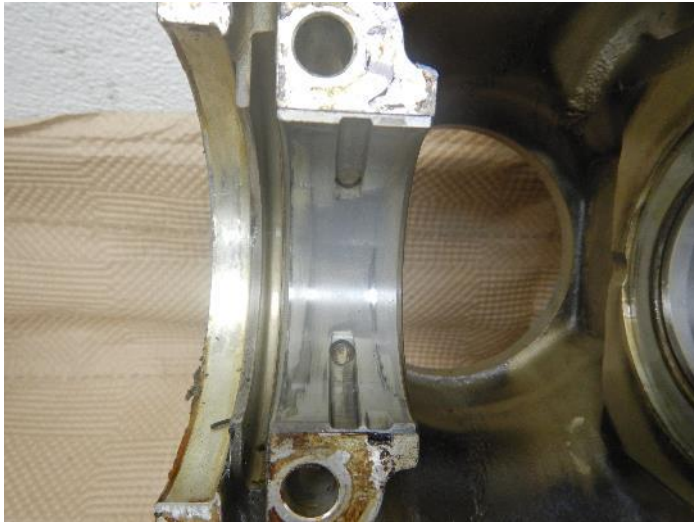
Bearing exhibited normal signatures.

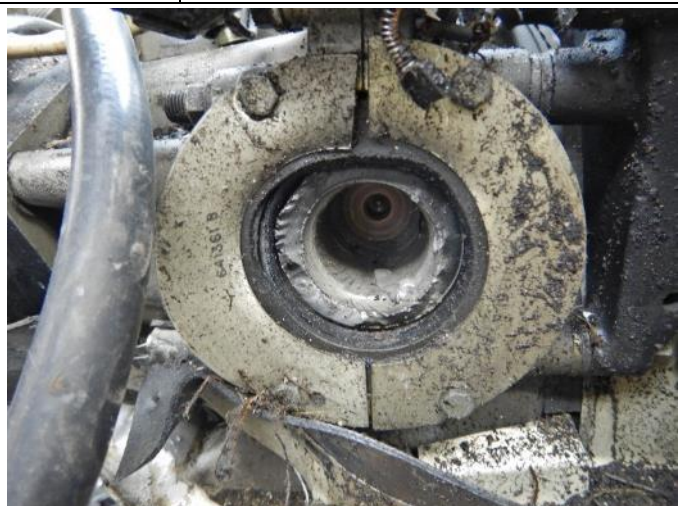
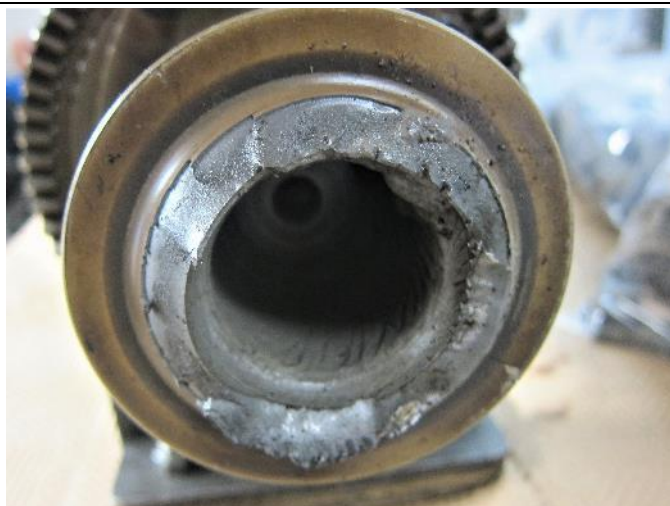
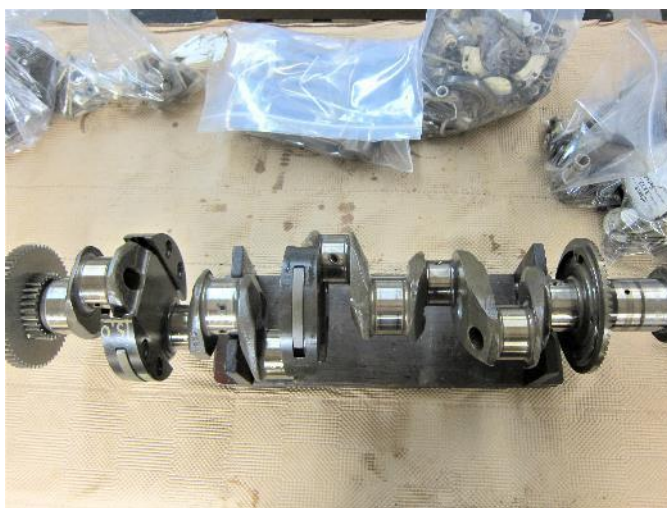
The propeller flange was fractured from impact at the crankcase seal. The main and rod journals exhibited normal operating signatures.

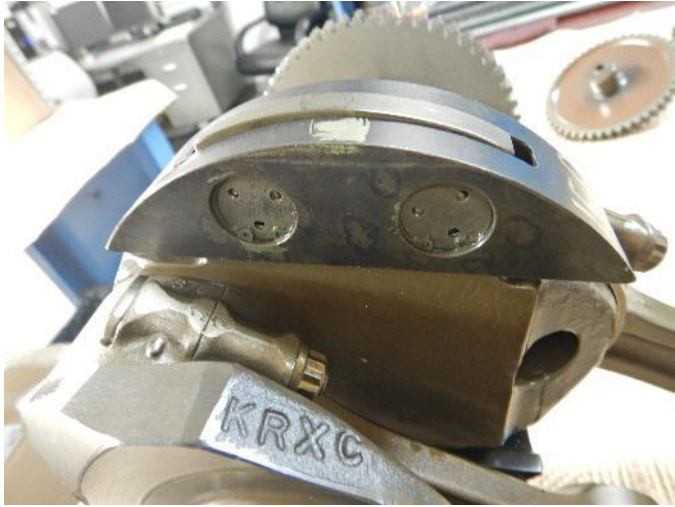
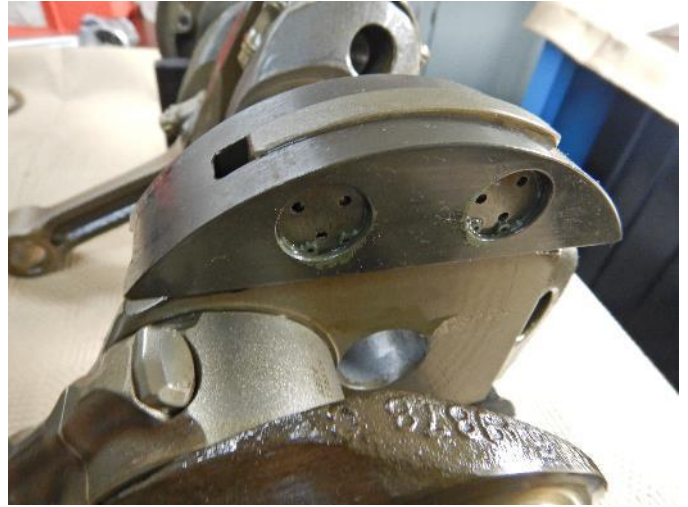
Torsion dampers/counterweights were free to move on pins. Plate and snap rings intact and correctly oriented.

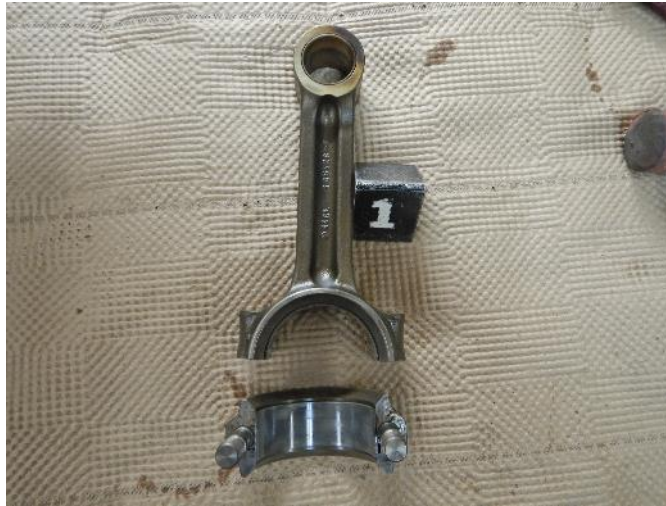
The bearing exhibited normal wear patterns

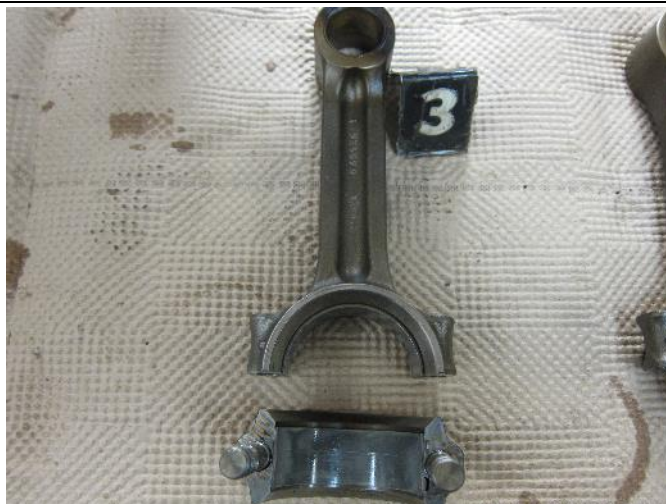
**#3 CONNECTING  
ROD**

The bearing exhibited normal wear patterns

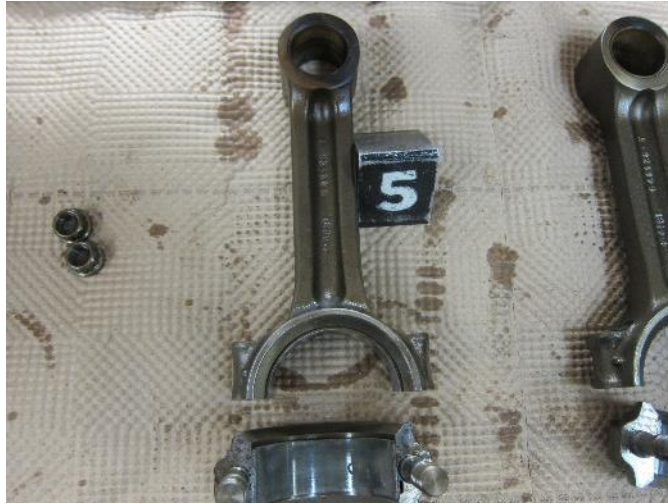
The bearing exhibited normal wear patterns

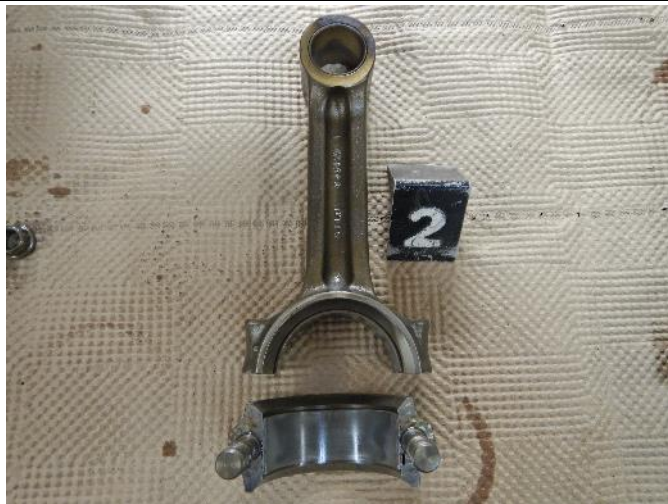
**#2 CONNECTING  
ROD**

The bearing exhibited normal wear patterns

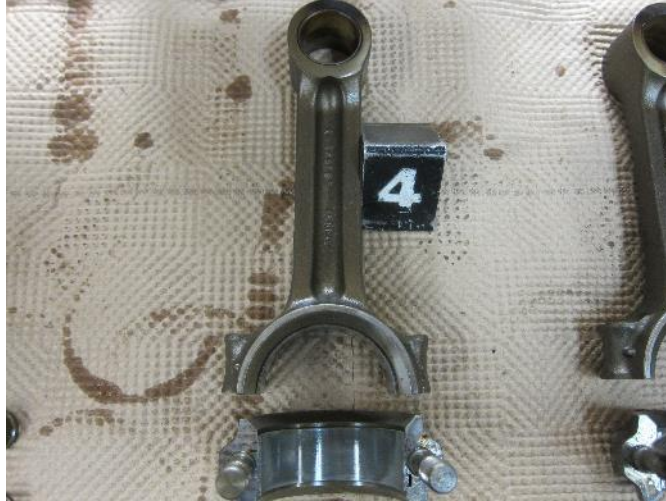
The bearing exhibited normal wear patterns

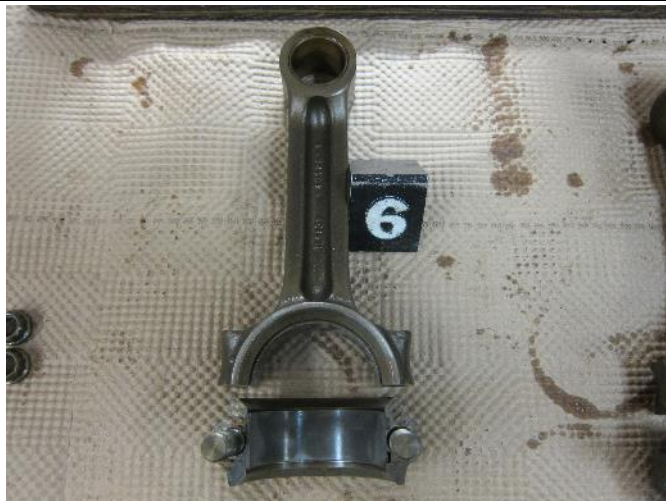
**#6 CONNECTING  
ROD**

The bearing exhibited normal wear patterns

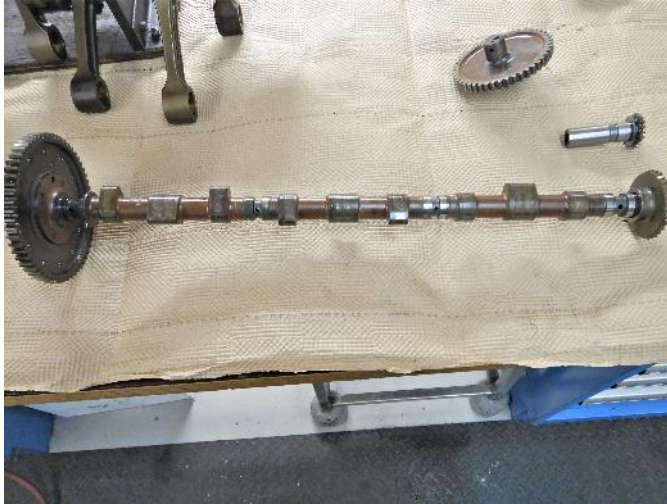
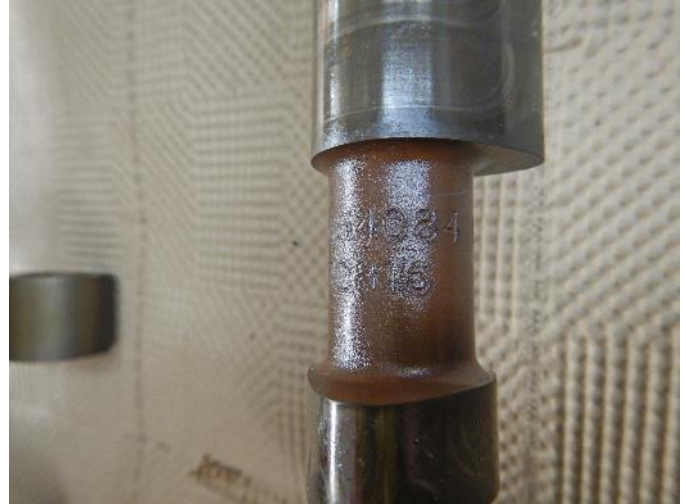
The Camshaft exhibited normal operating signatures.

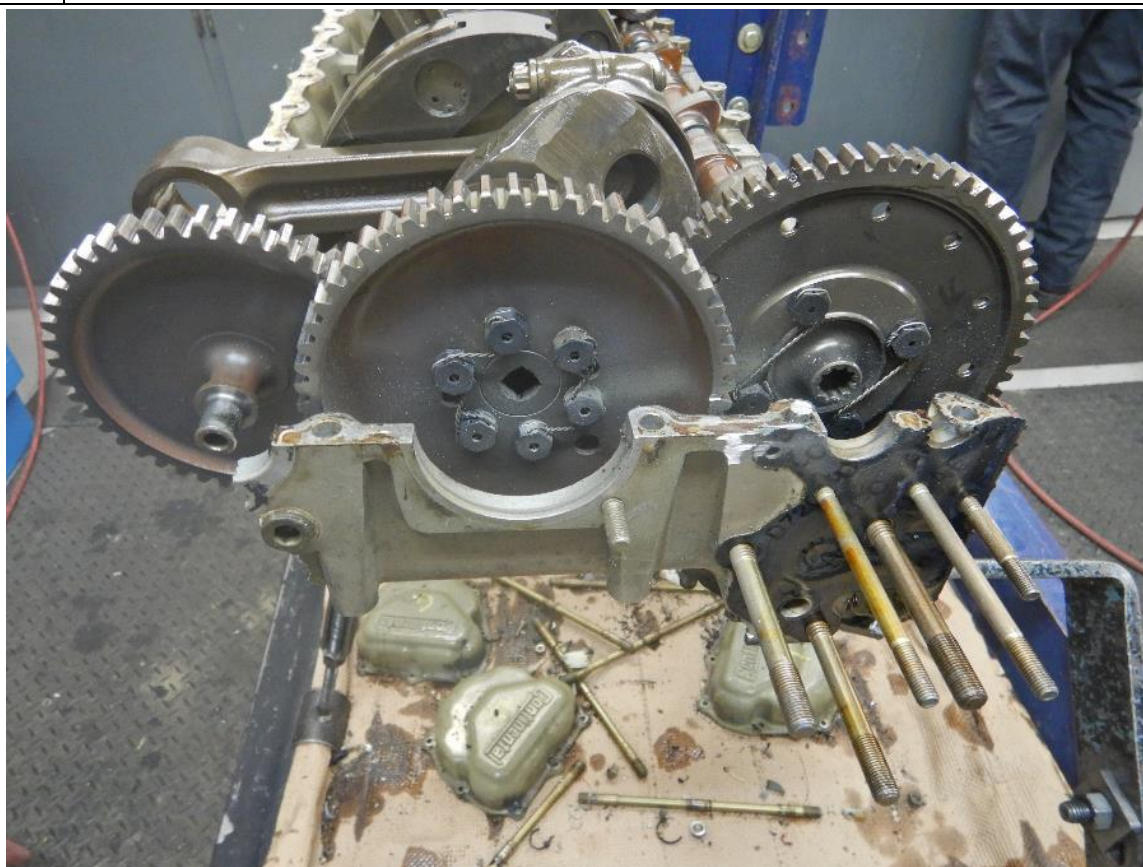
All accessory gears were intact and exhibited normal operating signatures.

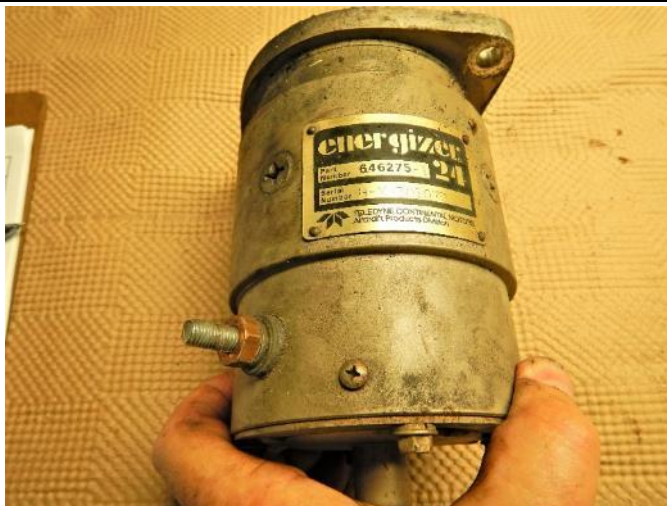
The starter exhibited normal operating signatures.

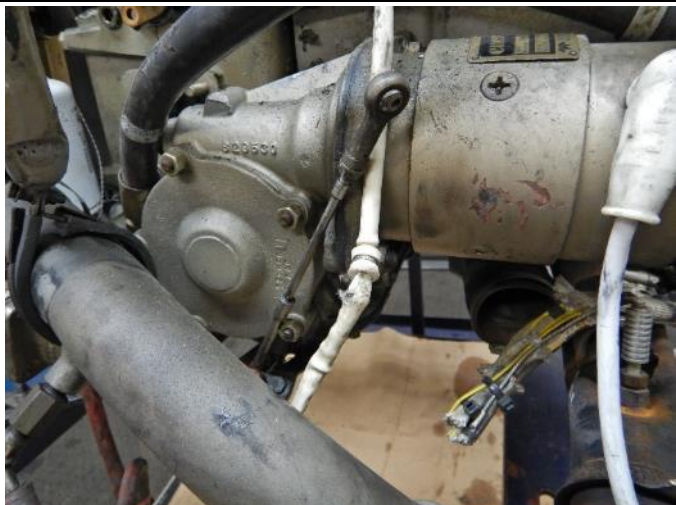
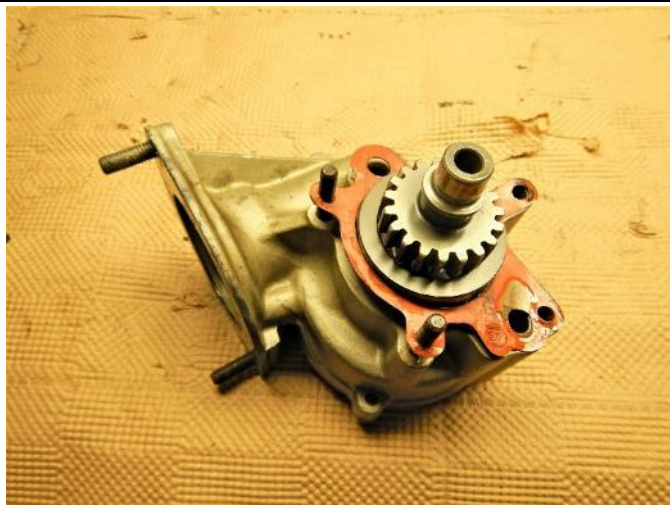
### STARTER ADAPTER

The starter adapter shaft rotated normally. Spring and gear were intact.

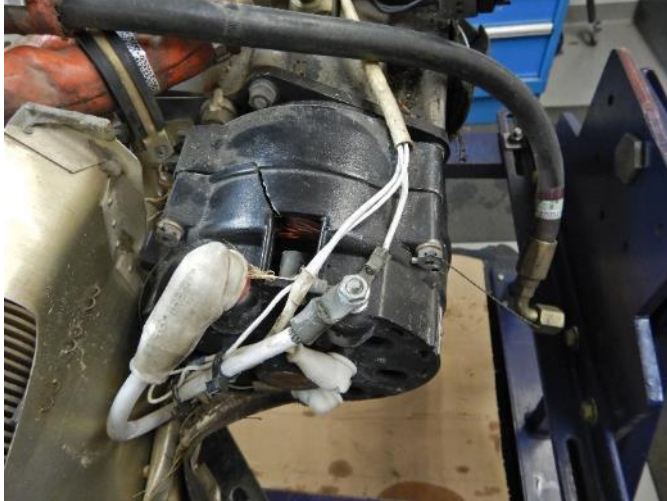
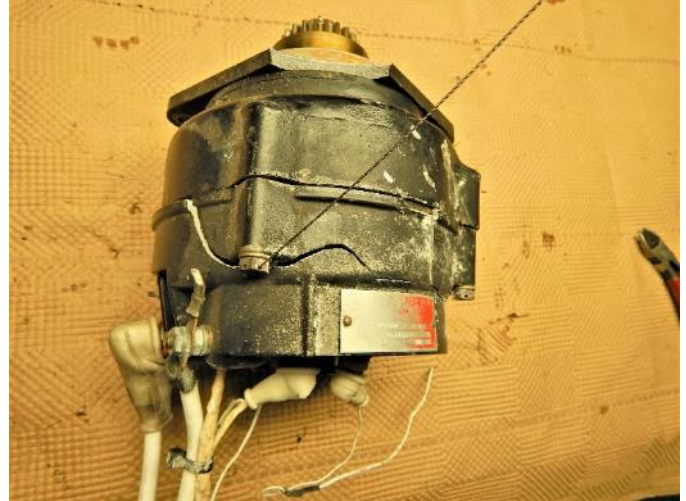
The alternator case including mounting ears were impact damaged. The alternator rotated normally, and the coupling was intact.

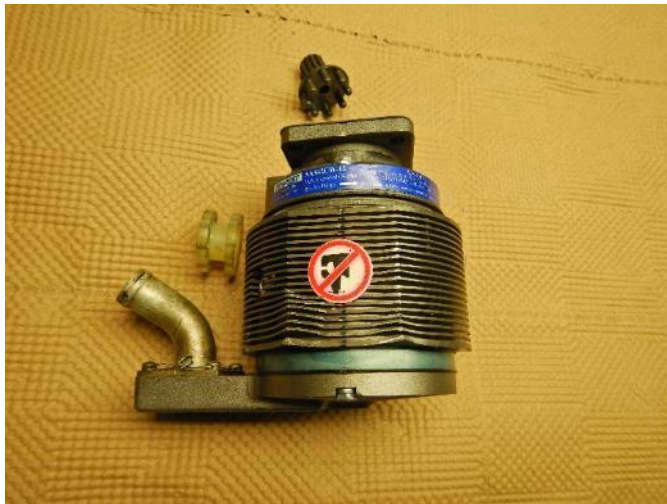
## VACUUM PUMP

The outside pump housing was impact damaged. The carbon rotor and vanes were intact. The drive couplings were intact. The pressure plate and housing exhibited normal wear signatures.
