# ENGINE EXAMINATION REPORT

| AIRCRAFT MAKE & MODEL | Beechcraft 58 Baron |
| FILE NUMBER | 18-383 |

| EXAMINATION | | ACCIDENT DATA | |
|---|---|---|---|
| <b>DATE</b> | 10-8-2019 | <b>NTSB ACCIDENT #</b> | CEN19FA124 |

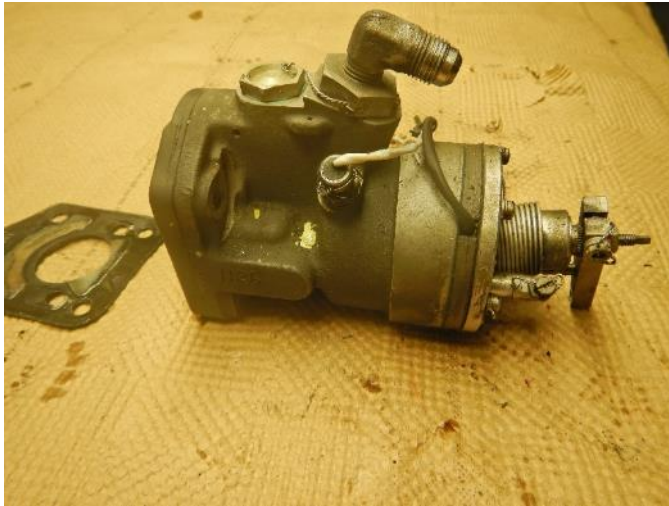
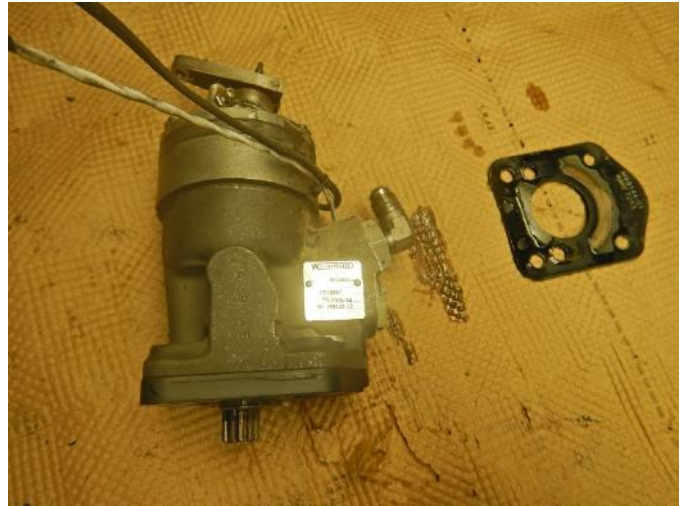
Shaft rotates freely and oil is discharged when rotated. Gasket screen was clean. control arm was secured.

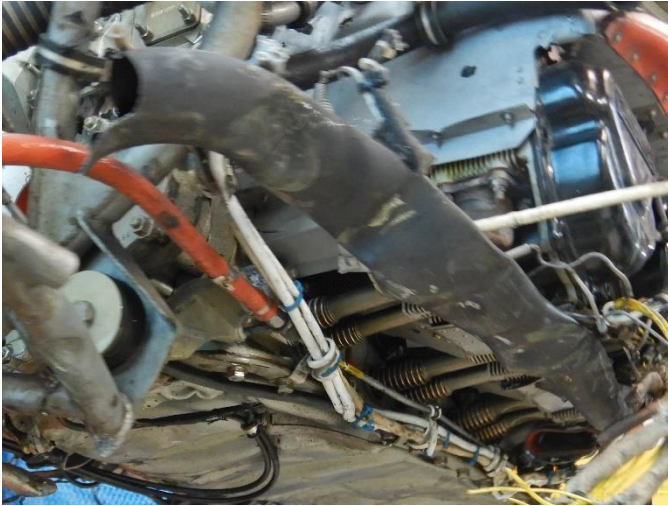
#### EXHAUST SYSTEM

Condition: Exhaust components were impact damaged.

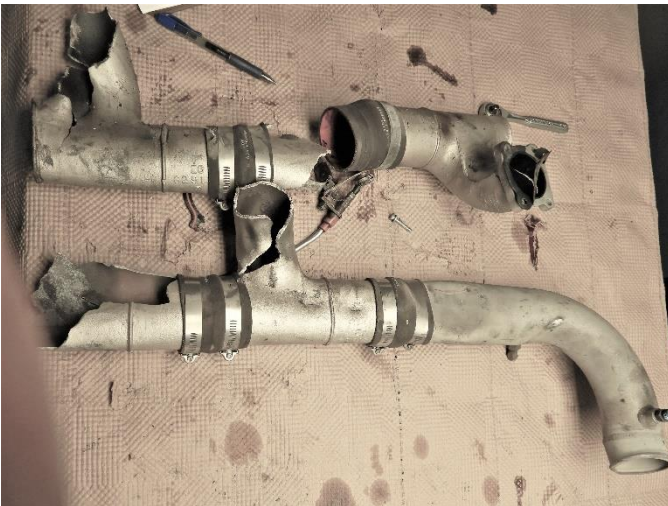
#### INDUCTION SYSTEM

Condition: Several induction components exhibited impact damage.

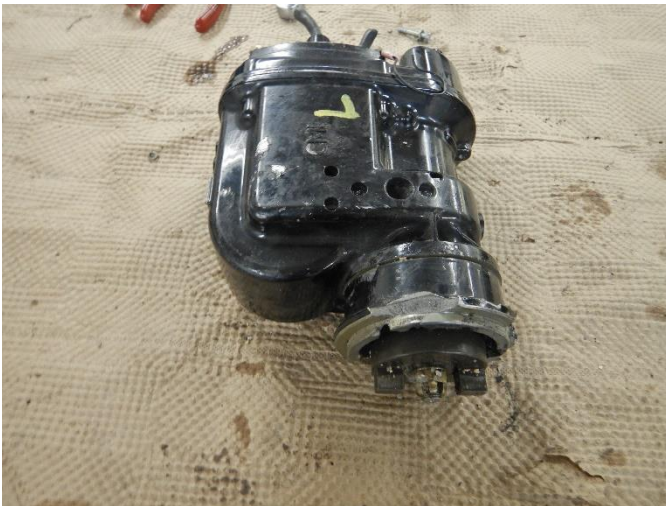
| <b>LEFT MAGNETO</b> | Manufacturer: Continental<br>Factory Rebuilt | M/N: S6RN-1225 | S/N: F17CA251R |

| Condition: | The mount flange was impact damaged. The impulse coupling released normally, and the magneto functional test was normal. | | |

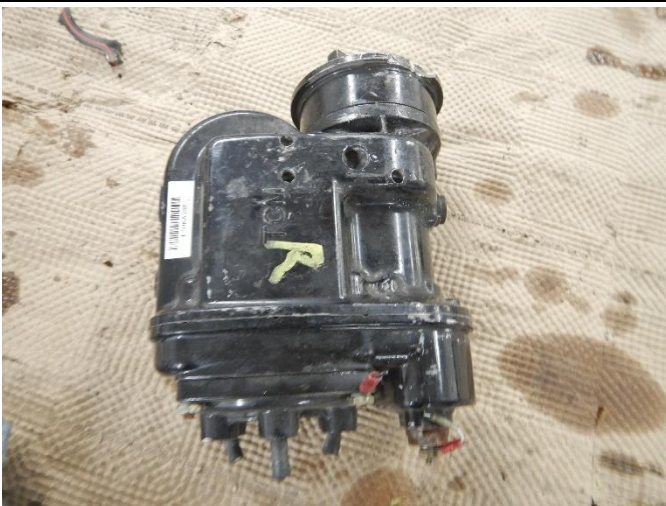
| <b>RIGHT MAGNETO</b> | Manufacturer: Continental<br>Alpha Systems | M/N: S6RN-1225 | S/N: F10KA188 |

| Condition: | The mount flange was impact damaged. The impulse coupling released normally, and the magneto functional test was normal. | | |

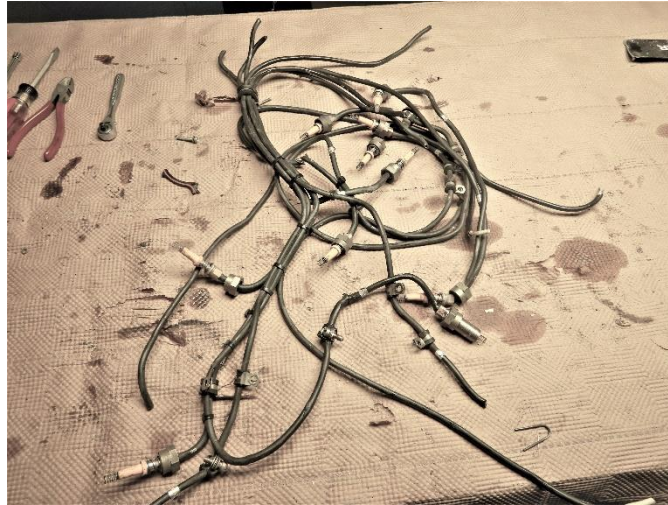
| IGNITION HARNESS | Manufacturer: Undetermined | P/N: Undetermined | S/N: Undetermined |

| Condition: | Individual leads were cut and impact damaged. | | |

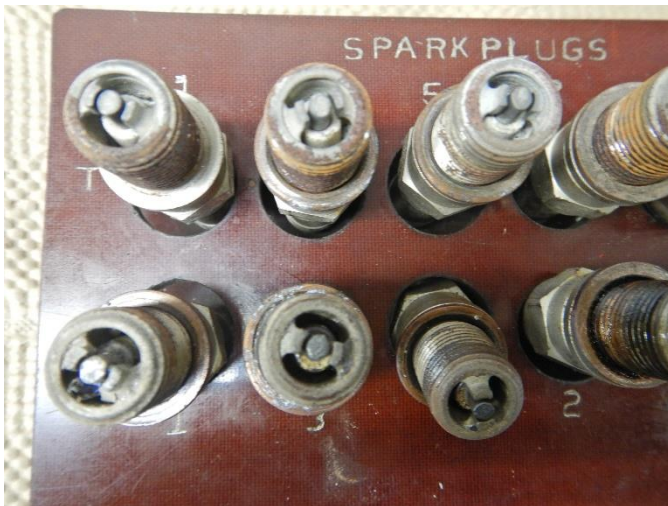
| SPARK PLUGS | Manufacturer: Tempest | P/N: URHB32E |

| Condition: | Top sparkplug # 4 and bottom sparkplug # 5 were impact damaged. When compared to a Champion Sparkplug "Check-A-Plug" chart, the condition was <i>worn out normal</i> with only minimal combustion deposits consistent with a lean fuel mixture. | |

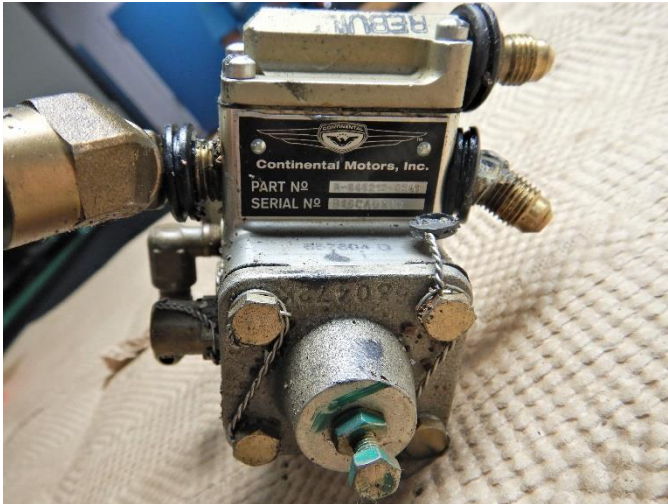
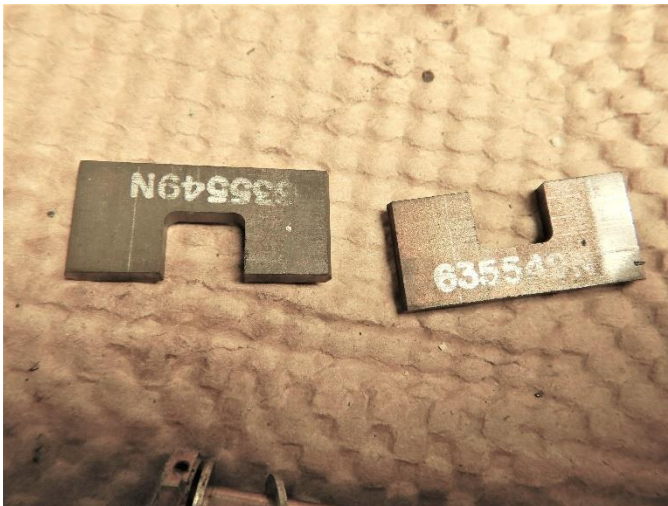
| FUEL PUMP | Manufacturer: Continental | P/N: R646212-55A1 | S/N: B16CA080R |

| FUEL PUMP | Manufacturer: Continental | P/N: R646212-55A1 | S/N: B16CA080R |
|---|---|---|---|
| Condition: | The fuel pump drive coupling was intact, and the fuel pump operated smoothly when manually rotated. A lead seal was present on the assembly bolts. The pump shaft would not slide from case bushing due to light corrosion on steel shaft. | | |

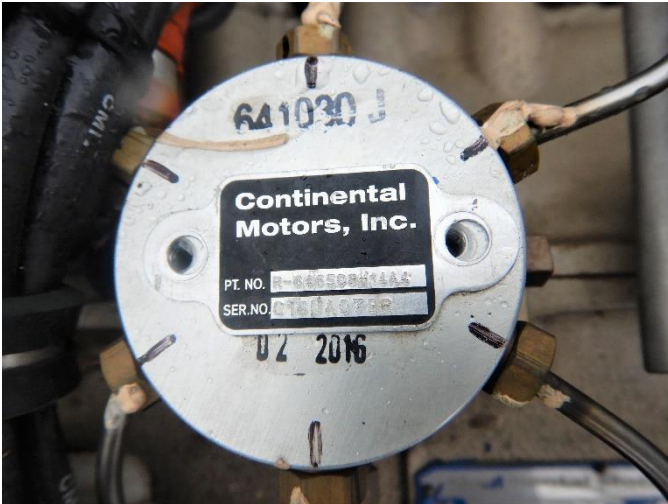
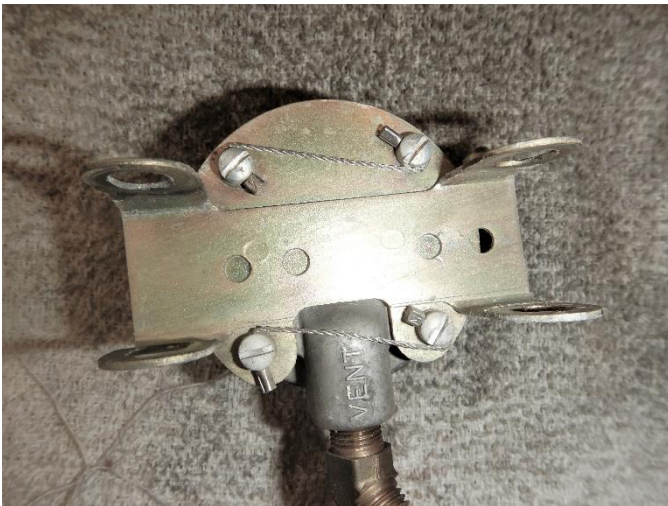
The fuel manifold data plate was removed by unknown persons at the accident site. The two assembly screws were missing. The data plate was located on the crankcase near the fuel manifold mount. The photo below on the top left is from the accident site. Assembly hardware was secured properly.

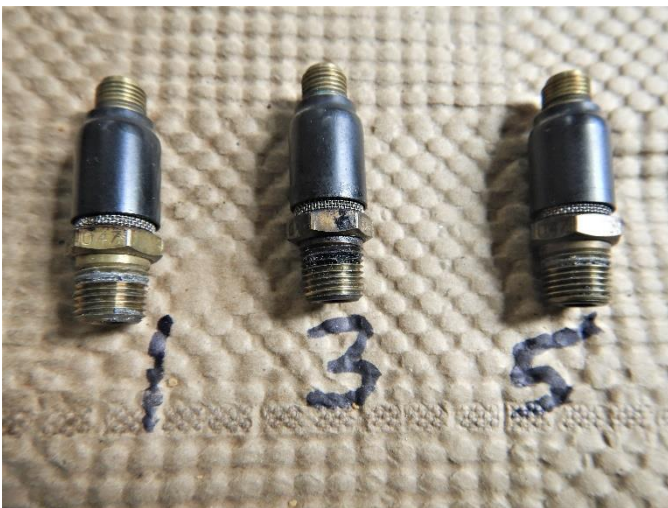
| Position | #1 | #3 | #5 | #2 | #4 | #6 |
|---|---|---|---|---|---|---|
| Condition: | All injection orifices were open. Injector # 4 was impact damaged. | | | | | |

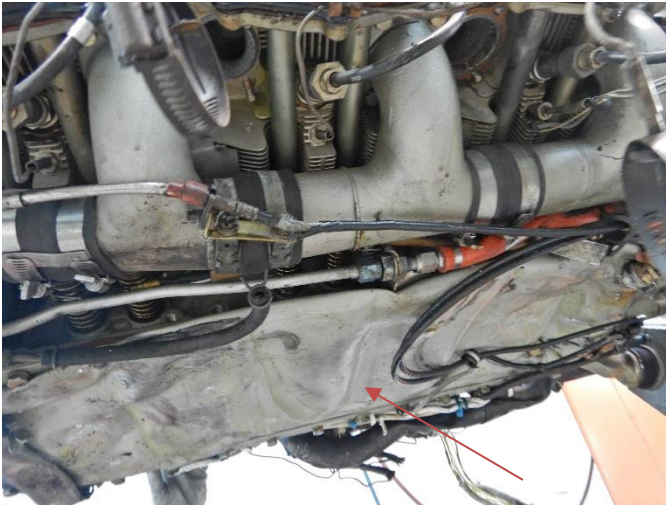
#### OIL SUMP

Condition: The oil sump was impact damaged.

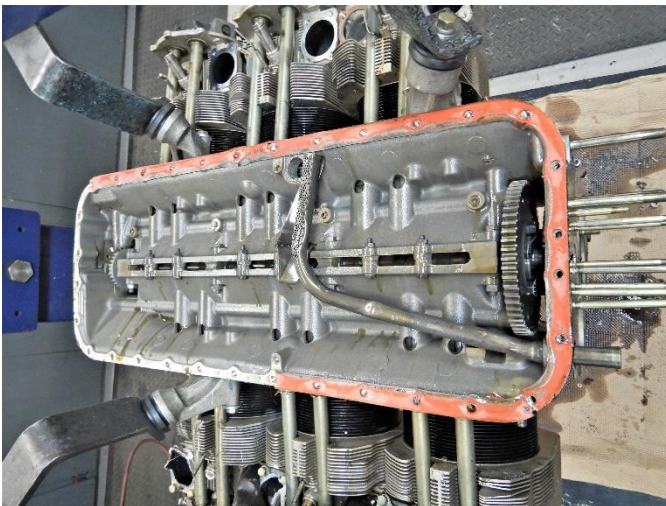
#### OIL PICK-UP TUBE & SCREEN

Condition: The pick-up tube was displaced upward due to impact forces. The screen was clean.

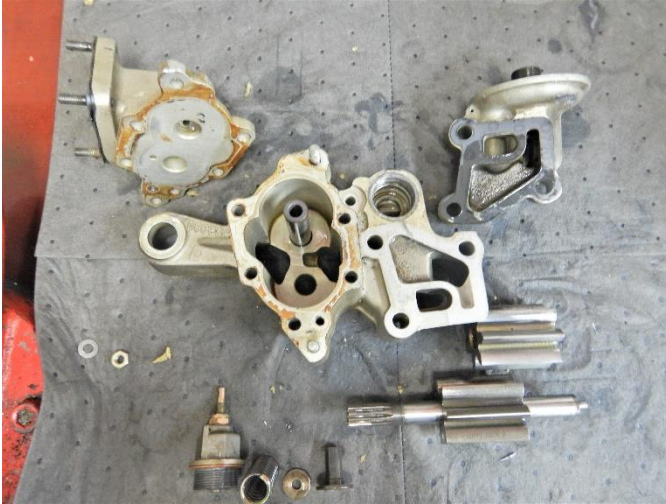
There was no evidence of hard particle passage on gears, pump cavity, or end plate.

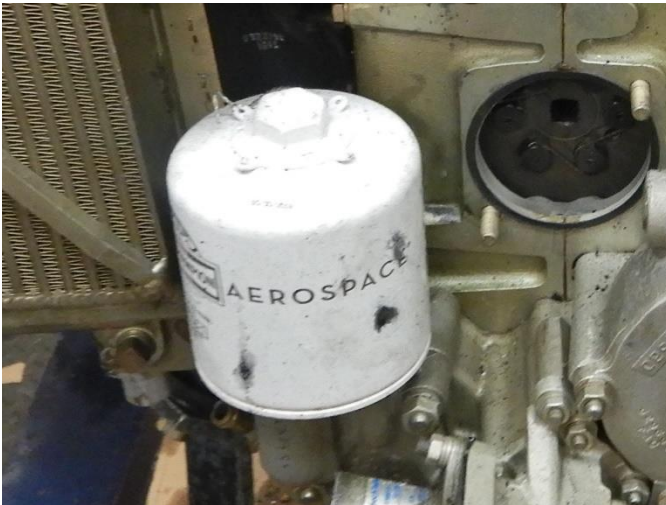
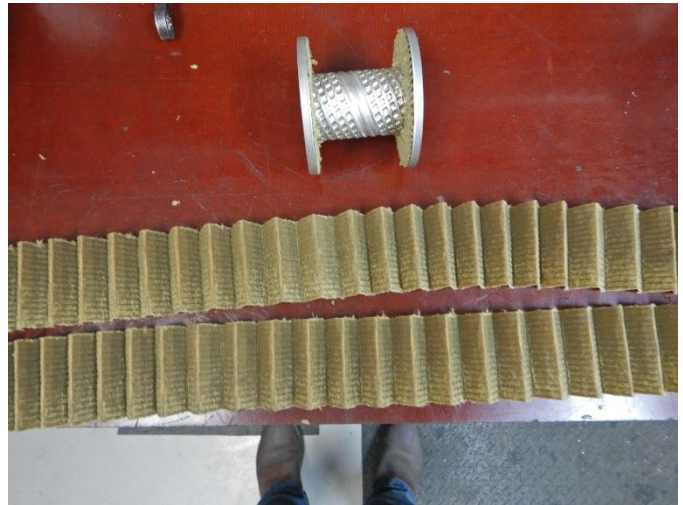
## OIL FILTER

No metal contamination found in filter media.

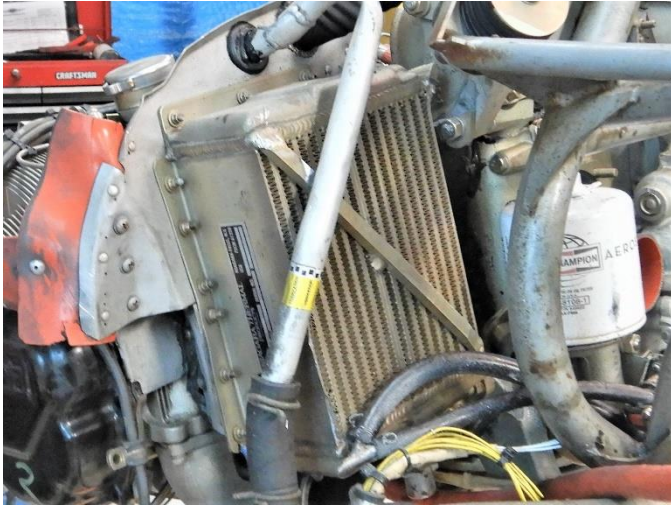
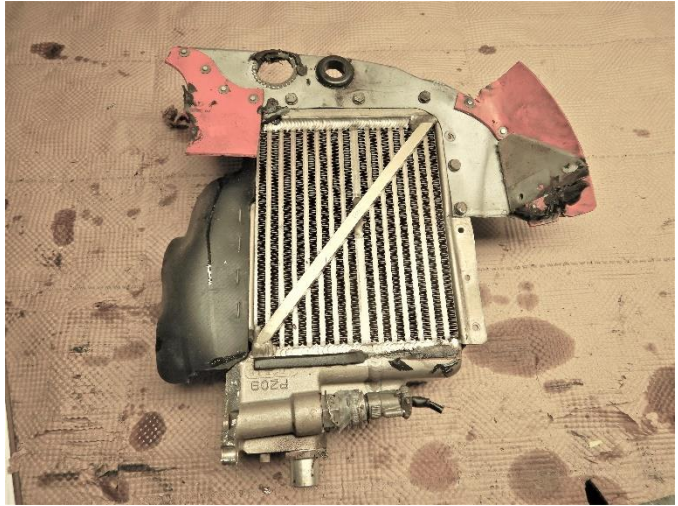
| Condition: | The oil cooler was intact with minor damage to the attachment flange. | | | |

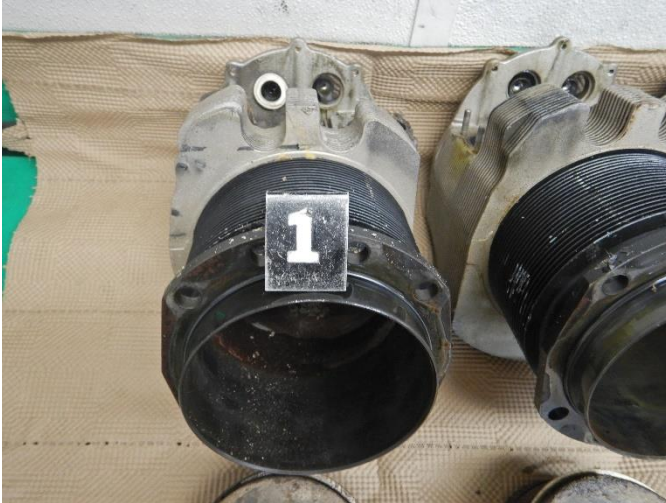
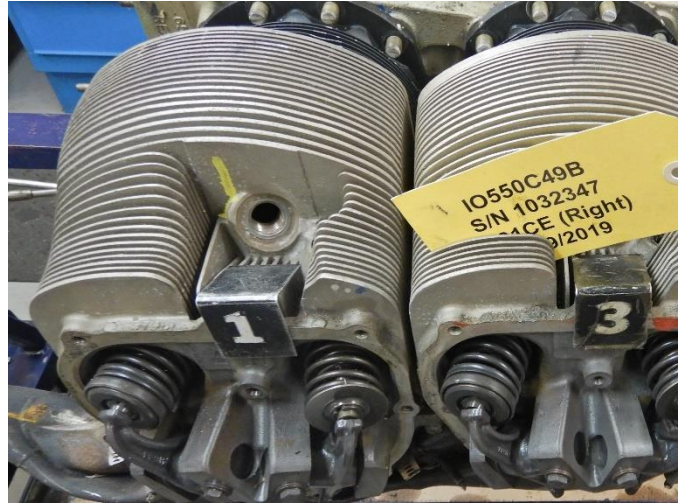
| Condition: | Cylinder exhibited normal operating signatures. | | |

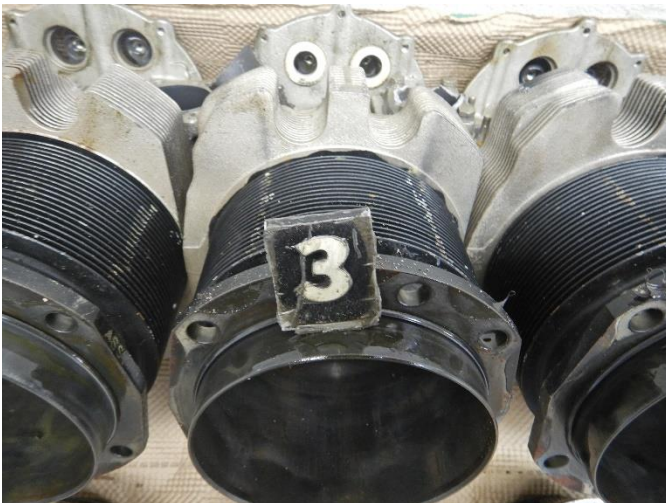
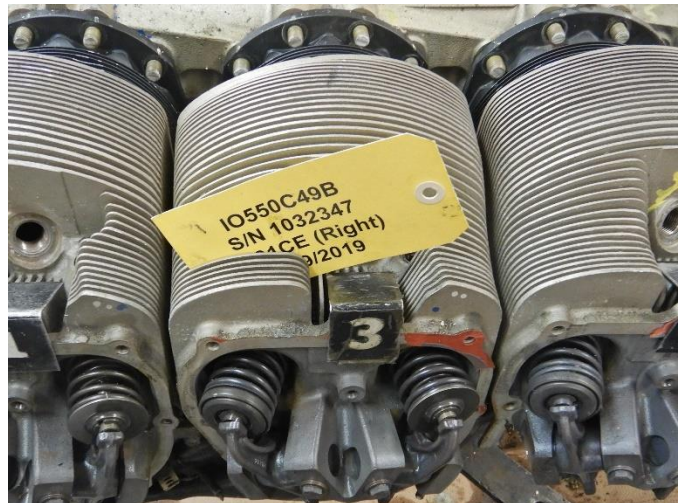
| Condition: | Cylinder exhibited normal operating signatures. | | |

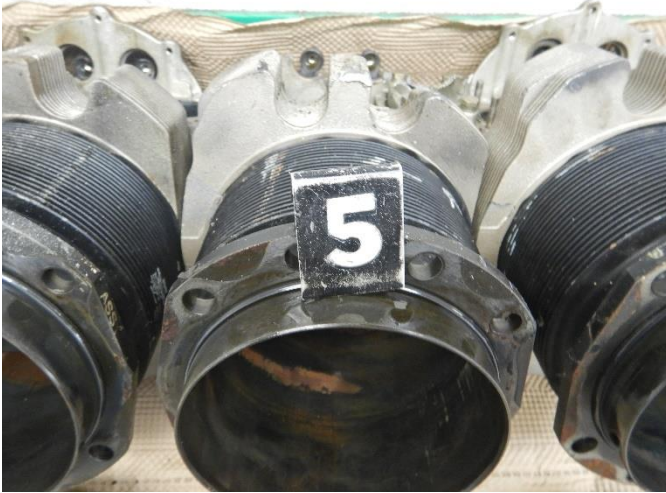
| Condition: | Cylinder # 5 exhibited impact damage to the lower cylinder head and push rods. | | |

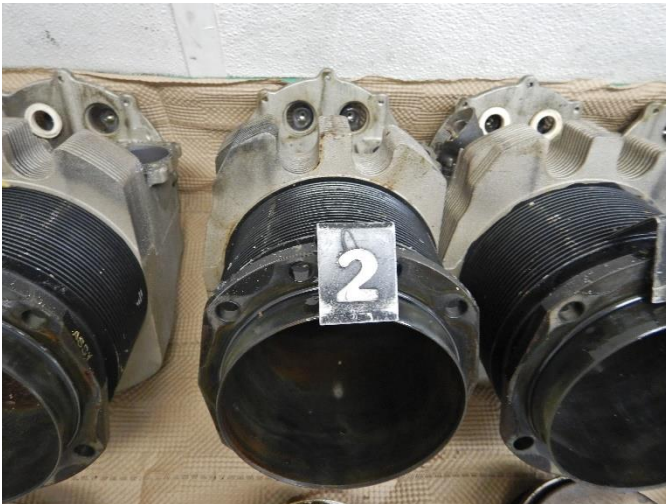
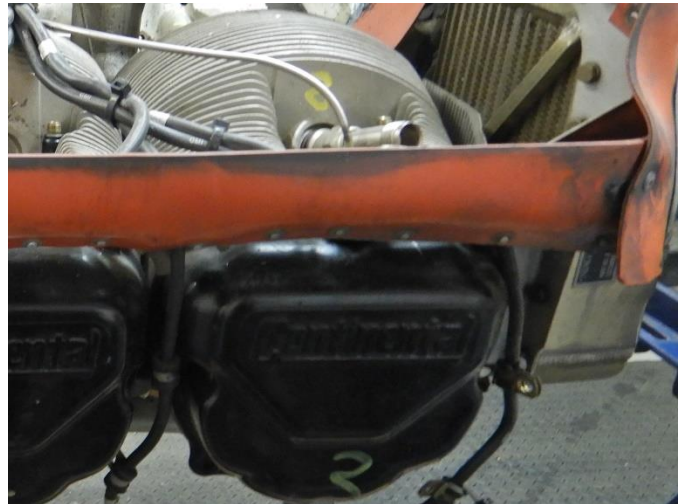
| Condition: | Cylinder exhibited normal operating signatures. | | |

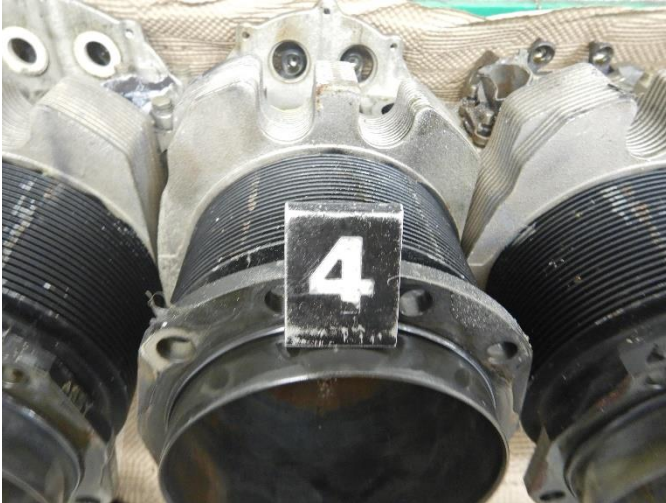
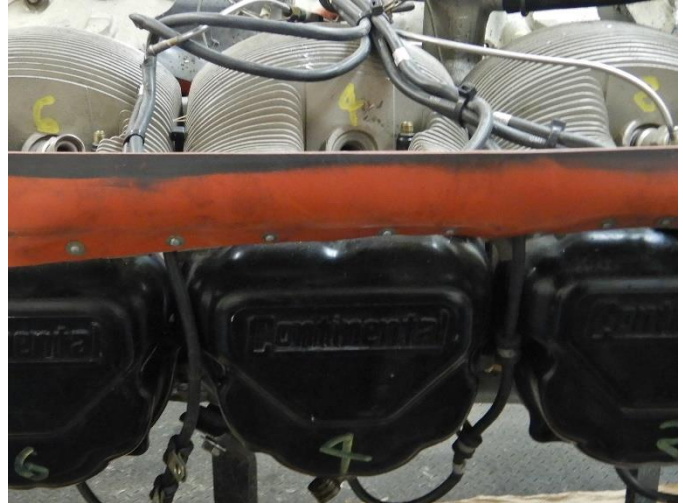
| Condition: | Cylinder exhibited normal operating signatures. | | |

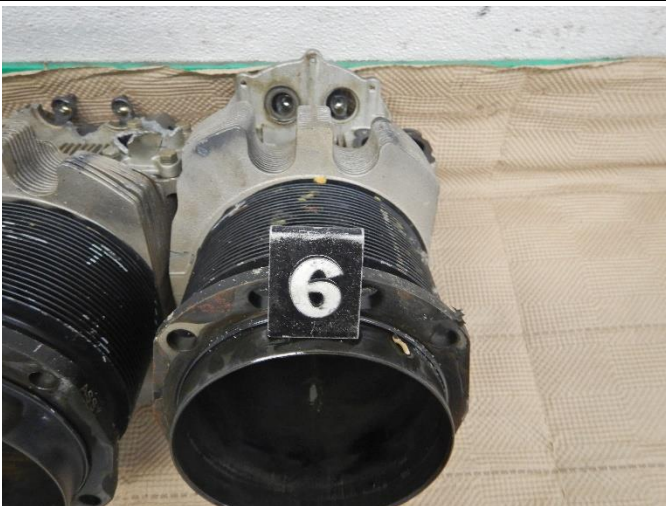
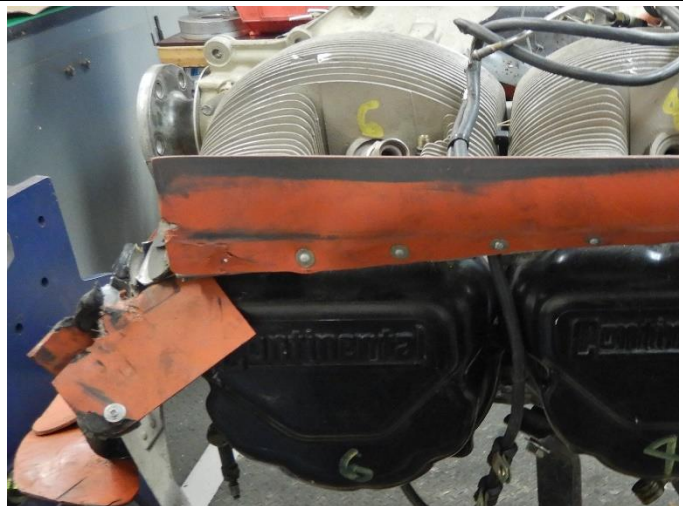
| <b>CYLINDER #6</b> | P/N: 658552A1 | S/N: AC16BA109 | Head Date: 3/16 |

| Condition: | Cylinder exhibited normal operating signatures. | | |

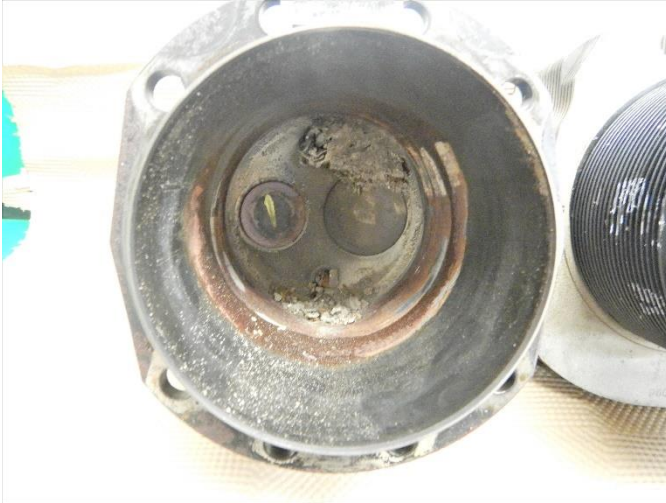
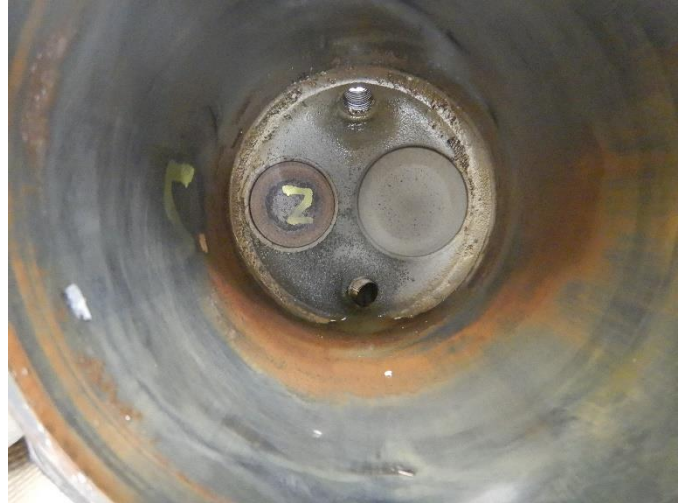
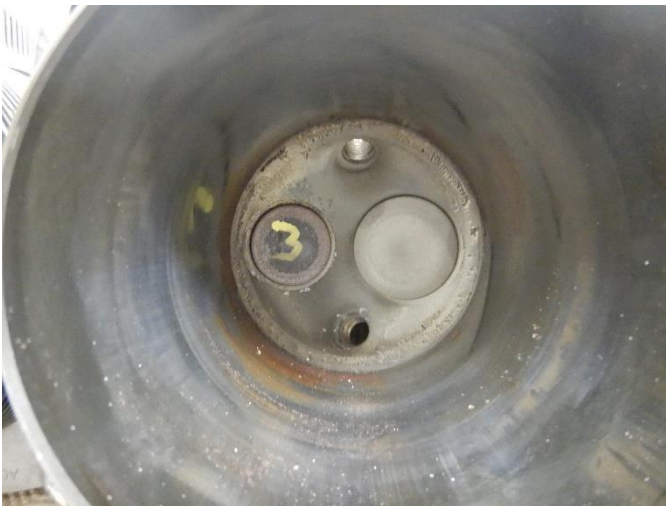
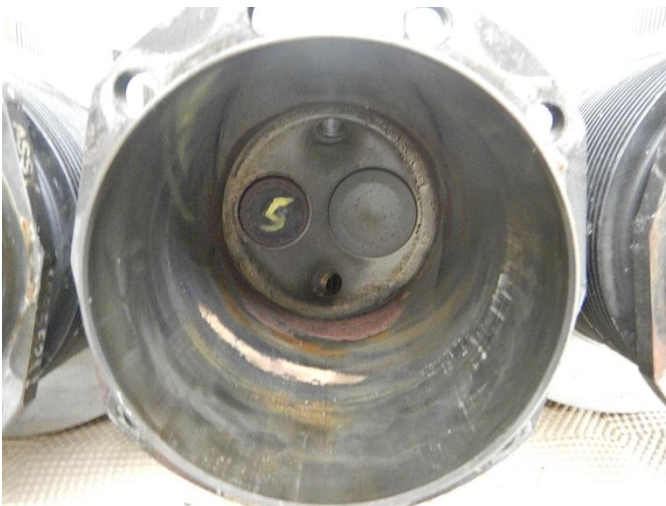
All valves were intact. Valve heads and combustion chambers were nearly devoid of combustion deposits.

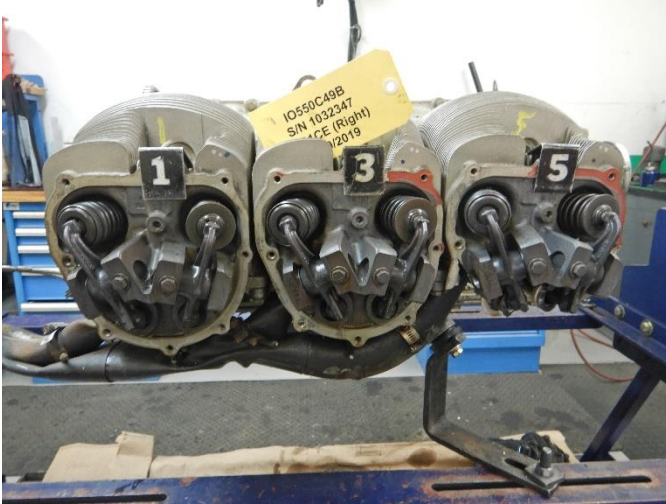
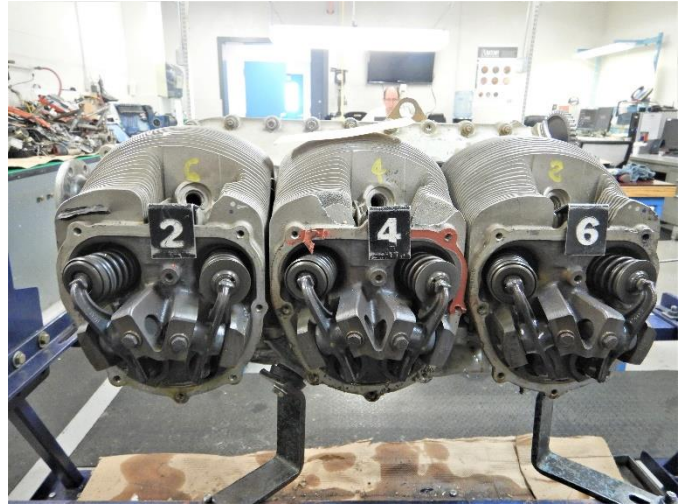
### ROCKER ARMS AND SHAFTS

Condition: All rocker arms and shafts were intact and in place. Pushrods for cylinder # 5 were impact damaged.

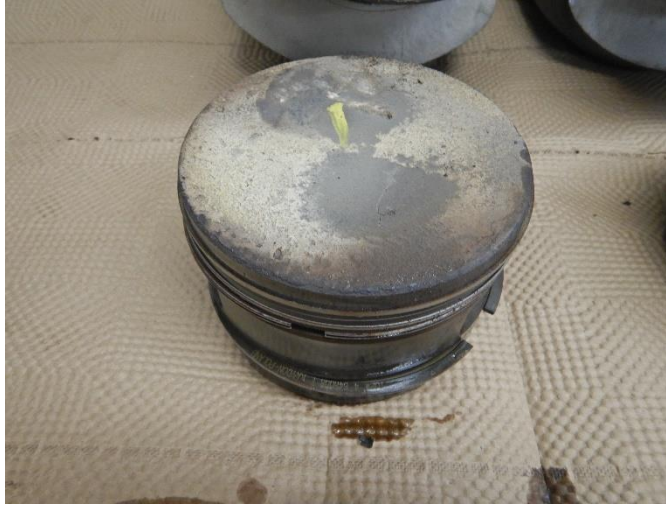
The piston was intact with light combustion deposits. The rings were intact and free in their grooves.

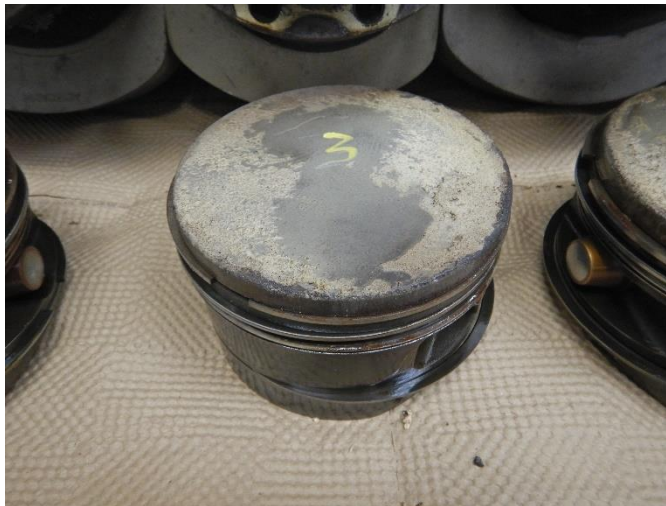
### #3 PISTON, RINGS AND PIN

The piston was intact with light combustion deposits. The rings were intact and free in their grooves.

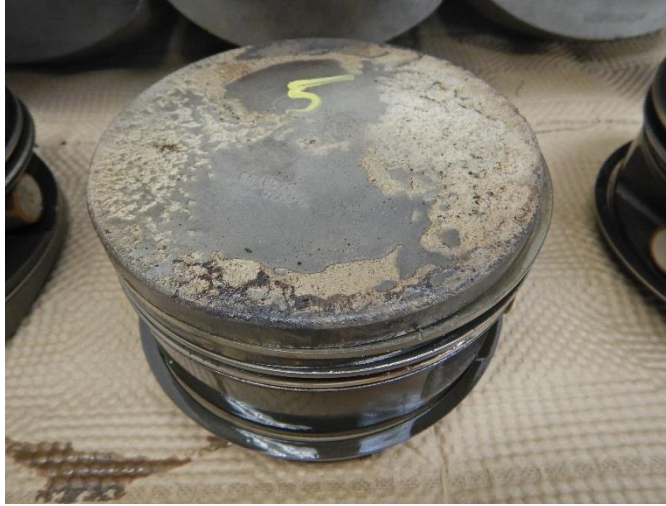
The piston was intact with light combustion deposits. The rings were intact and free in their grooves.

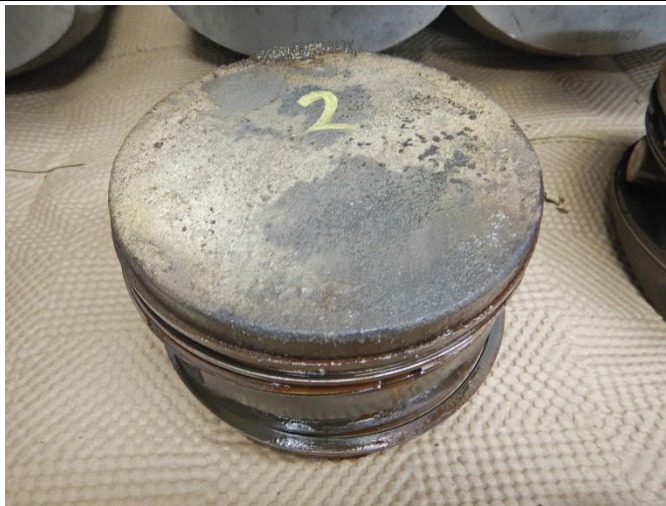
## #2 PISTON, RINGS AND PIN

The piston was intact with light combustion deposits. The rings were intact and free in their grooves.

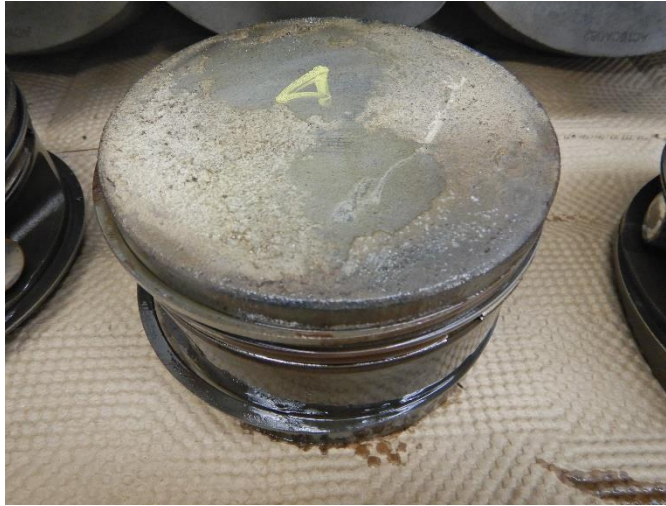
The piston was intact with light combustion deposits. The rings were intact and free in their grooves.

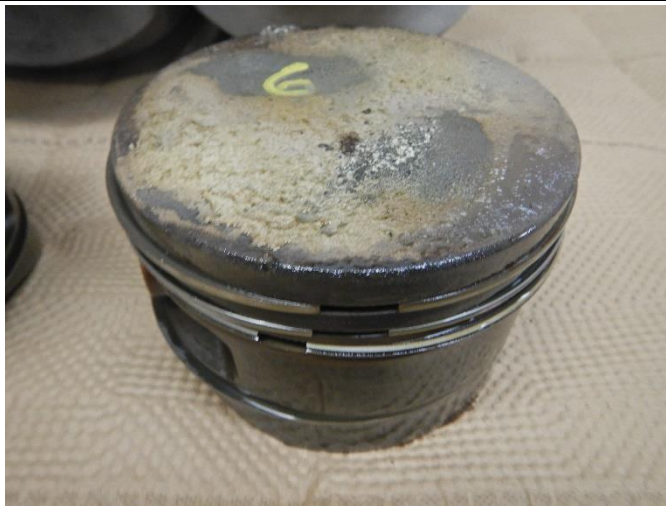
## #6 PISTON, RINGS AND PIN

The piston was intact with light combustion deposits. The rings were intact and free in their grooves.

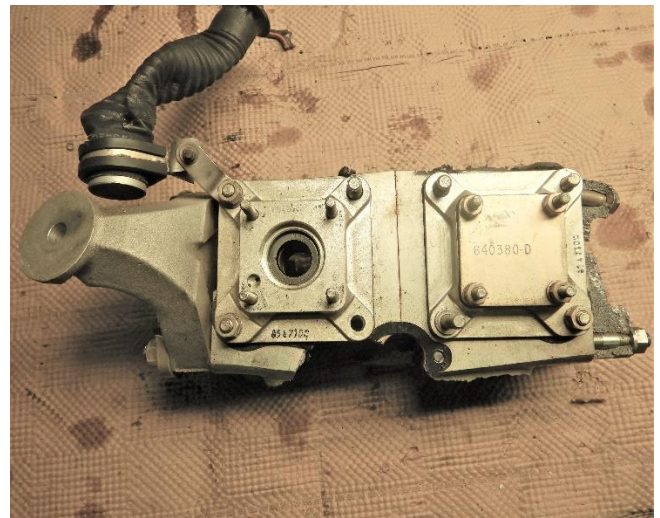
| Condition: | The rear-top portion of the crankcase at the magneto mount/top engine mount separated due to impact damage. The top section released during the engine examination. | | | |

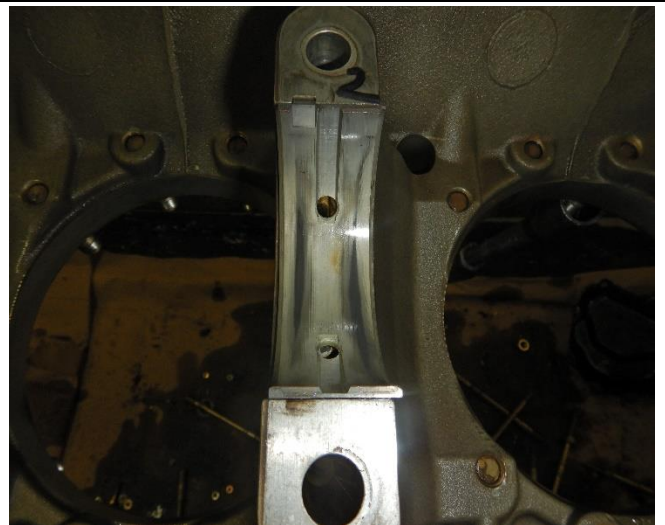
## #2 MAIN BEARINGS

The bearing exhibited normal operating signatures.

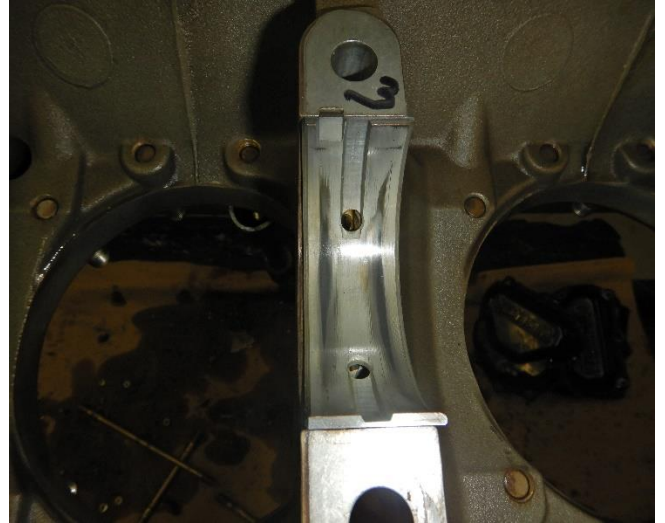
Condition: The bearing exhibited normal operating signatures.

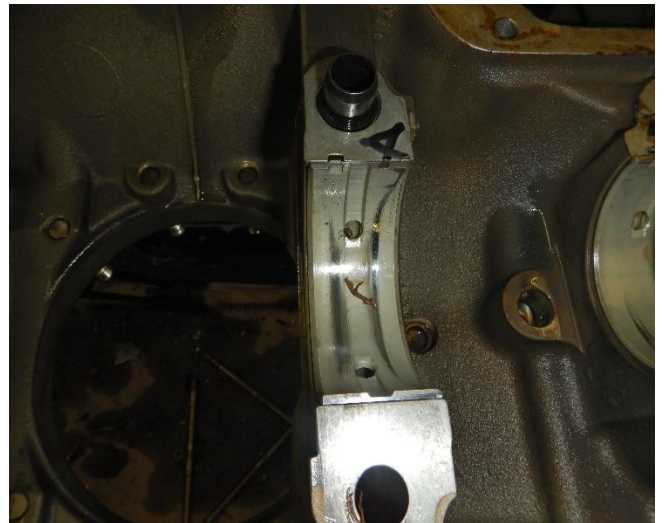
## #4 MAIN BEARINGS

Condition: The bearing exhibited normal operating signatures.

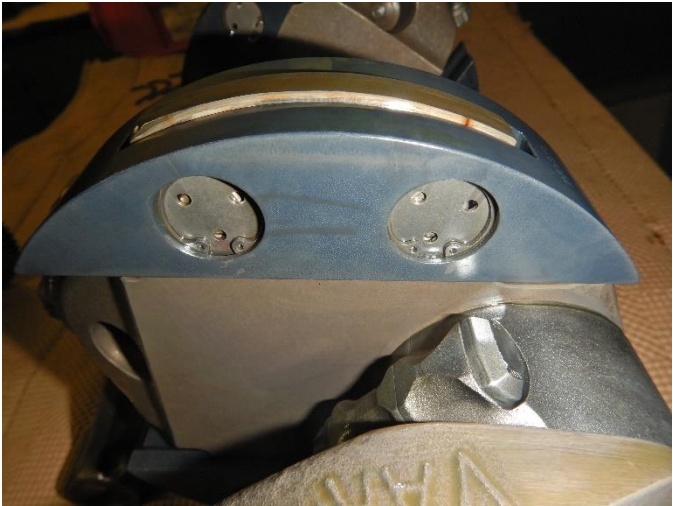
| COUNTER WEIGHTS | |

| Condition: | Dampers floated freely on pins. All plates and snap rings were intact and oriented correctly. |

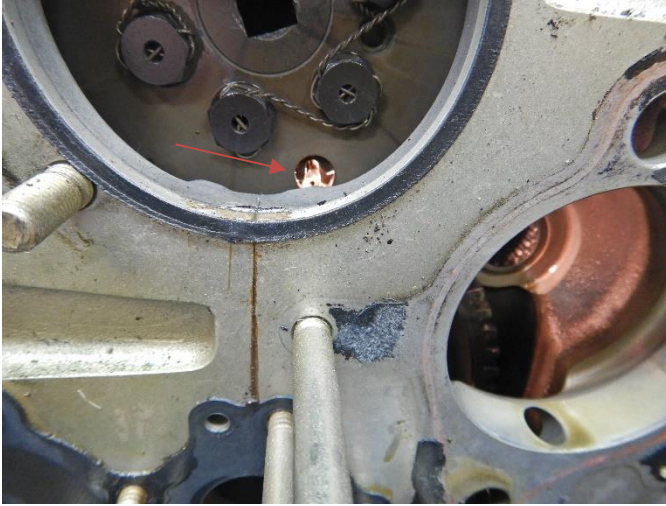
## INTERNAL TIMING

Condition: Correct internal timing was verified.

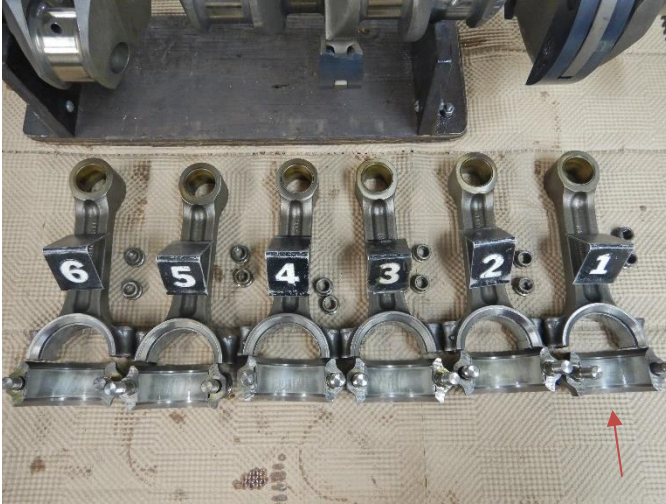
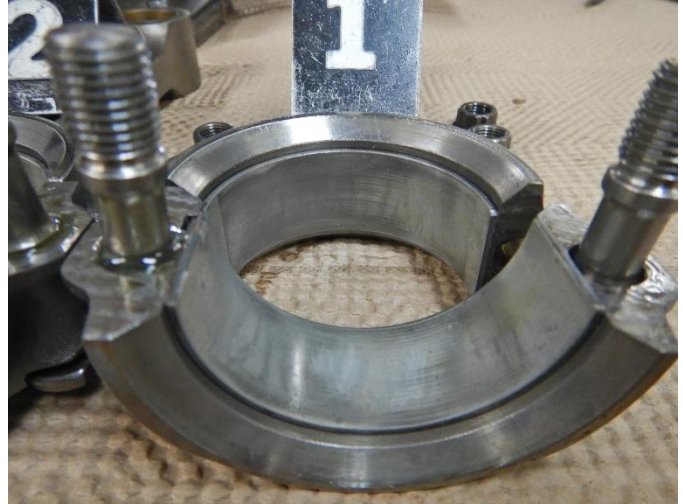
Condition: The connecting rod exhibited normal operating signatures.

Condition: Bearing exhibited normal operating signatures.

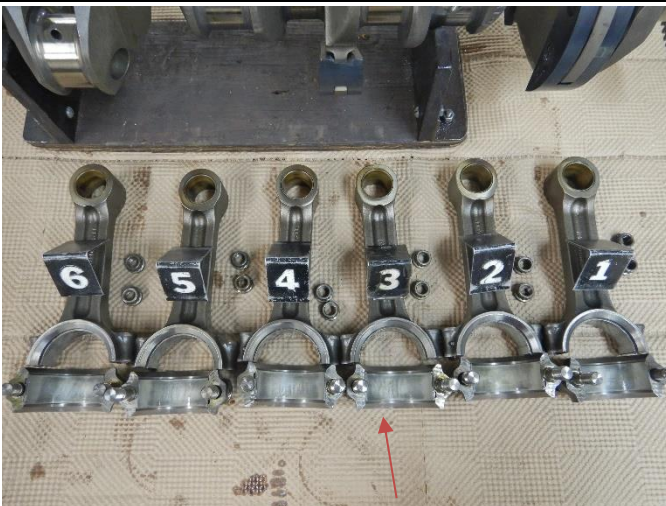
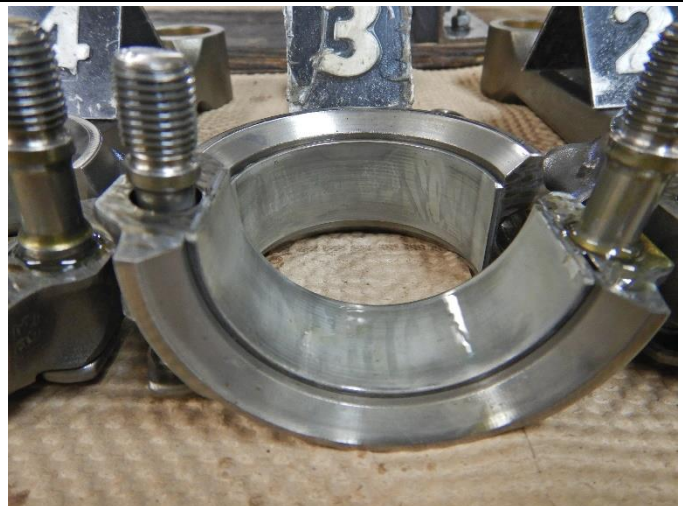
Condition: The connecting rod exhibited normal operating signatures.

Condition: Bearing exhibited normal operating signatures.

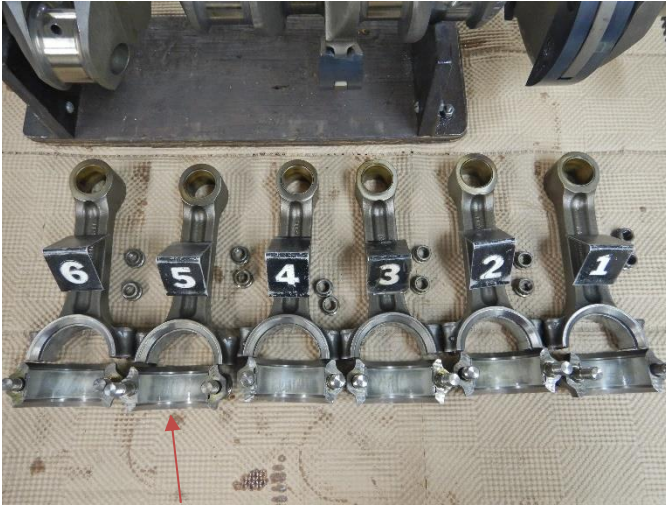
Condition: The connecting rod exhibited normal operating signatures.

Condition: Bearing exhibited normal operating signatures.

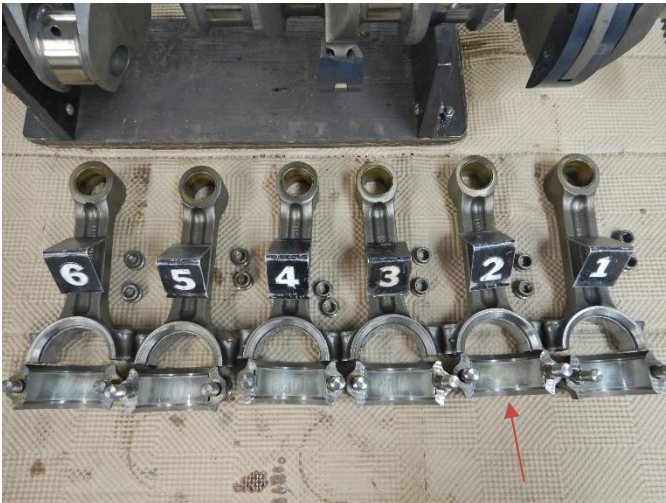
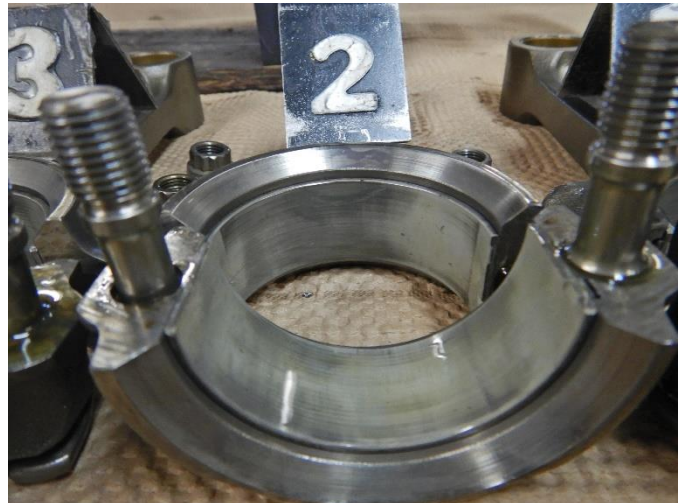
## #2 CONNECTING ROD

Condition: The connecting rod exhibited normal operating signatures.

Condition: Bearing exhibited normal operating signatures.

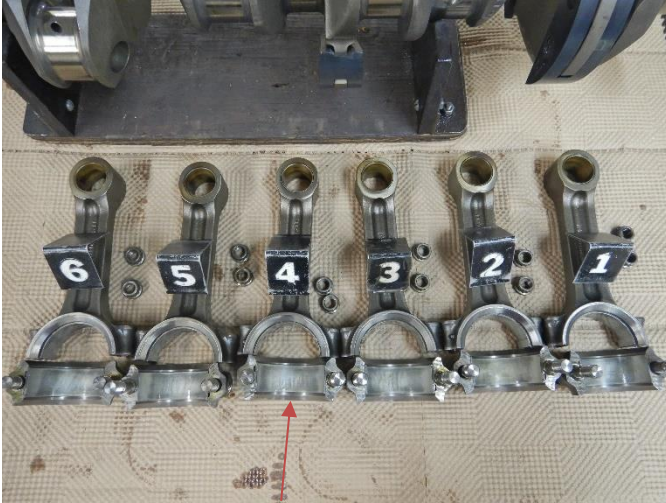
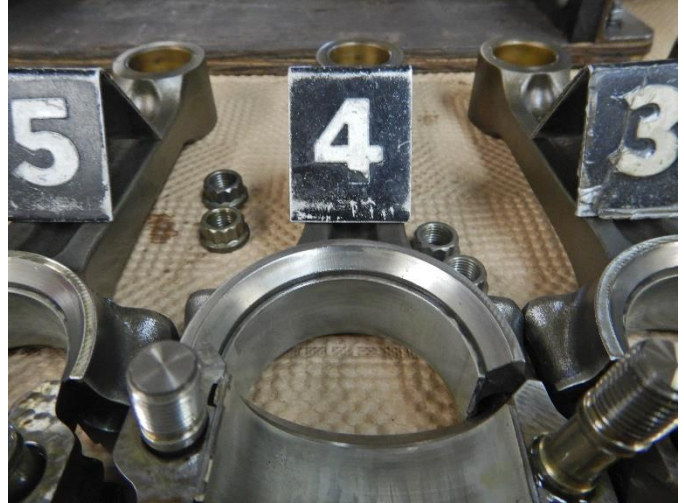
| #4 CONNECTING ROD BEARING | P/N: 642398 | |

| Condition: | The connecting rod exhibited normal operating signatures. | |
| Condition: | Bearing exhibited normal operating signatures. | |

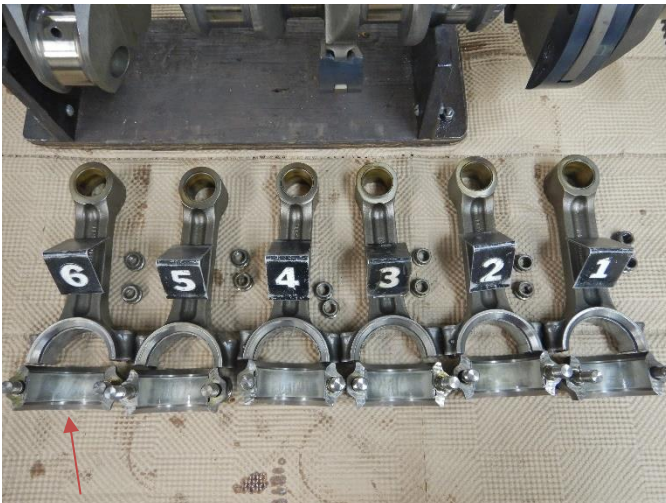
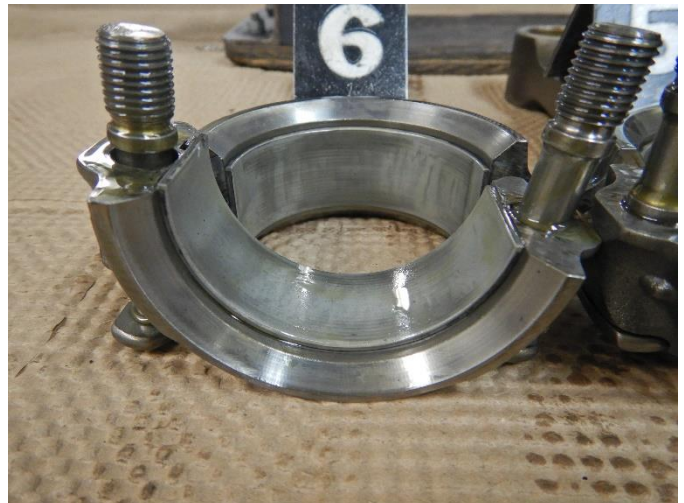
| #6 CONNECTING ROD | P/N: 655911 | Forging or Serial Number: AE16DA171 |

| Condition: | The connecting rod exhibited normal operating signatures. | |
| Condition: | Bearing exhibited normal operating signatures. | |

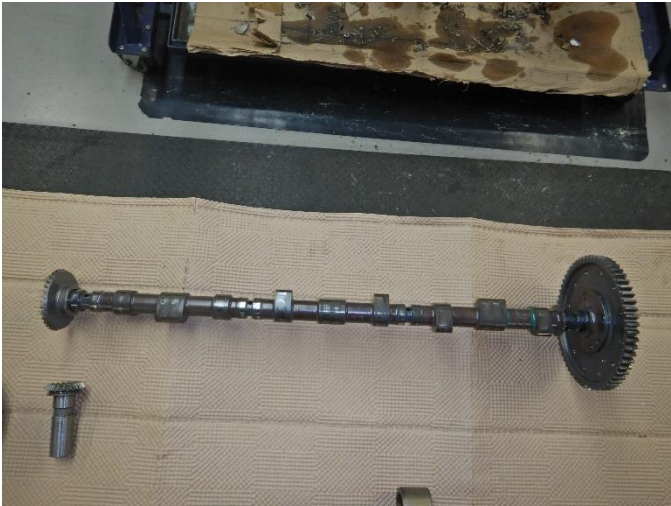
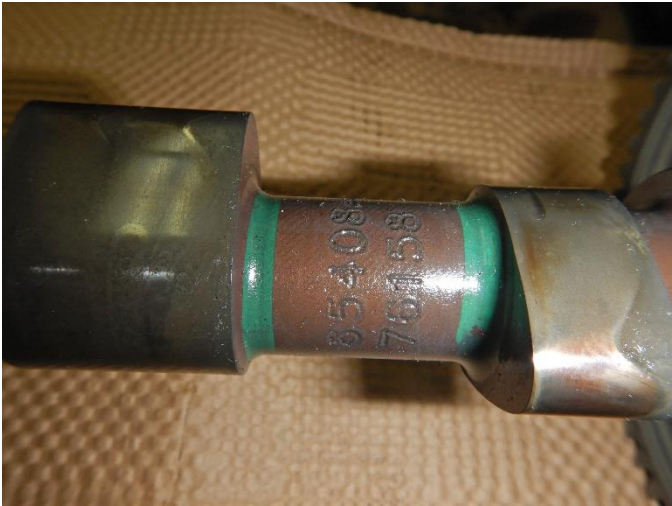
| CAMSHAFT | P/N: 654084 | S/N: 76158 |

| Condition: | Exhibited normal operating signatures. | |
